# APPENDIX B PHOTOGRAPHIC LOG

**PHOTOGRAPHIC LOG**

**Site Location: BBC Llandaff, Cardiff**

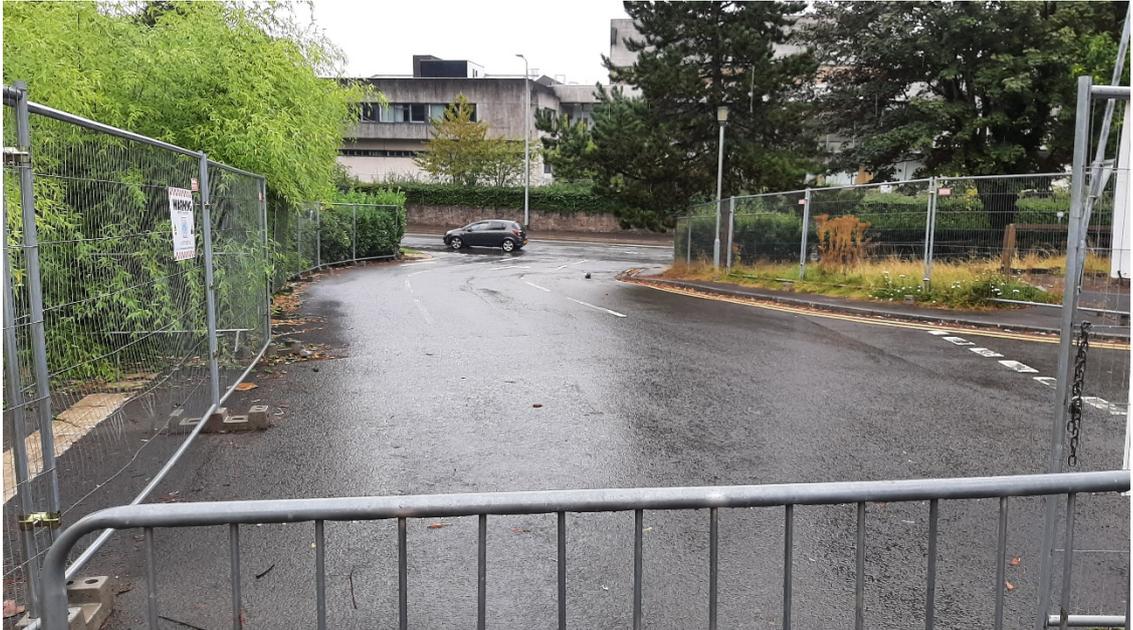
<p><b>Photo No.</b> 32</p>

<p><b>Date:</b> 9<sup>th</sup> Sept 2021</p>	
<p>General view of site entrance, looking north towards Llantrisant Road</p>
