ASBESTOS MANAGEMENT SURVEY REPORT  
SURVEY

3Sixty Waste Management Ltd  
Chapel Farm Ind Est  
Cwmcarn  
NP11 7BH

Asbestos Survey Report No- Doc 043

Date of Report: - 05<sup>th</sup> April 2016

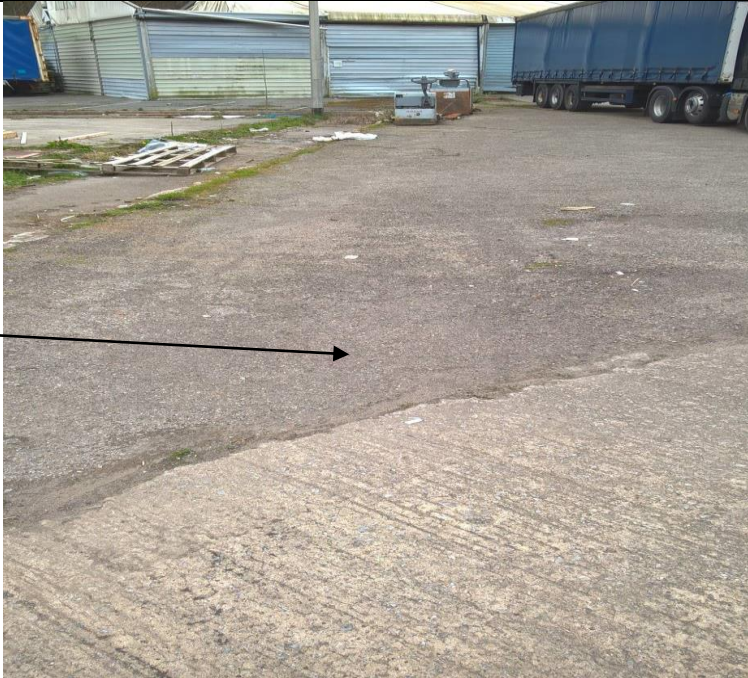
Sample Details	
Sample No	001
Position of Sample	Area -A
Product	Floor Debris
Extent/Quantity	Within proposed Compound Area
Type of Asbestos	No Asbestos Detected in Sample
Photograph

No Asbestos Detected in Sample
--------------------------------

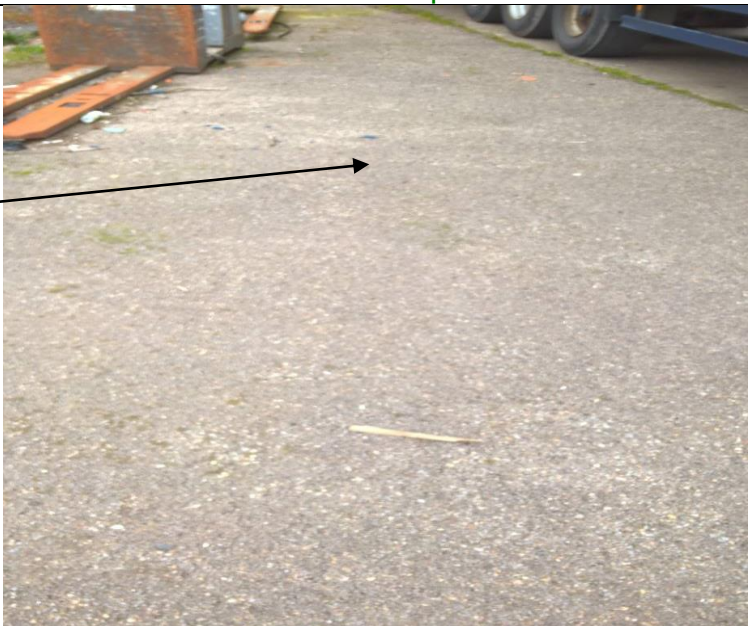
Sample Details	
Sample No	002
Position of Sample	Area -B
Product	Floor Debris
Extent/Quantity	Within proposed Compound Area
Type of Asbestos	No Asbestos Detected in Sample
Photograph

No Asbestos Detected in Sample

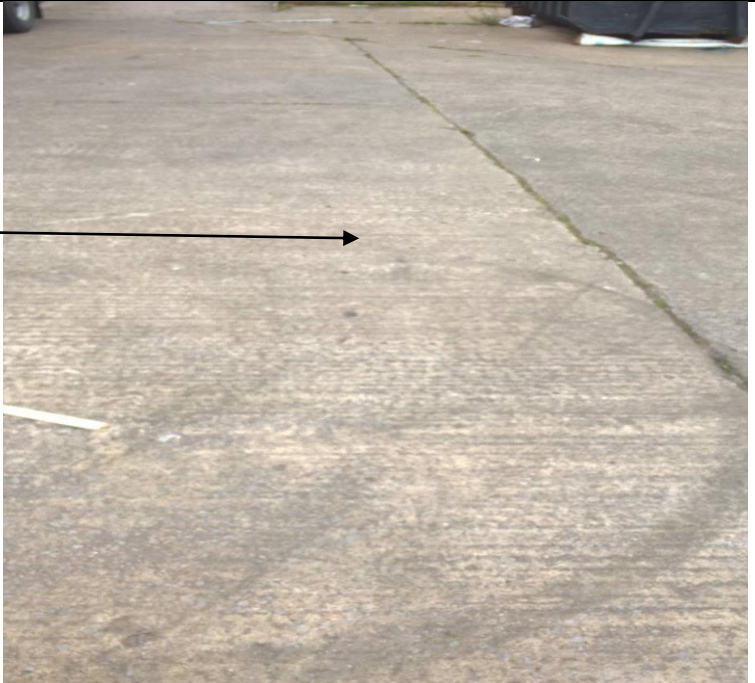
Sample Details	
Sample No	003
Position of Sample	Area -C
Product	Floor Debris
Extent/Quantity	Within proposed Compound Area
Type of Asbestos	No Asbestos Detected in Sample
Photograph

No Asbestos Detected in Sample

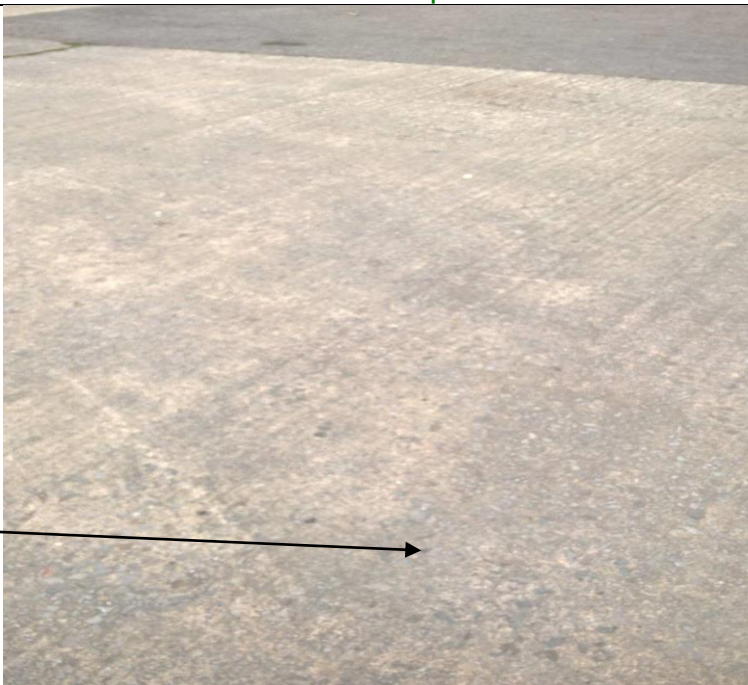
Sample Details	
Sample No	004
Position of Sample	Area -D
Product	Floor Debris
Extent/Quantity	Within proposed Compound Area
Type of Asbestos	No Asbestos Detected in Sample
Photograph

No Asbestos Detected in Sample
