| Contract/Job Name | <b>Carreg Y Groes</b> |
| Location/Location Address: | <b>LJT1 railway line between 2m 594yds &amp; 2m 534yds</b> |
| Give a brief description of works to be carried out: | <b>Maintenance of 55m stretch of wall</b><br><br><b>De-veg wall. Repair capping voids &amp; cracking, re-point stone work.</b><br><br><b>Rope access required for the pointing works.</b> |

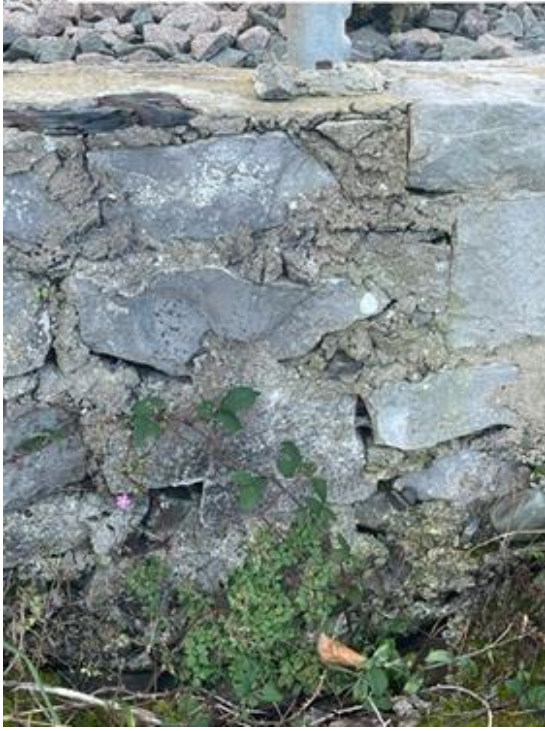
| <p>High mileage end of structure</p> | <p>Areas of larrying and repointing required</p> |

Re-pointing will be carried out using hand tools and secondary containment measures to be in place beneath point of work to catch any mortar/arising from work task. Small amounts of mortar applied at any one time to fill joint to correct level.

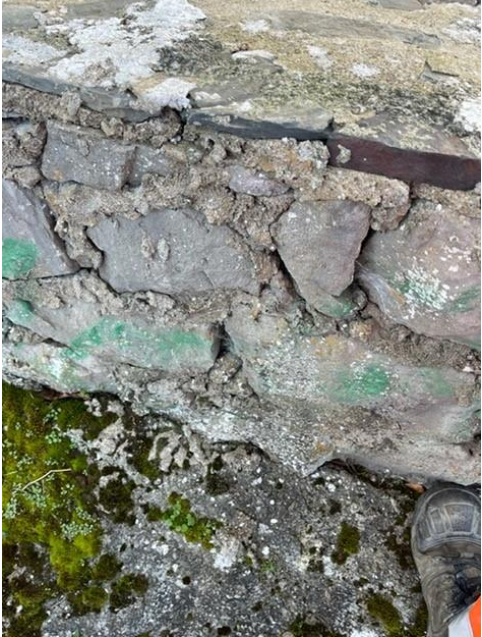
| <p>Areas of larrying and repointing required</p> | <p>Capping repairs required</p> |

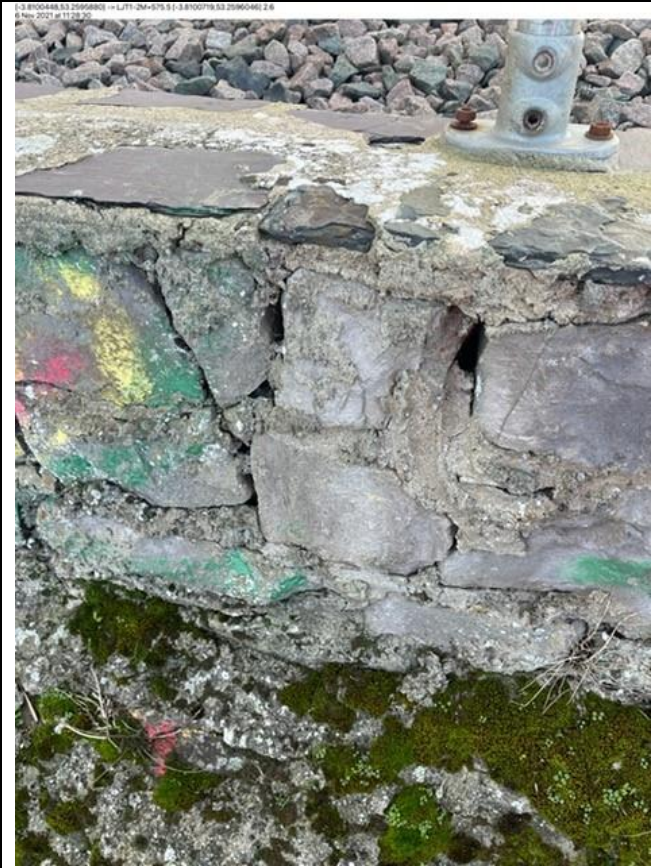
*Capping repairs required*

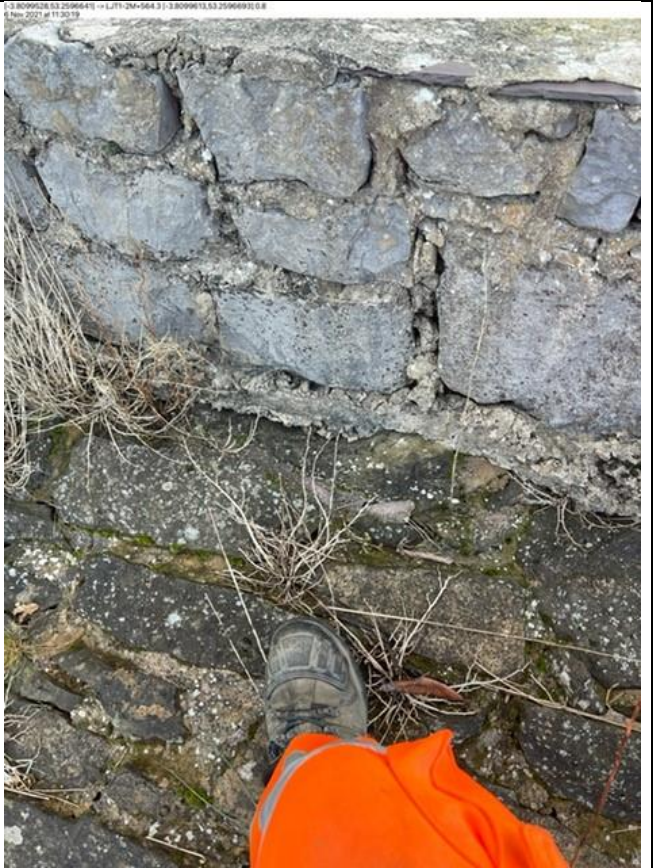
*Capping repairs required*
