# DRAINAGE SOLUTIONS

Job Sheet 02519

| ROA Recycling | Client: ROA |

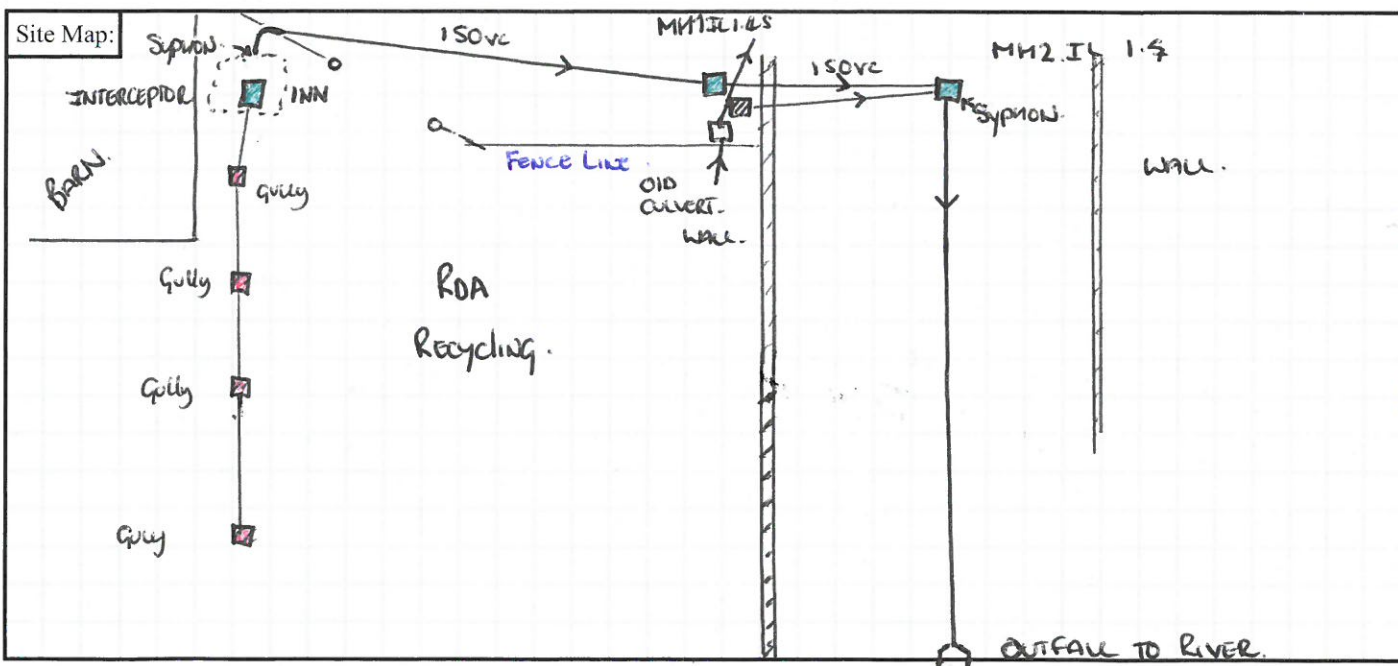
Comments: Arrived on site to investigate INTERCEPTOR RUN. LOCATED CONVECTIVITY TO 2 DOWN STREAM MANHOLES MANHOLE 2 HAS WHAT FEELS TO BE SYPHON LEAVING CHAMBER TOWARDS RIVER. ALSO SYPHON LEAVING INTERCEPTOR UNABLE TO HAVE COMPLETE SURVEY BETWEEN MH1 AND MH2 LINE HOLDING DUE TO SYPHON. INFORMED THAT OUTFALL HAS FLAP VALVE THAT OVERGROWS WITH BRUSH DEBRIS AND HASN'T BEEN CLEANED IN LONG TIME.
