**EAST WASTE  
MANAGEMENT SITE,  
LLANWERN STEELWORKS**

**PERMIT EAWML/30003**

**2016 Annual Review of  
Environmental  
Monitoring**

*Report Number 1555r1v1d0117*

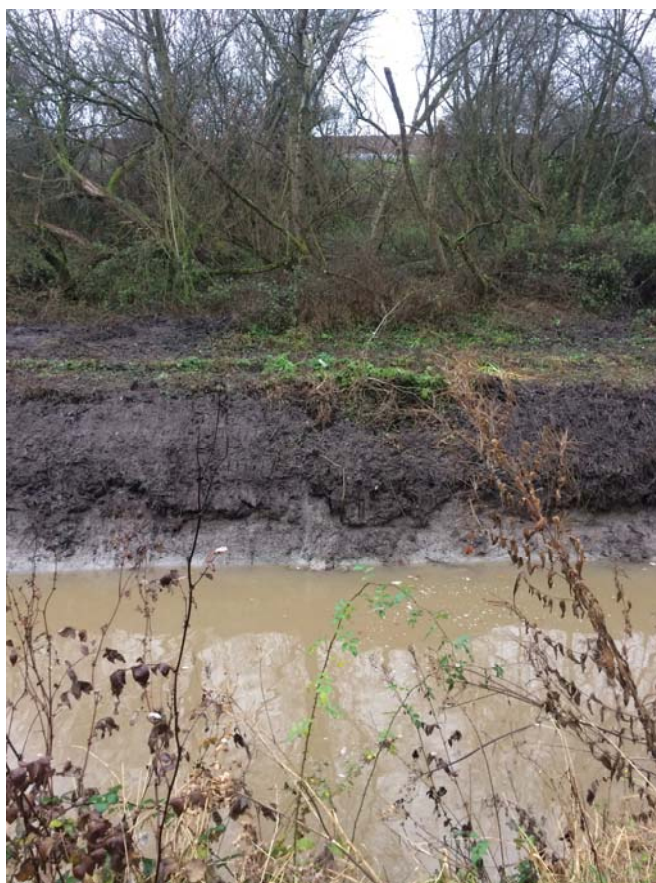
The monitoring data from 2016 continues to indicate that upgradient and downgradient surface water chemistry is generally very similar. However, there are times when there are abrupt changes in several parameters including pH and alkalinity. Subtle differences in the concentration of sodium, potassium, chloride, sulphate and alkalinity are also apparent and as leachate has been observed along this flank and as the waste in the landfill is being exposed during the restoration works, this aspect of the monitoring programme should continue to be closely scrutinised. Recent inspection of the adjacent reen indicates that the reen is cut into low permeability deposits and that there are no obvious visual signs of staining indicative of leachate (see Plate 1).

Plate 1. Reen flowing from right to left along eastern side of site

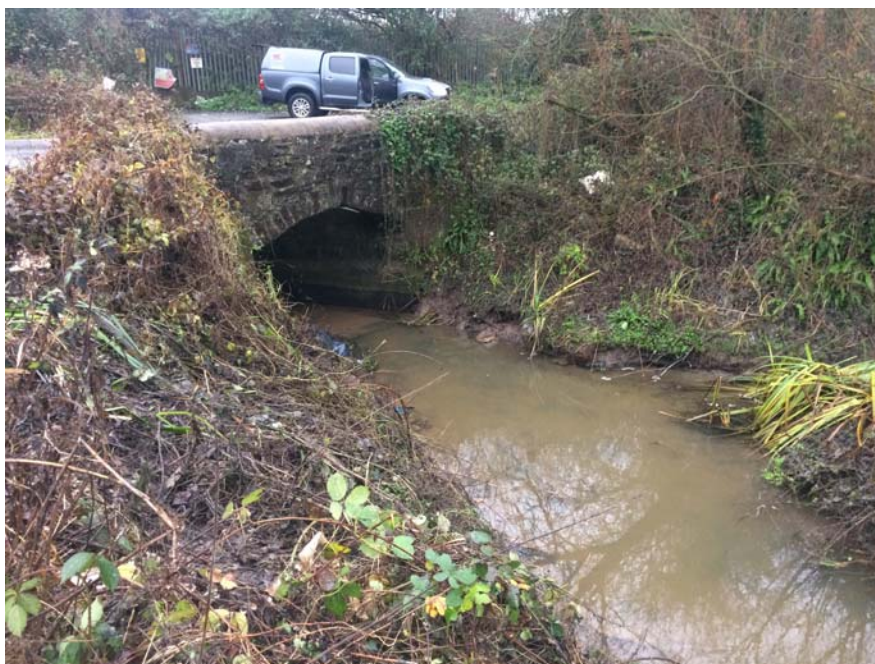
Continued scrutiny of upstream influences is also required as observations in December 2016 (see Plate 2) suggest that there are upstream sources of suspended solids.

Plate 2. Suspended solids in surface water upstream of site

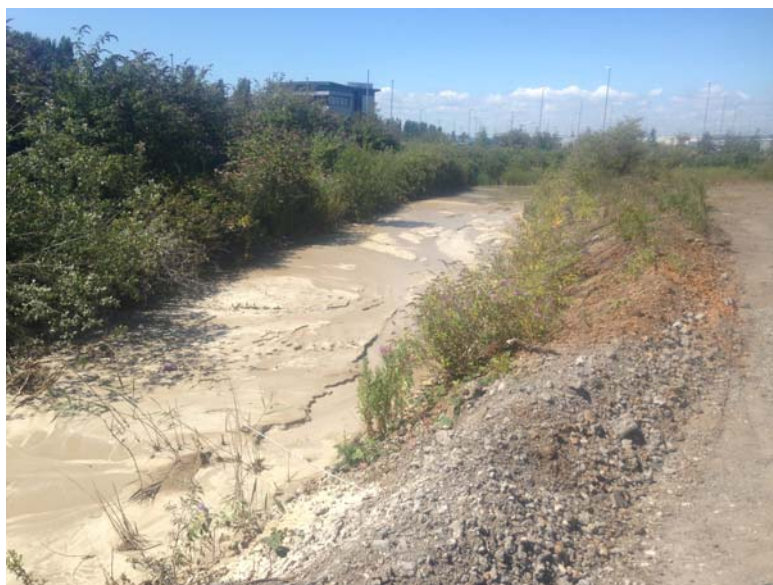
Initial results from the testing of samples collected from the leachate collection ditch that runs along the western side of the site (see Plate 3) confirm that the hydrochemistry is dominated by leaching of slag wastes and is characterised by high pH, alkalinity and calcium and low metals. Within this, and other ditches across the wider steelworks site, Tata has also observed an increased deposition of particulates. The precise cause of these variations is not fully understood but is being actively investigated by Tata.

Plate 3. Leachate Collection Ditch at southwest corner of site
