## **Band 1 Marine Licence Method Statement**

A minor work remit has been requested by Network Rail to reinstate missing sections of concrete apron and rectify trips in the walkway at Llanfairfechan.

## MWC1052 – Llanfairfechan Method Statement

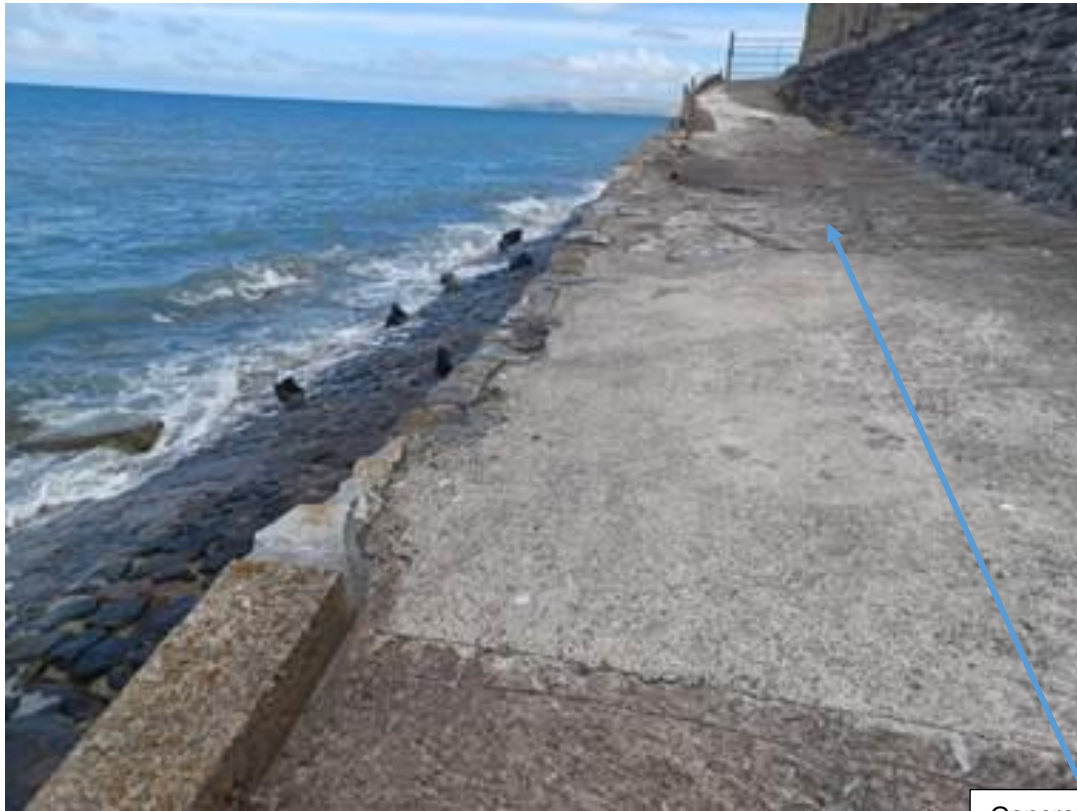
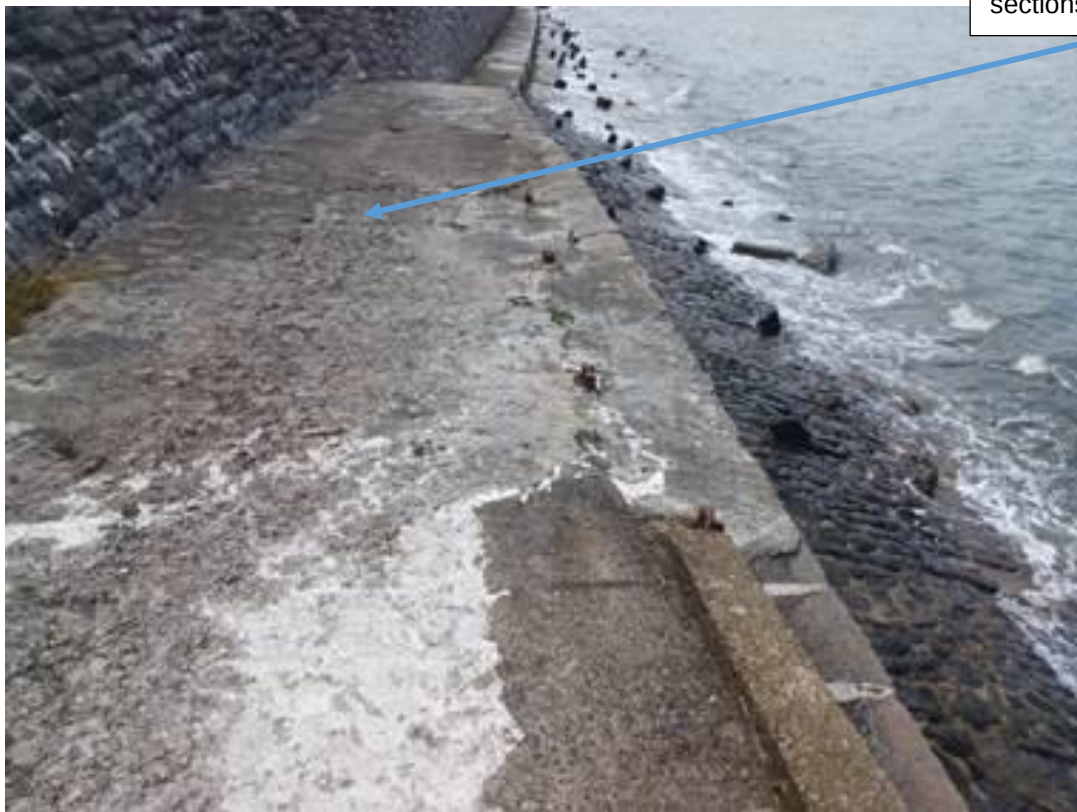
Concrete apron missing  
sections of concrete

3. A centre line from apron to apron will be marked and dowel bars drilled along this line at even spacing's.
4. Lacer bars will be steel tied top and bottom allowing for sufficient concrete cover.

5. A wooden shutter will be installed to match the dimensions of the existing Apron.
6. Fast set marine grade concrete will be mixed in the adjacent yard away from the sea wall and taken to site in buckets on the wheeled trolley.

7. Concrete will be placed in the shutter using a tremmie, as not to spill concrete on the seawall during installation and finished to match the existing apron.

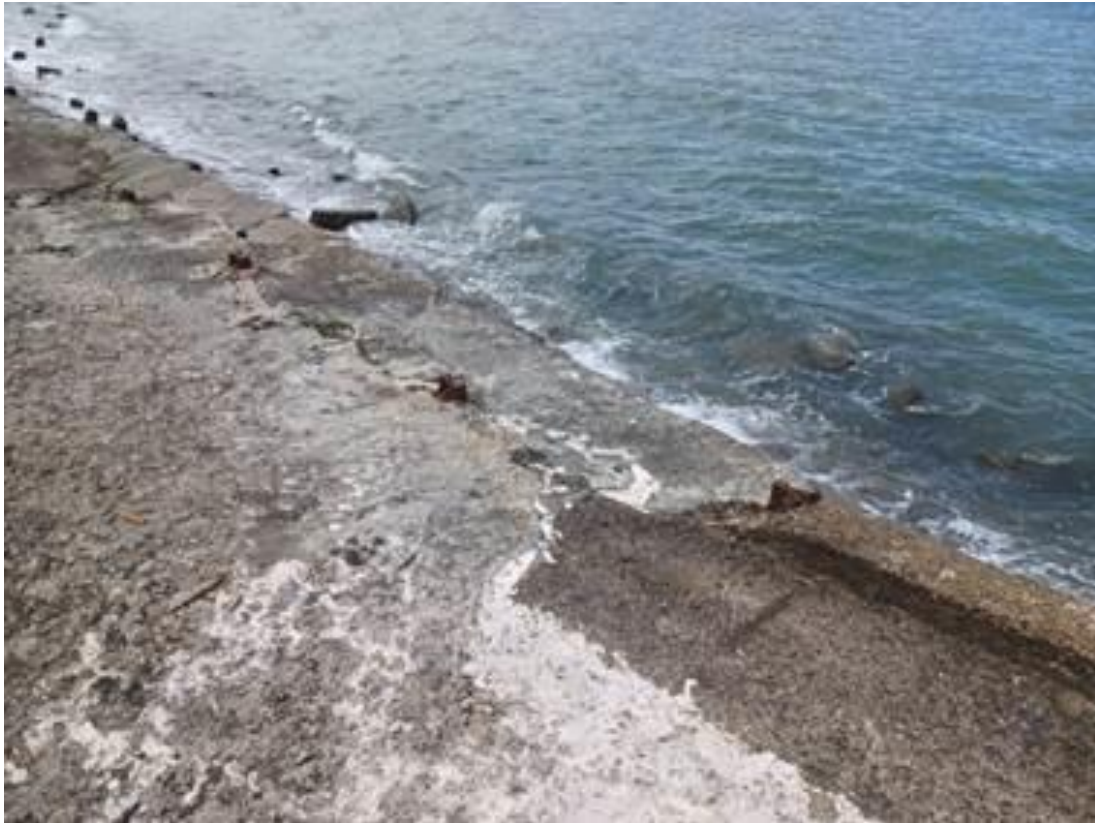
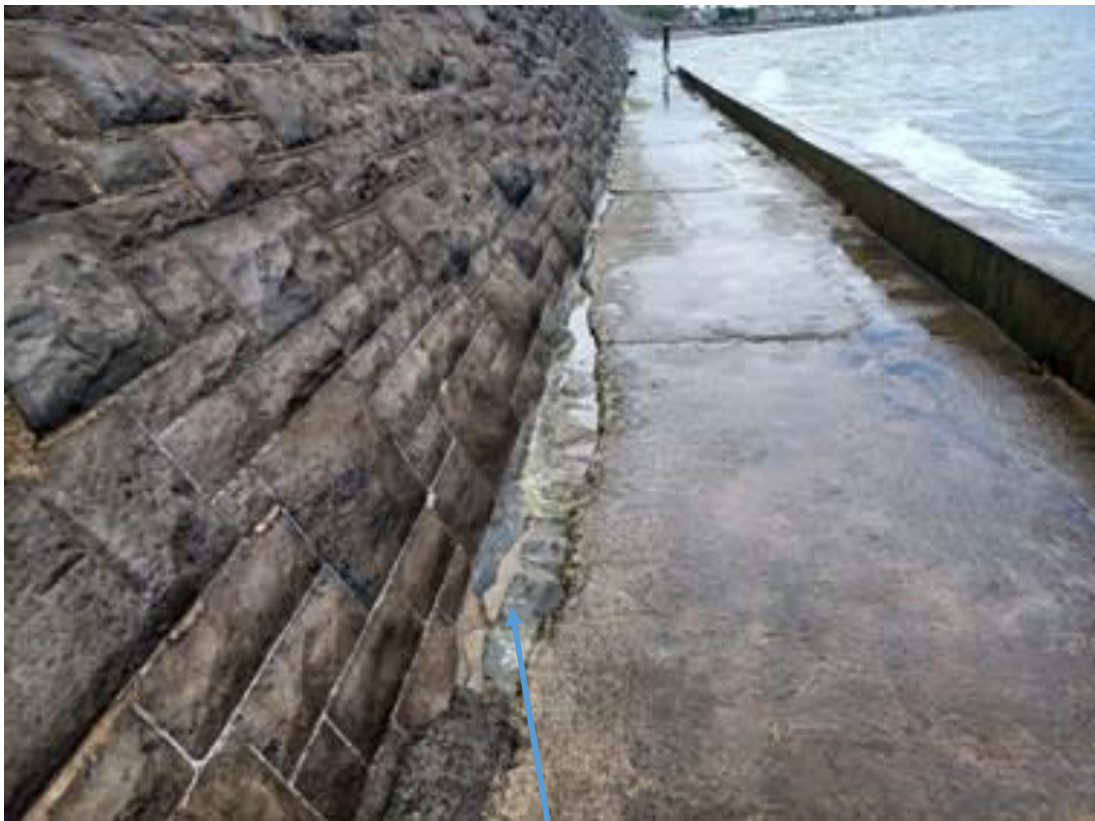
Trip hazards – missing concrete in walkway

8. Once cured, the concrete shutters will be removed and taken away from site.
9. Where there are trip hazards (concrete has washed away from walkway), areas will be cut square to obtain a decent depth edge.

10. Expamet (stainless steel mesh) will then be screwed to the bottom of the trench to act as re-enforcing.
11. Quick set marine grade concrete will be poured into the trench and floated to meet the existing levels present.
