Fish Habitat Assessment Report

Snowdonia VIP Project - Water Discharge

HOCHTIEF UK Ltd

January 2023

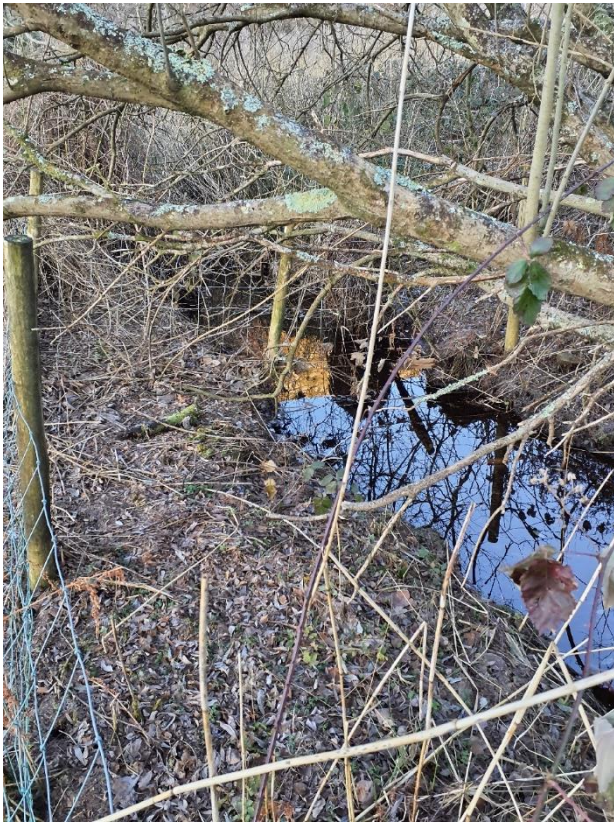
Target Note description	Photo
UNAMED WATERCOURSE 1	
TN1, Photo 1 – looking downstream. Slow run with low flow. Muddy, leafy substrate. Poor fry habitat.

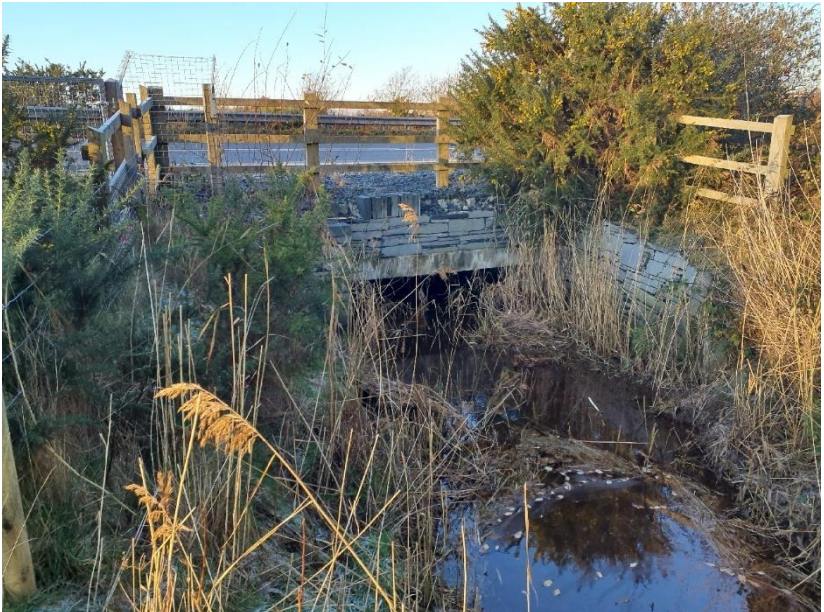
Target Note description	Photo
<p>TN12, Photo 12 – Main road bridge. 2.5m wide, 30cm deep, silty substrate.</p>

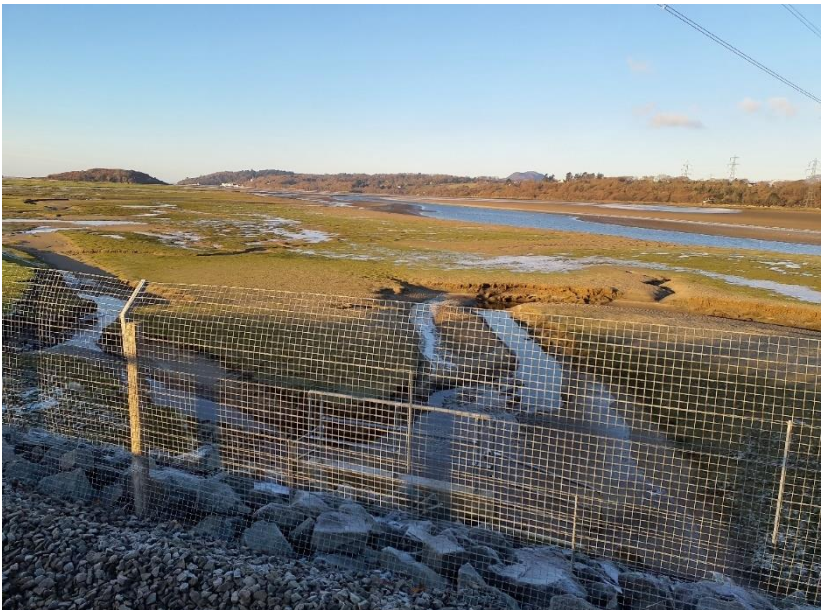
<p>TN13, Photo 13 – discharge point location, salt marsh. Inaccessible and unable to determine if there are any major obstacles to migratory fish.</p>

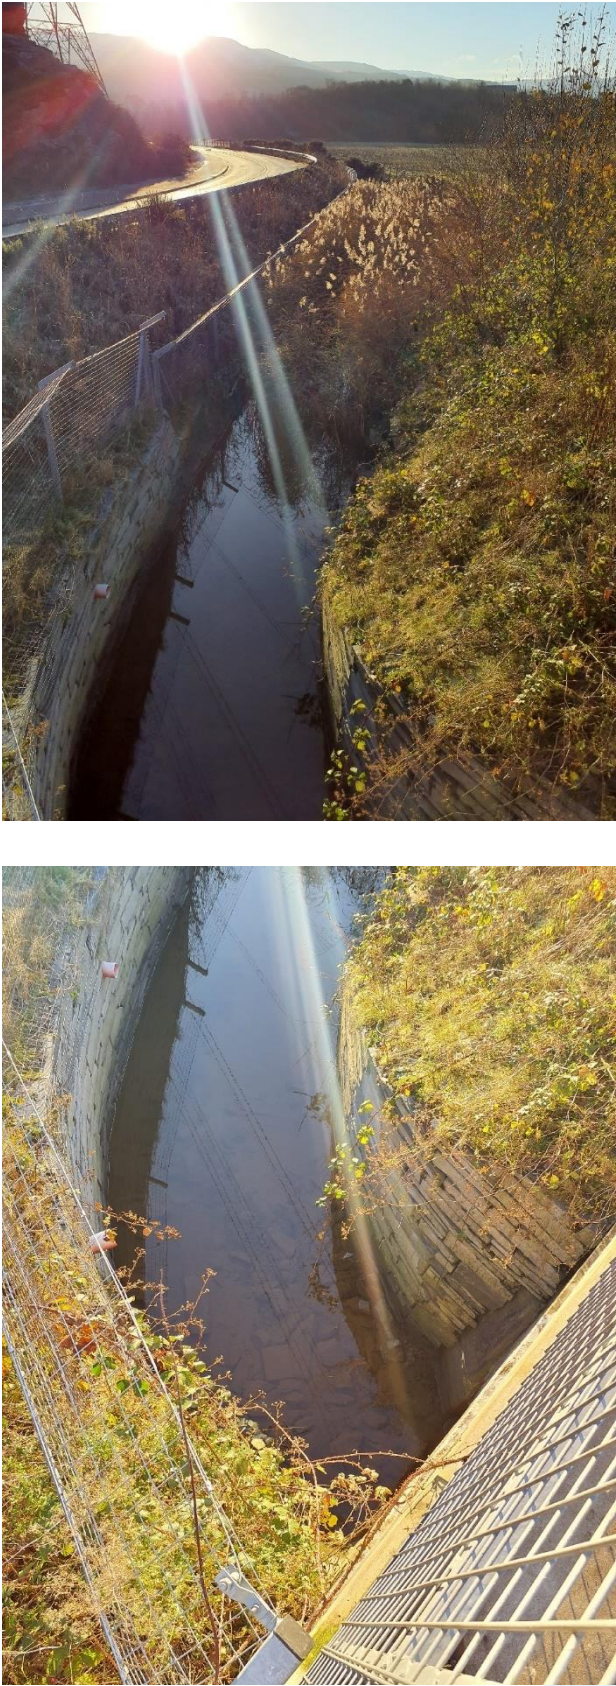
Target Note description	Photo
<p>TN14, Photos 14, 15, 16 – low flow. Some cobbles in bed but silty otherwise. 2.5m wide, 30cm deep. Lack of bankside cover for fish. Channel is highly modified..</p>

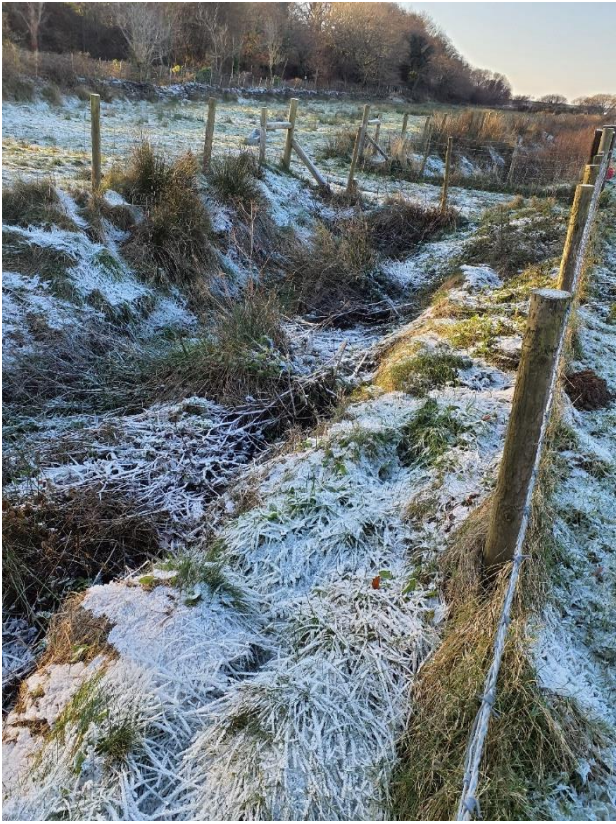
Target Note description	Photo
<p>TN18, Photo 20 – watercourse choked with rushes and grass, likely flow constriction. Overgrown Culvert also present and possibly impassable for migratory fish.</p>

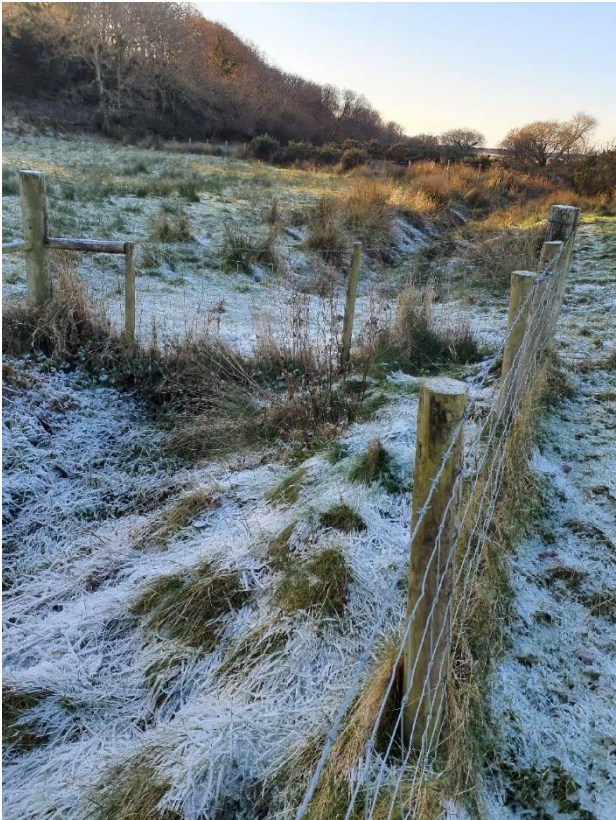
<p>TN19, Photo 21 – culvert/bridge choked with vegetation. Unsuitable for fish.</p>

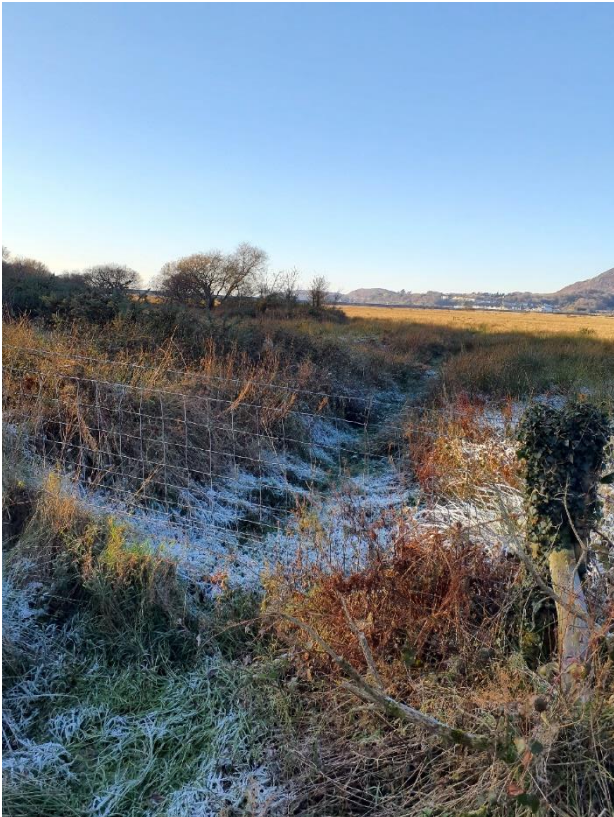
Target Note description	Photo
<p>TN20, Photo 22 – watercourse choked with vegetation.</p>

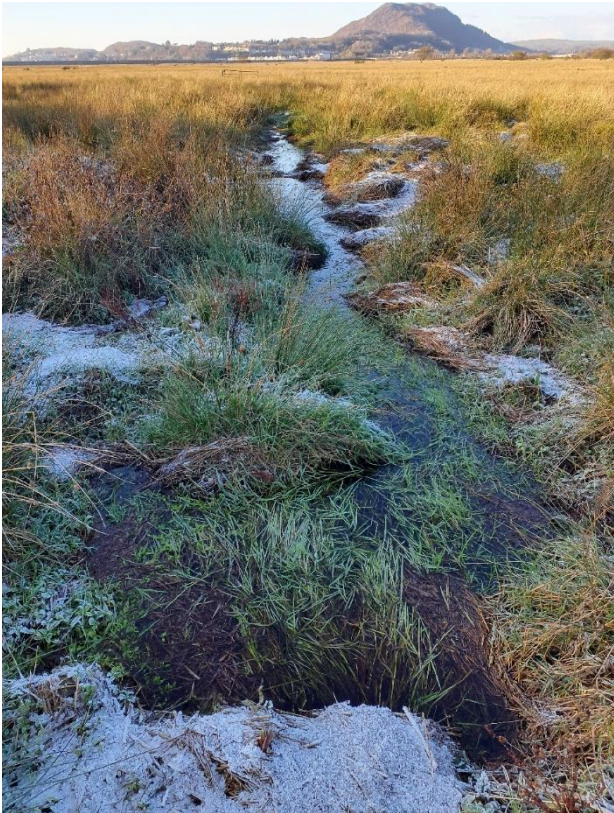
<p>TN21, Photo 23 – instream vegetation and culvert.</p>

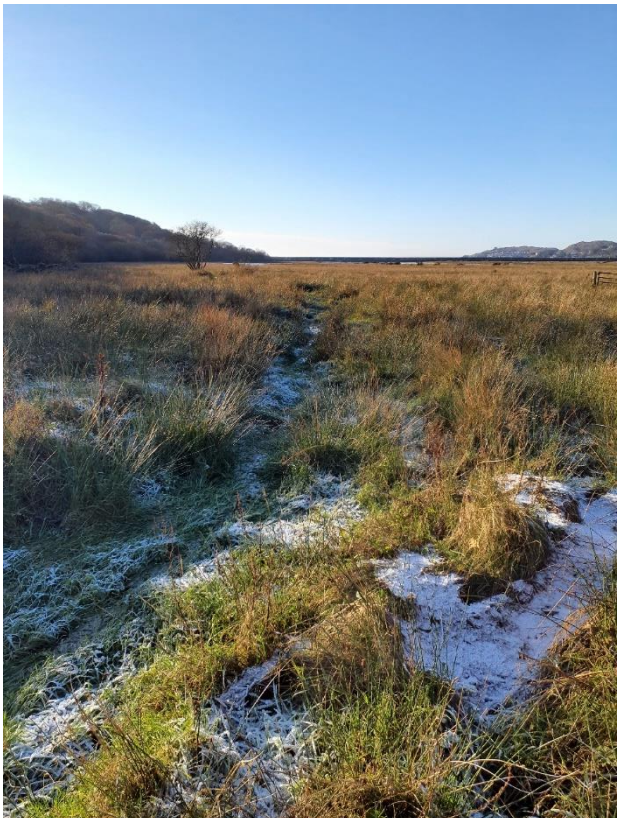
Target Note description	Photo
<p>TN22, Photo 24 – looking downstream towards saltmarsh. Stream is heavily choked with vegetation and polluted further upstream. Poor habitat quality for fish.</p>

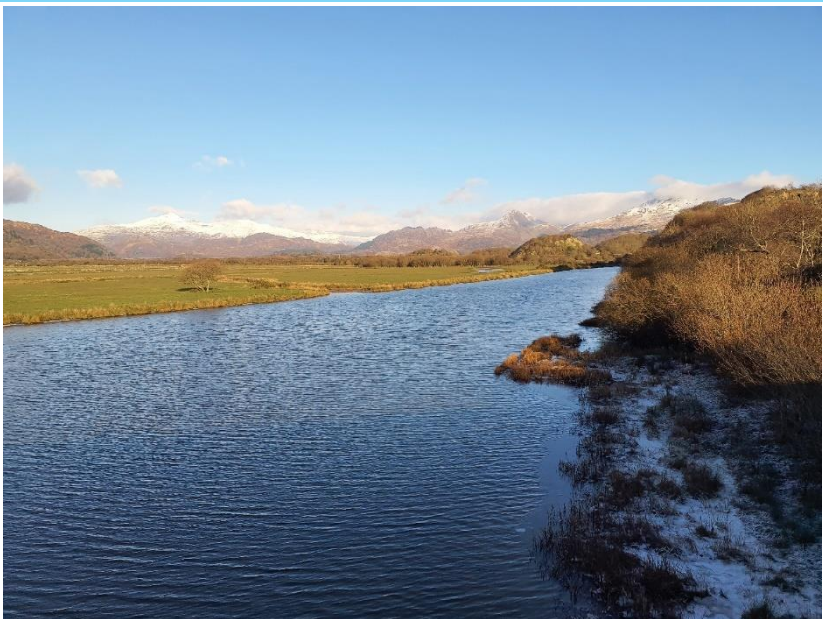
<p>RIVER GLASLYN</p>	
<p>TN23, Photo 25 – looking upstream. Pool with low flow. Substrate is sandy with some patches of exposed bedrock. Poor spawning habitat. Suitable for adult fish.</p>

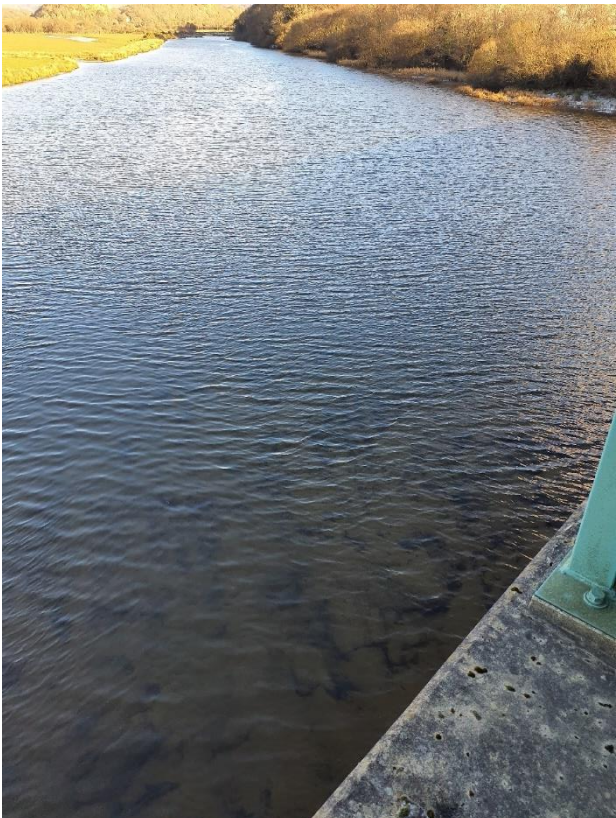
Target Note description	Photo
<p>TN24, Photo 26 – boulders and rocks visible in riverbed providing cover for fish.</p>

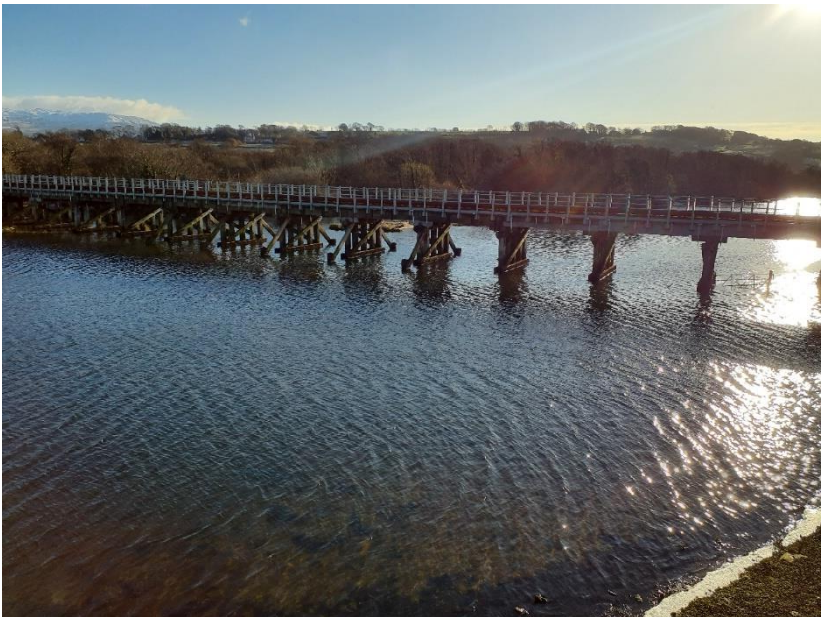
<p>TN25, Photo 27 – looking downstream towards railway bridge which is just upstream of extraction point. River is 40m wide. Depth approximately 2m.</p>

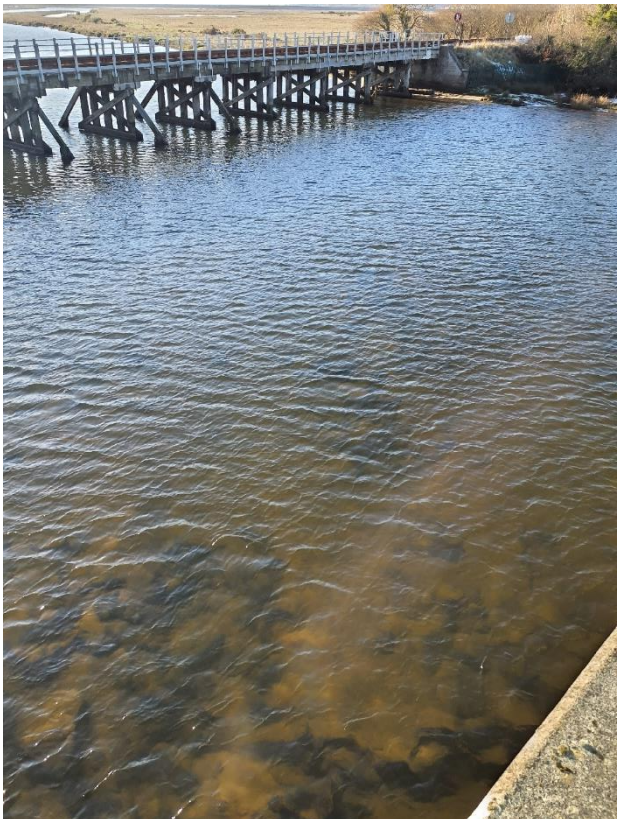
Target Note description	Photo
<p>TN26, Photo 28 - large boulders and cobbles visible on riverbed bed.</p>
