Schedule 5 request for more information EPR/XP3830UR/V007 (PAN-019159)

Project Augerre permit variation application.

Assessment of the suitability of the containment and drainage systems for new silos

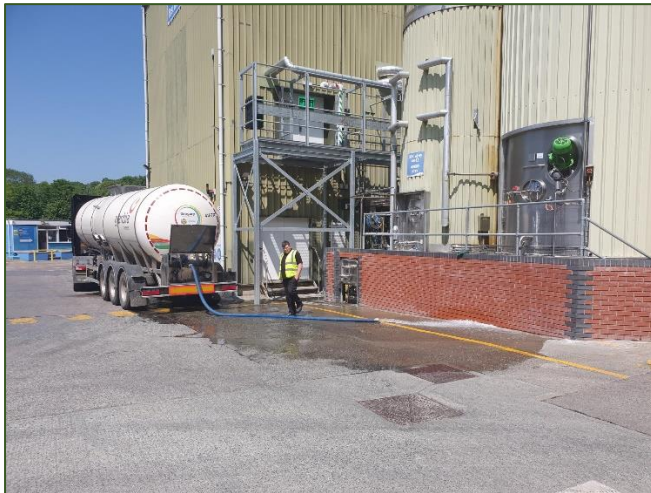
Photo 1 – tanker being emptied to ground at the new whey silo location. Valve opened and water permitted to flow freely.

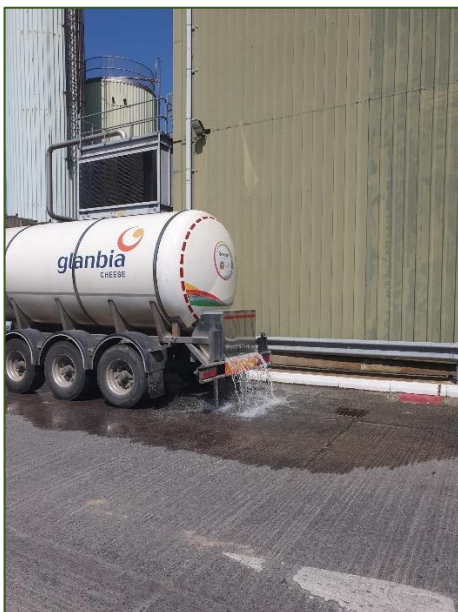
Photo 2 – tanker being emptied to ground at the new whey silo location. Valve opened and water permitted to flow freely.

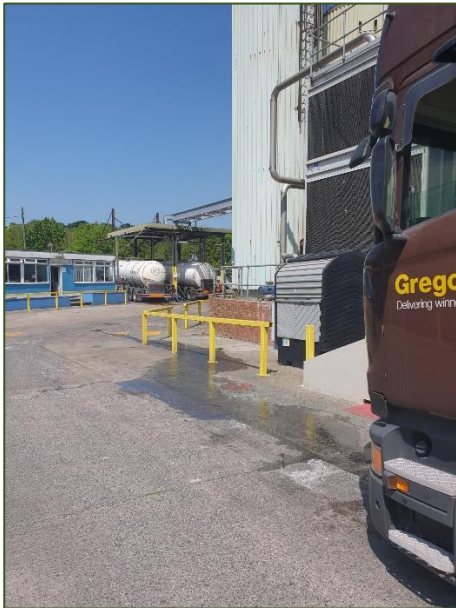
Photo 3 – Route of any flow from the whey silo location. Note direction down roadway and towards the drains.

The distance between the silo location and the drain that would typically take the runoff material is 35m away.

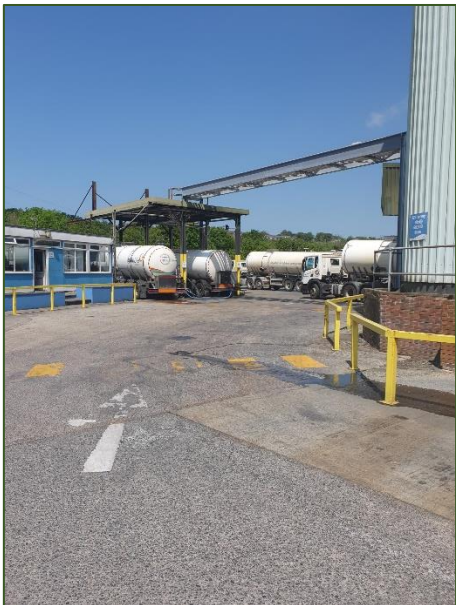
Material leaving the whey silos has been observed through simulation from on-site tankers to flow from the silo platform area down the roadway and towards the drain located in the centre of the roadway near to the GDL office block (see photo 4).

Photo 4 – Route of any flow from the whey silo location. Note direction down roadway and towards the drains.

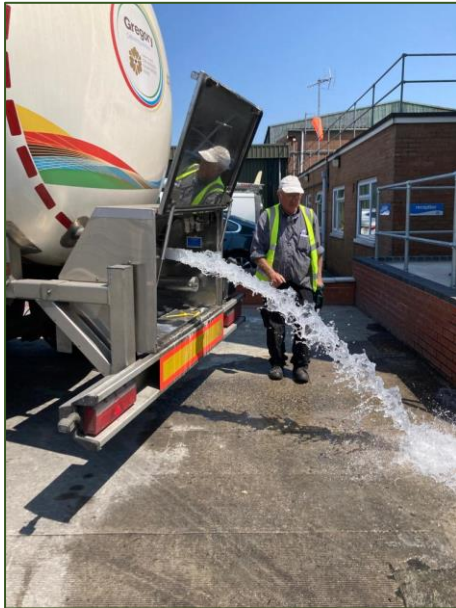
Photo 5 – tanker being emptied to ground at the new milk silo location. Valve opened and water permitted to flow freely.

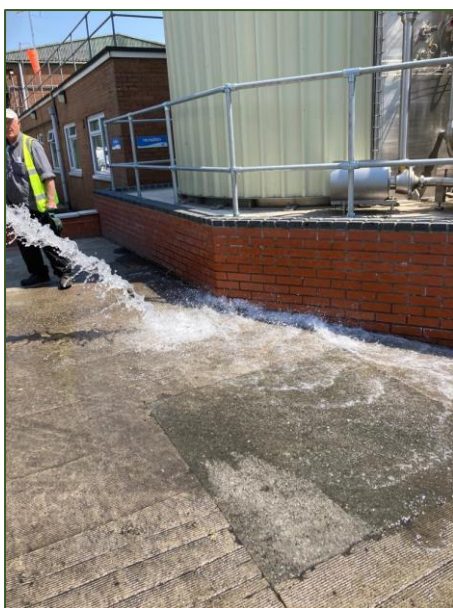
Photo 6– tanker being emptied to ground at the new milk silo location. Valve opened and water permitted to flow freely.

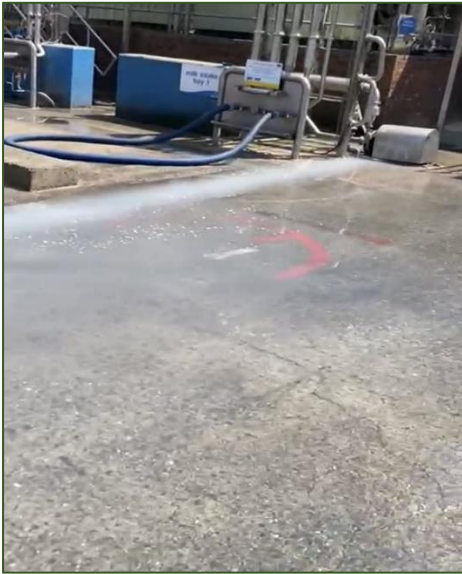
Photo 7 – main water flow towards the milk intake area and drains.

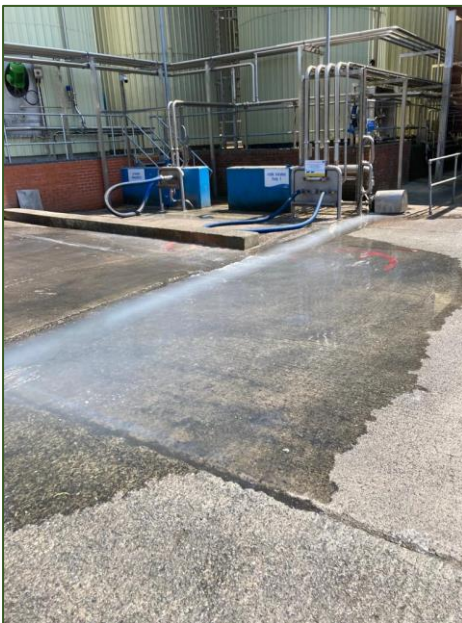
Photo 8 – main water flow towards the milk intake area and drains.

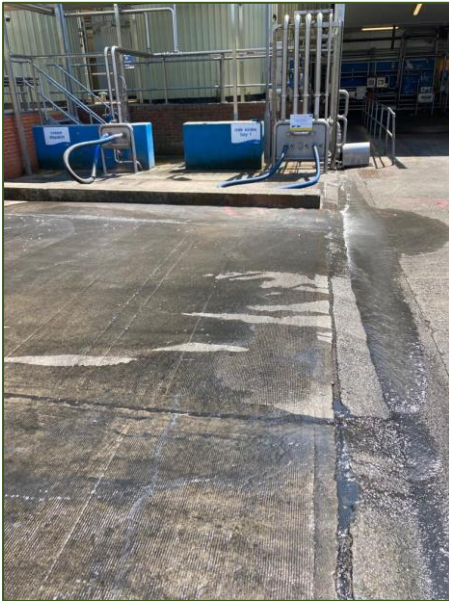
Photo 9 – main water flow towards the milk intake area and drains.

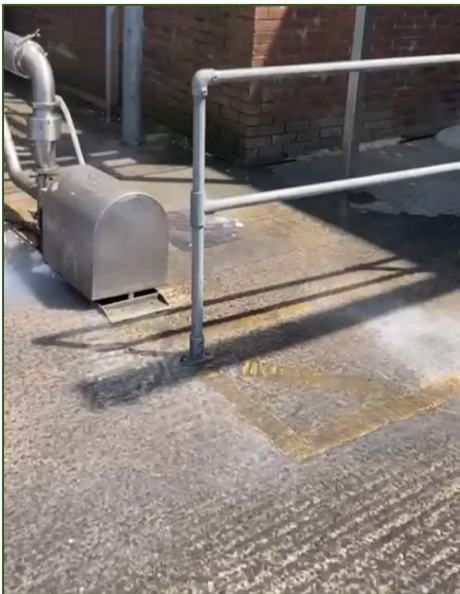
Photo 10 – main water flow towards the milk intake area and drains.

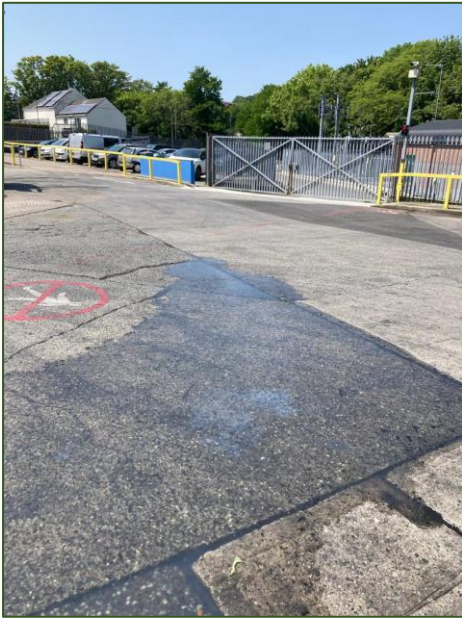
Photo 11 – proportion of flow towards the side gate drain.

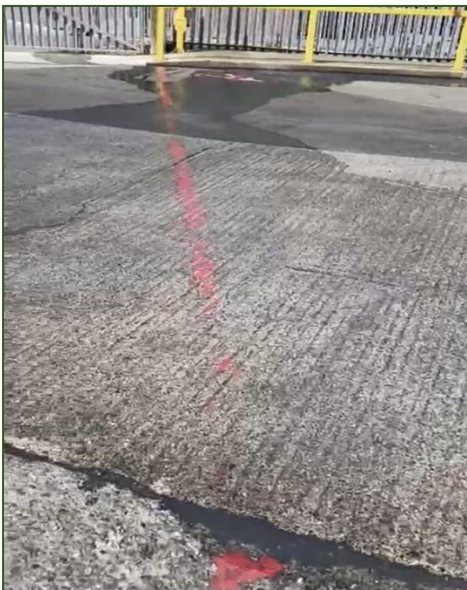
Photo 12 – proportion of flow towards the side gate drain.

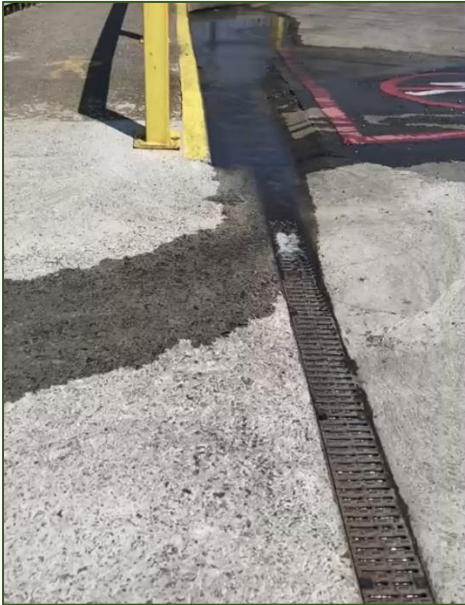
Photo 13 – proportion of flow towards the side gate drain. Small volume exceeded drain gully and flowed to gateway.

It is considered that there would be a small proportion of the milk that would potentially leave the site perimeter. As such, in response to these findings the site has engaged with a civils contractor to explore options for this location including increased drain size at this location and / or some form of catchment bund.

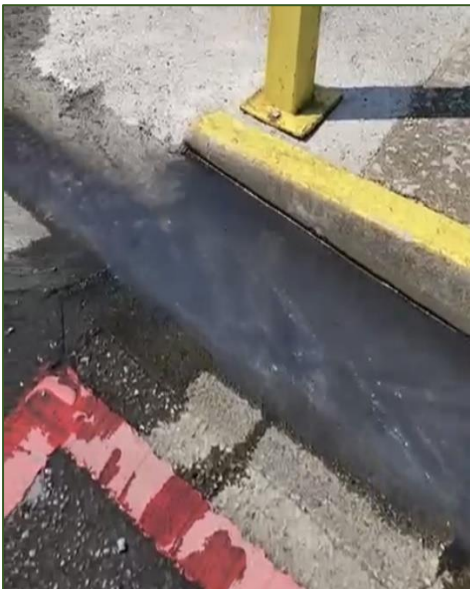
Photo 14 – proportion of flow towards the side gate drain. Small volume exceeded drain gully and flowed to gateway.
