Compliance Assessment Report CAR_NRW0042845

Permit being assessed: AN0305901

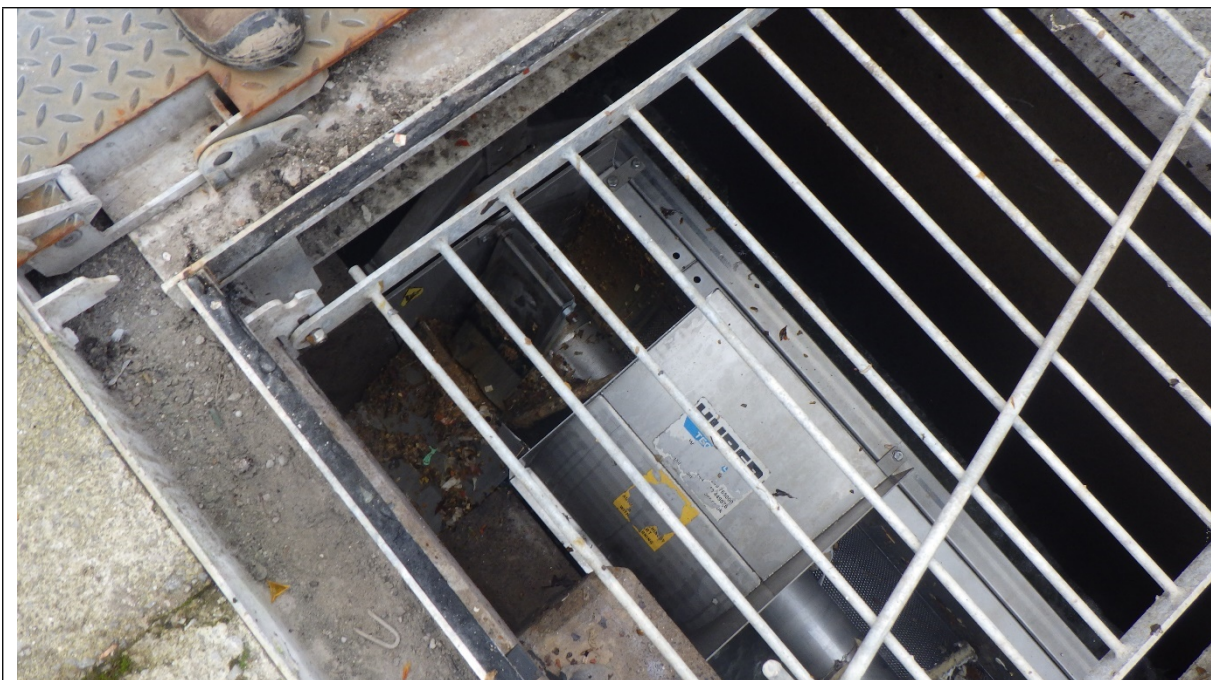
Figure 1: Site visit photo – flipper arms clearing the screen of debris. This debris is then returned to foul for treatment and not discharged.

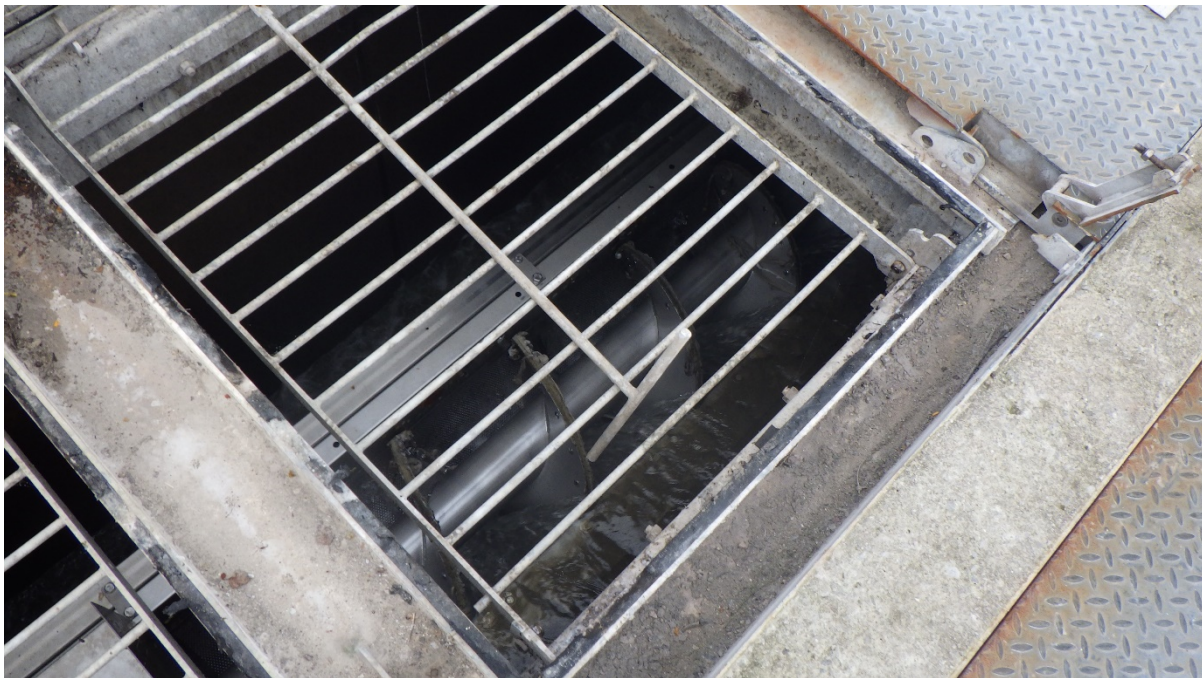
Figure 3: Site visit photo – automated screen debris removal working at the time of the visit.

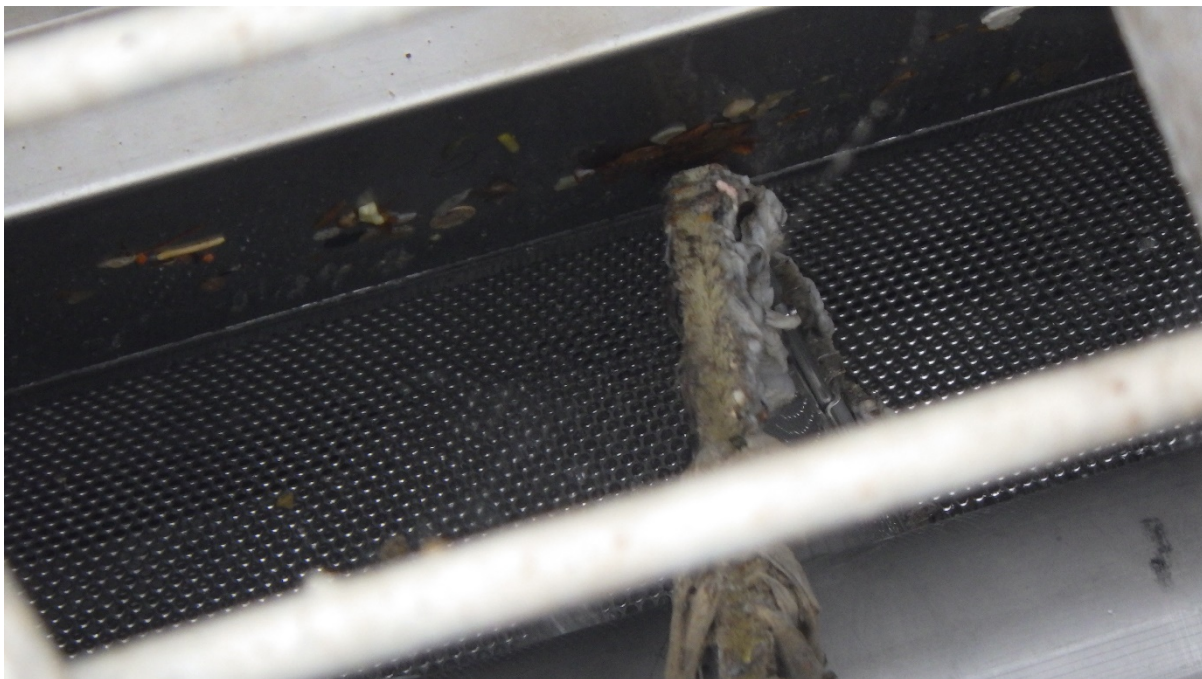
Figure 4: Site visit photo – screen condition at the time of the visit.

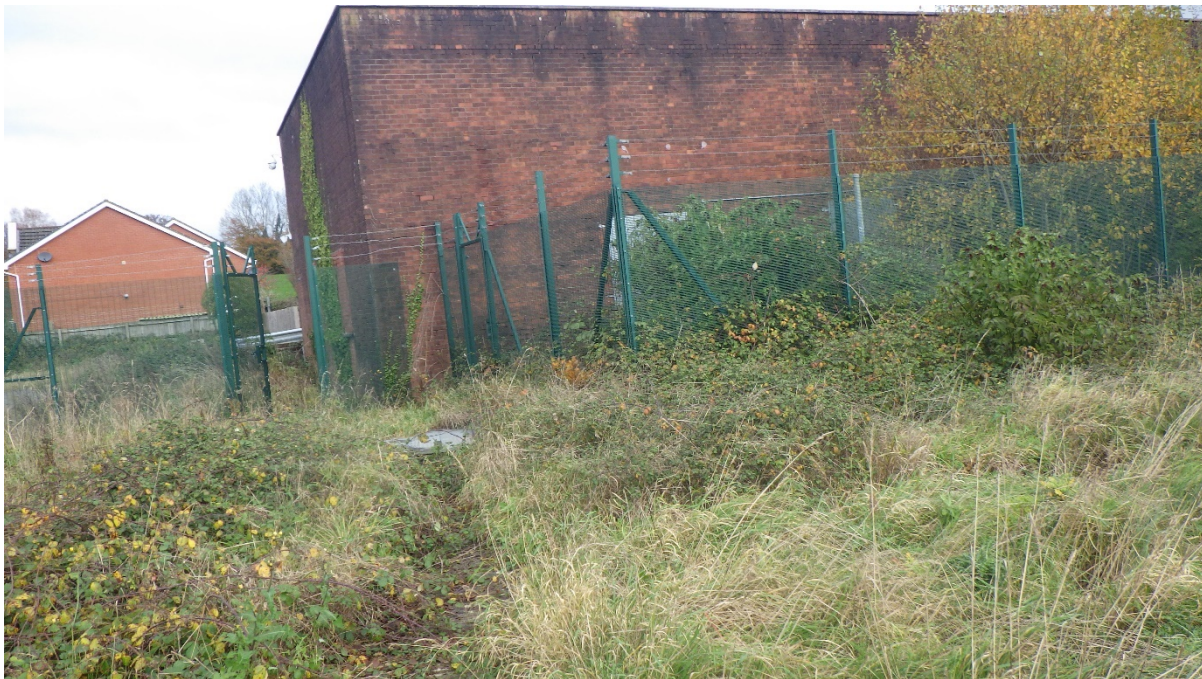
Figure 5: Site Visit Photos – access to storm tanks at the rear of the compound.

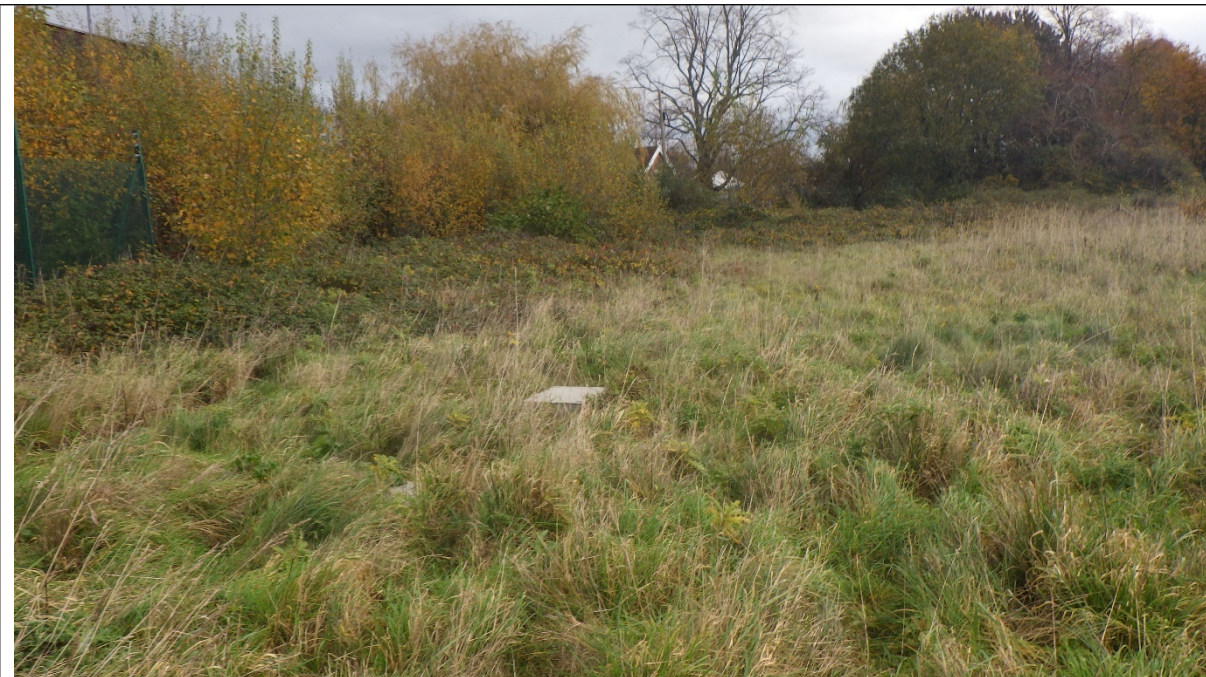
Figure 6: Site visit photo – An example of an access point to the storage tanks.

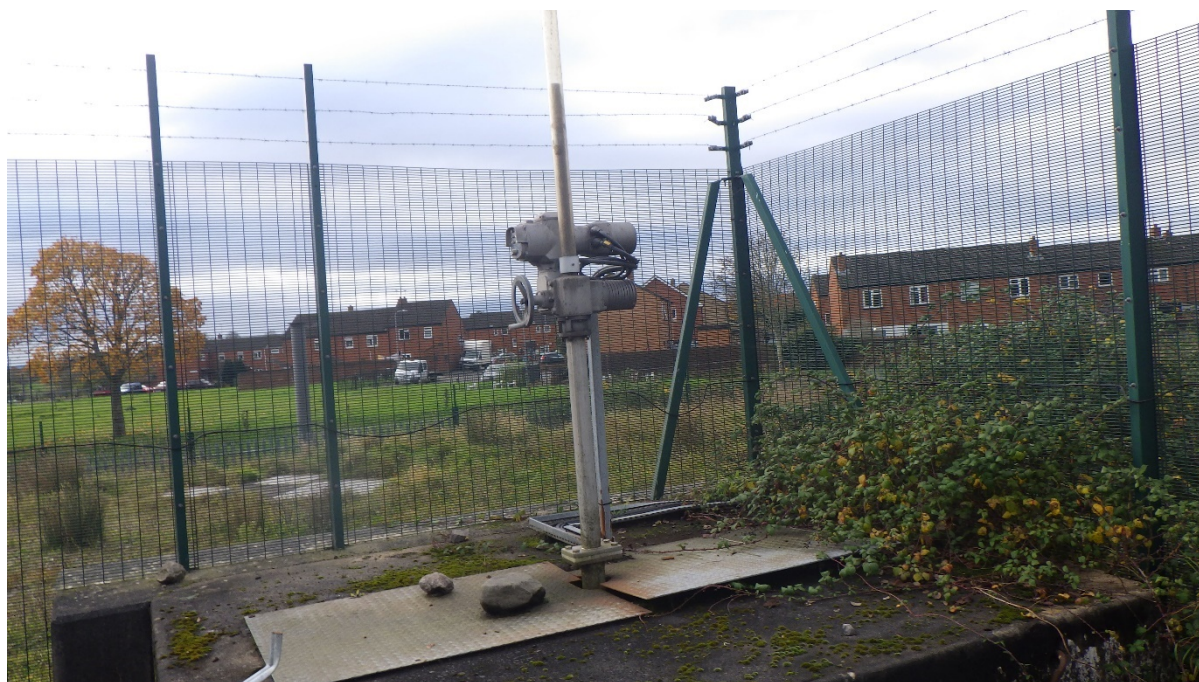
Figure 7: Site visit photos – Final penstock before storm line leaves site. Condition of the chamber covers is noted as a general improvement consideration.

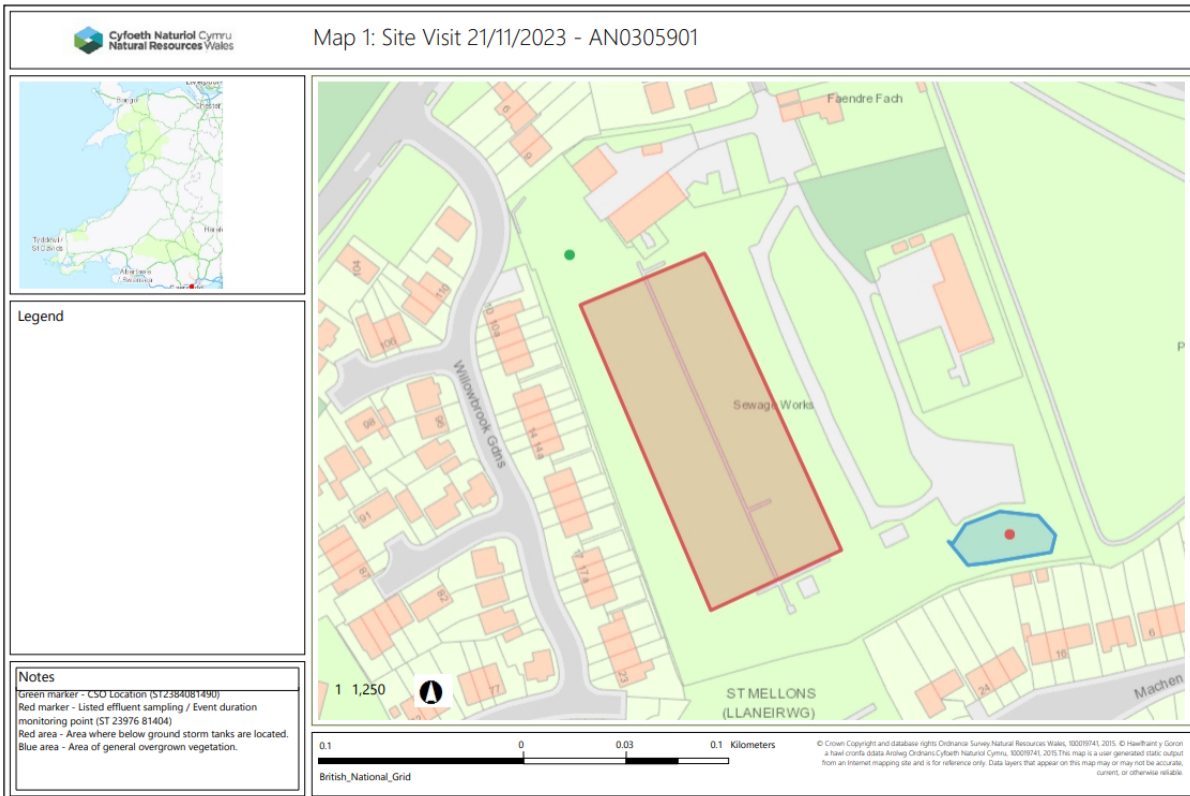
Map 1 – Location of CSO, storage tanks and monitoring point. Note that the area highlighted in blue is overgrown and made locating the monitoring point difficult.

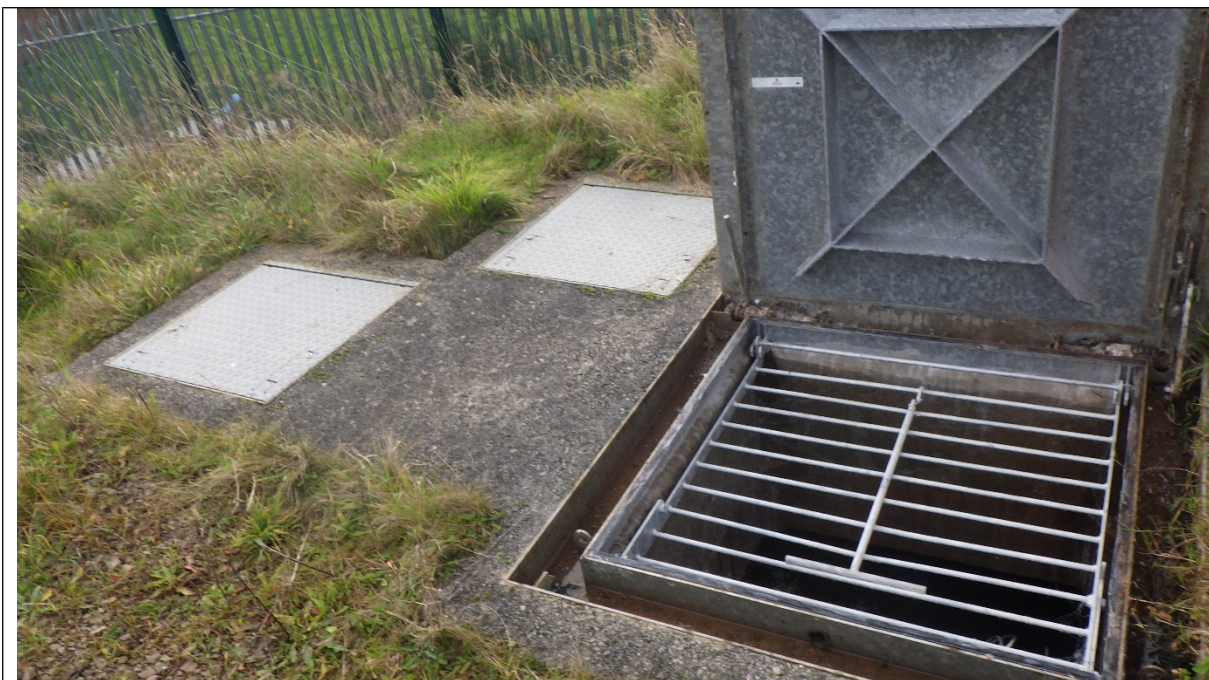
Figure 8: Site visit photo – Final inspection/access point before storm line leaves site.

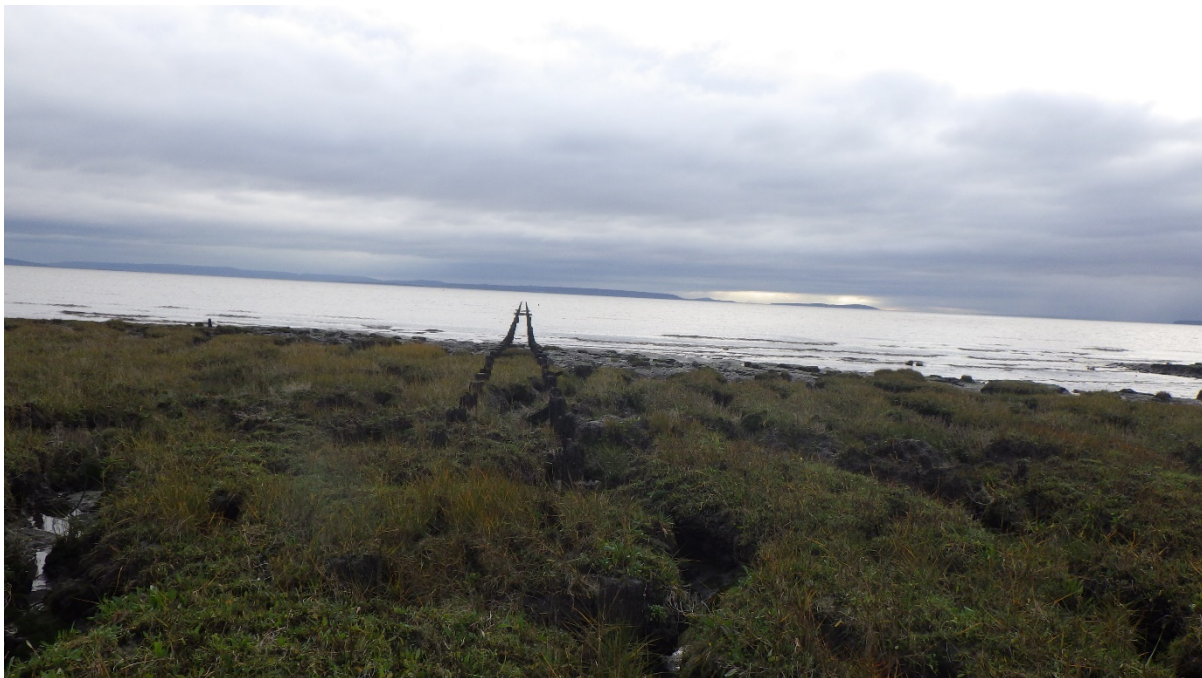
Figure 10: Site visit photo – Storm outfall submerged and inaccessible at the time of the visit.
