38795/R3/Rev1

**08/08/2023**

### Ecological walkover – 1129\_WAL\_MPH

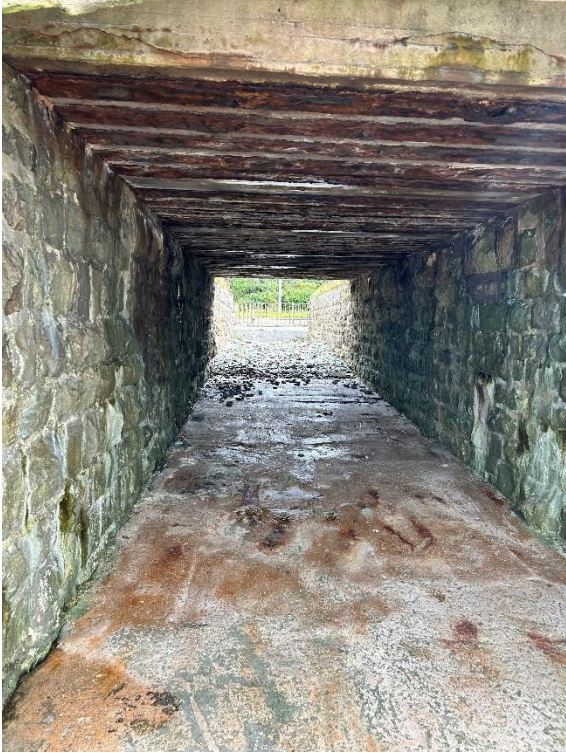
The stone pedestrian walkway tunnel and railway at Penmaenmawr is currently in use and is therefore most likely unsuitable for use as a potential roost. No other potential roosting features (PRF) were found.

**Photo 1** – stone access tunnel under the railway line to the beach front from the public walkway.

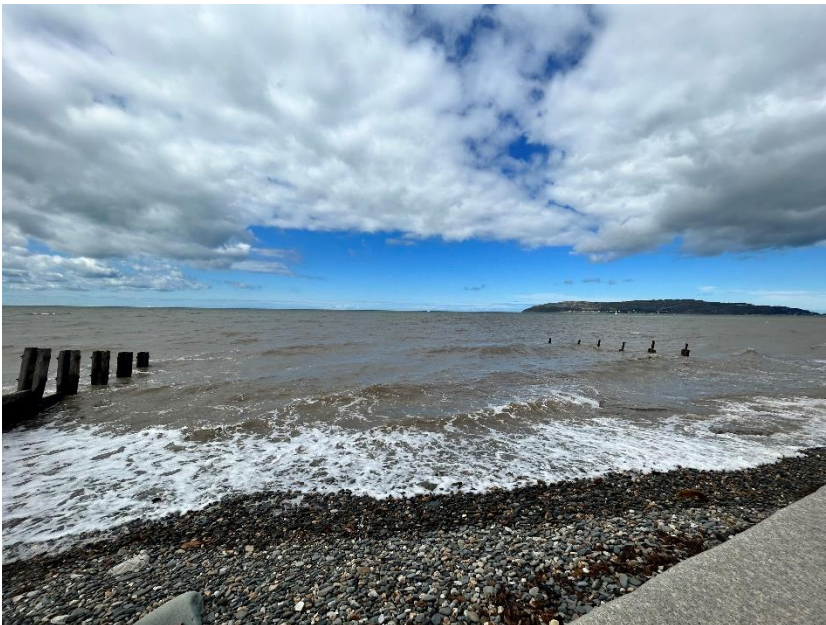
The area is accessed via a stone walkway tunnel beneath the railway line overhead (see photo 1) off the A55 dual carriageway. The walkway drops down onto concrete hardstanding then down onto the pebble beach, as shown in photos 2-5. The beach itself has very limited vegetation and is bordered by the stone seawall and large boulders, as shown in photos 3 and 4. A large headland lies to the east of the site, and a smaller headland lies to the west where a water treatment plant is situated. The western headland is covered with grasses and sand dune vegetation, along with some larger bushes and bulrushes further west. This lies outside of the working area however. The accessibility of the site was limited due to the tide as shown in photo 2.

**Photo 2** – pebble beach where redundant sleeper breakers lie. Site is bordered by seawall and large boulders to the east and west.

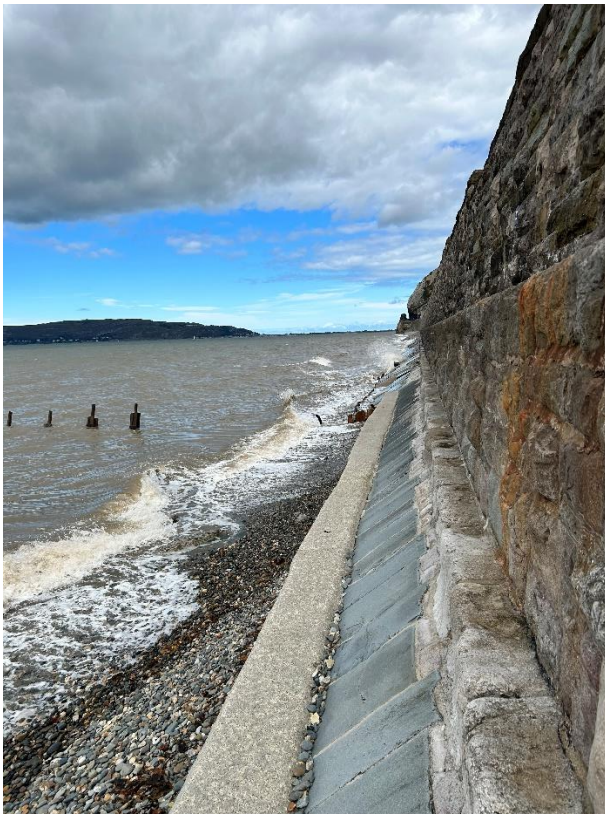
**Photo 3** – concrete and stone seawall and redundant rail groins facing east towards headland.

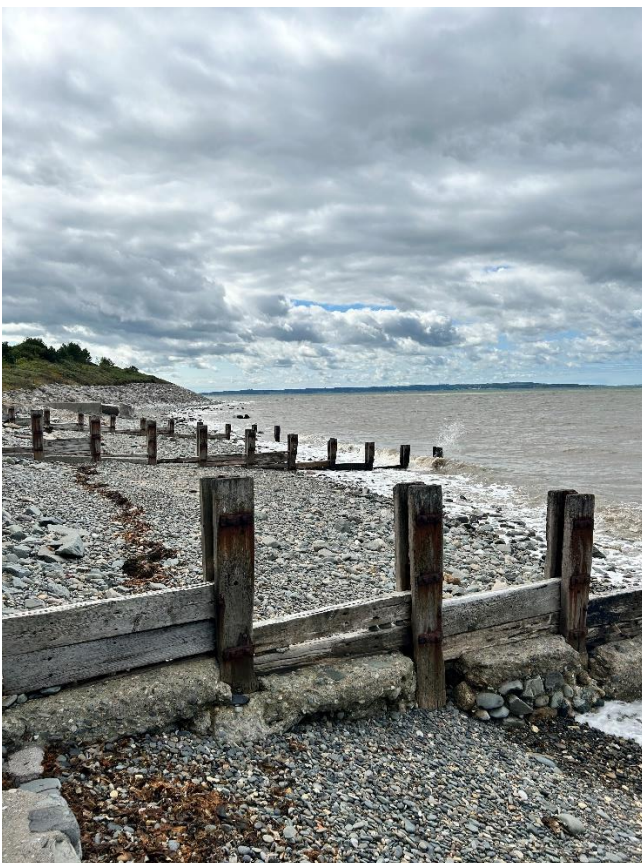
**Photo 4** – wooden and metal sleeper groins on pebble beach looking west towards grassy headland.

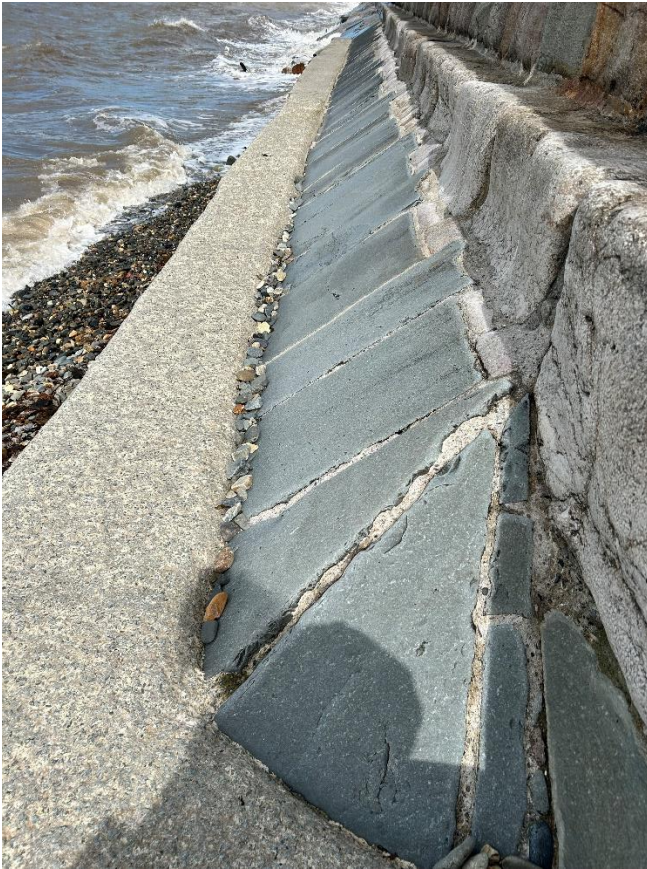
**Photo 5** – stone and concrete seawall upon entering site from tunnel.
