Clydach Geomorphology Survey

29/08/2025

Stage 1 Geomorphology Assessment

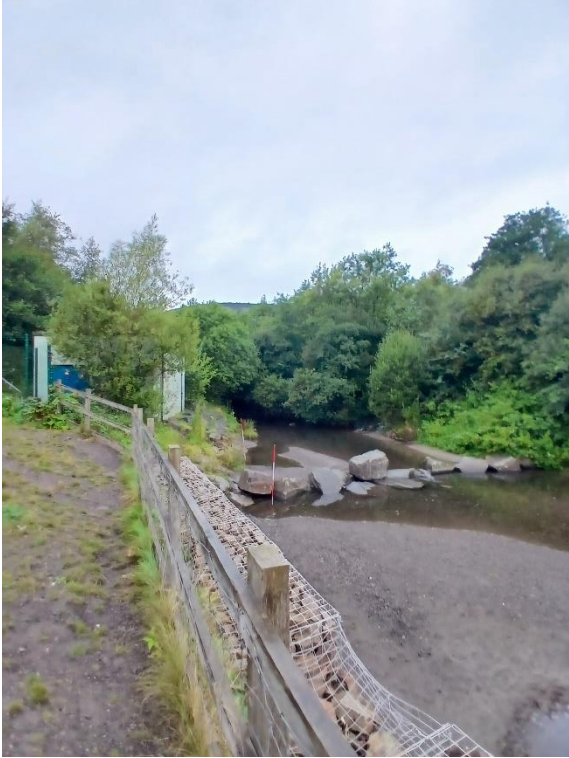
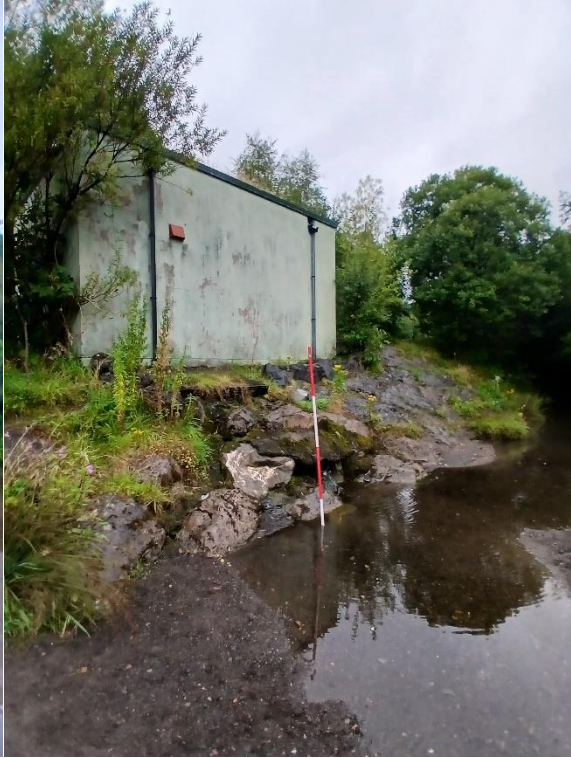
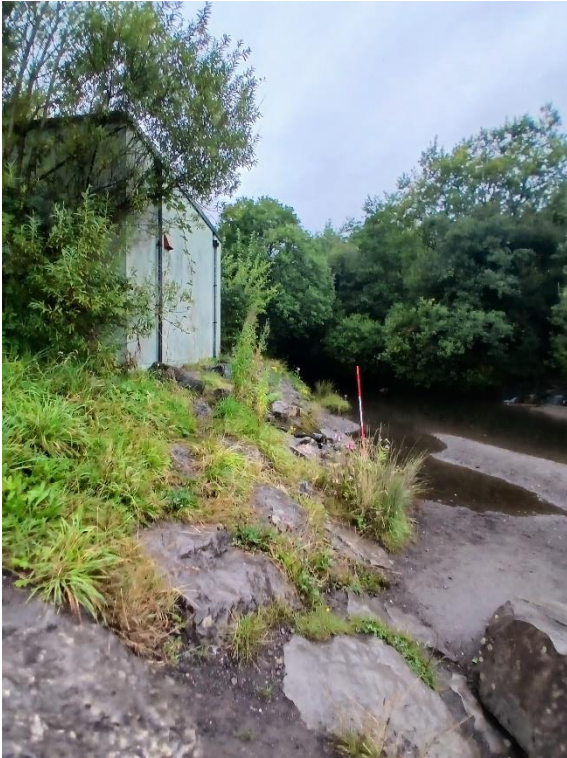
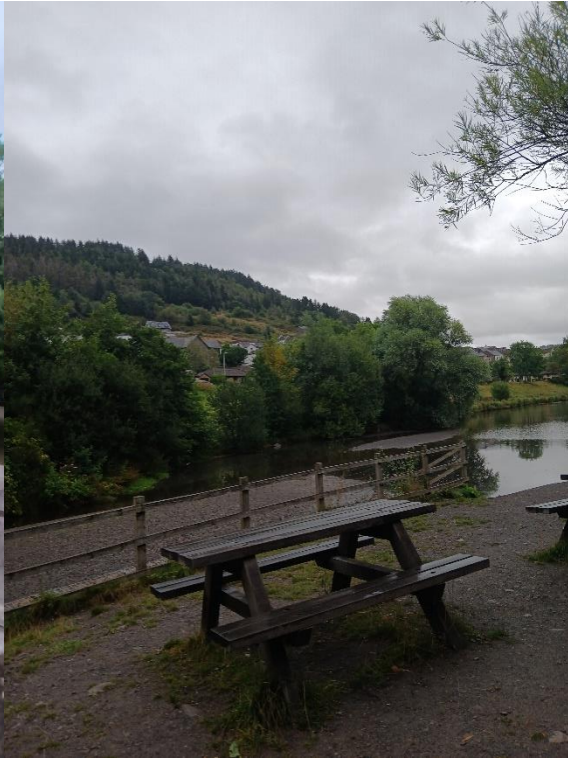
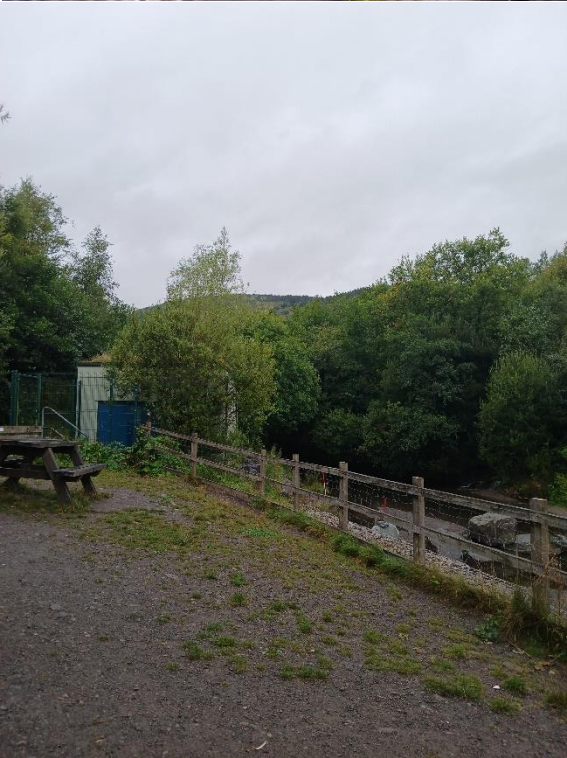
Location A

SS 98044 92848. Location approximately 300m upstream of the proposed abstraction point is the discharge of an existing community hydropower scheme. Between this location and the proposed intake is a 300m long manmade lake with a high level of sedimentation. Upstream from this photo the watercourse is heavily modified.

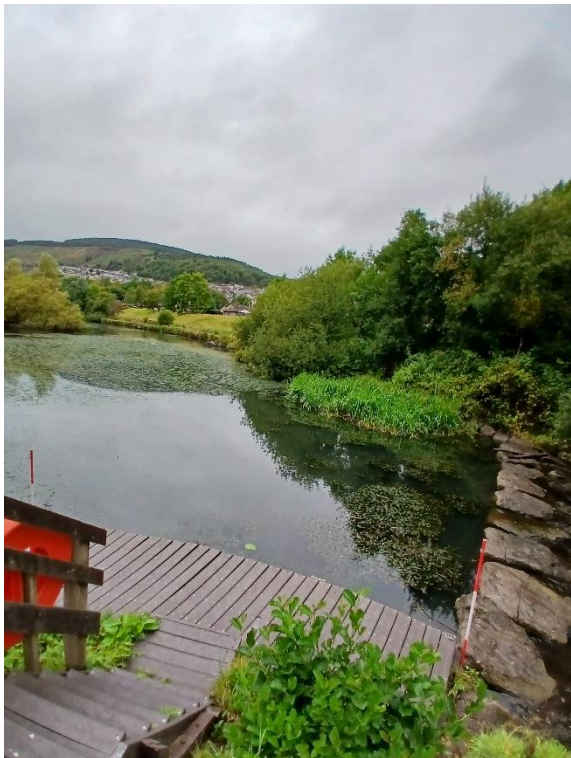
SS 98296 92820. View upstream of the proposed abstraction point. A heavily modified stretch of watercourse comprising a manmade lake that is a significant sediment trap.

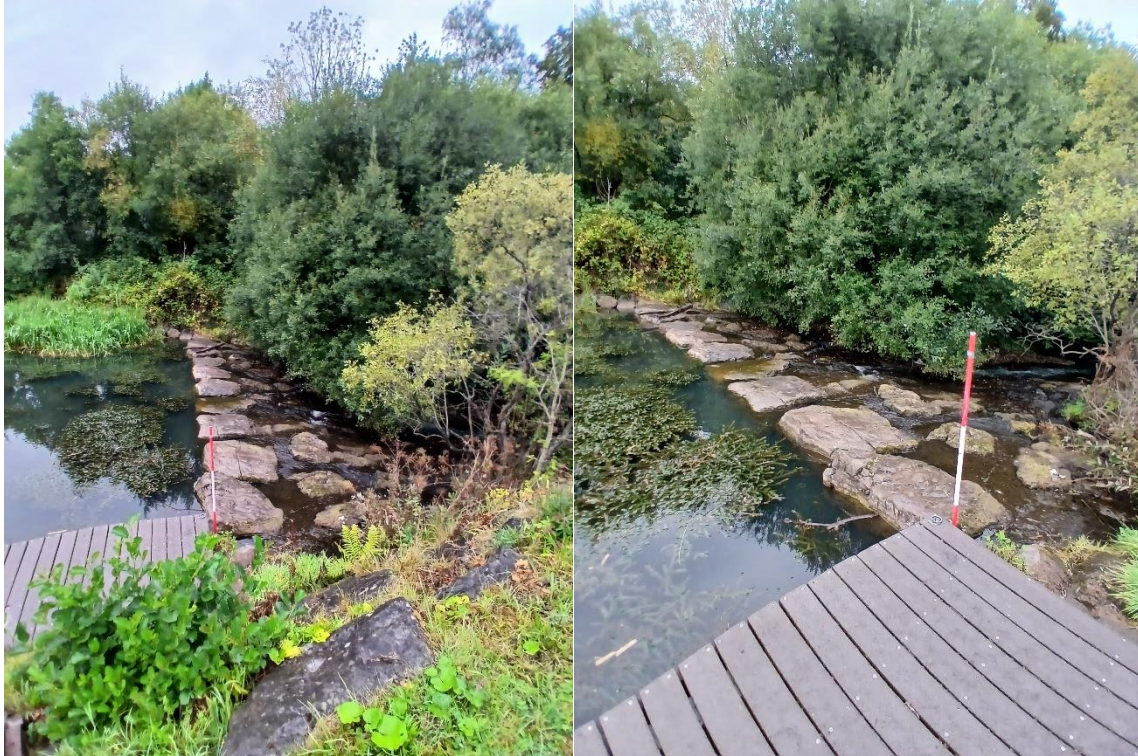
SS 98296 92820. View of existing outflow from the lake and location of the leat intake (to the right where the wooden deck is). The watercourse from here is entirely manmade with the bed and banks consisting of large rocks embedded in concrete. A small weir wall (approx. 200m high) would be built downstream of the existing overflow to ensure HOF can be maintained, but would not be higher than the existing overflow crest.

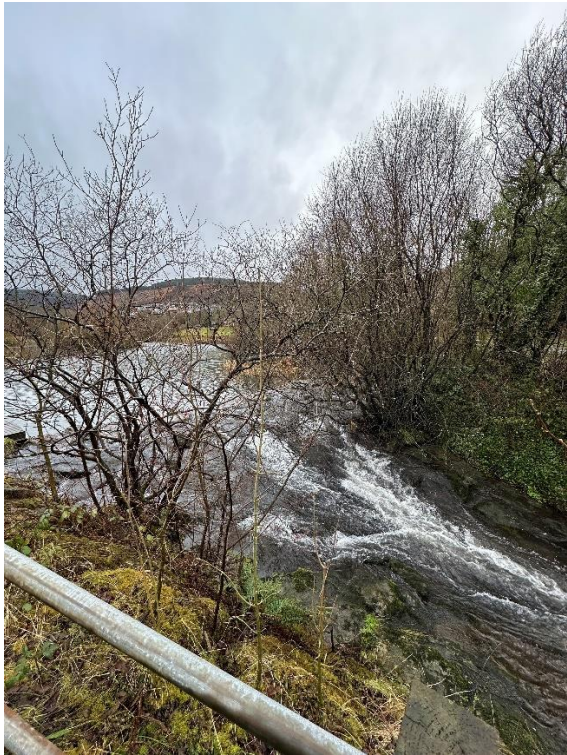
SS 98296 92818. Location of the proposed intake on the bank. The excavations needed down to the watercourse for the outflow are all through manmade concrete banks materials.

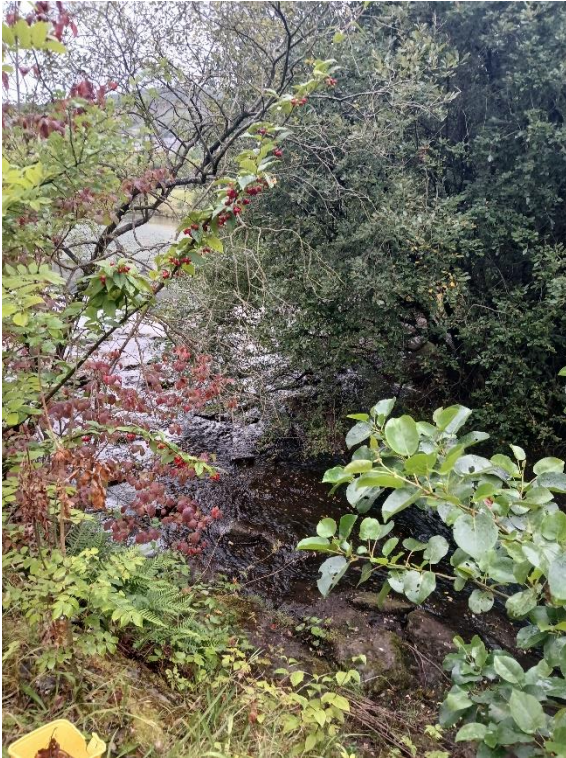
Location C

SS 98329 92816. View downstream of intake location with further views of the concrete channel.

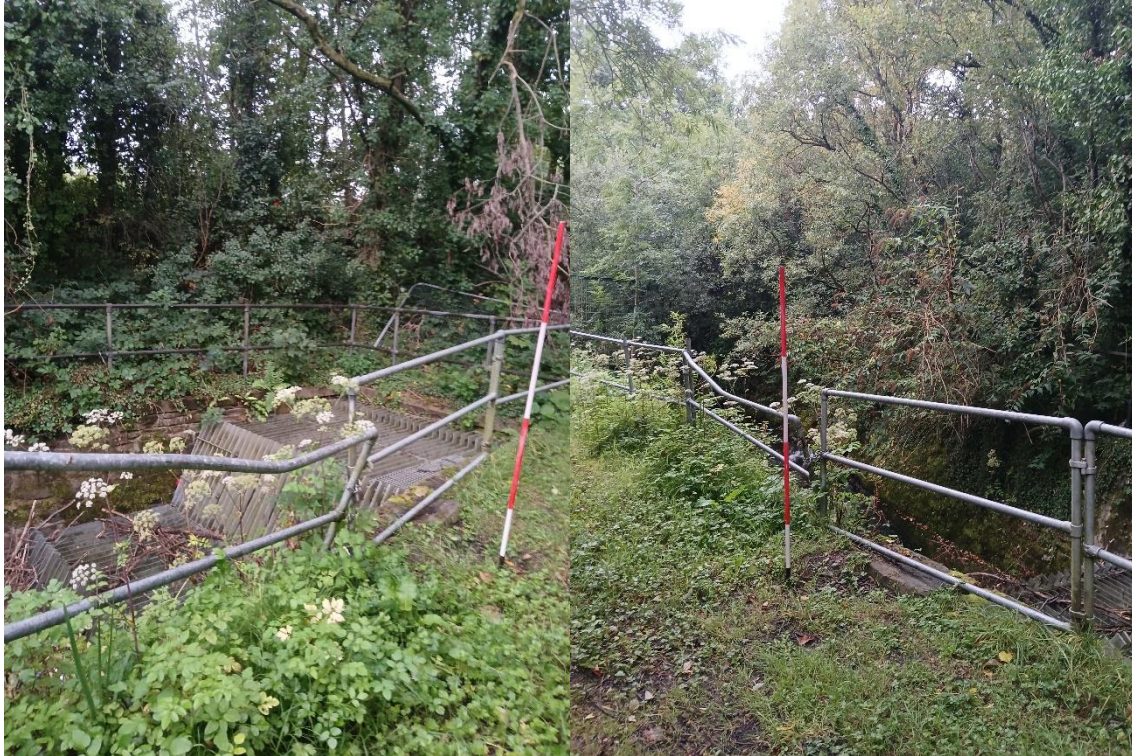
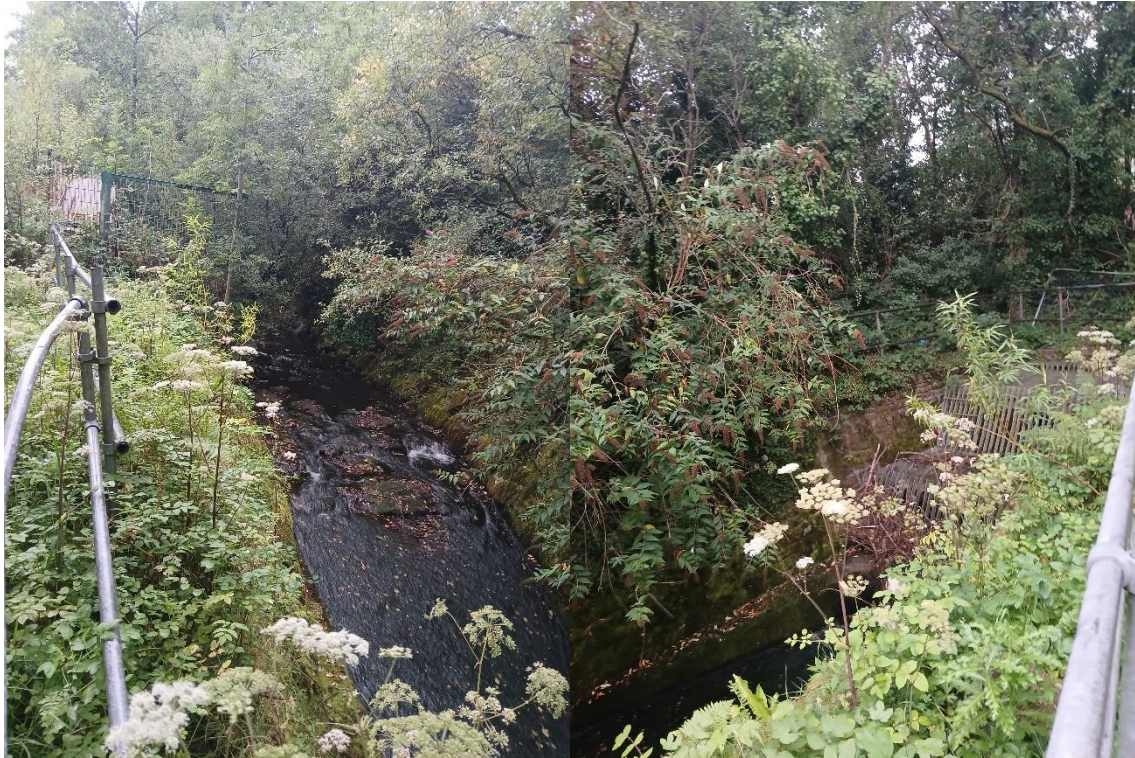
Location D

SS 98329 92816. Below the intake location the watercourse leaves the concrete lined manmade watercourse channel and enters an (approx.) 870m concrete lined channel for the remainder of the depleted reach. The abstracted water would travel down a buried penstock that takes a relatively direct route through RCT Council owned land to the discharge location.

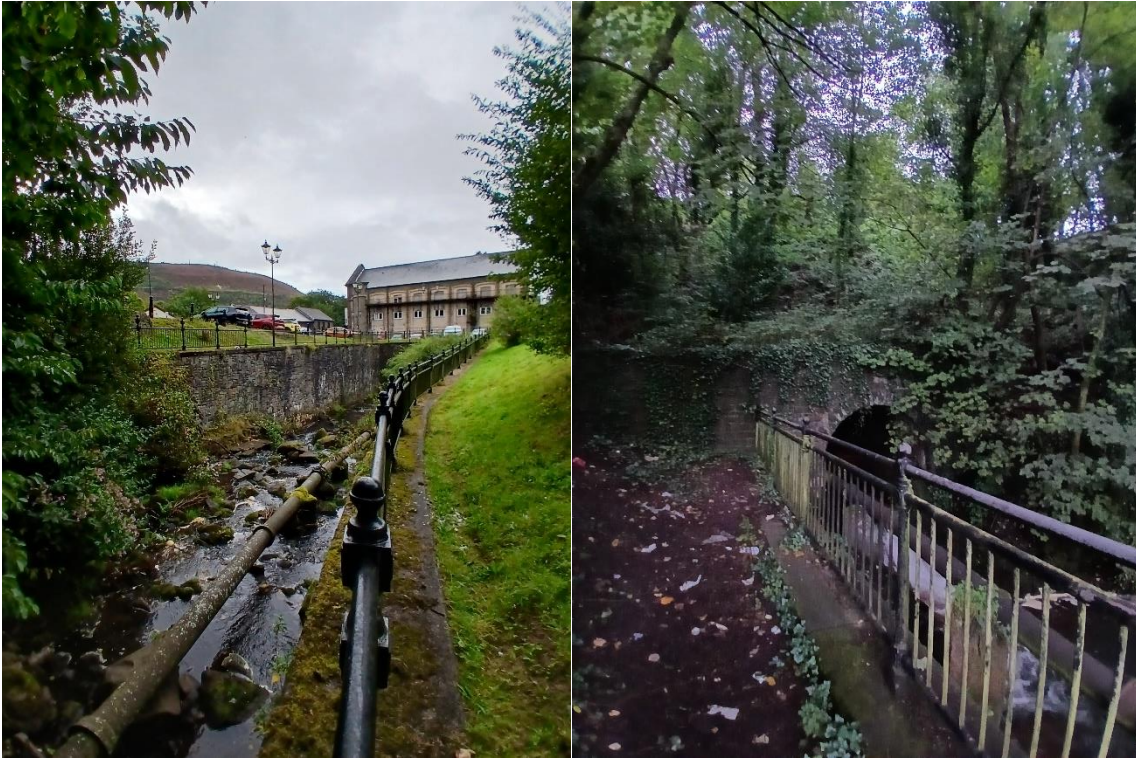
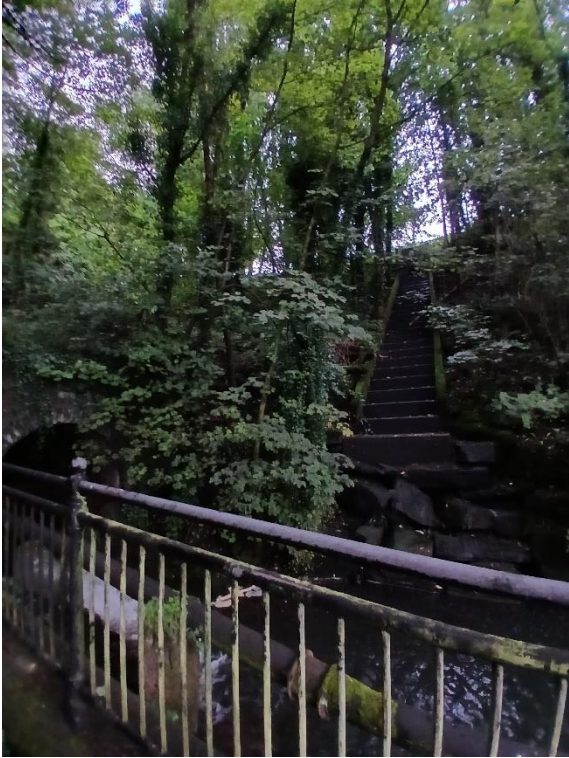
Location E

SS 99161 92694. Location approximately 25m downstream of the proposed turbine house and 20m from the discharge of the culvert. All abstracted water would be returned adjacent to the culvert into the heavily modified channel.

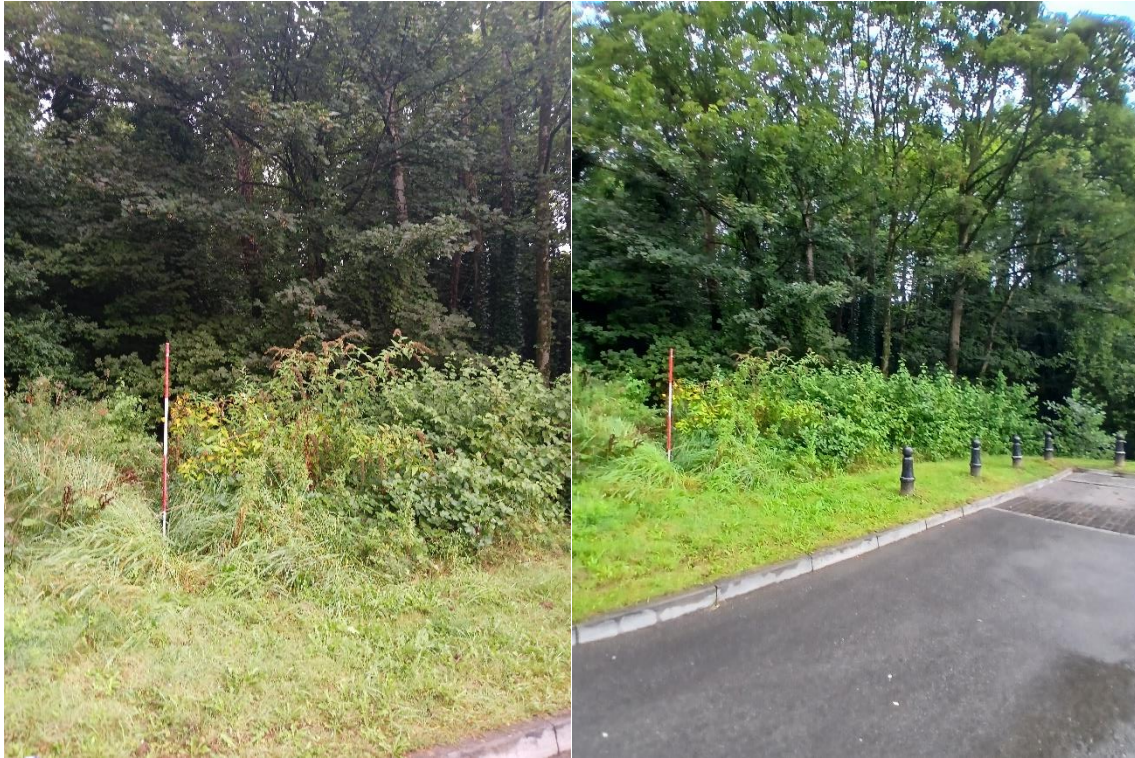
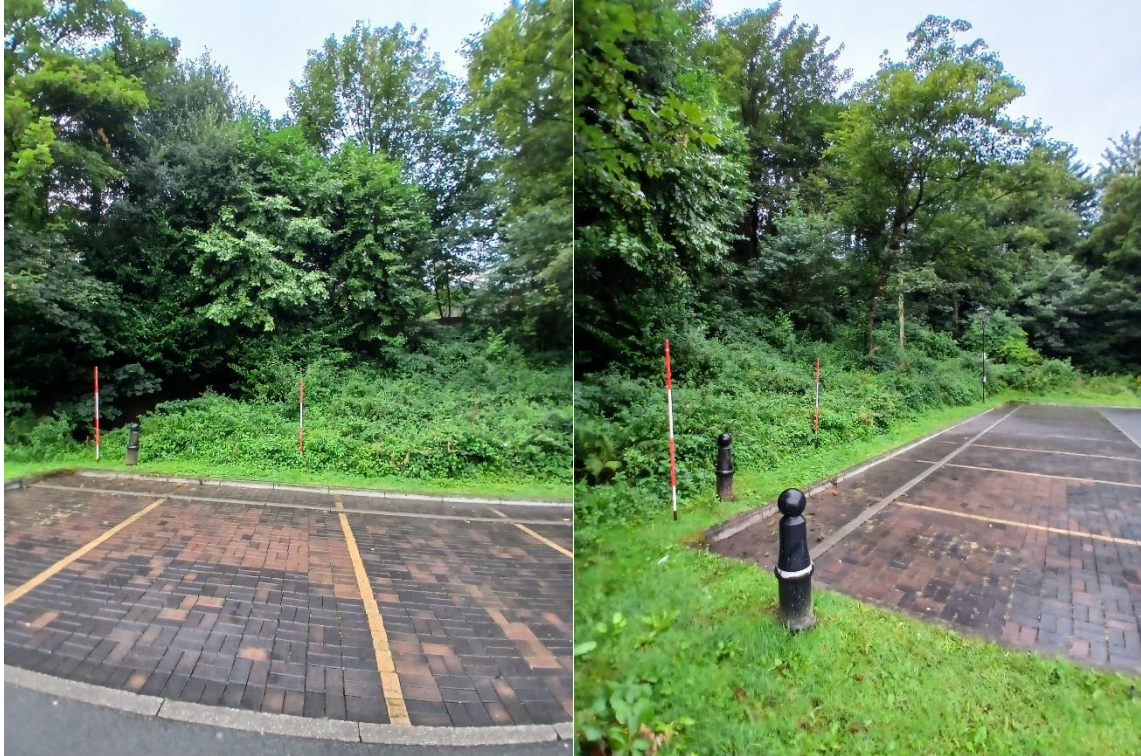
Powerhouse

SS 99196 92649. Proposed location of the scheme powerhouse located in De Winton Street Car Park. Abstracted water will be transported via piping underneath the car park to the channel as shown in Location E.

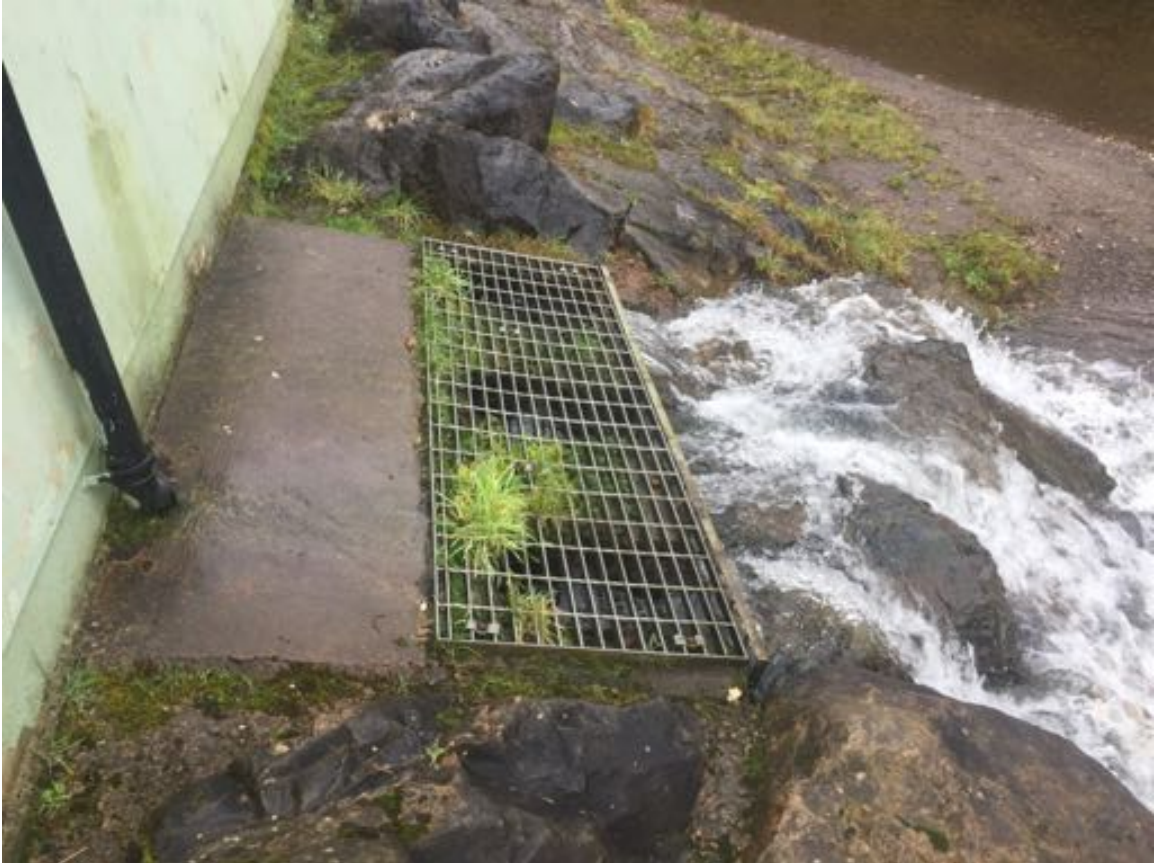
Photo A1: SS 98044 92848. Location approximately 300m upstream of the proposed abstraction point is the discharge of an existing community hydropower scheme. Between this location and the proposed intake is a 300m long manmade lake with a high level of sedimentation. Upstream from this photo the watercourse is heavily modified.

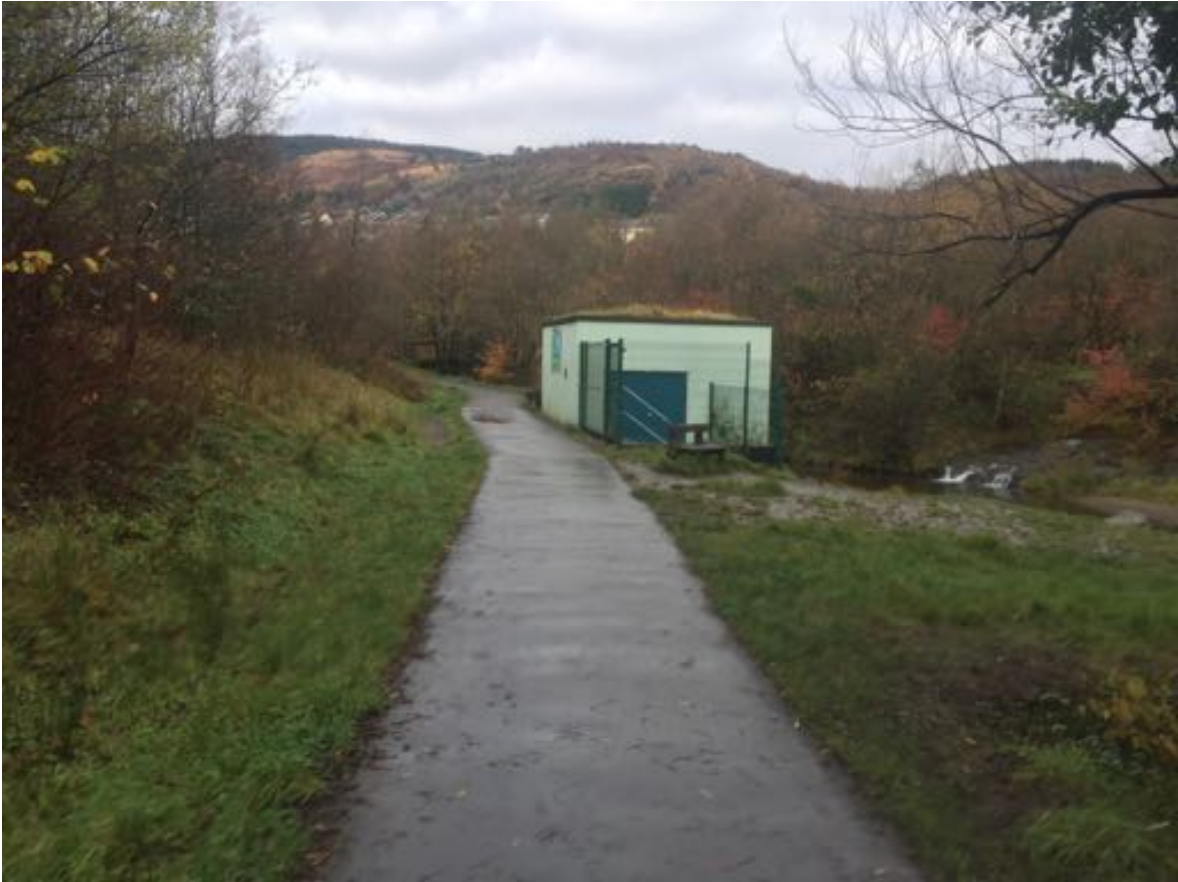
Photo A2: SS98121 92813. View of the existing turbine house on the southern bank of the Cwm Clydach Lake.

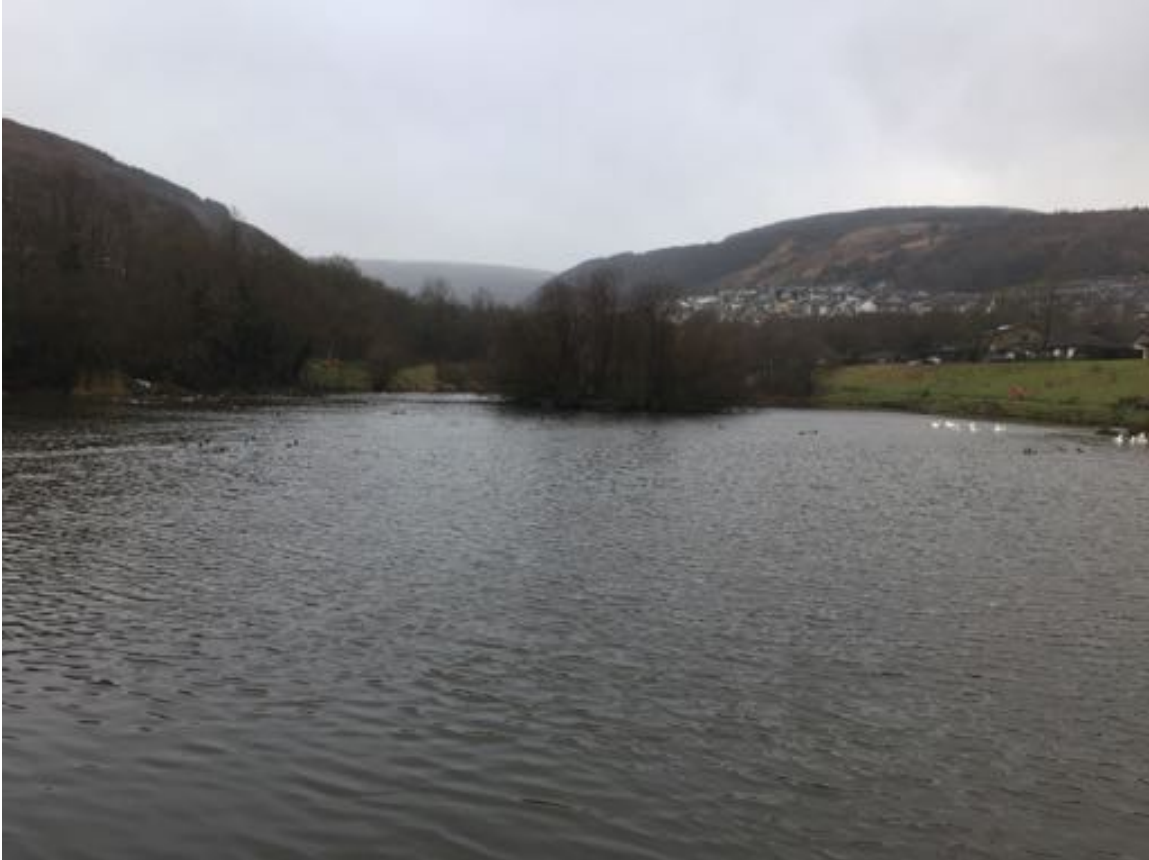
Photo B1: SS 98296 92820. View upstream of the proposed abstraction point. A heavily modified stretch of watercourse comprising a manmade lake that is a significant sediment trap.

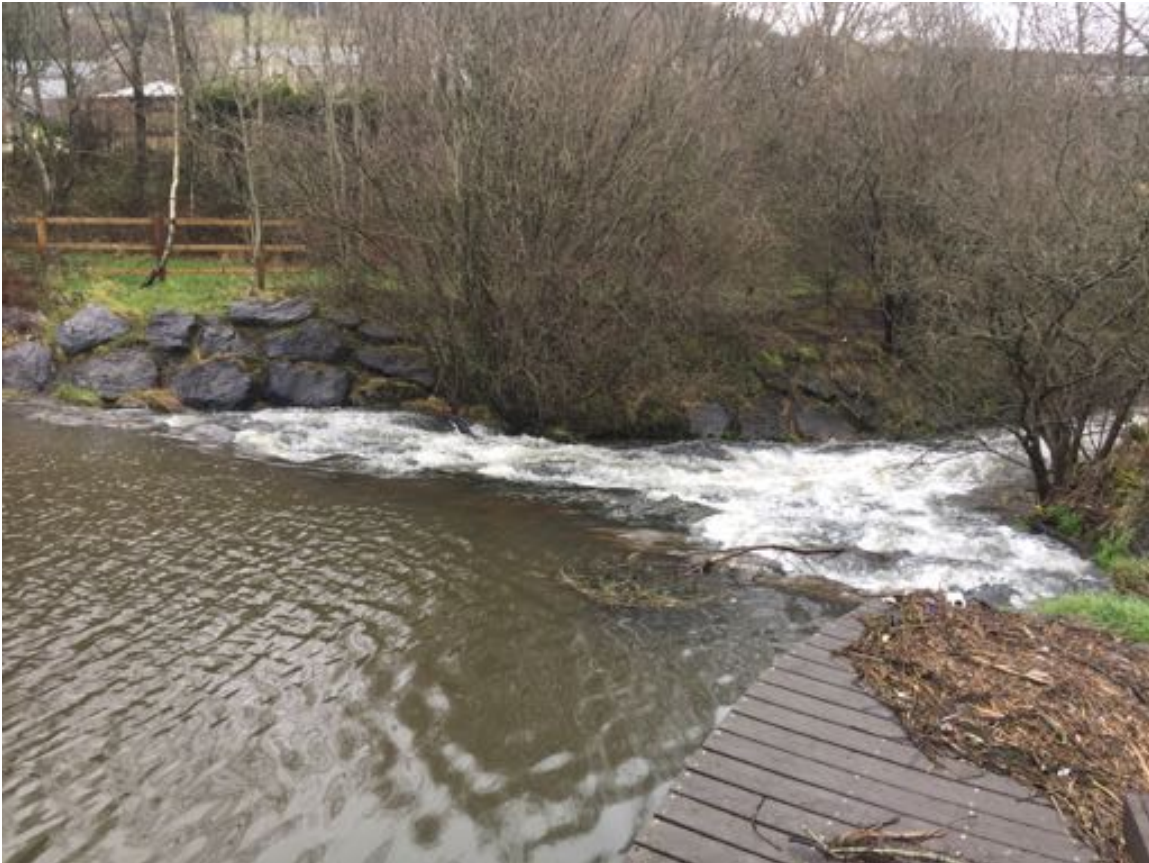
Photo B2: SS 98296 92820. View of existing outflow from the lake and location of the leat intake (to the right where the wooden deck is). The watercourse from here is entirely manmade with the bed and banks consisting of large rocks embedded in concrete. A small weir wall (approx. 200m high) would be built downstream of the existing overflow to ensure HOF can be maintained, but would not be higher than the existing outflow crest.

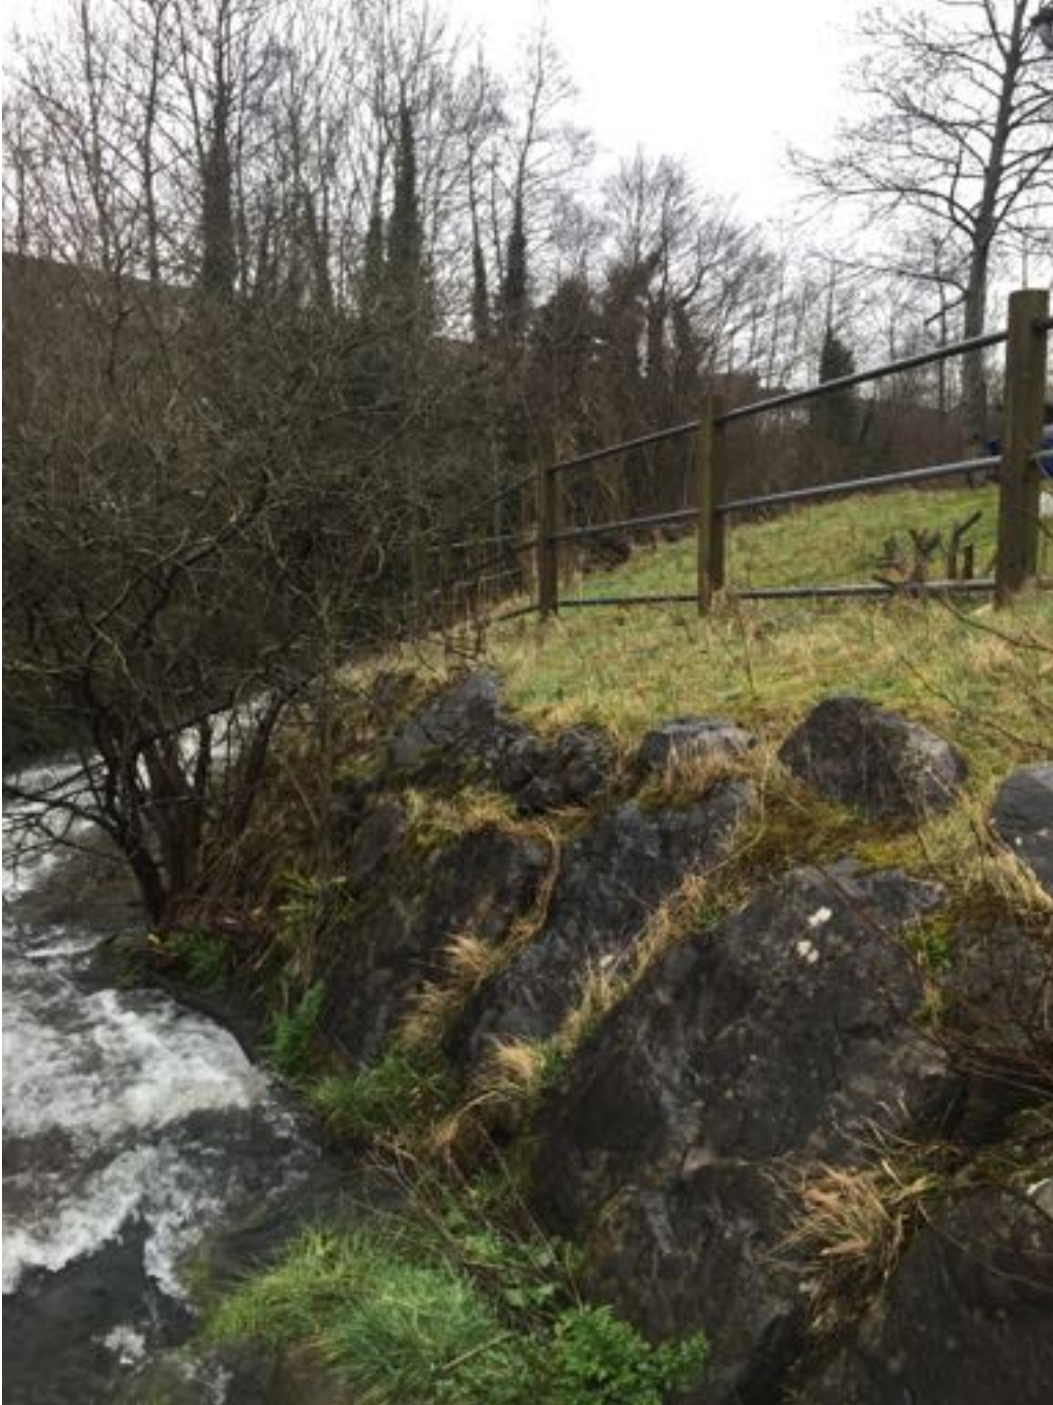
Photo B3 (Upstream) & B2 (Downstream): SS 98296 92820. Route and location of proposed leat from the existing lake outflow crest. Intake box (coanda screen) would be built into the bank with excess water cascading back into the concrete lined channel.

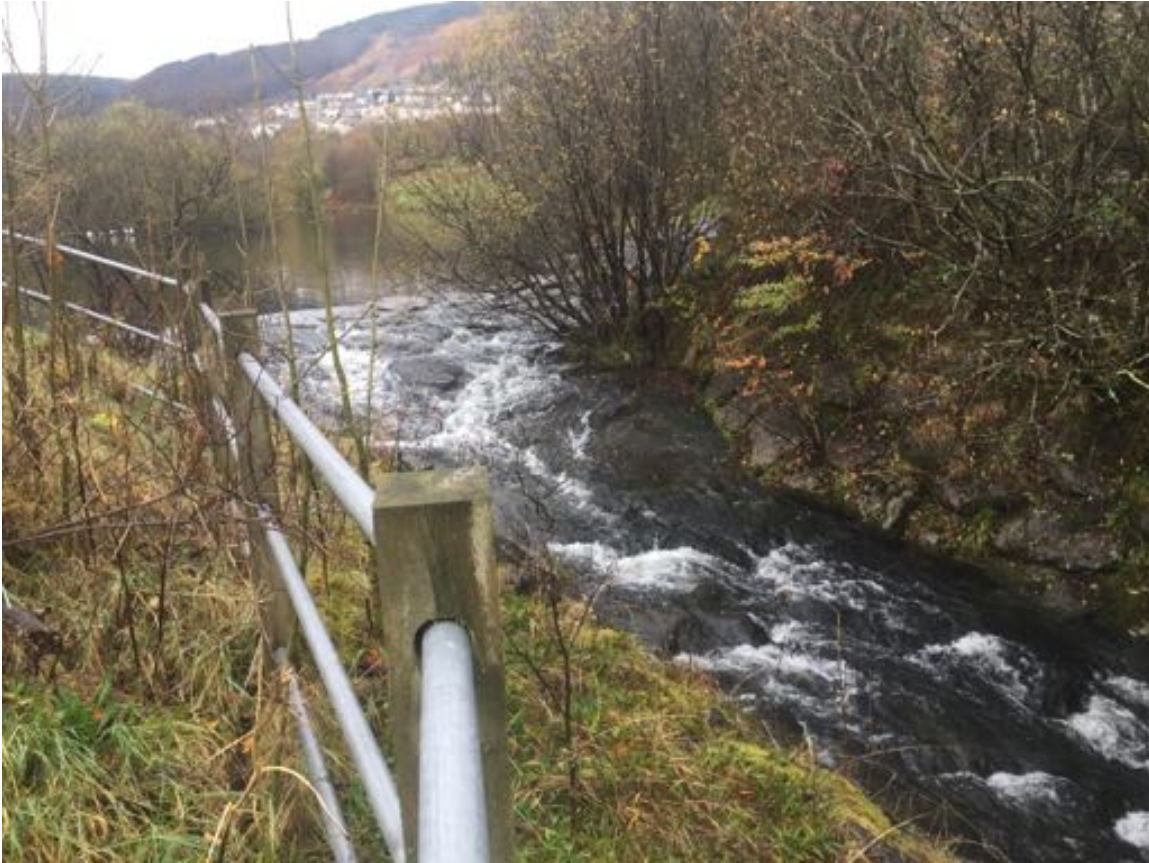
Photo C1: SS 98329 92816 Location of the proposed intake on the bank. The excavations needed down to the watercourse for the outflow are all through manmade concrete banks materials. Leat channel follows broadly the fence line, but would have a grill and/or be fully buried.

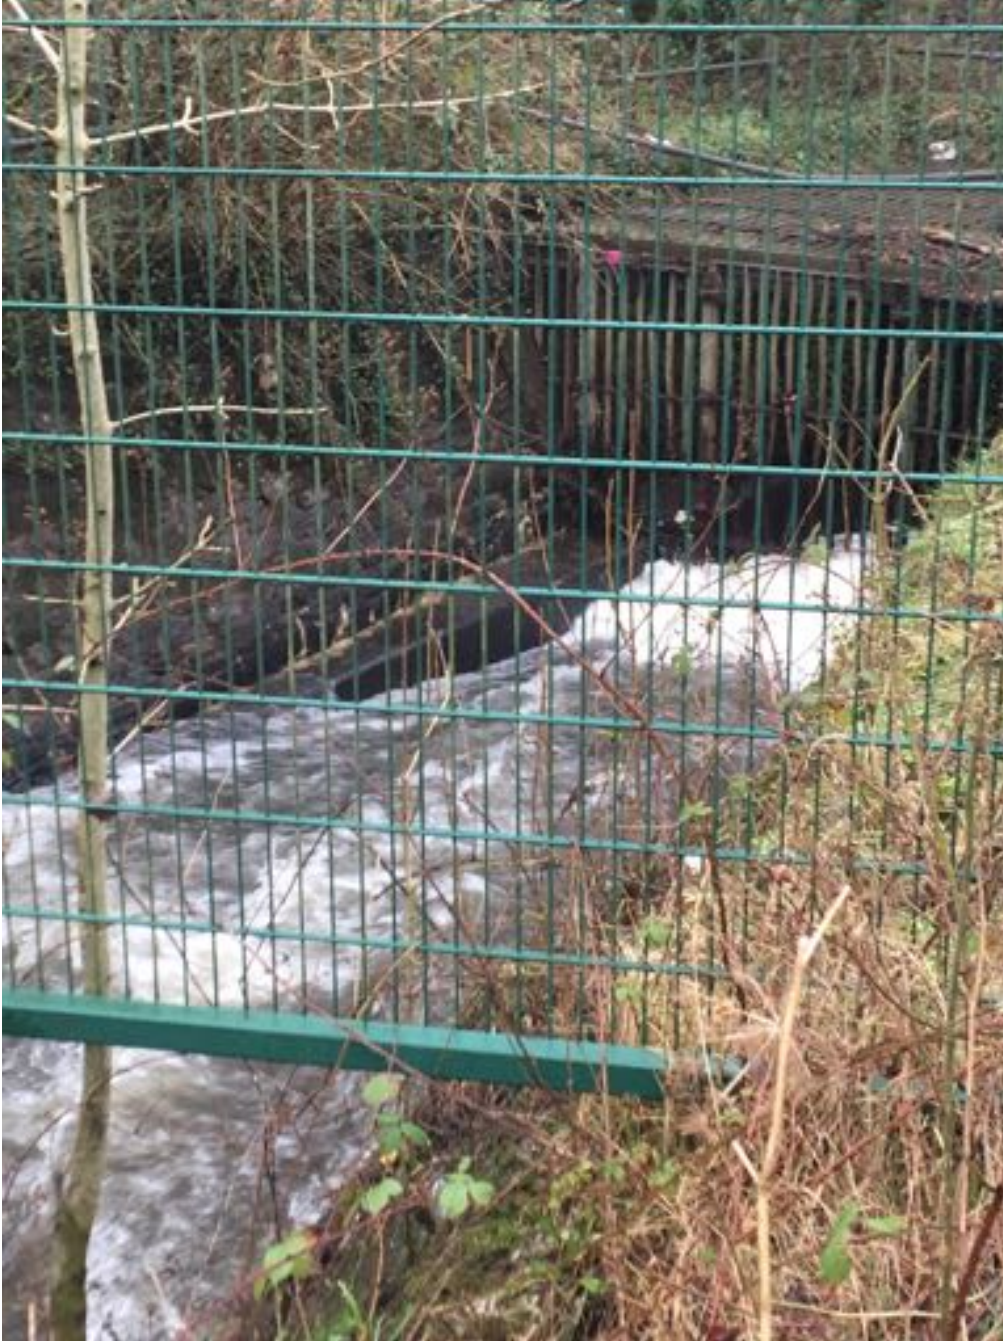
Photo D1 (Downstream): SS 98329 92816. Below the intake location the watercourse leaves the concrete lined manmade watercourse channel and enters an (approx.) 870m concrete lined channel for the remainder of the depleted reach. The abstracted water would travel down a buried penstock that takes a relatively direct route through RCT Council owned land to the discharge location.

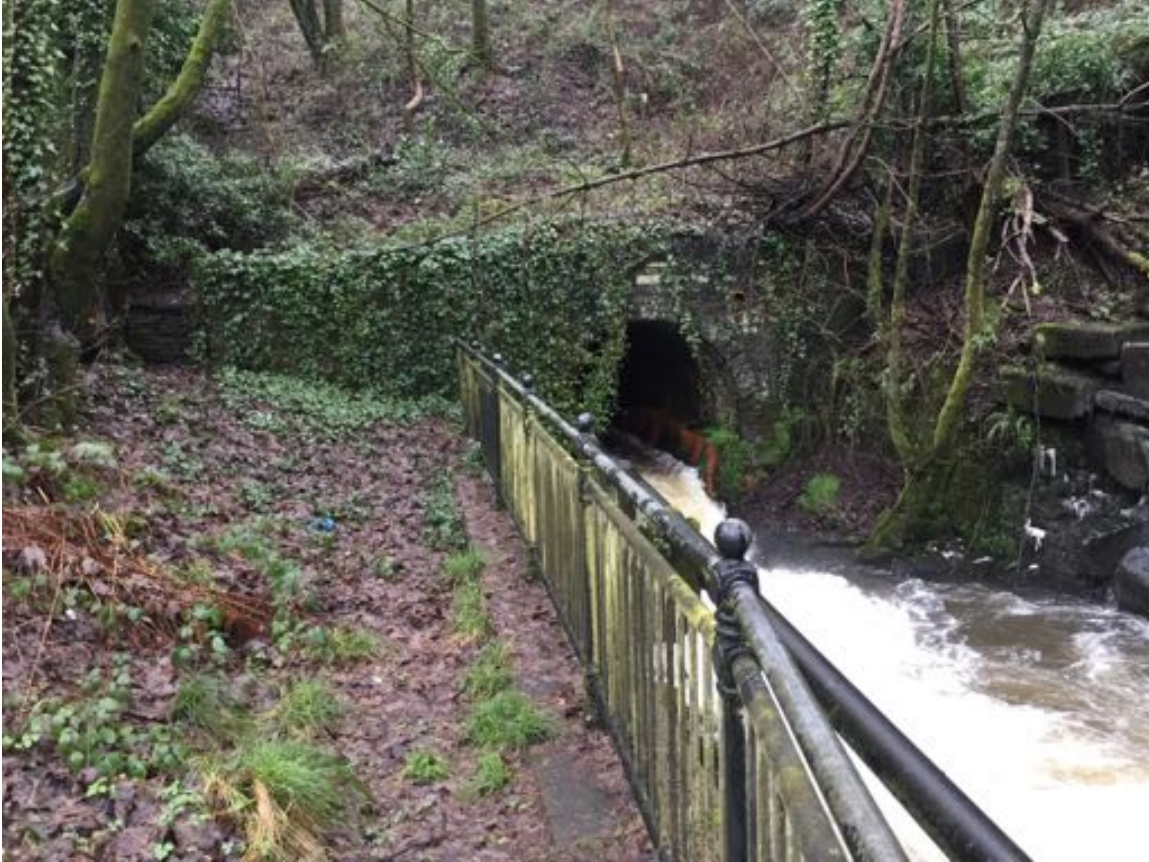
Photo E1 (Upstream): SS 99161 92694. Location approximately 25m downstream of the proposed turbine house and 20m from the discharge of the culvert. All abstracted water would be returned adjacent to the culvert into the heavily modified channel.

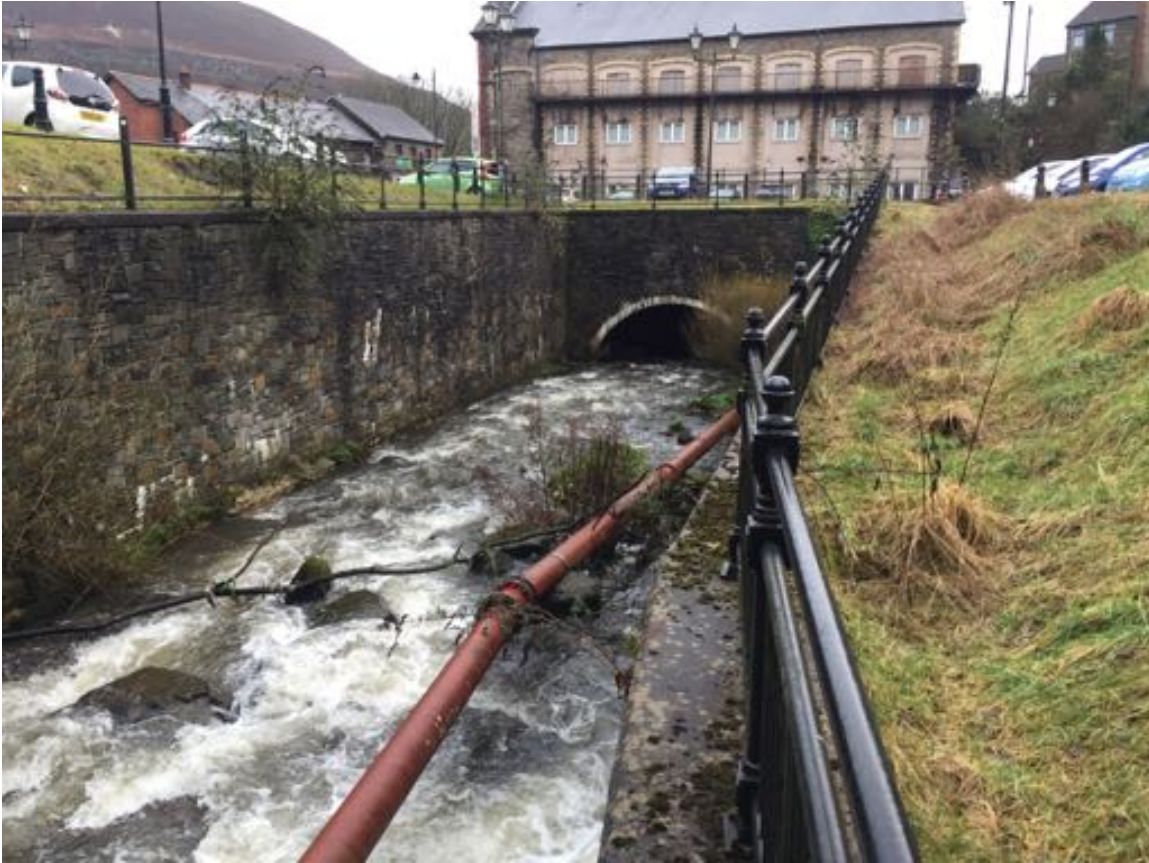
Photo E2 (Downstream): SS 99161 92694. Downstream of the proposed a discharge location the heavily modified channel is 'open' for approximately 50m before entering into another tunnel as it travels under Tonypany Town Centre.

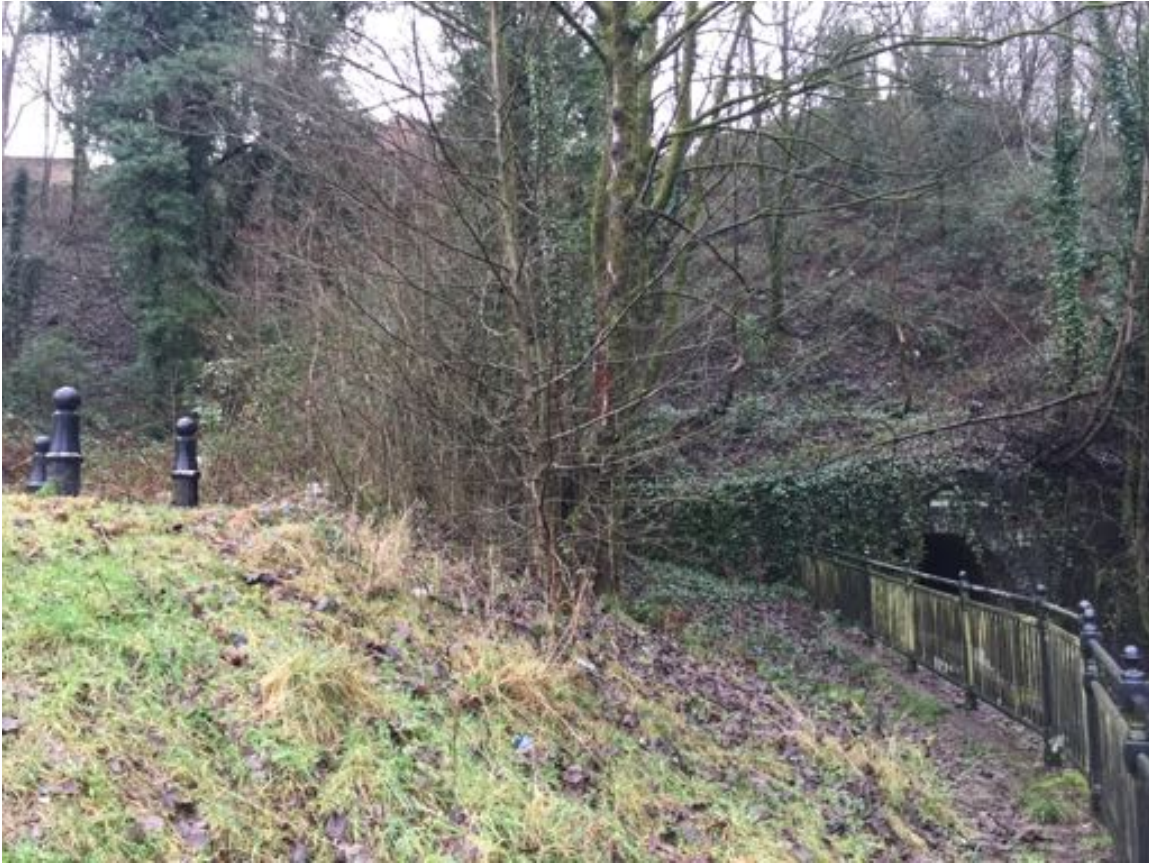
Photo E3: SS 99161 92694. View of proposed turbine house location (to the left, by the bollards) and the route of the proposed tailrace to the discharge point where the culvert outflow is located.

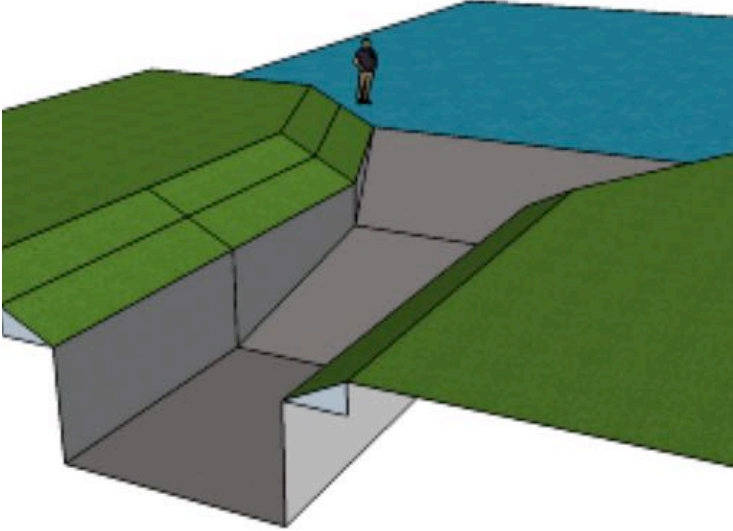
Image C1 (Upstream): SS 98296 92820. Existing View from the northern bank towards the location of the intake. All heavily modified. Lake outflow dominates the areas.

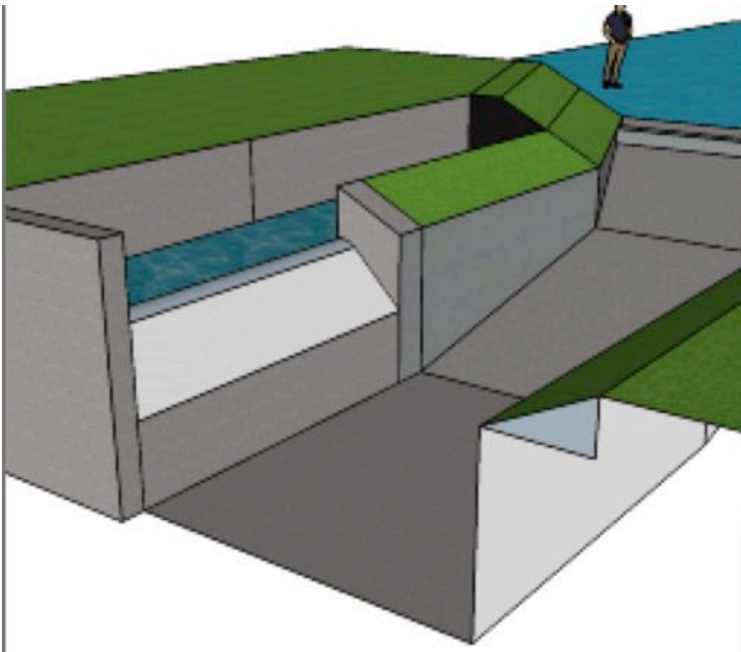
Image C2 (Upstream): SS 98296 92820. Proposed View from the northern bank towards the location of the intake. Leat channel leads from manmade lake to intake box on the bank. Excess water flows back into concrete channel.
