TITLE: Engineering Advice Note Reactor Buildings – Pre-cast Concrete Panels Overview AUTHOR: Aled Hughes – Project Engineer FUNCTION: Engineering	DATE: January 2023 TRAWS-EAN-23-005 QA GRADE: 3
DISTRIBUTION: Project Files Document Centre Systems Engineering Decommissioning Programme (Site) Work Control	STATION: Trawsfynydd ATTACHMENTS: Appendix A - Original PCCPP As Built Drawings Appendix B – Structural Strengthening and Repair Drawings Appendix C - PCCPP Detailed Information Spreadsheet Appendix D - Defect Panel Drawings Appendix E - Supplementary Drawings
QA STATEMENT: All work has been carried out in accordance with the relevant company quality procedures.

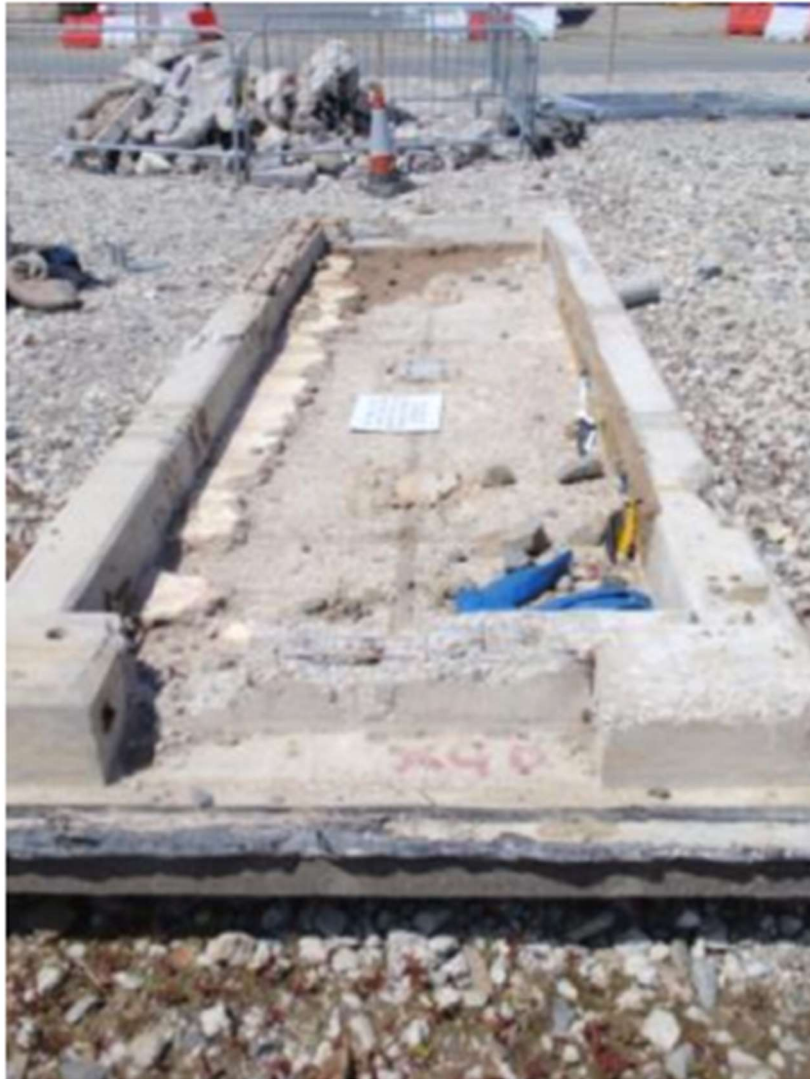
Figure 12: Defect panel W-0520

In October 2008, an inspection of the PCCP revealed that one of the PCCP, (panel reference W-0520) located in the northwest stair core of reactor building was in a poor state of deterioration. The condition was sufficiently serious to warrant immediate action as it was judged a hazard and a risk to health and safety on the site. It was recommended that the PCCP should be removed the removal of the PCCP was carried out in March 2010.

Given the constraints of the time, extraction of the PCCP involved the removal of restraining brackets installed as part of the strengthening works discussed in Section 4.1. It was found necessary to cut some of the concrete in the panel ribs locally as there was still good adhesion of the PCCP to the parent support concrete. This was possibly due to epoxy resin adhesive that had been injected behind the restraint brackets.

ARUP were commissioned in June 2010 to carry out an inspection of the failed PCCP. For further information into the findings of the inspection please refer to the report "0035 Inspection of 'X-Defect' Precast Panel".

The void was then infilled with a specially designed prefabricated steel frame with profiled metal sheeting. This component is still in place whilst the removed PCCP is still housed on site. Further details of the removal methodology are provided in Appendix D.

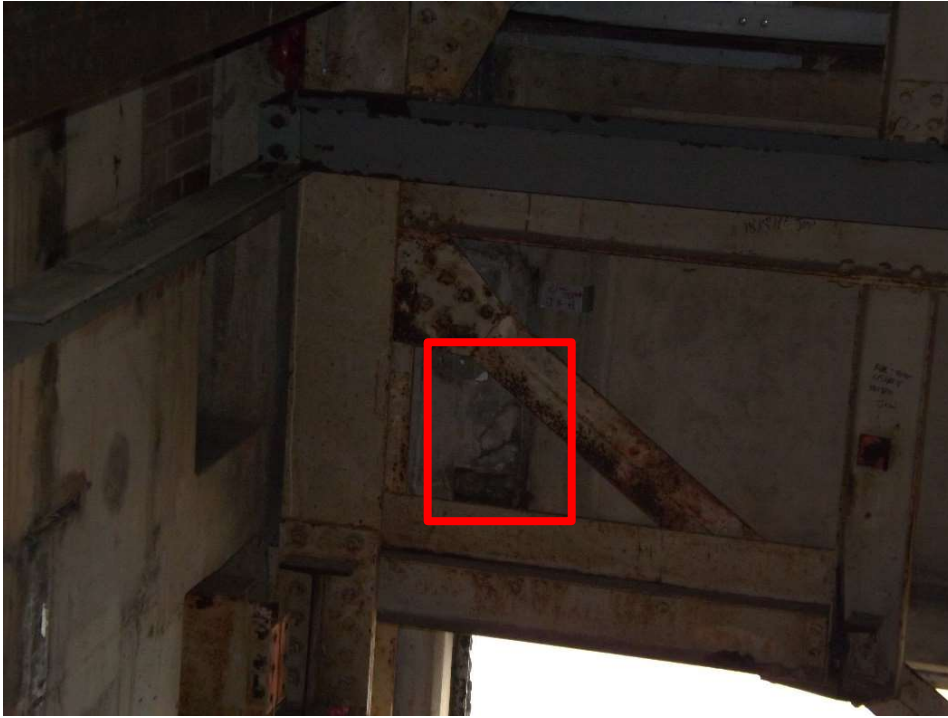
Figure 13: Class D Defect – 10314a/1

There is only one Class D defect identified in the 2018 LC28 report which is located on the fifth floor in interspace 8/9 room number 2080. The defect is located on a concrete corbel supporting a PCCP which has evidence of deterioration. Access to the defect area is problematic and can only be inspected from distant fifth floor slab. This defect is continually inspected. The defect ID number is 10314a/1 and its location can be seen on drawing TRA/3630/ST/46073 in Appendix E. A photo of the defect can be seen below.

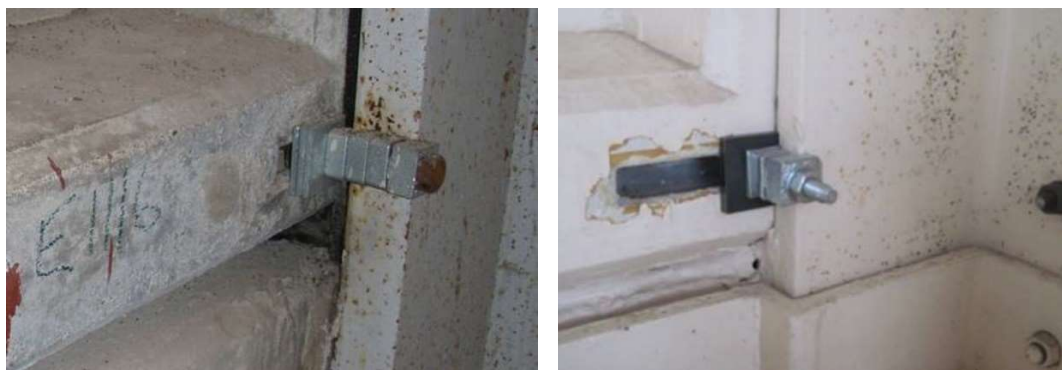
Figure 15: Example Lindaptor Repair

- At the time, the condition was observed to be good with minor surface corrosion and no appreciable section loss.
- In a small number of cases, missing or degraded lindaptor connections were replaced. This included the replacement/addition of packing spacers given the significant column flange depth. These works were evidenced with Inspection and Test Plans specific to PCCP.
