# GREENLINK MARINE ENVIRONMENTAL STATEMENT- WALES

Welsh and Irish Landfall Final Selection Report

P1975\_R4484\_RevF1  
June 2019

Greenlink Interconnector  
- connecting the power markets  
in Ireland and Great Britain

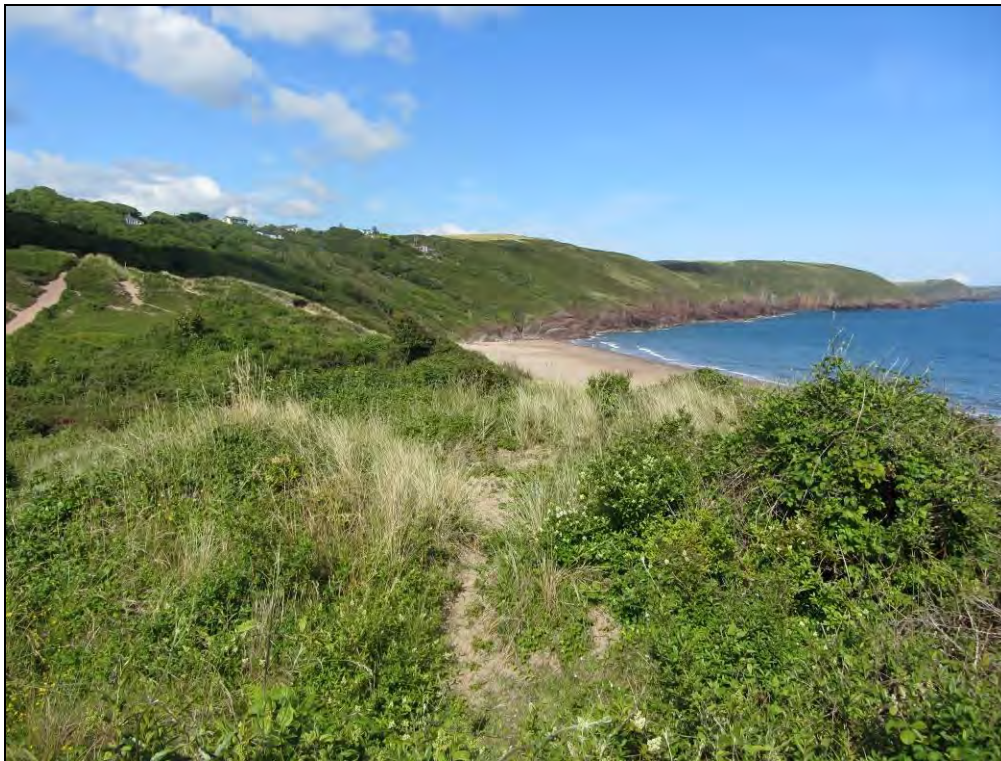
**Figure 5-7 View of Freshwater East looking North; note steep slope to the West**

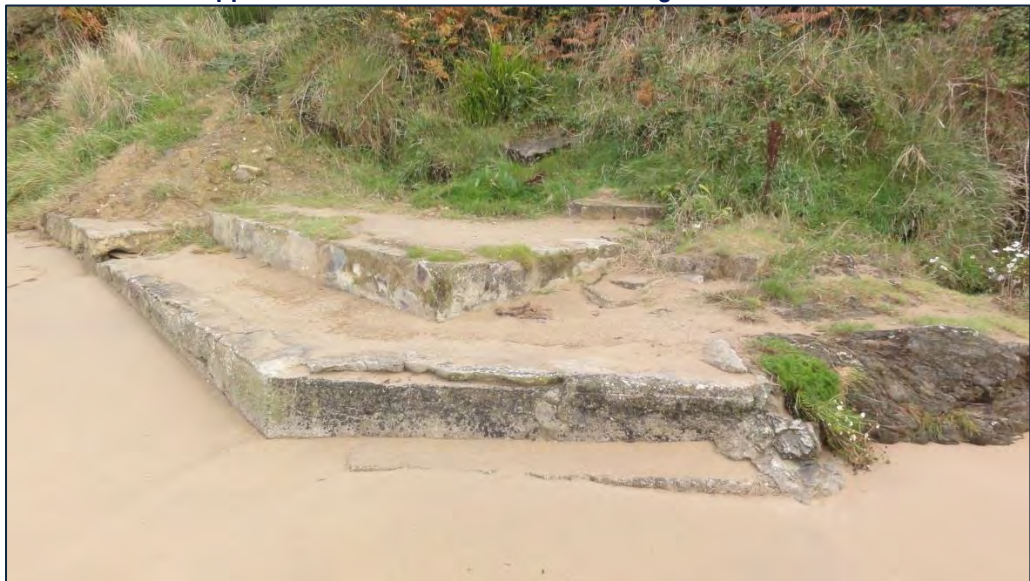
**Figure 5-5: Unknown concrete stepped structures at the south end of Baginbun Beach.**

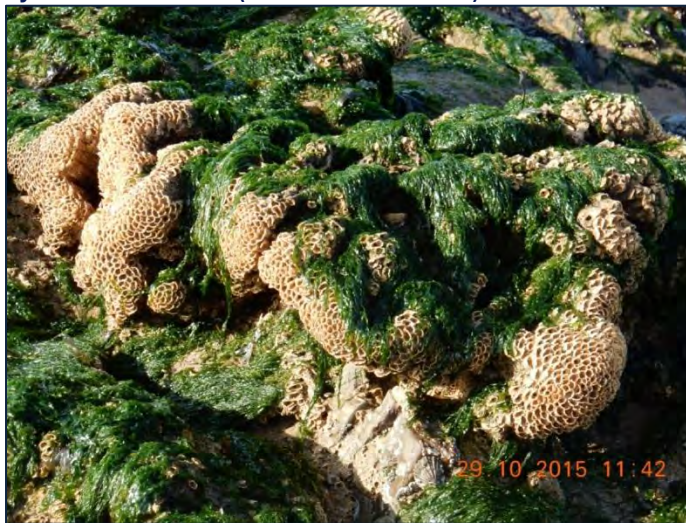
Figure 7-7: Honeycomb Worm Reef (*Sabellaria Alveolata*) on intertidal rocks at Booley Bay Landfall.

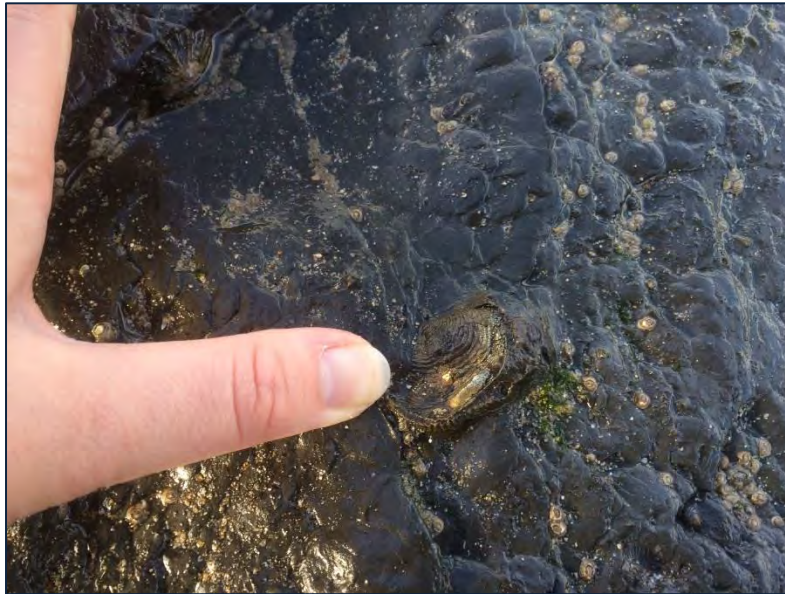
**Figure 8-6: A fossil found on the rock outcrop at Boyce's Bay. Fossil appeared to be naturally coated in pyrite.**

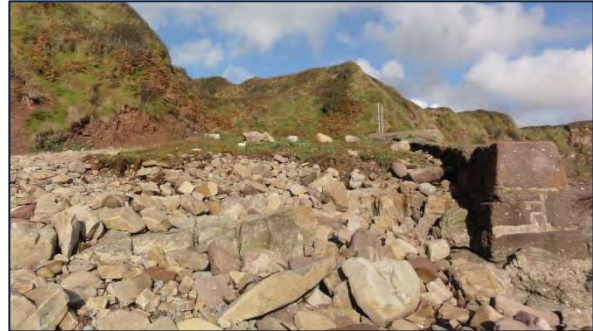
Figure 12-2: Rocky conditions at the base of the access road and evidence of sea defences.

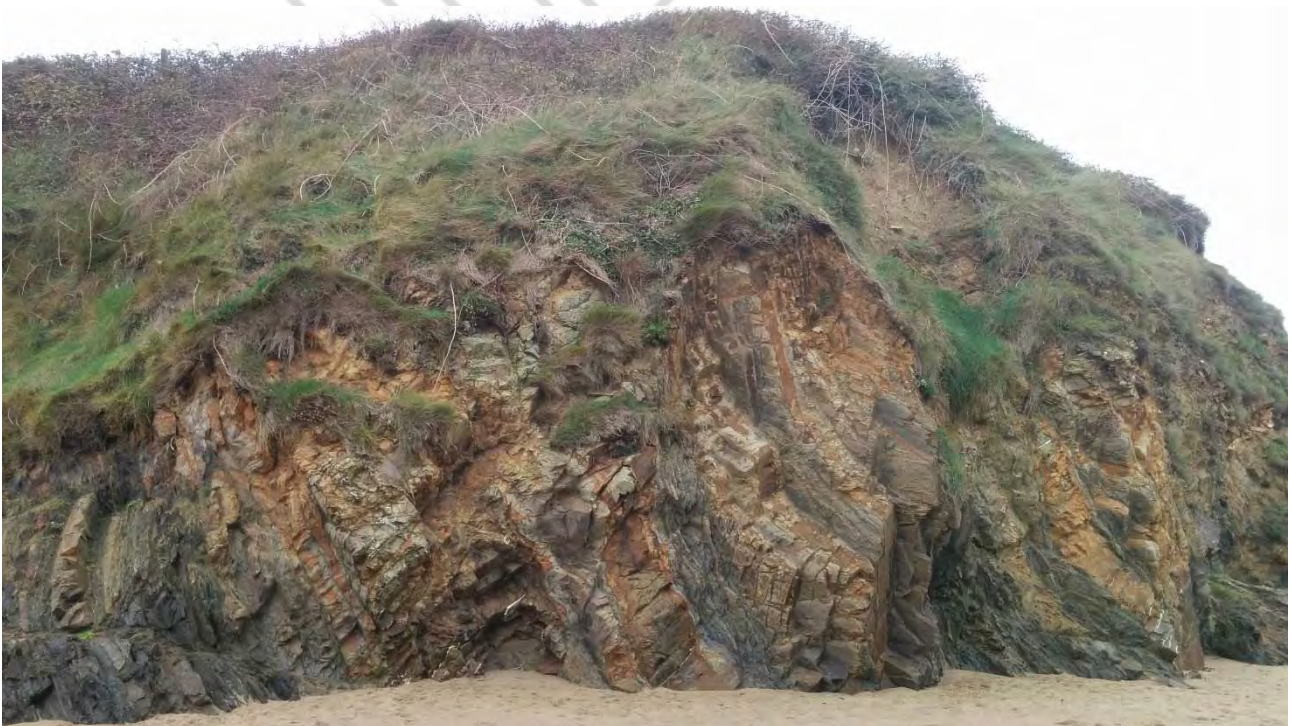
**Photo 3: Subsoil overlying bedrock**

The slope morphology changes along the cliff with the greatest variability in the bedrock. Towards the crest of the slope the overburden is either standing at a steep to sub-vertical angle or is densely vegetated. Minor visual indicators of slope movement and shallow slumping of the subsoil material were observed along the slope as indicated in Photo 2 and Photo 3 below.

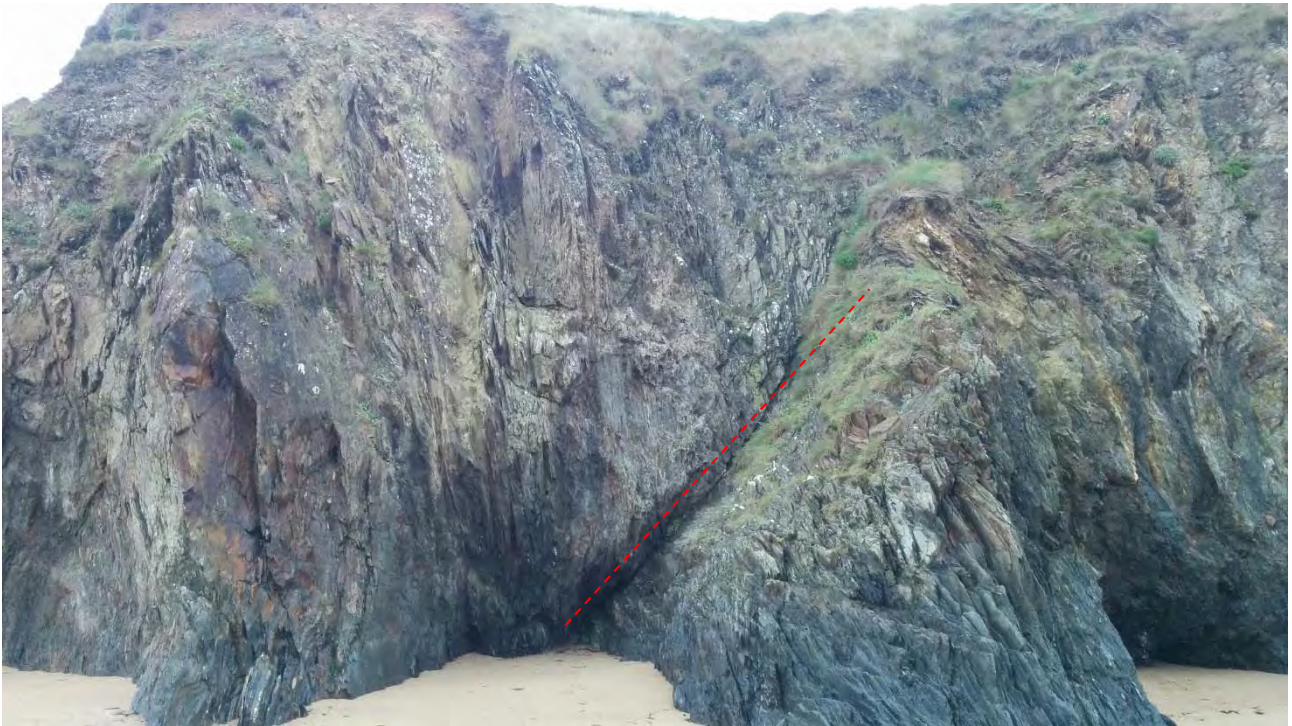
**Photo 5: Faulting visible on rockface (faultline shown in red)**

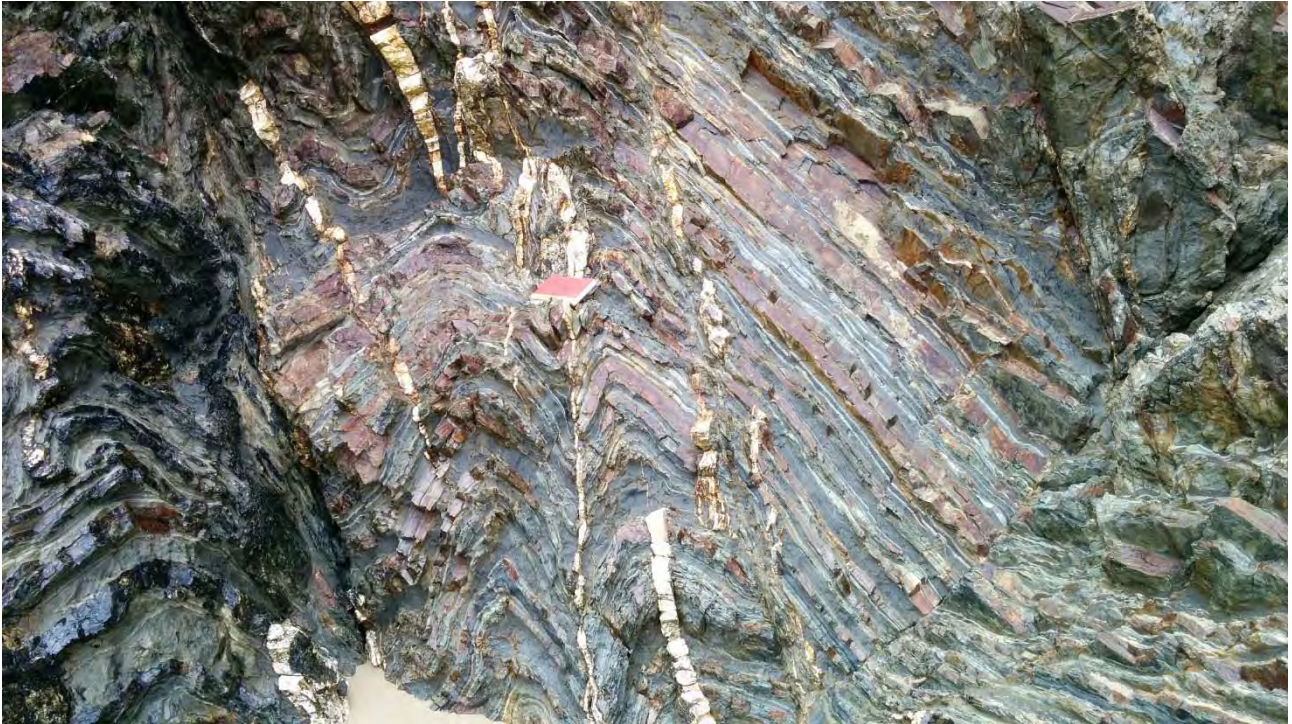
**Photo 6: Chevron folding in interlayered meta-sediments.**

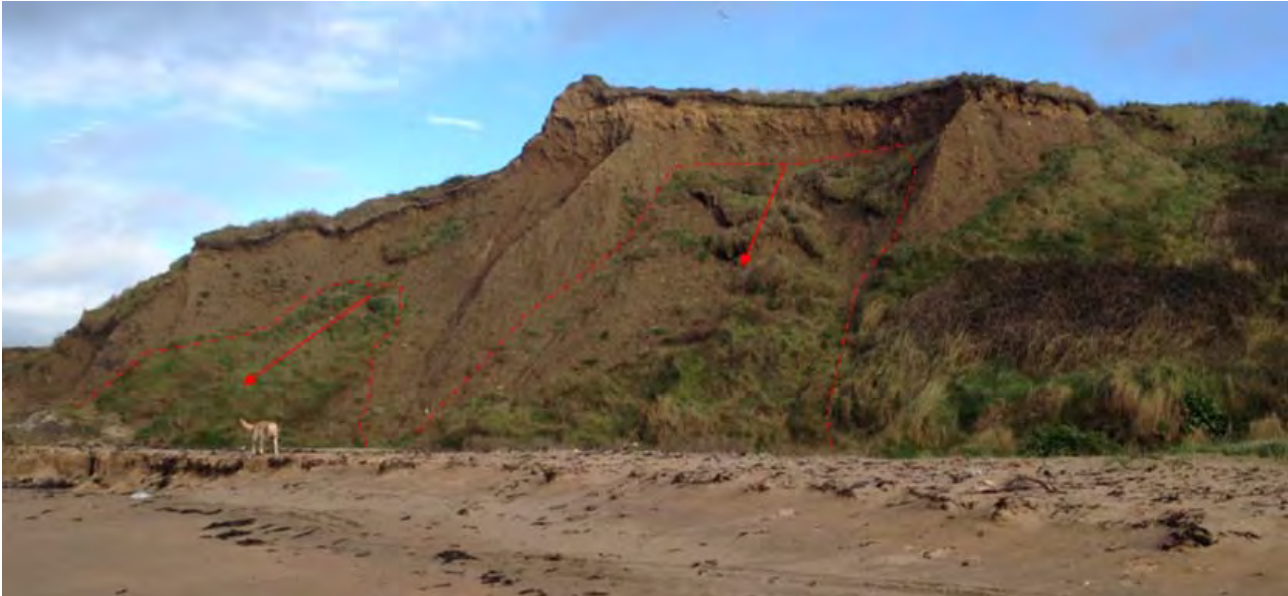
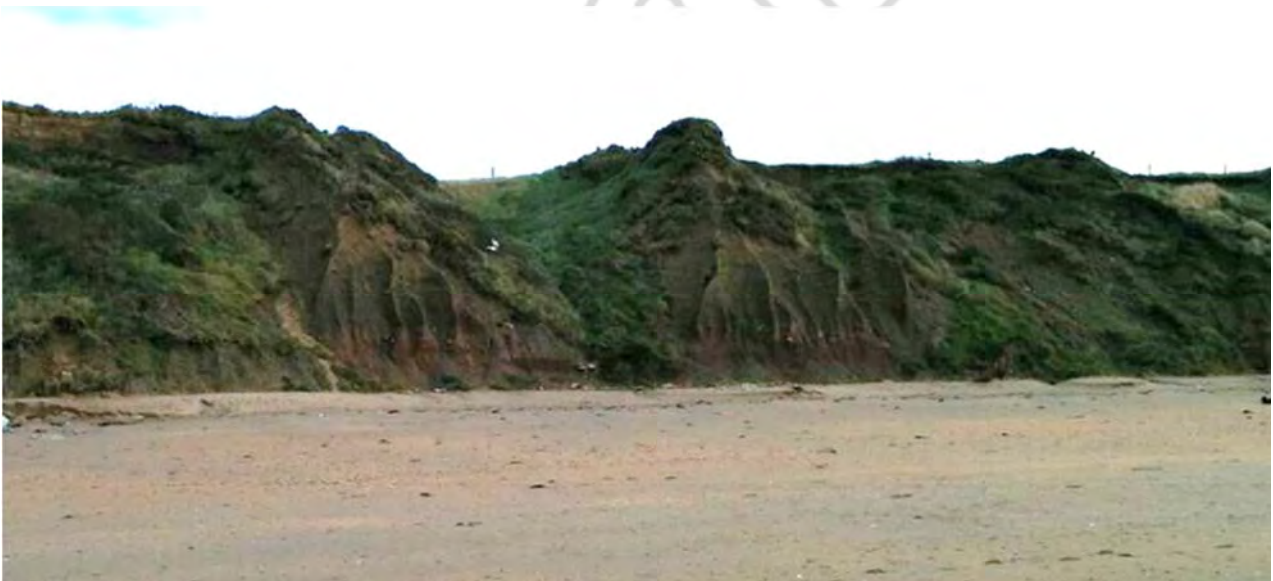
There is an abundance of slope failures visible along the slope. These failures appear to be progressive and predominantly shallow and are likely to have formed due to continual cliff recession due to over-steepening of the slope by erosion of the toe of the slope (Photo 11).

**Photo 11: Slope failure along soil slopes.**

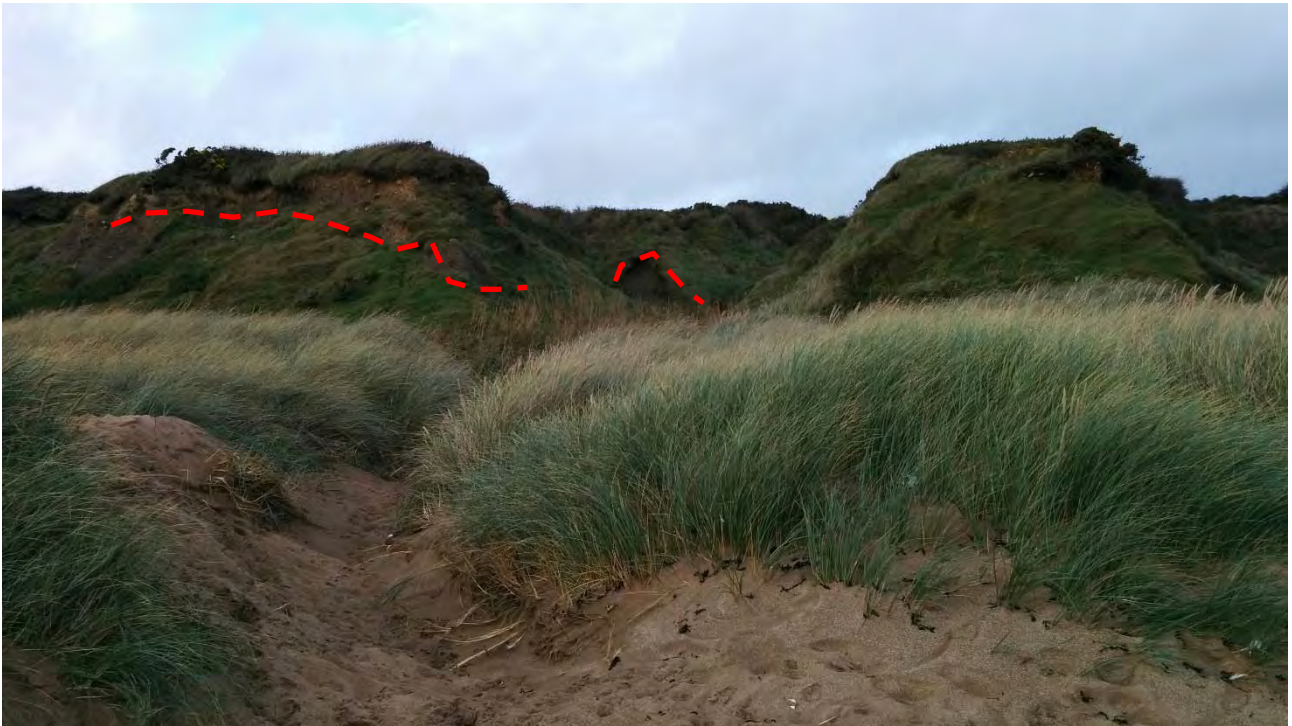
**Photo 13: Minor instabilities**

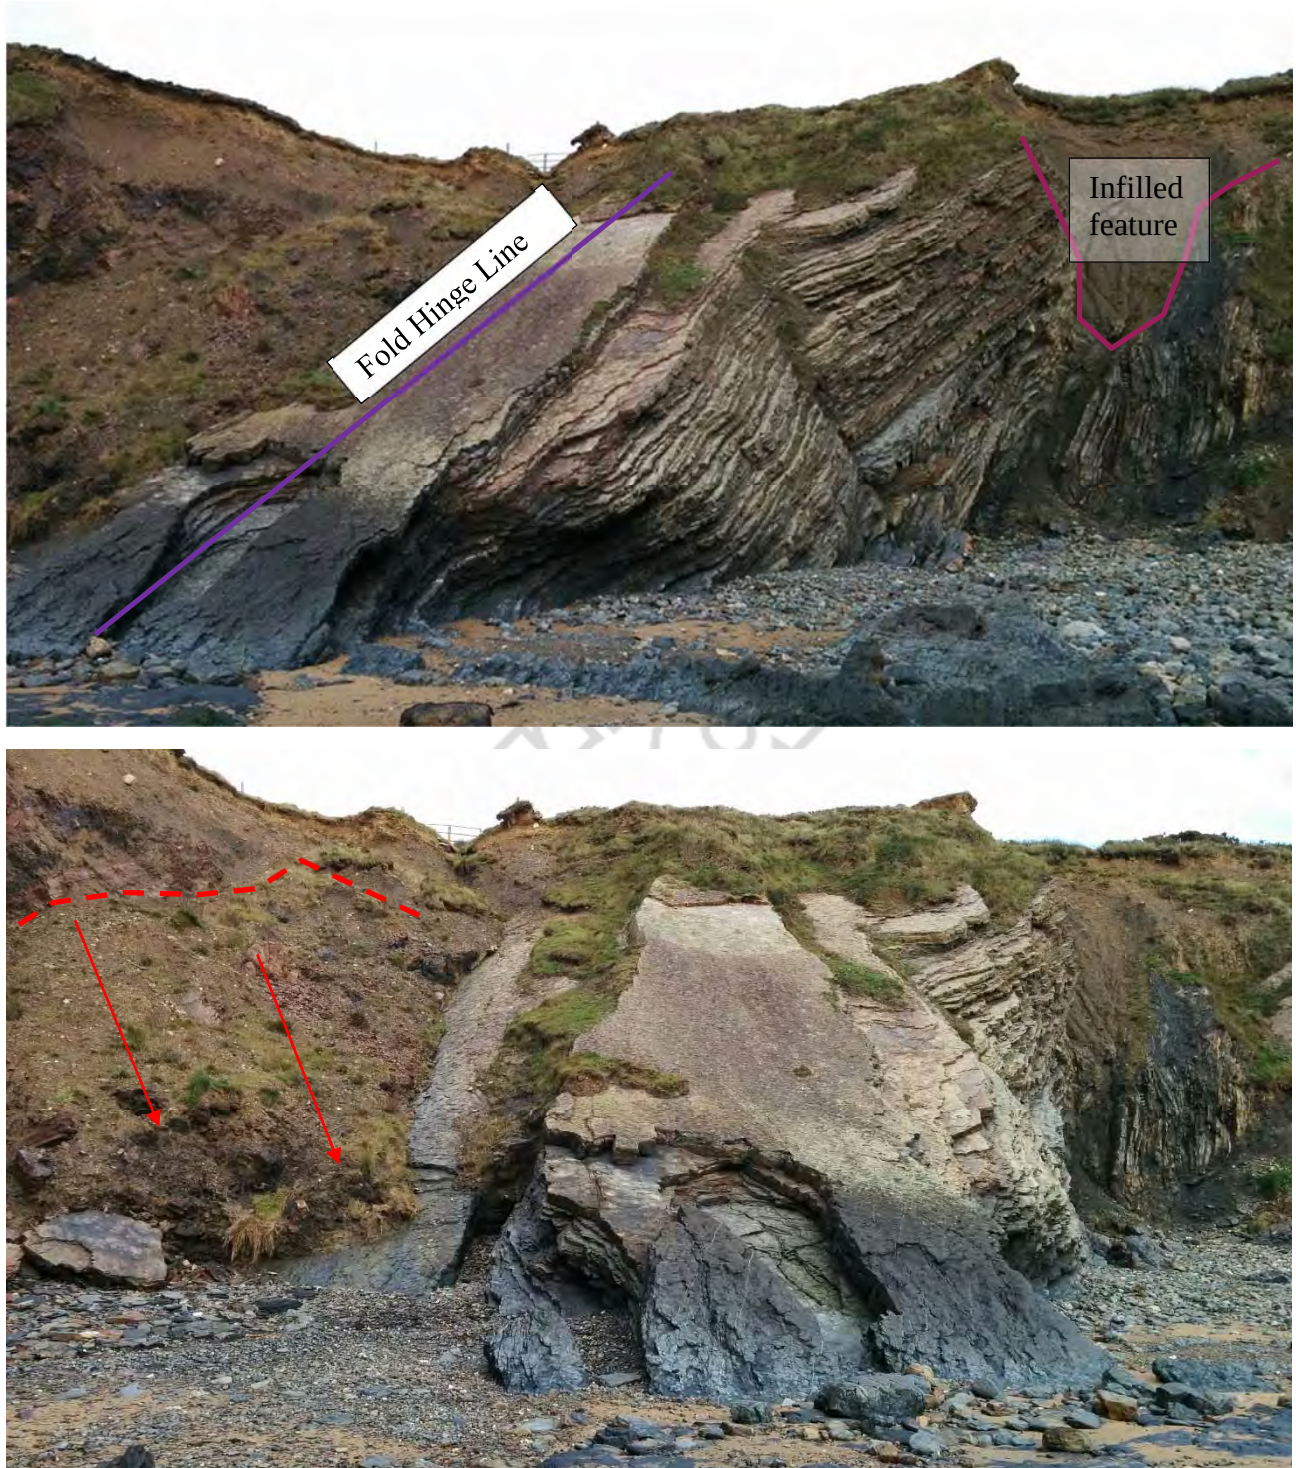
The geology is complex with interlayered meta-sediments and many structural features evident.  
(Photo 15)

**Photo 15: Outcropping fold and adjacent areas of infill and instability**
