# Erebus: Onshore Cable Route

## Technical Appendix 20.5 - Bat Survey Report

### **Re: Onshore Cable Route Pembrokeshire Tree Inspection – Letter Report**

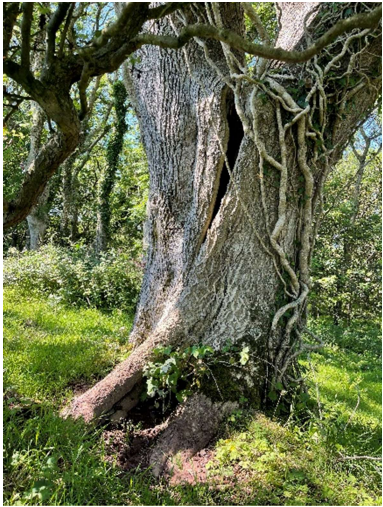
| Tree Number | Tree Species and size | PRF Type | PRF Height /Aspect | PRF Description | Suitability for roosting bats | Photo |
|---|---|---|---|---|---|---|
| 106 | Ash<br>14 m High<br>90 cm DBH | Split in fork | 1.2 m<br>E aspect of stem | <p>Split (10 cm wide, extending 1 m into stem) at low fork due to leaning leader. Creaking, and unlikely to persist.</p> <p>Split is upward facing, with sheltering opportunities limited to numerous sections of splintered heartwood. No evidence of use by bats during either of the inspections. Potential to support transitional use by low number of bats.</p> | Moderate | |

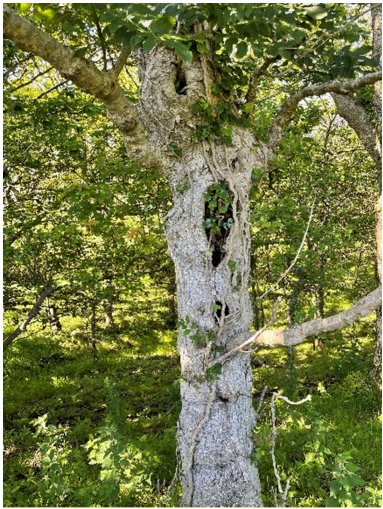
| 107 | Ash<br>12 m High<br>40 cm<br>DBH | Tear out | 1.5 m<br>SE<br>aspect<br>of stem | External damage of 30 cm x 10 cm, extending to a depth of 7 cm with downward developed bowl. Fungal fruiting bodies present on decaying heartwood. Small cavity (3 cm wide) present behind flaking heartwood. Remainder of feature is exposed and offers no shelter. No evidence of use by bats. | Low | |

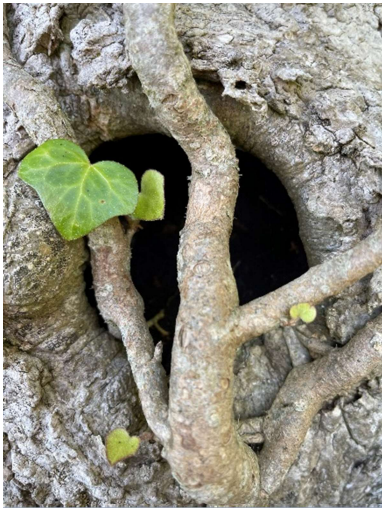
| | | Wound | 1.2 m<br>SE<br>aspect<br>of stem | External damage of 10 cm x 7 cm (partially covered by ivy), extending upward by 20 cm to join tear out cavity above (via narrow labyrinth). Internal cavity is clean and dry. Woodlouse present at apex of cavity during inspection on 05 August 2021. No evidence of use by bats during either of the inspections. Potential to support small number of bats. | Moderate | |

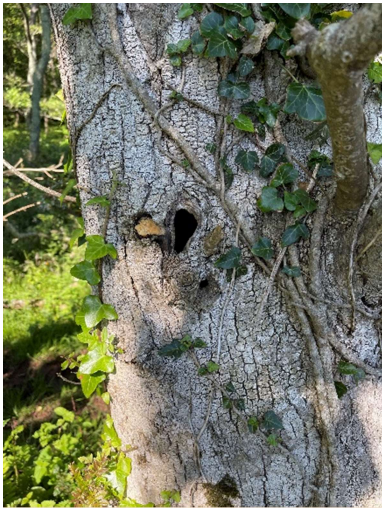
| 108 | Ash<br>10 m High<br>40 cm<br>DBH | Wound | 1 m<br>SE<br>aspect<br>of stem | Small (4 cm x 3 cm) entrance extending to 20 cm upward developed narrow tube. No evidence of use by bats. May support single small bat. | Low | |

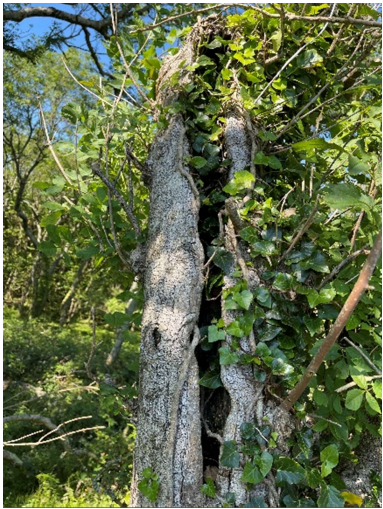
| | | Tear out | 1.5 m<br>SE<br>aspect<br>of stem | 70 cm long x 5 cm wide tear out in main stem with ivy occluding internal cavity. Detritus covering internal surfaces. Limited shelter offered. No evidence of use by bats. May support transitional use by single bats. | Low | |

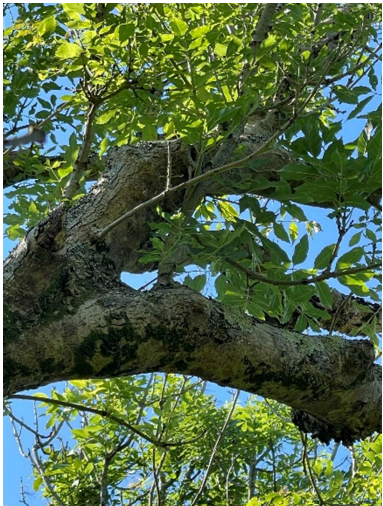
| | | Knot hole | 7 m<br>W<br>aspect<br>on limb | Superficial, rear of cavity visible from ground. | Negligible | |

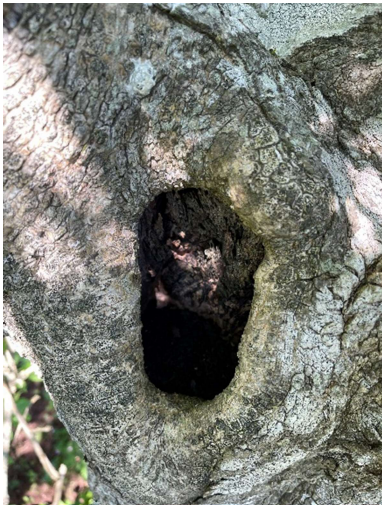
| 109 | Ash<br>5 m High<br>40 cm<br>DBH | Knot hole | 1.8 m<br>SW<br>aspect<br>of stem | 10 cm x 7 cm entrance to shallow, exposed bowl.<br>Upward facing and likely to collect water. | Negligible | |

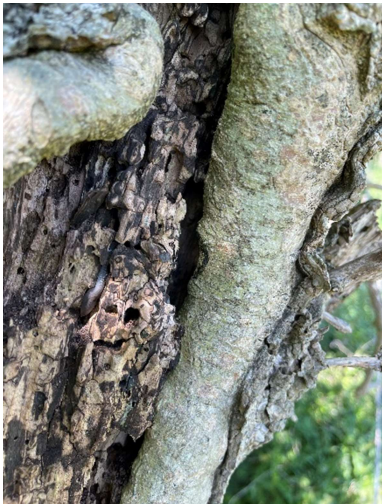
| | | Tear out | 2 m<br>SW<br>aspect<br>of stem | Narrow gap (c. 1 cm wide) caused by bark forming 'ram's horns' along edge of tear out. Shallow depth (max 2 -3 cm). No evidence of use by bats. May support low numbers of small bats. | Low | |

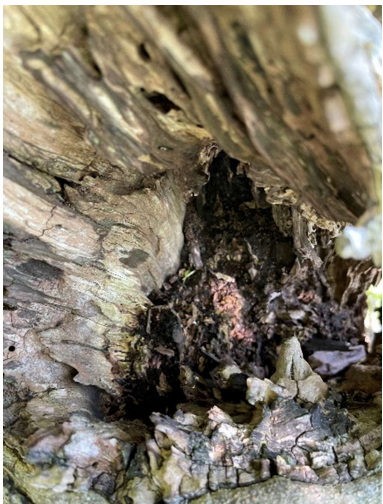
| | | Pollard decay | 2.4 m<br>Centre<br>of stem | Upward-facing bowl at top of stem providing no sheltering opportunities for bats. | Negligible | |

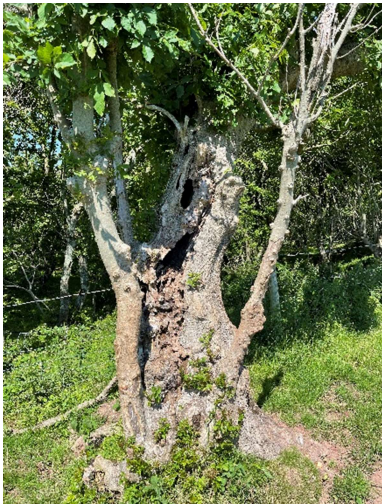
| 110 | Ash<br>4 m High<br>50 cm DBH | Wound and decay | 1.8 m SE aspect of stem. | <p>15 cm x 5 cm entrance (upper) and 40 cm x 10 cm entrance (lower) leading to upward developed internal cavity extending to 1 m into stem.</p> <p>Internal surfaces are clean and dry. Woodlouse present during all inspections.</p> <p>No evidence of use by bats during any of the inspections, but suitable size to support a large colony.</p> | High | |

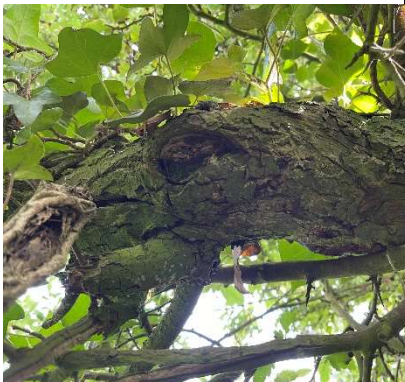
| 127 | Hawthorn<br>5 m High<br>20 cm DBH | Decay | 2 m N aspect on limb. | <p>Narrow (1 cm x 5 cm) split at base of limb. No evidence of use by bats. May provide shelter for single bat.</p> | Low | |

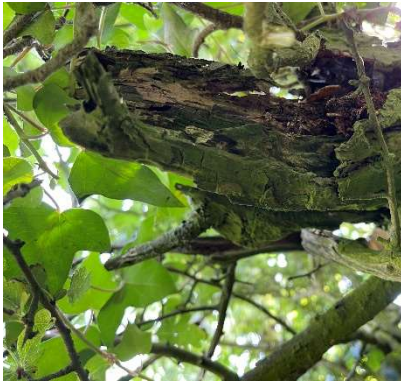
| | | Decay | 2 m<br>N aspect<br>on limb. | Damage at terminus of decaying limb with small cavity. No evidence of use by bats. May provide shelter for single bat. | Low | |

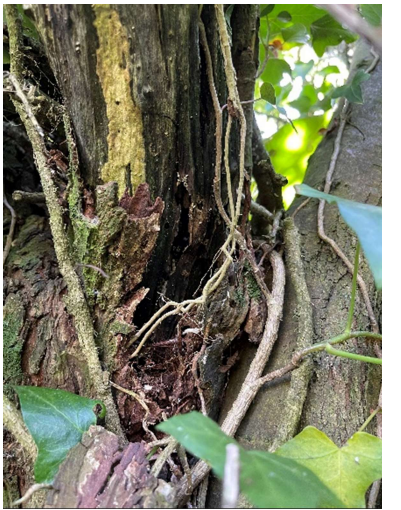
| | | Dropped limb | 3 m<br>NE aspect<br>on limb. | Upward facing with no sheltered crevices present. Likely to collect water during rain. | Negligible | |

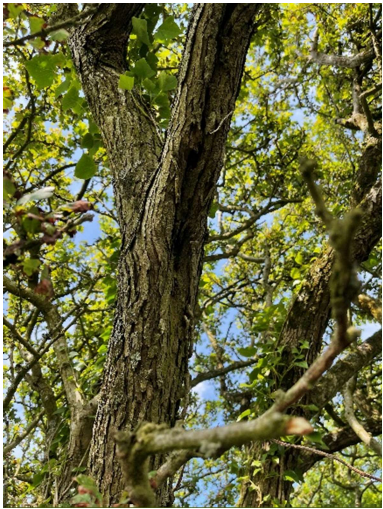
| 128 | Hawthorn<br>5 m High<br>20 cm<br>DBH | Minor<br>wound<br>and ivy | 1.8 m<br>S aspect<br>of stem. | Very shallow fissure in the bark with no shelter provided. Ivy cover at the base of the tree is unsubstantial, and would not provide sufficient shelter for roosting. | Negligible | |

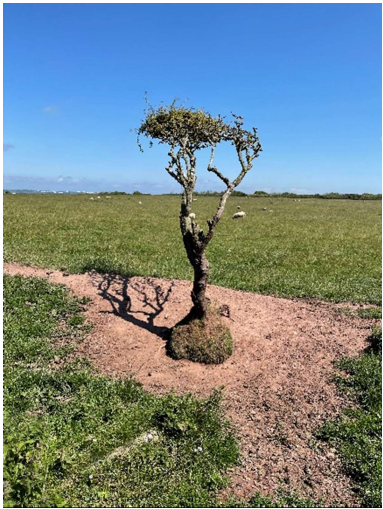
| 87 | Hawthorn<br>2 m High<br>15 cm<br>DBH | - | - | Small through hole in limb present, but no shelter provided for a bat. | Negligible | |
