ZP3599VV – Demolition Summary

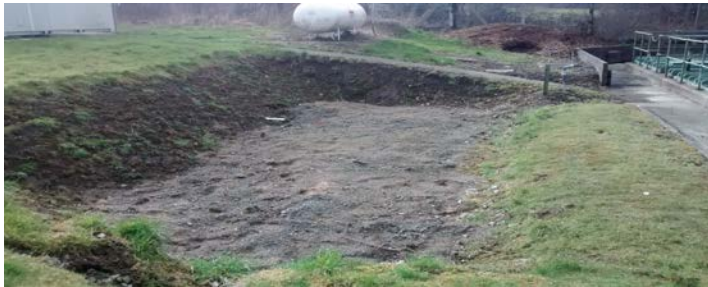
Photo of inlet chamber following removal and reinstatement of ground:

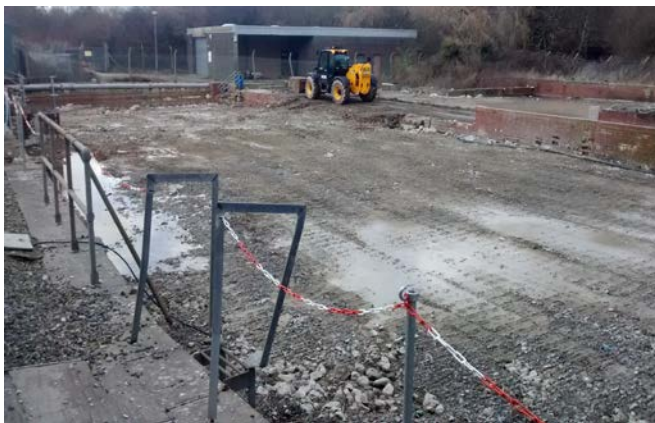
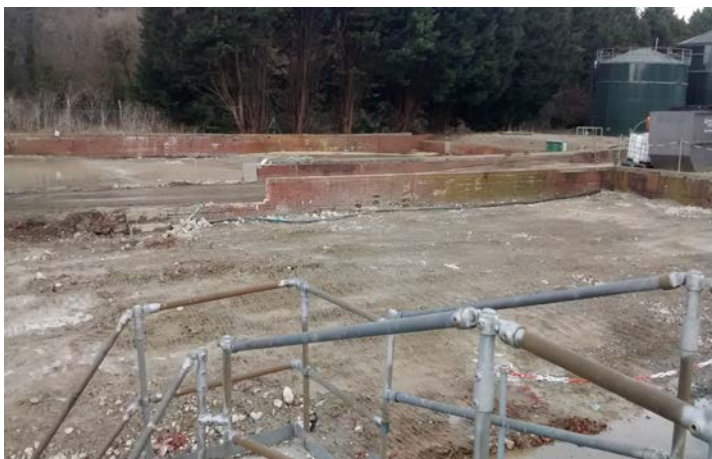
Photos of the original drying beds following removal of the equipment are shown below:

Photo of drying beds following removal and reinstatement of ground:
