Site Condition Report

Unit 1C, Tremorfa Industrial Estate, Cardiff

Bayliss Metals

**Date:** March 2015  
**Our Ref:** JER6480  
**RPS**  
2420 The Quadrant, Aztec West,  
Almondsbury, Bristol, BS32 4AQ  
**Tel:** (0)1454 853 000  
**Fax:** (0)1454 205 820  
**Email:** rpssw@rpsgroup.com

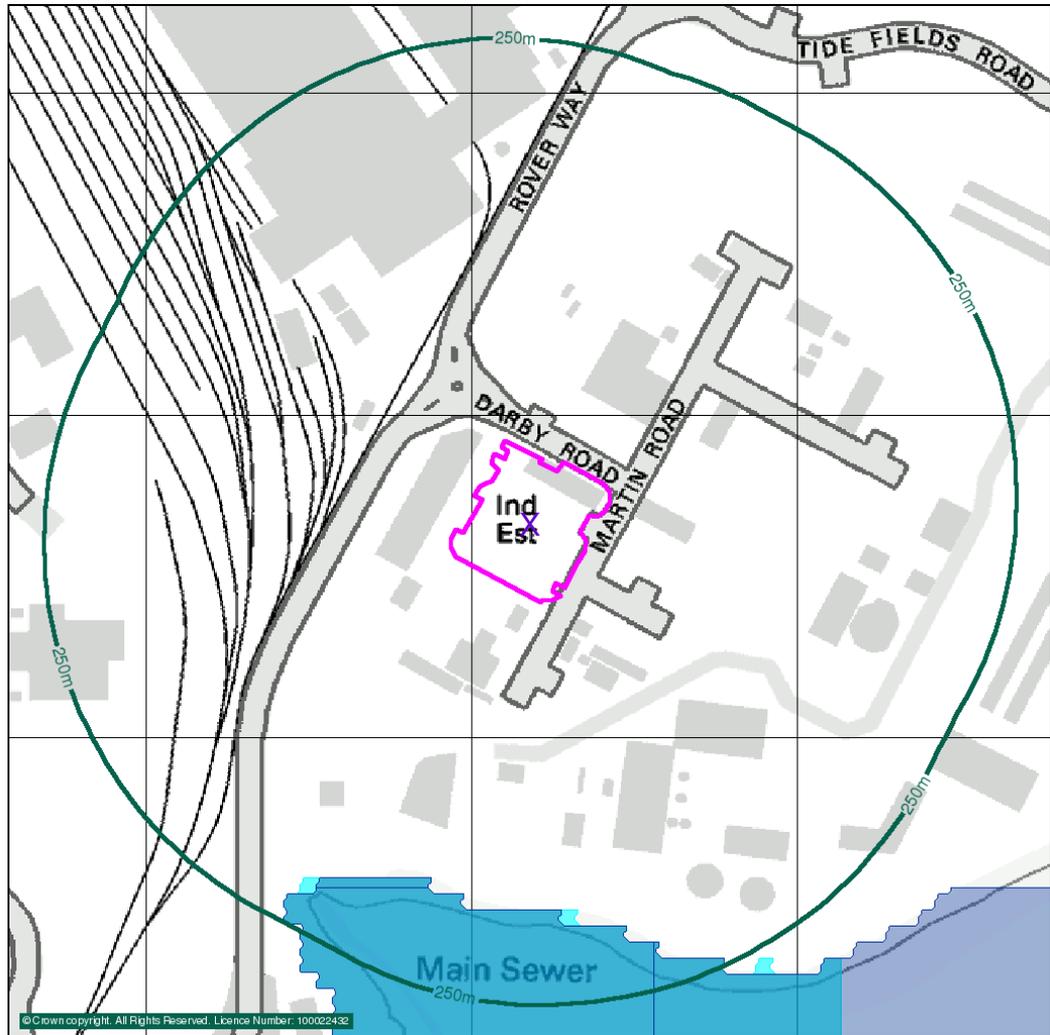
**Flood Map**

General		Area of Floodplain	
Site Boundary	Areas Benefitting from Flood Defences	Extreme Flooding from Rivers or Sea without Defences (Zone 2)	
Search Buffer	Flood Water Storage Areas	Flooding from Rivers or Sea without Defences (Zone 3)	
Bearing Reference Point	Flood Defences		
Reference Number

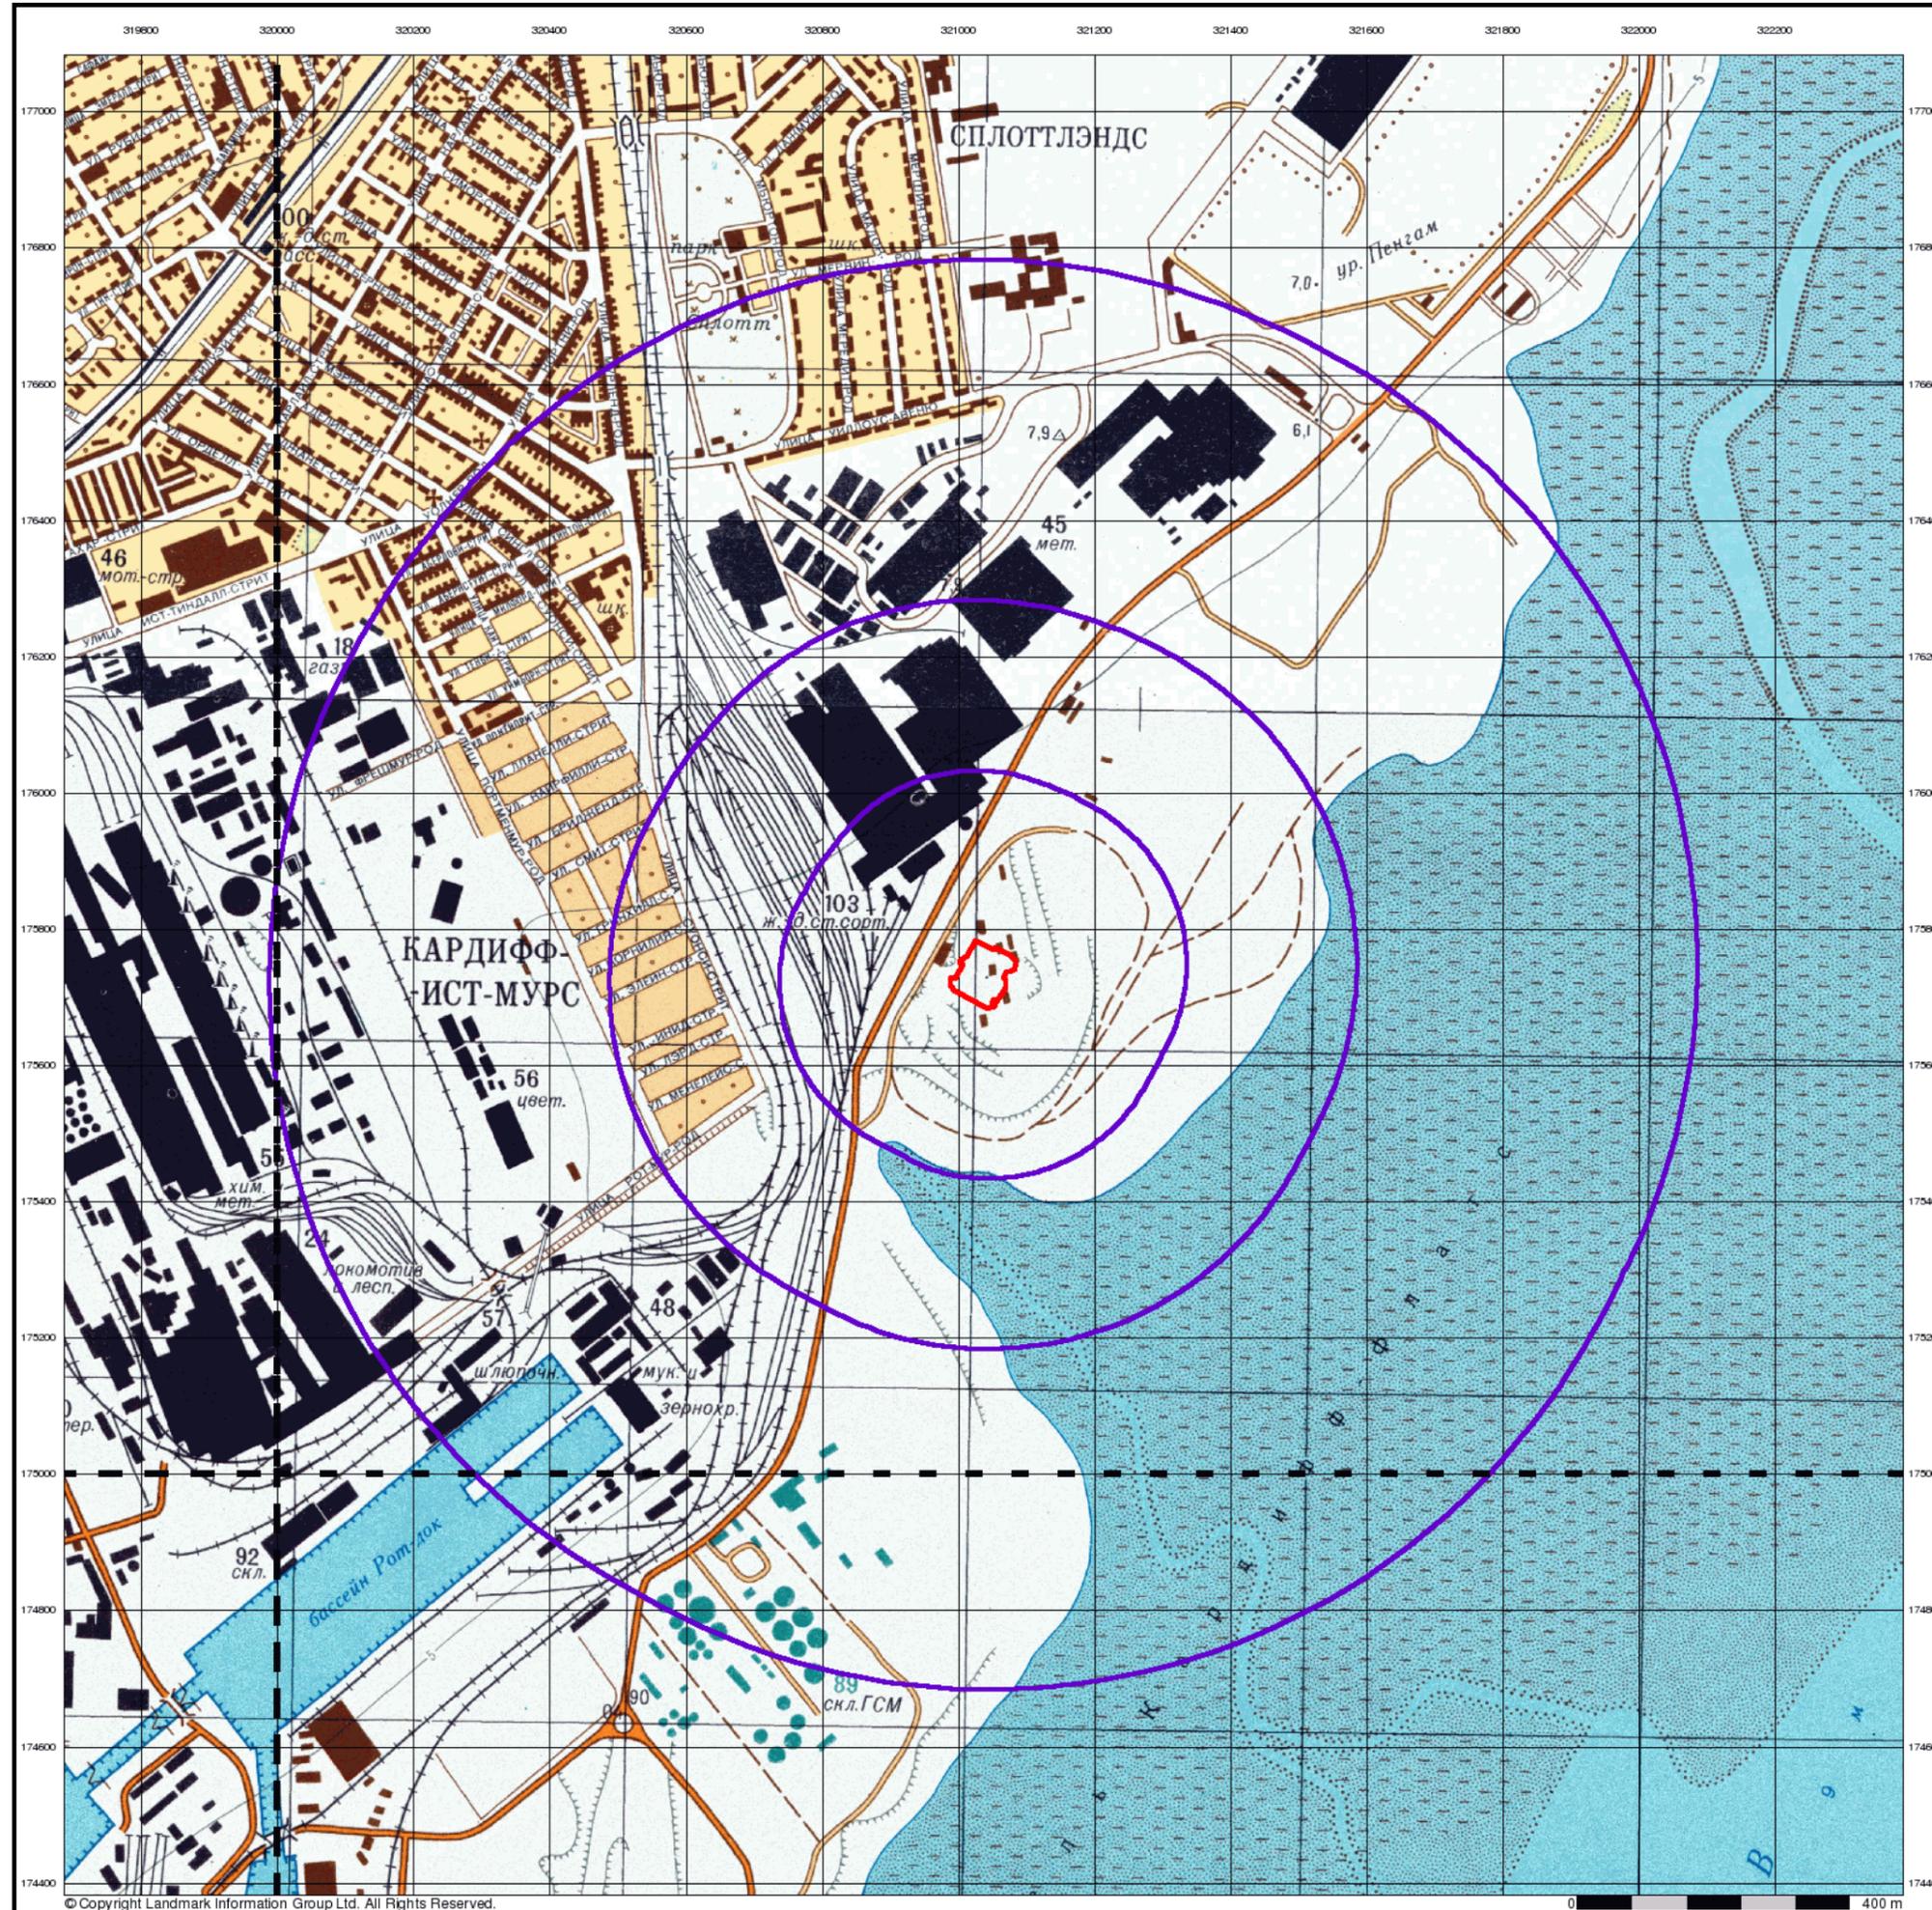
**Cardiff**  
**Published 1982**  
**Source map scale - 1:10,000**

These maps were produced by the Russian military during the Cold War between 1950 and 1997, and cover 103 towns and cities throughout the U.K. The maps are produced at 1:25,000, 1:10,000 and 1:5,000 scale, and show detailed land use, with colour-coded areas for development, green areas, and non-developed areas. Buildings are coloured black and important building uses (such as hospitals, post offices, factories etc.) are numbered, with a numbered key describing their use. They were produced by the Russians for the benefit of navigation, as well as strategic military sites and transport hubs, for use if they were to have invaded the U.K. The detailed information provided indicates that the areas were surveyed using land-based personnel, on the ground, in the cities that are mapped.

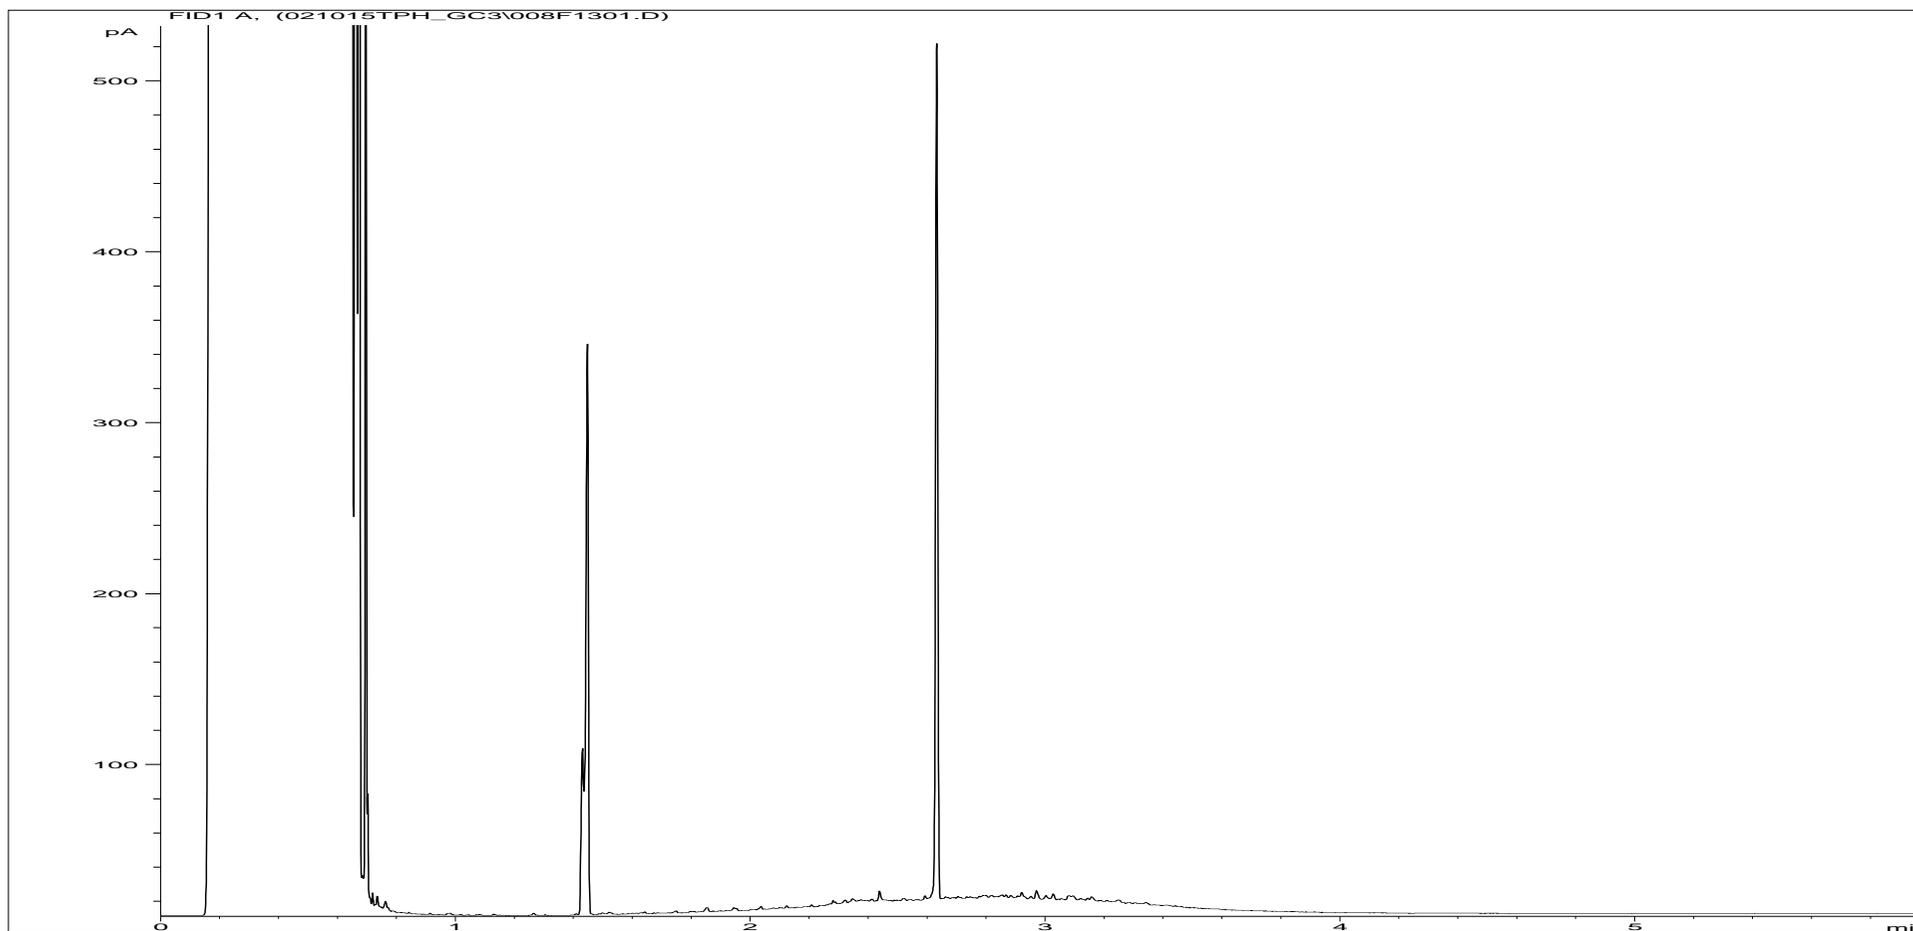
Petroleum Hydrocarbons (C8 to C40) by GC/FID Aliphatics Fraction.

<b>Sample ID:</b>	CL1538962ALI	<b>Job Number:</b>	S15_1118
<b>Multiplier:</b>	15.2	<b>Client:</b>	RPS
<b>Dilution:</b>	1	<b>Site:</b>	Bayliss Metals
<b>Acquisition Method:</b>	5UL_RUNF.M	<b>Client Sample Ref:</b>	TP01 0.5-1m
<b>Acquisition Date/Time:</b>	10-Feb-15		
<b>Datafile:</b>	D:\TES\DATA\Y2013\02\021015TPH_GC3\008F1301.D

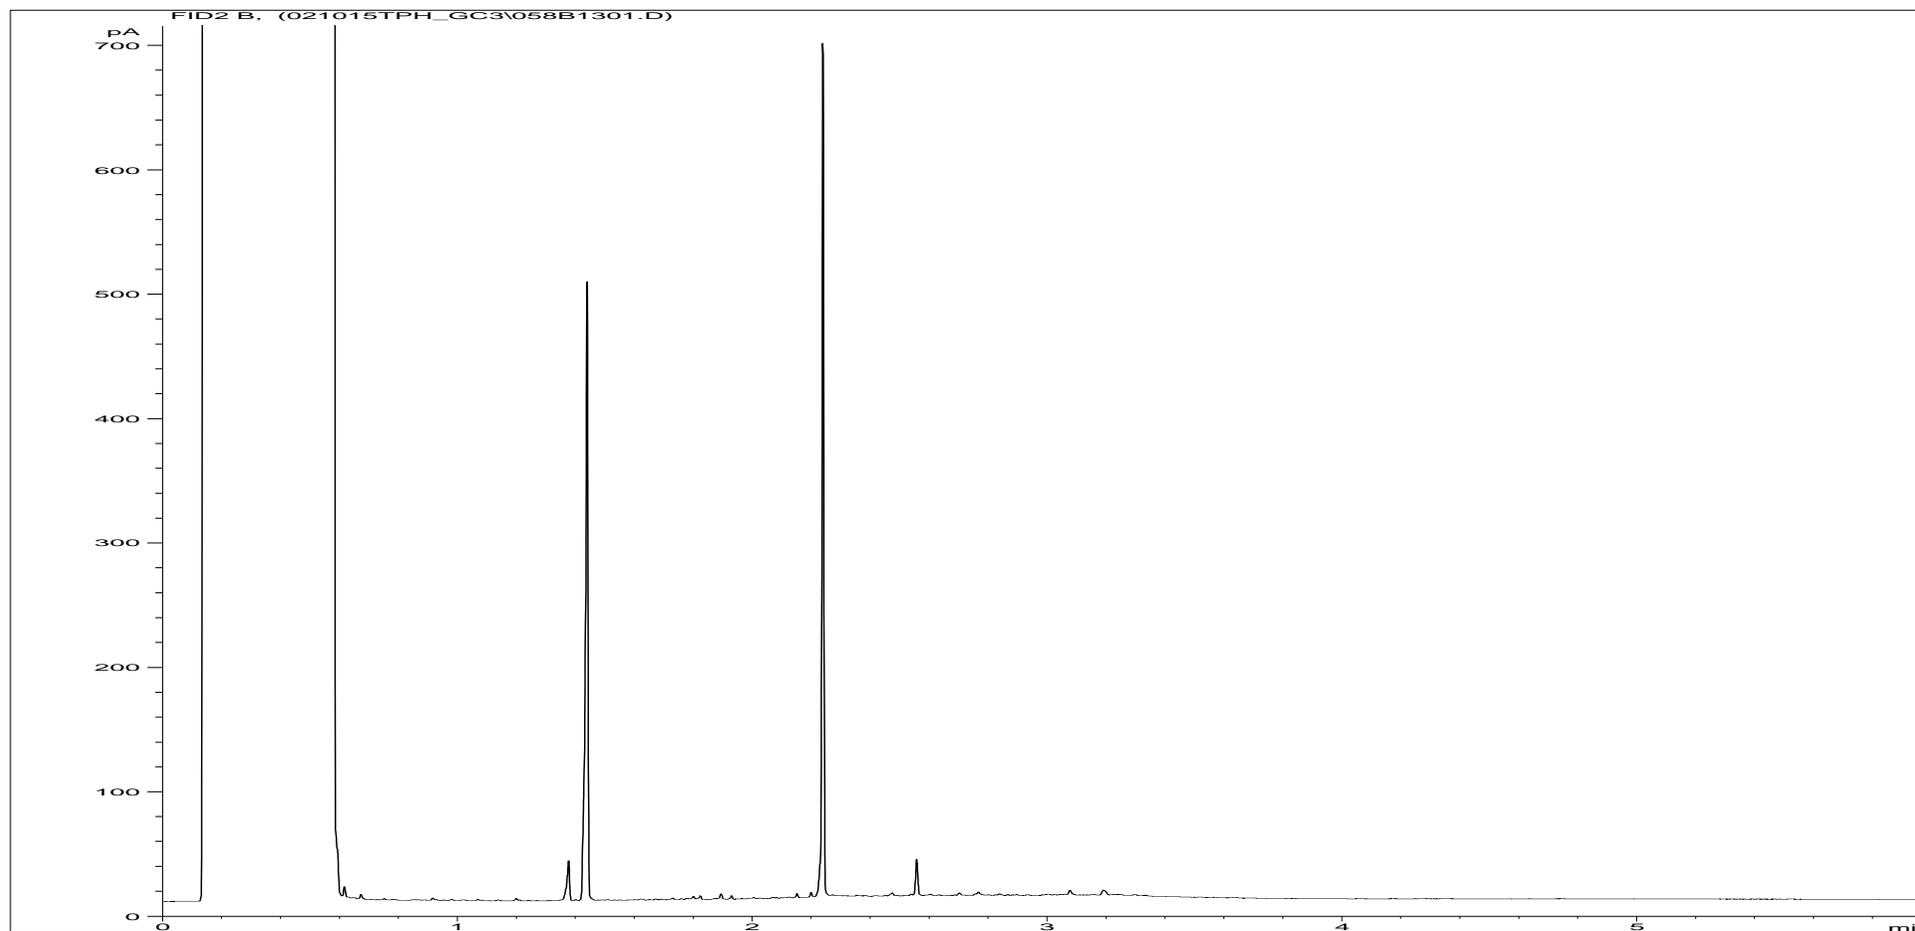
Petroleum Hydrocarbons (C8 to C40) by GC/FID Aromatics Fraction.

<b>Sample ID:</b>	CL1538962ARO	<b>Job Number:</b>	S15_1118
<b>Multiplier:</b>	11.36	<b>Client:</b>	RPS
<b>Dilution:</b>	1	<b>Site:</b>	Bayliss Metals
<b>Acquisition Method:</b>	5UL_RUNF.M	<b>Client Sample Ref:</b>	TP01 0.5-1m
<b>Acquisition Date/Time:</b>	10-Feb-15		
<b>Datafile:</b>	D:\TES\DATA\Y2013\02\021015TPH_GC3\058B1301.D

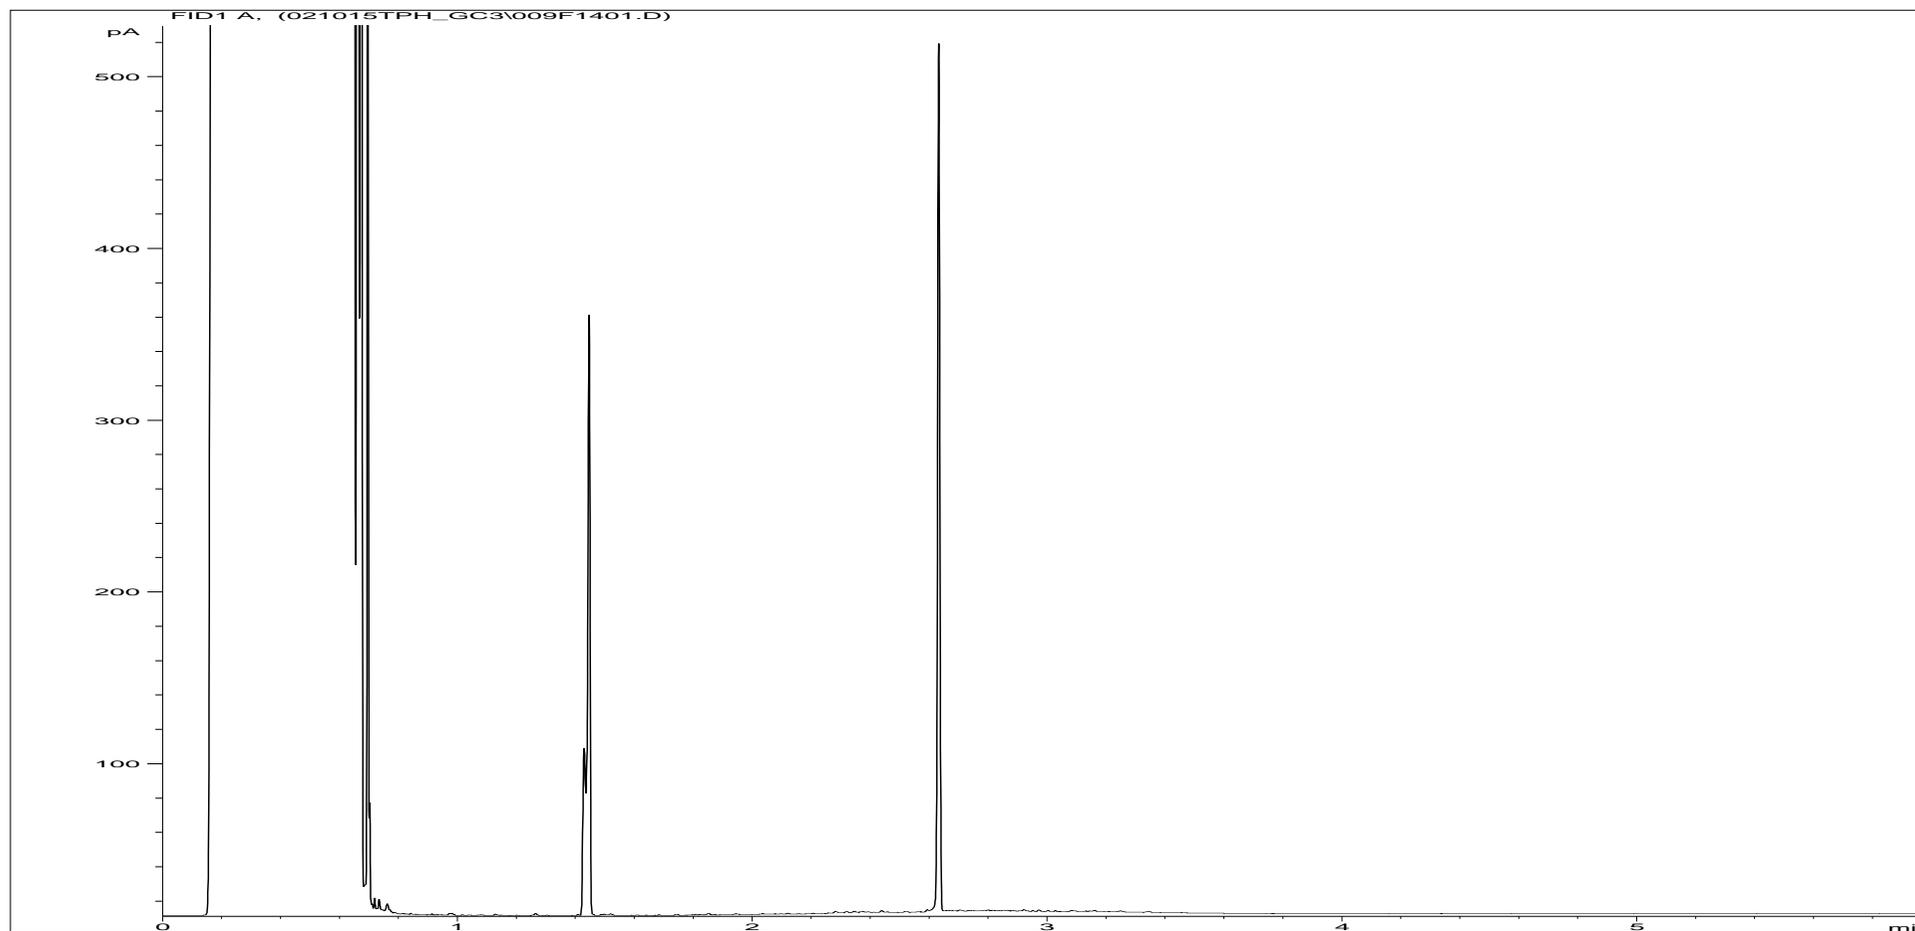
Petroleum Hydrocarbons (C8 to C40) by GC/FID Aliphatics Fraction.

<b>Sample ID:</b>	CL1538963ALI	<b>Job Number:</b>	S15_1118
<b>Multiplier:</b>	15.36	<b>Client:</b>	RPS
<b>Dilution:</b>	1	<b>Site:</b>	Bayliss Metals
<b>Acquisition Method:</b>	5UL_RUNF.M	<b>Client Sample Ref:</b>	TP02 0.5-1m
<b>Acquisition Date/Time:</b>	10-Feb-15		
<b>Datafile:</b>	D:\TES\DATA\Y2013\02\021015TPH_GC3\009F1401.D

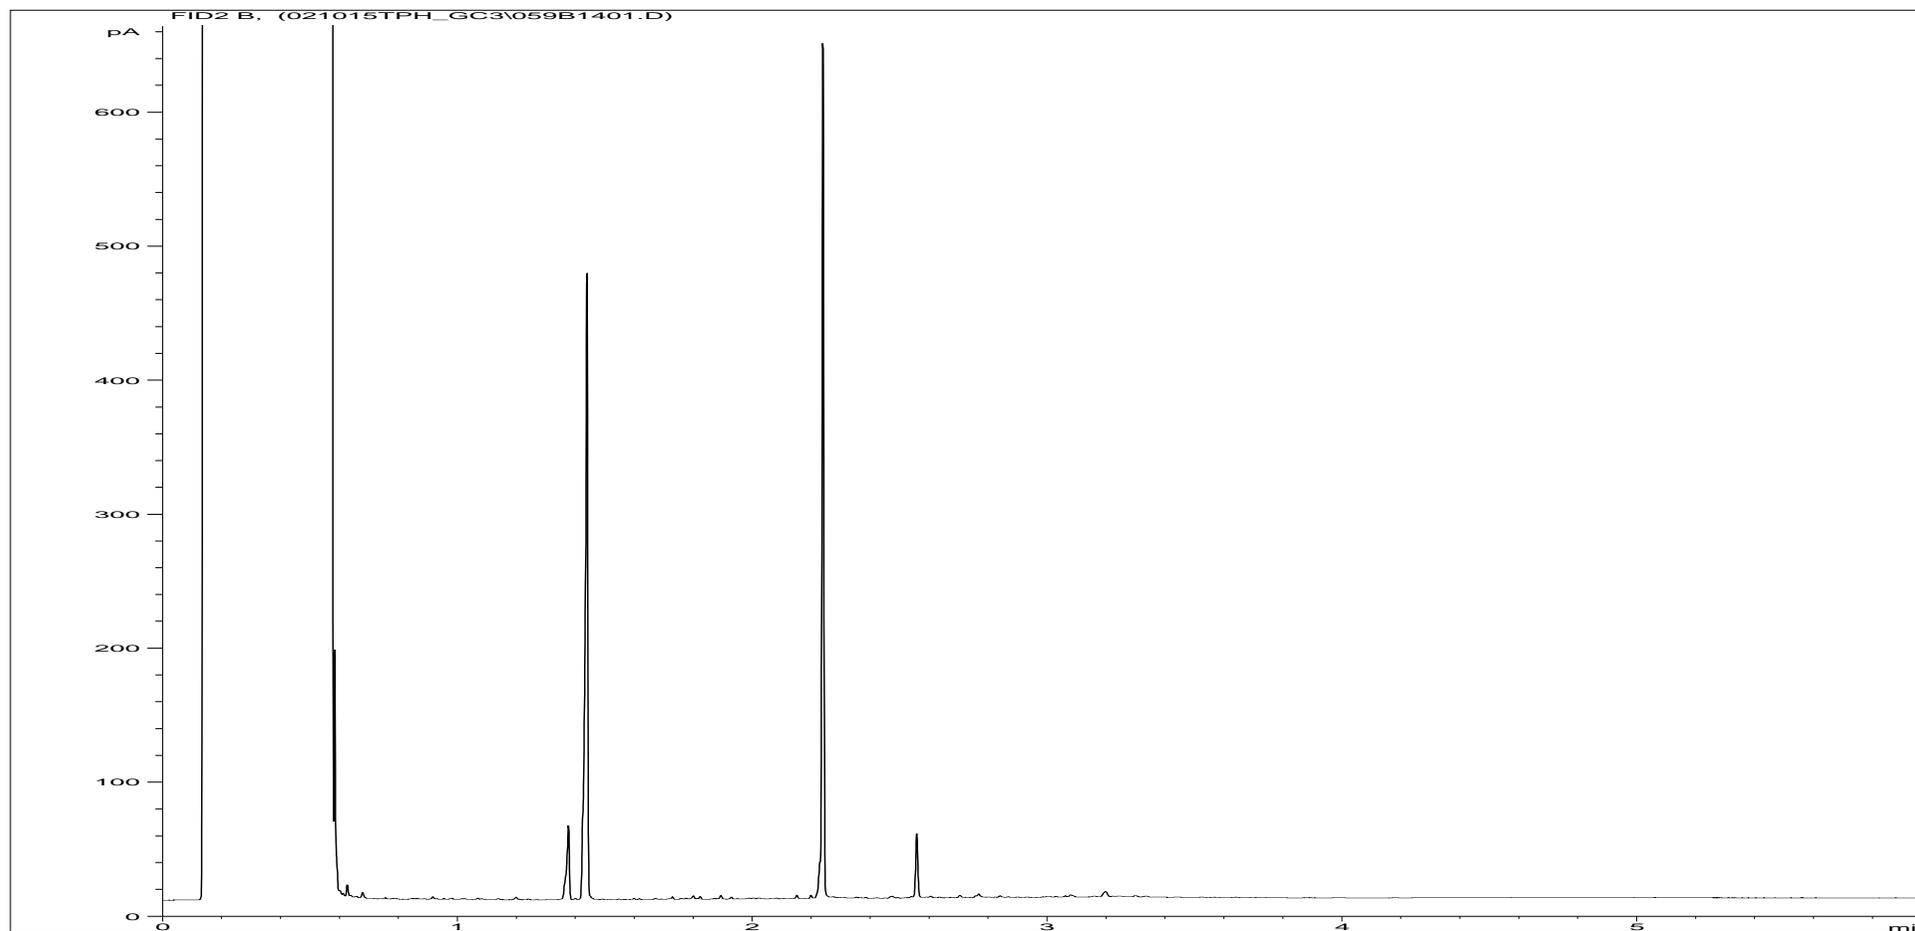
Petroleum Hydrocarbons (C8 to C40) by GC/FID Aromatics Fraction.

<b>Sample ID:</b>	CL1538963ARO	<b>Job Number:</b>	S15_1118
<b>Multiplier:</b>	11.36	<b>Client:</b>	RPS
<b>Dilution:</b>	1	<b>Site:</b>	Bayliss Metals
<b>Acquisition Method:</b>	5UL_RUNF.M	<b>Client Sample Ref:</b>	TP02 0.5-1m
<b>Acquisition Date/Time:</b>	10-Feb-15		
<b>Datafile:</b>	D:\TES\DATA\Y2013\02\021015TPH_GC3\059B1401.D

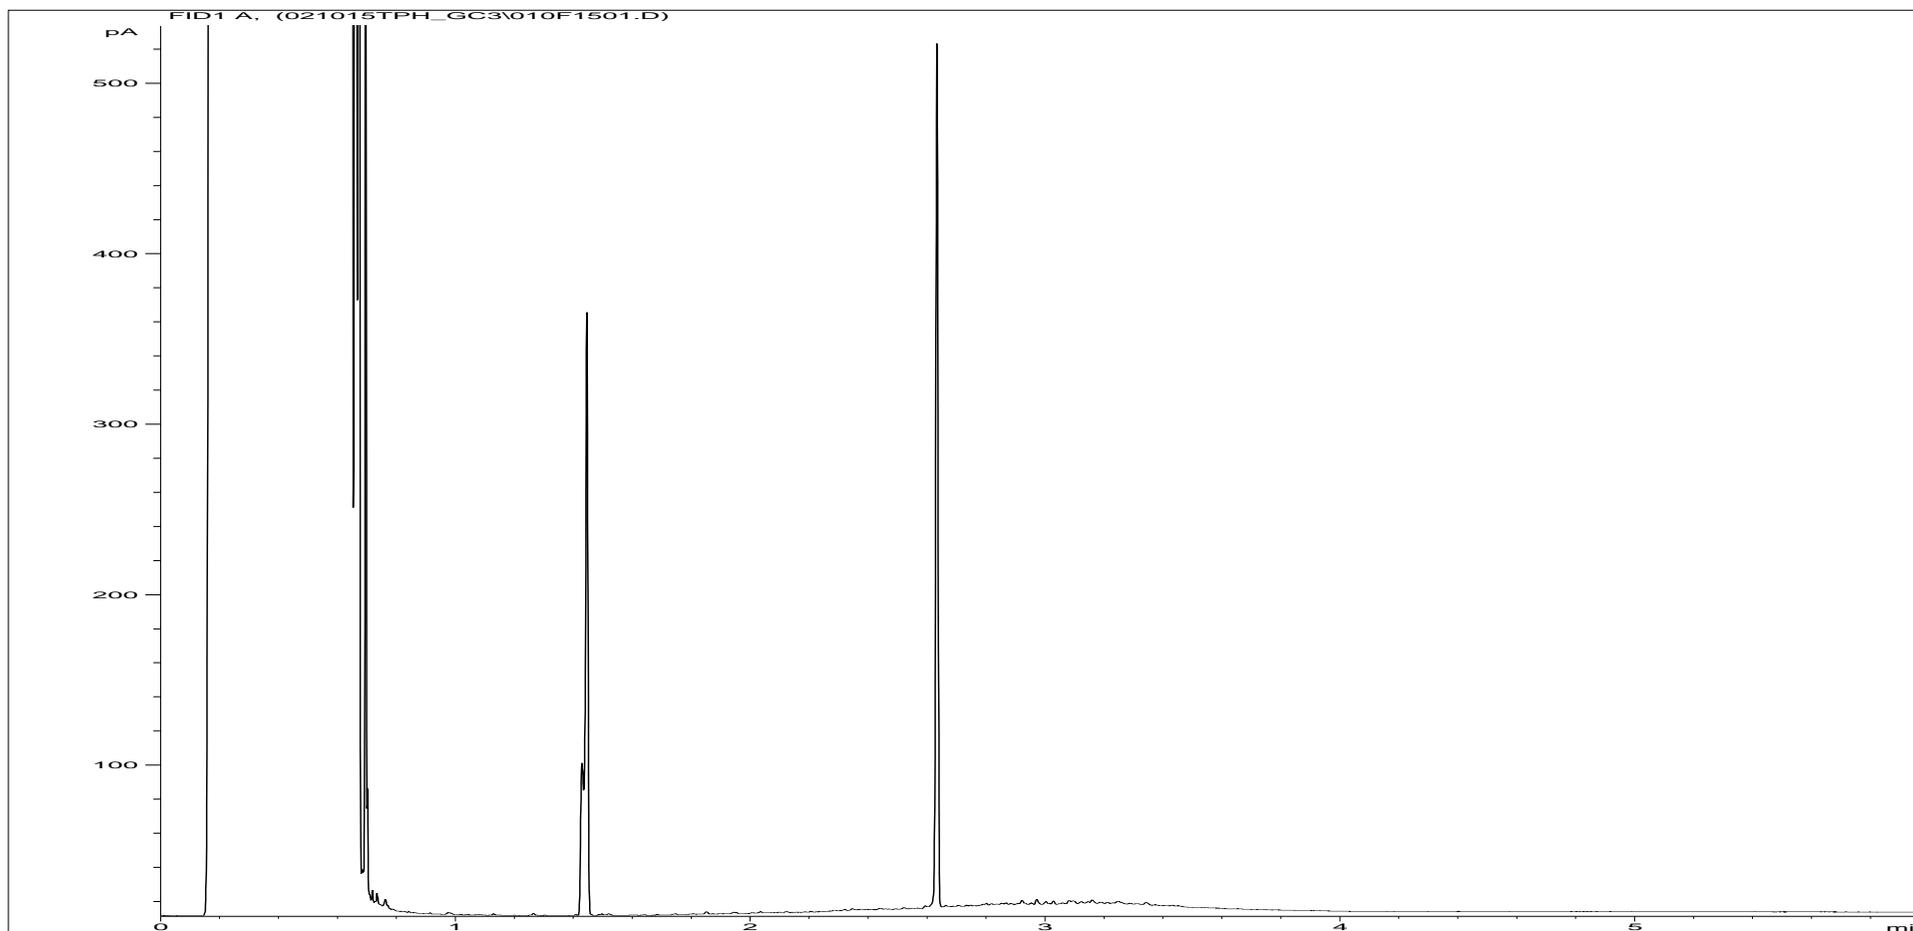
Petroleum Hydrocarbons (C8 to C40) by GC/FID Aliphatics Fraction.

<b>Sample ID:</b>	CL1538964ALI	<b>Job Number:</b>	S15_1118
<b>Multiplier:</b>	14.88	<b>Client:</b>	RPS
<b>Dilution:</b>	1	<b>Site:</b>	Bayliss Metals
<b>Acquisition Method:</b>	5UL_RUNF.M	<b>Client Sample Ref:</b>	TP04 0.5-1m
<b>Acquisition Date/Time:</b>	10-Feb-15		
<b>Datafile:</b>	D:\TES\DATA\Y2013\02\021015TPH_GC3\010F1501.D

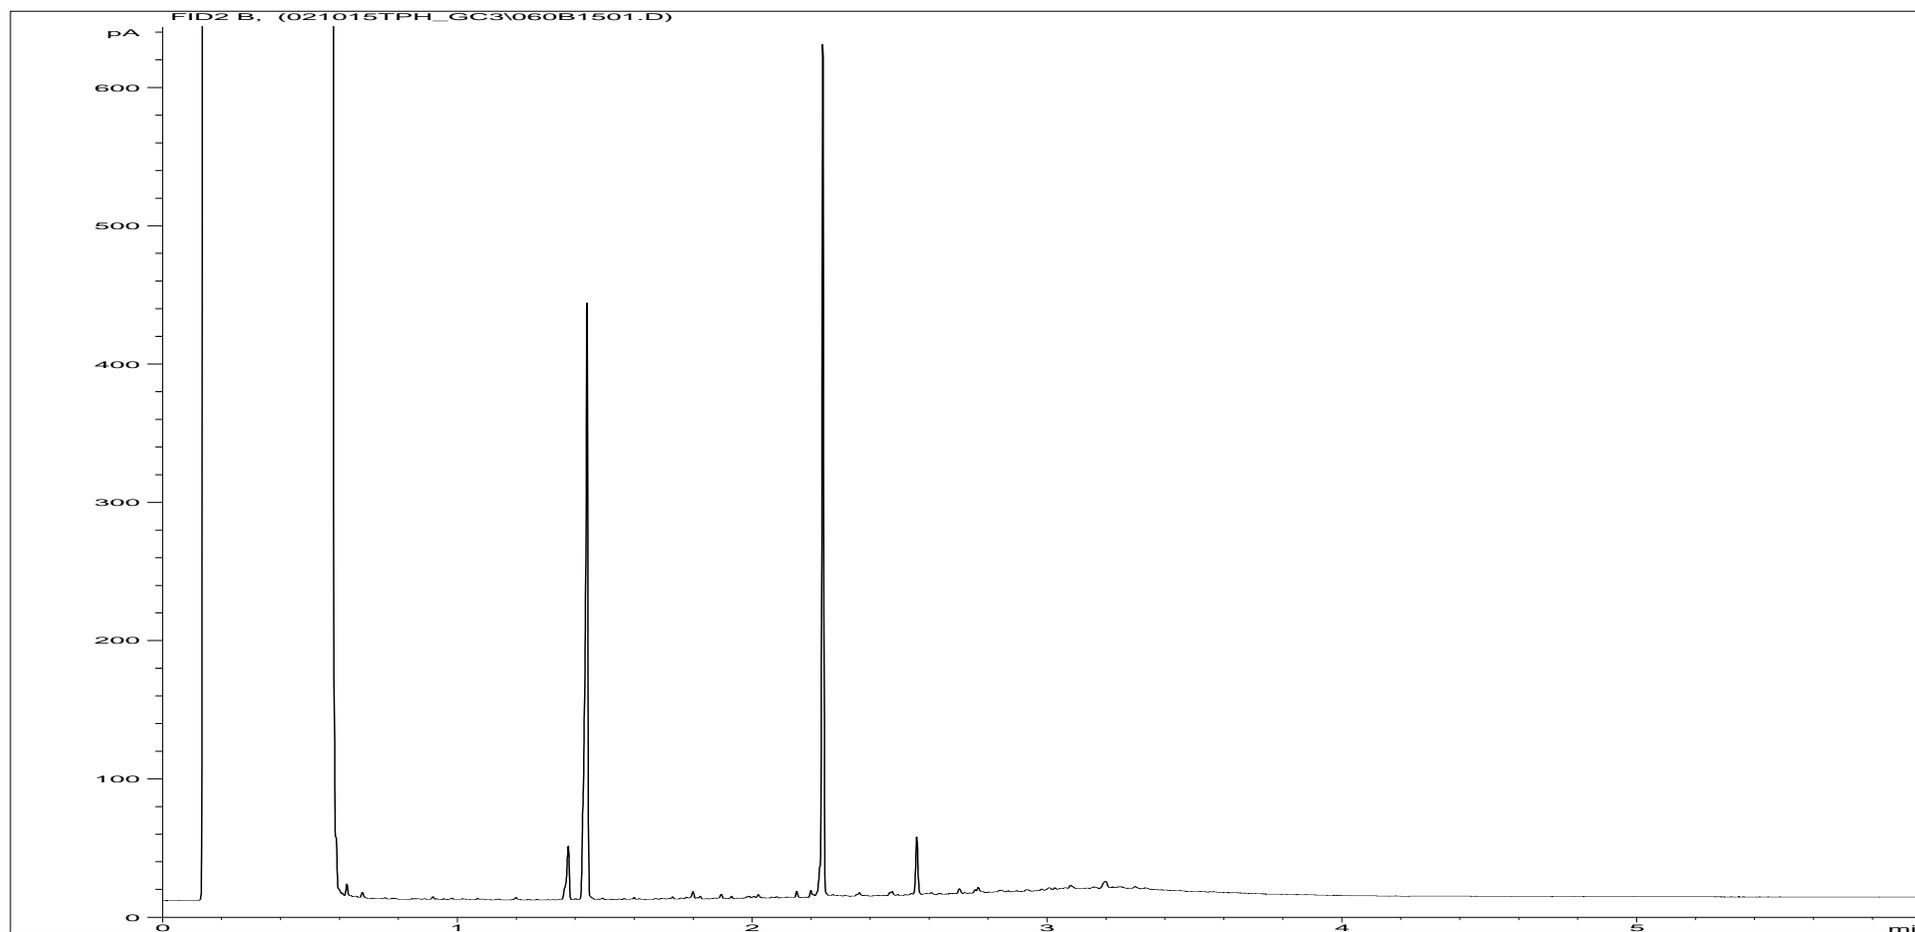
Petroleum Hydrocarbons (C8 to C40) by GC/FID Aromatics Fraction.

<b>Sample ID:</b>	CL1538964ARO	<b>Job Number:</b>	S15_1118
<b>Multiplier:</b>	11.2	<b>Client:</b>	RPS
<b>Dilution:</b>	1	<b>Site:</b>	Bayliss Metals
<b>Acquisition Method:</b>	5UL_RUNF.M	<b>Client Sample Ref:</b>	TP04 0.5-1m
<b>Acquisition Date/Time:</b>	10-Feb-15		
<b>Datafile:</b>	D:\TES\DATA\Y2013\02\021015TPH_GC3\060B1501.D

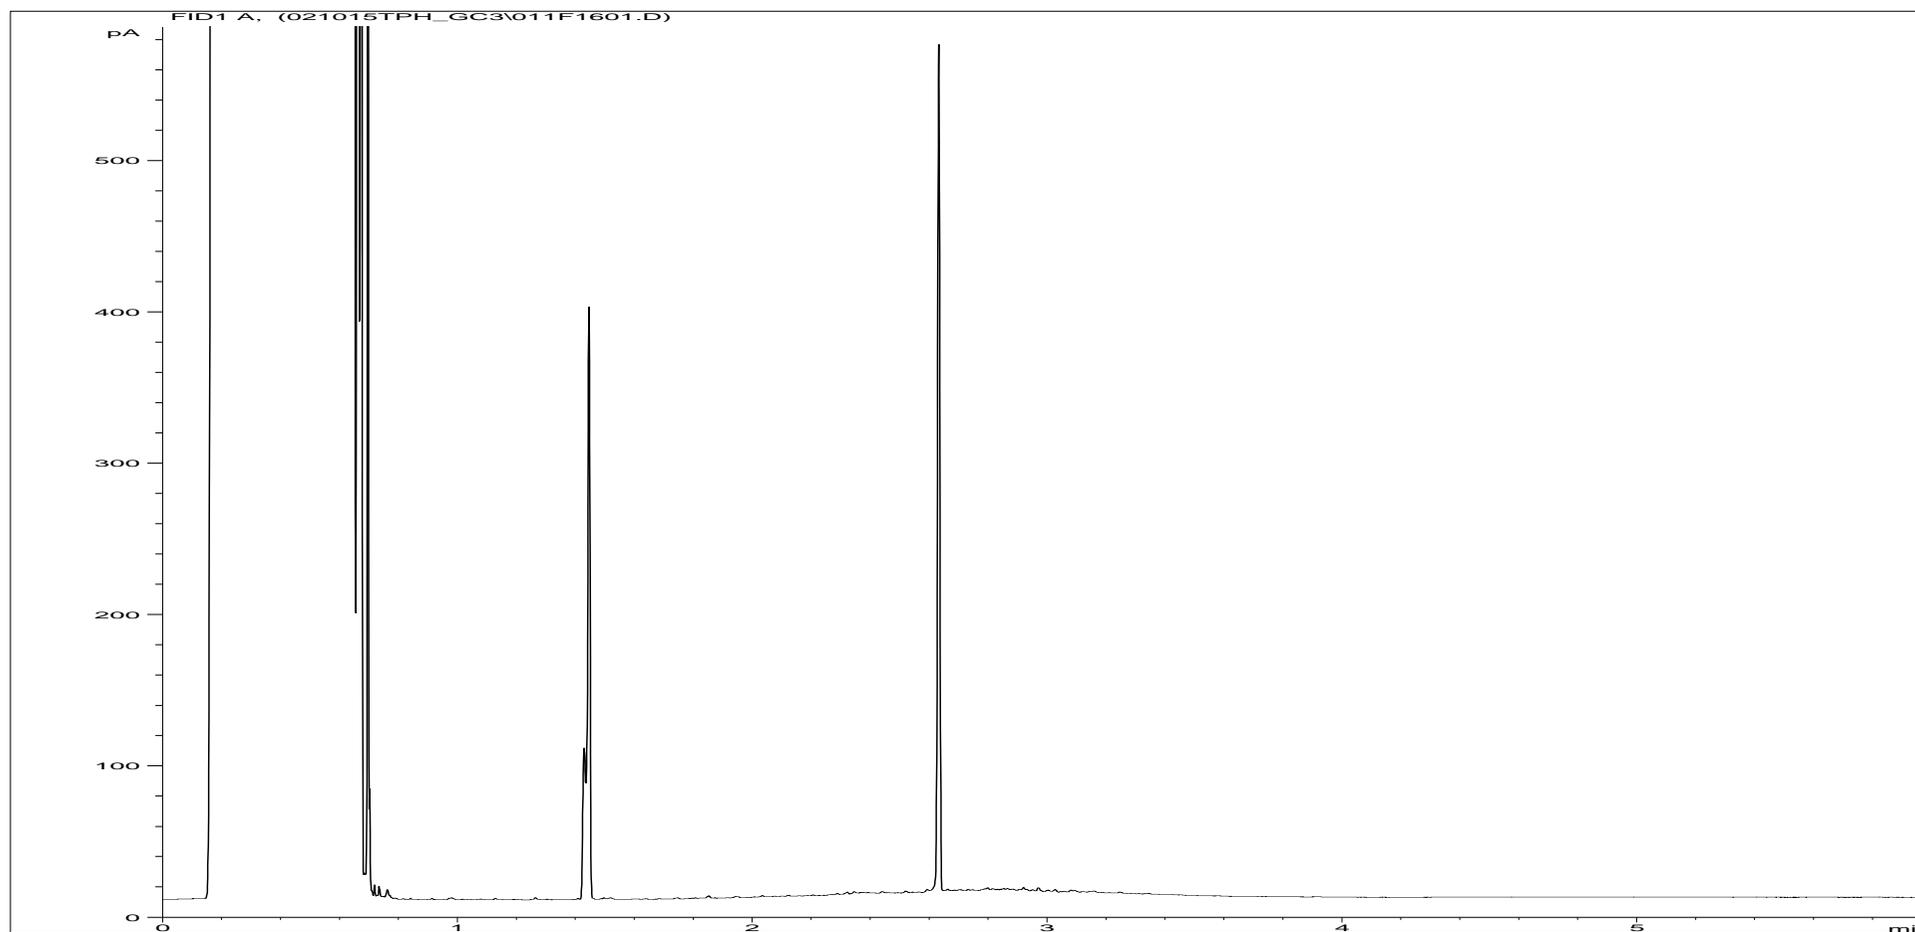
Petroleum Hydrocarbons (C8 to C40) by GC/FID Aliphatics Fraction.

<b>Sample ID:</b>	CL1538965ALI	<b>Job Number:</b>	S15_1118
<b>Multiplier:</b>	15.2	<b>Client:</b>	RPS
<b>Dilution:</b>	1	<b>Site:</b>	Bayliss Metals
<b>Acquisition Method:</b>	5UL_RUNF.M	<b>Client Sample Ref:</b>	TP05 0.5-1m
<b>Acquisition Date/Time:</b>	10-Feb-15		
<b>Datafile:</b>	D:\TES\DATA\Y2013\02\021015TPH_GC3\011F1601.D

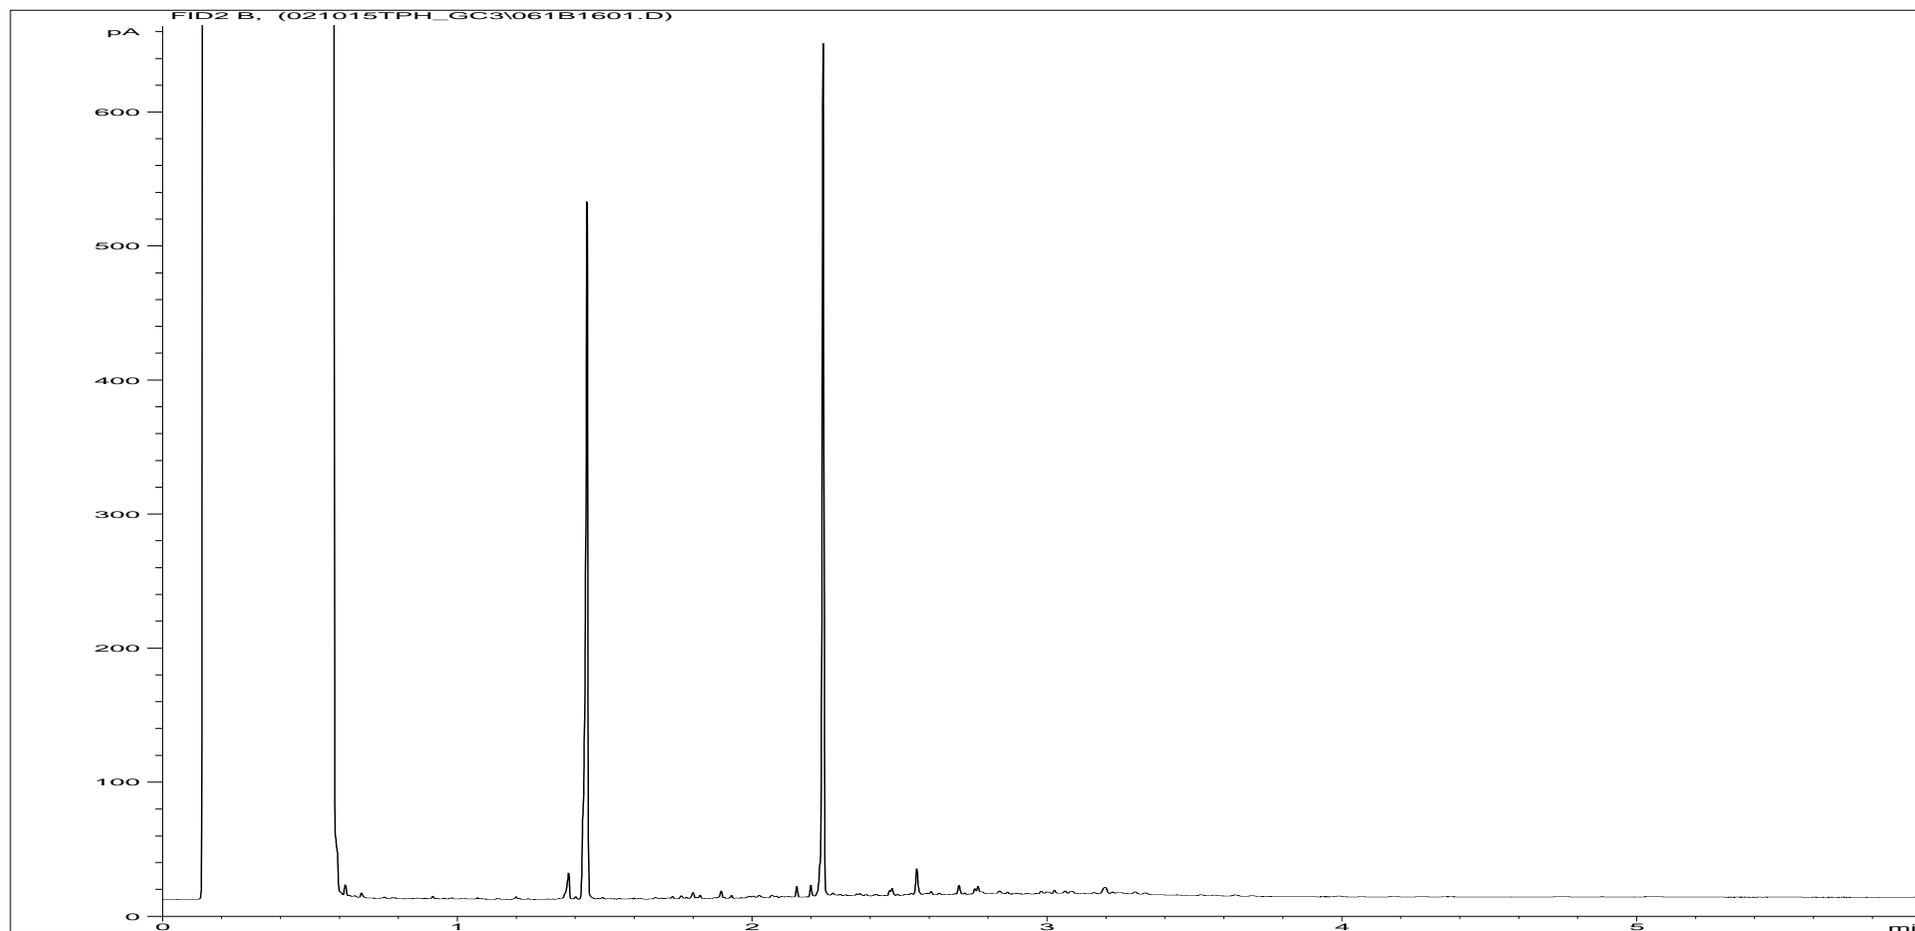
Petroleum Hydrocarbons (C8 to C40) by GC/FID Aromatics Fraction.

<b>Sample ID:</b>	CL1538965ARO	<b>Job Number:</b>	S15_1118
<b>Multiplier:</b>	11.36	<b>Client:</b>	RPS
<b>Dilution:</b>	1	<b>Site:</b>	Bayliss Metals
<b>Acquisition Method:</b>	5UL_RUNF.M	<b>Client Sample Ref:</b>	TP05 0.5-1m
<b>Acquisition Date/Time:</b>	10-Feb-15		
<b>Datafile:</b>	D:\TES\DATA\Y2013\02\021015TPH_GC3\061B1601.D

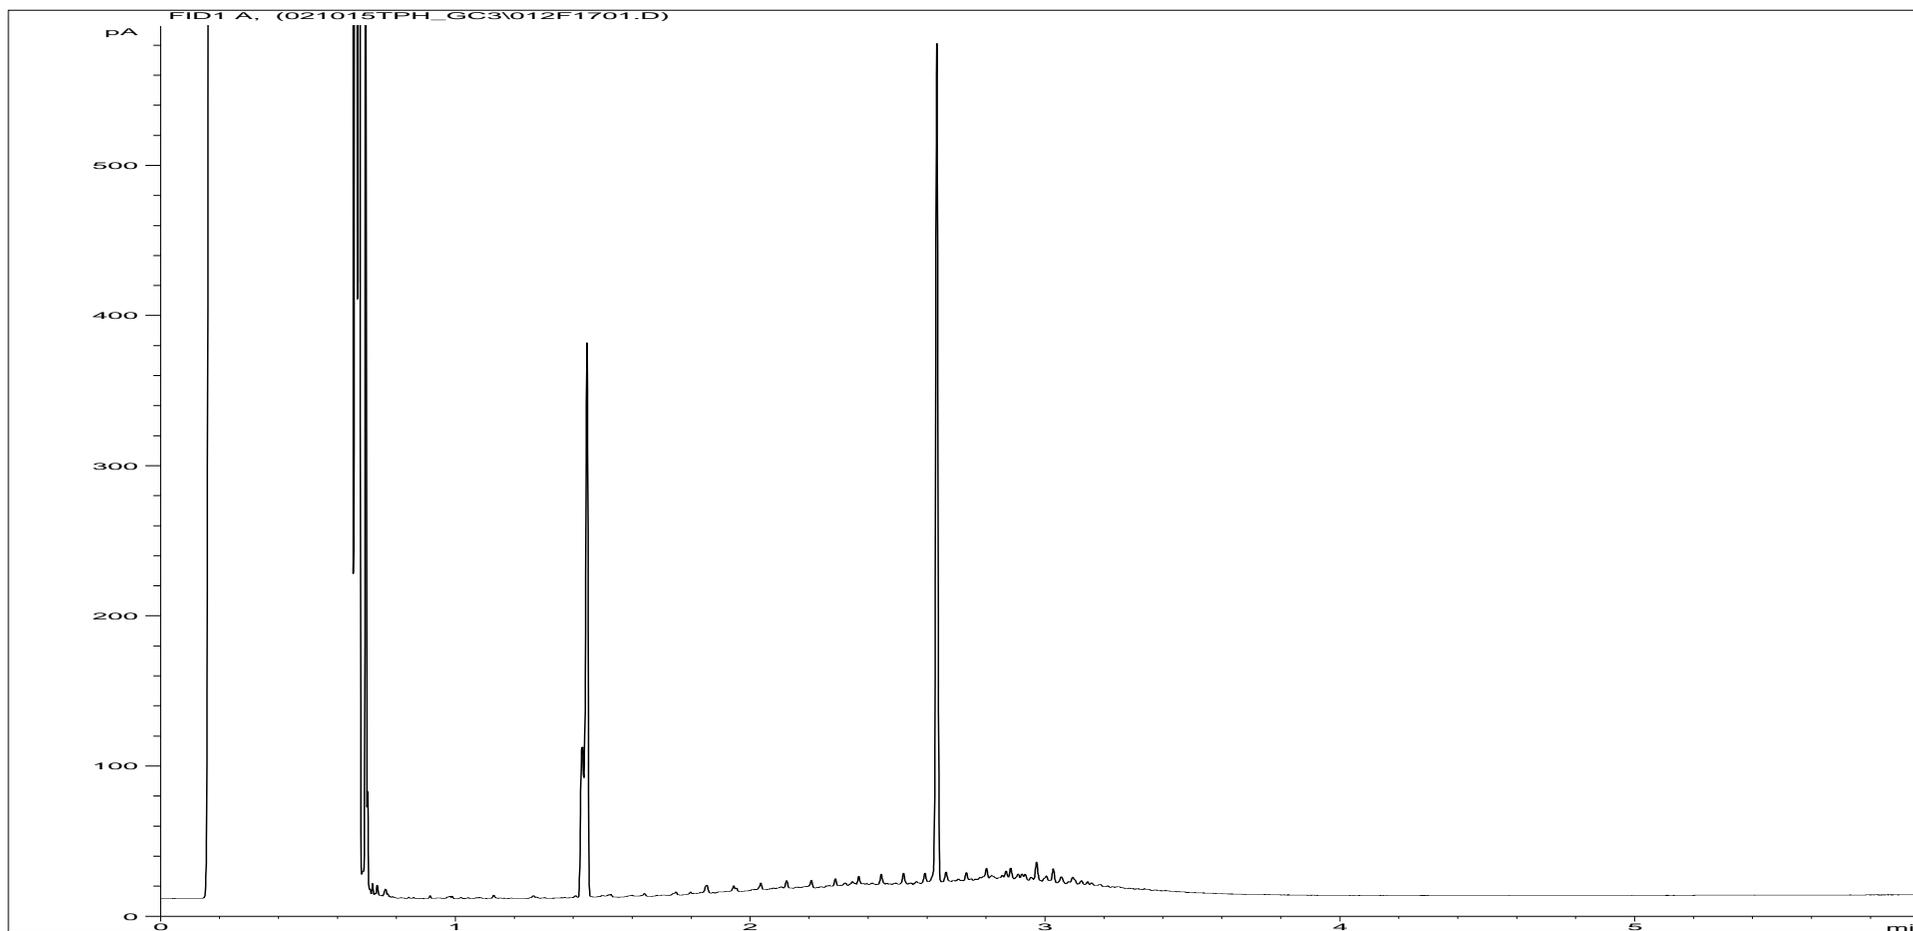
Petroleum Hydrocarbons (C8 to C40) by GC/FID Aliphatics Fraction.

<b>Sample ID:</b>	CL1538966ALI	<b>Job Number:</b>	S15_1118
<b>Multiplier:</b>	14.88	<b>Client:</b>	RPS
<b>Dilution:</b>	1	<b>Site:</b>	Bayliss Metals
<b>Acquisition Method:</b>	5UL_RUNF.M	<b>Client Sample Ref:</b>	TP06 0.5-1m
<b>Acquisition Date/Time:</b>	10-Feb-15		
<b>Datafile:</b>	D:\TES\DATA\Y2013\02\021015TPH_GC3\012F1701.D
