Site Condition Report

Unit 1C, Tremorfa Industrial Estate, Cardiff

Bayliss Metals

**Date:** March 2015  
**Our Ref:** JER6480  
**RPS**  
2420 The Quadrant, Aztec West,  
Almondsbury, Bristol, BS32 4AQ  
**Tel:** (0)1454 853 000  
**Fax:** (0)1454 205 820  
**Email:** rpssw@rpsgroup.com

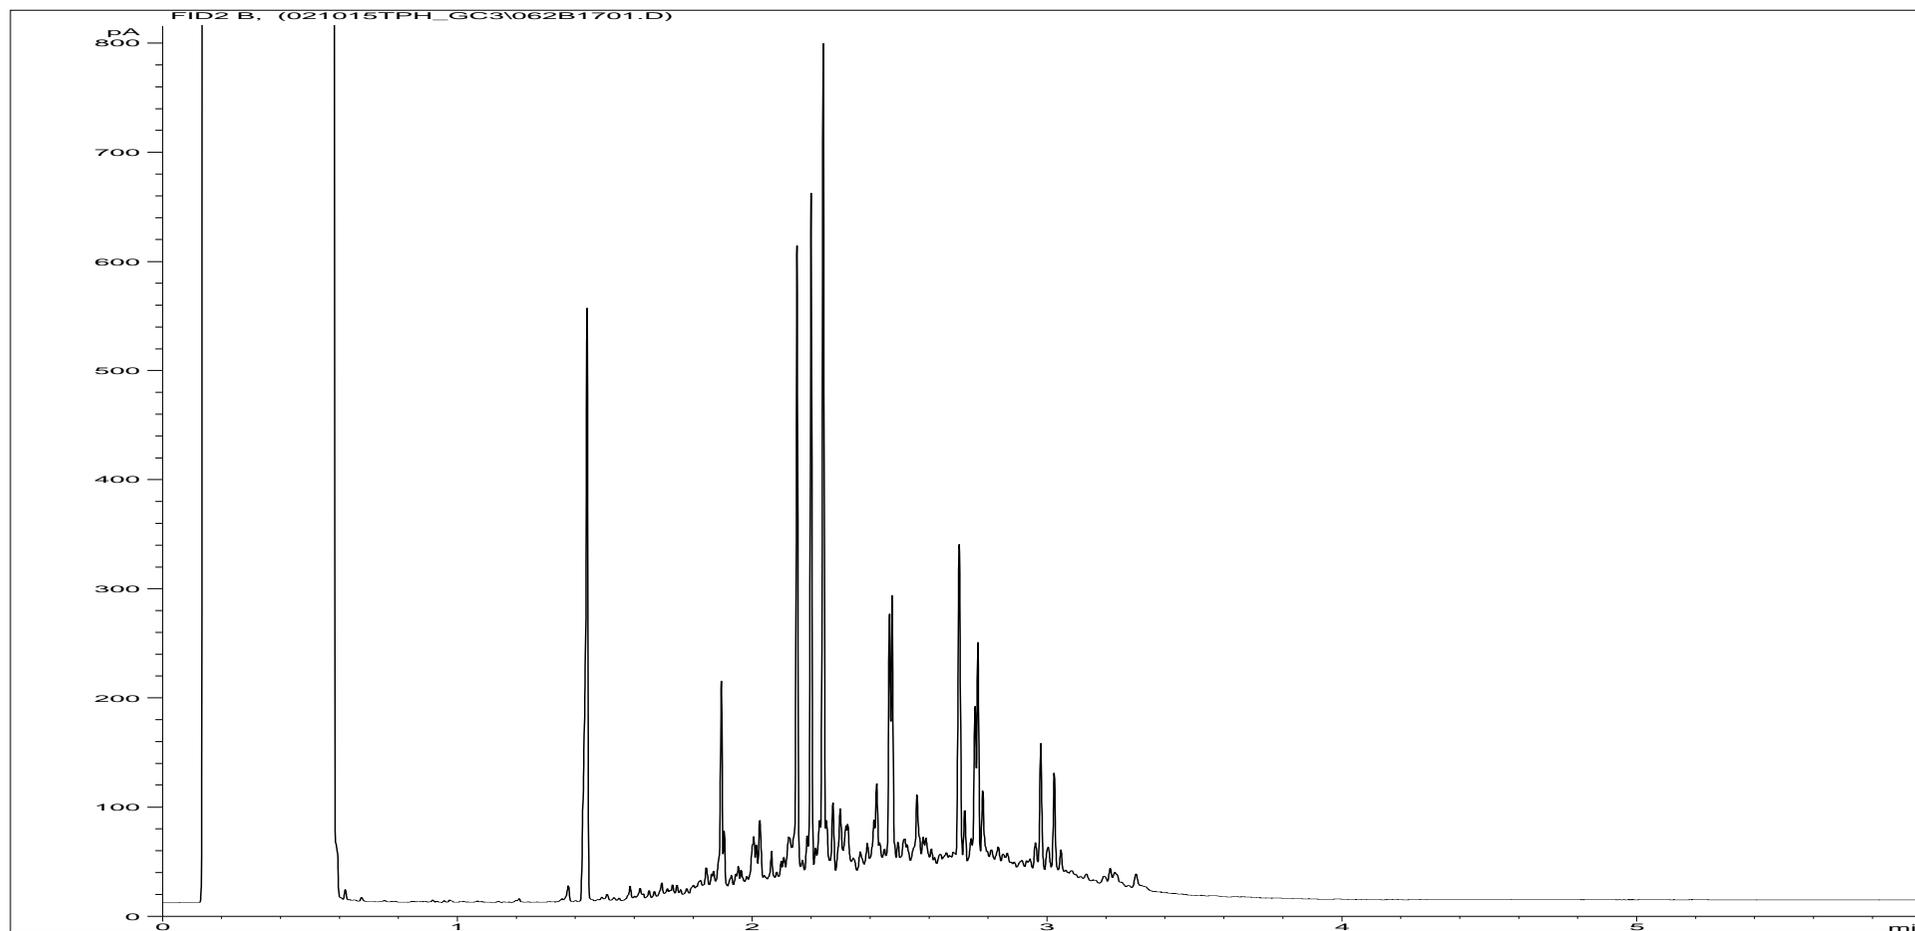
Petroleum Hydrocarbons (C8 to C40) by GC/FID Aromatics Fraction.

<b>Sample ID:</b>	CL1538966ARO	<b>Job Number:</b>	S15_1118
<b>Multiplier:</b>	11.2	<b>Client:</b>	RPS
<b>Dilution:</b>	1	<b>Site:</b>	Bayliss Metals
<b>Acquisition Method:</b>	5UL_RUNF.M	<b>Client Sample Ref:</b>	TP06 0.5-1m
<b>Acquisition Date/Time:</b>	10-Feb-15		
<b>Datafile:</b>	D:\TES\DATA\Y2013\02\021015TPH_GC3\062B1701.D

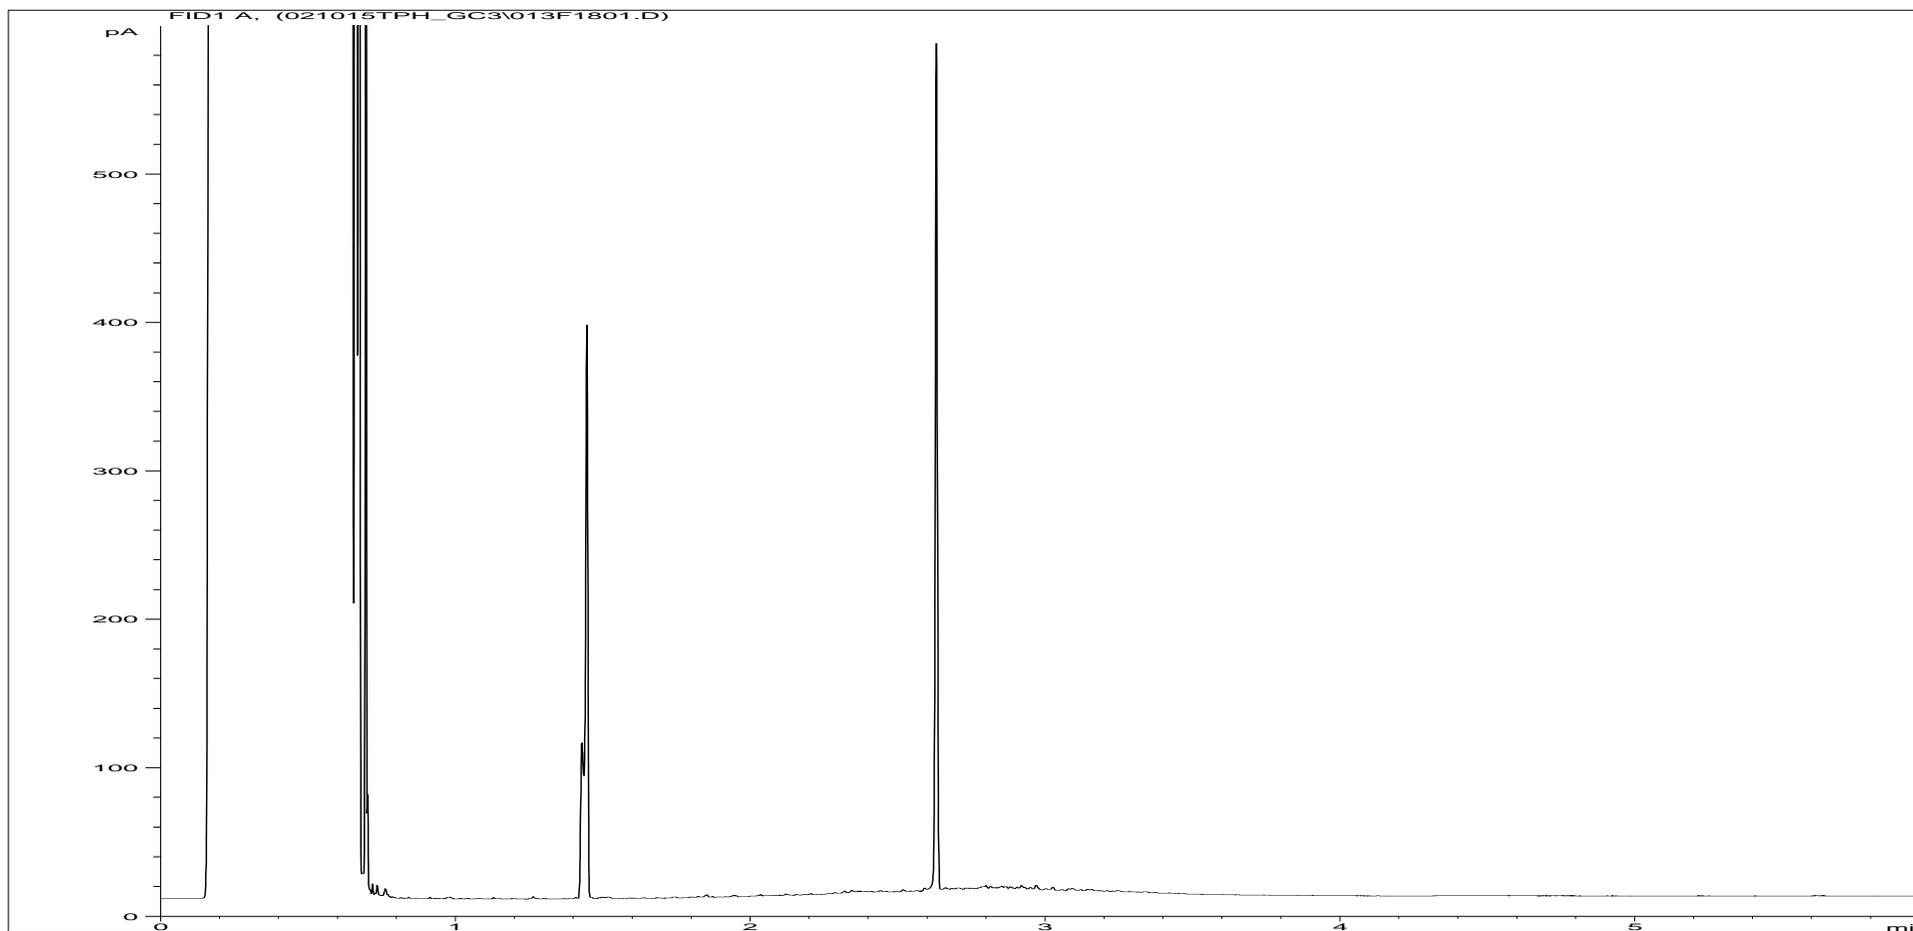
Petroleum Hydrocarbons (C8 to C40) by GC/FID Aliphatics Fraction.

<b>Sample ID:</b>	CL1538967ALI	<b>Job Number:</b>	S15_1118
<b>Multiplier:</b>	14.88	<b>Client:</b>	RPS
<b>Dilution:</b>	1	<b>Site:</b>	Bayliss Metals
<b>Acquisition Method:</b>	5UL_RUNF.M	<b>Client Sample Ref:</b>	TP07 0.5-1m
<b>Acquisition Date/Time:</b>	10-Feb-15		
<b>Datafile:</b>	D:\TES\DATA\Y2013\02\021015TPH_GC3\013F1801.D

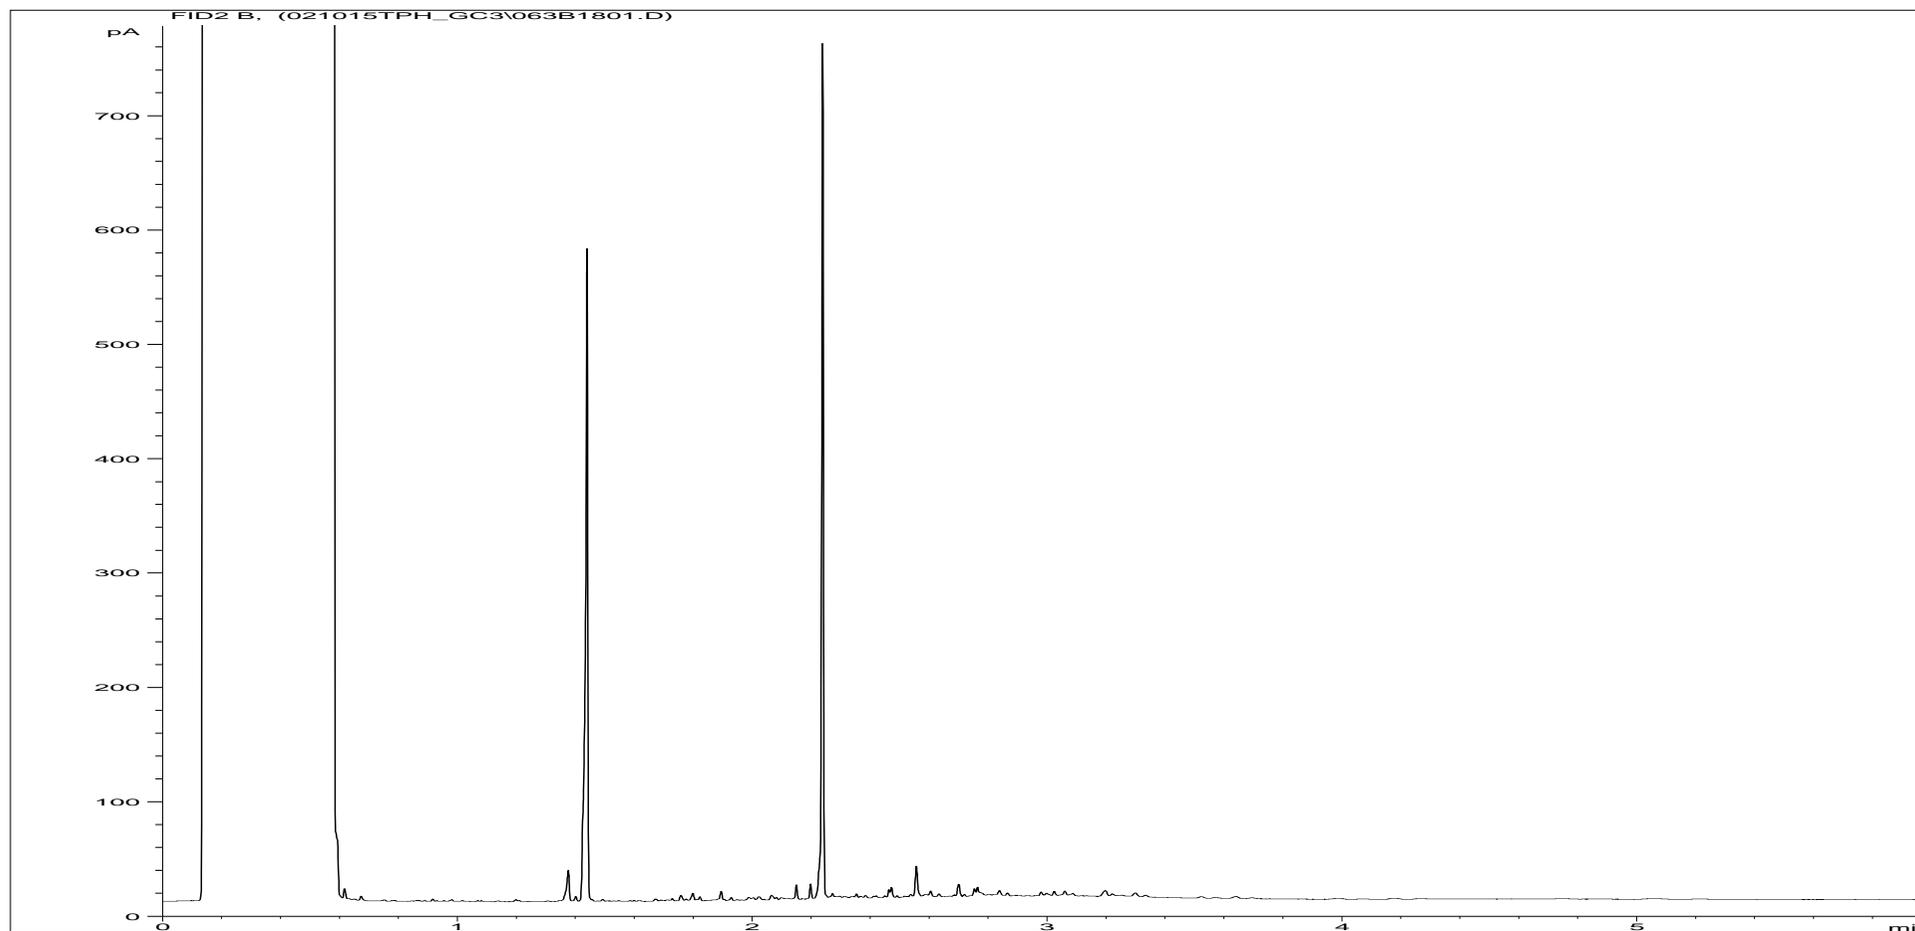
Petroleum Hydrocarbons (C8 to C40) by GC/FID Aromatics Fraction.

<b>Sample ID:</b>	CL1538967ARO	<b>Job Number:</b>	S15_1118
<b>Multiplier:</b>	11.2	<b>Client:</b>	RPS
<b>Dilution:</b>	1	<b>Site:</b>	Bayliss Metals
<b>Acquisition Method:</b>	5UL_RUNF.M	<b>Client Sample Ref:</b>	TP07 0.5-1m
<b>Acquisition Date/Time:</b>	10-Feb-15		
<b>Datafile:</b>	D:\TES\DATA\Y2013\02\021015TPH_GC3\063B1801.D

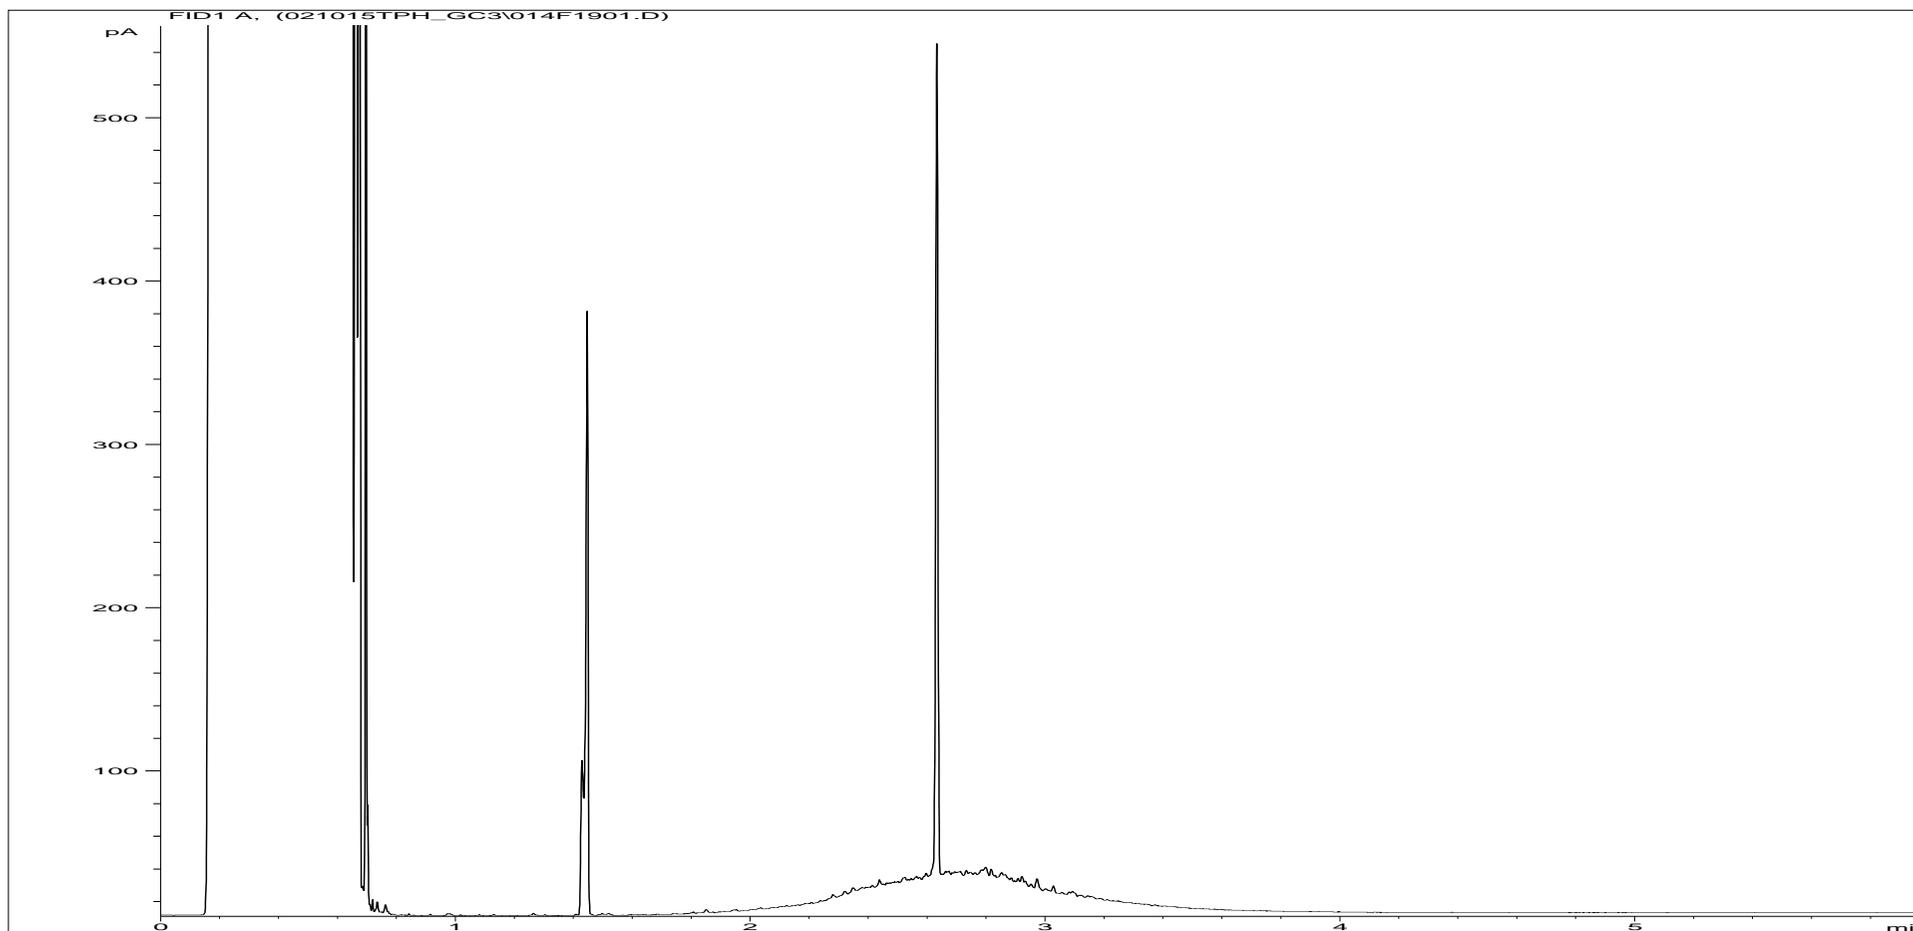
Petroleum Hydrocarbons (C8 to C40) by GC/FID Aliphatics Fraction.

<b>Sample ID:</b>	CL1538968ALI	<b>Job Number:</b>	S15_1118
<b>Multiplier:</b>	14.88	<b>Client:</b>	RPS
<b>Dilution:</b>	1	<b>Site:</b>	Bayliss Metals
<b>Acquisition Method:</b>	5UL_RUNF.M	<b>Client Sample Ref:</b>	SA01 2.5m
<b>Acquisition Date/Time:</b>	10-Feb-15		
<b>Datafile:</b>	D:\TES\DATA\Y2013\02\021015TPH_GC3\014F1901.D

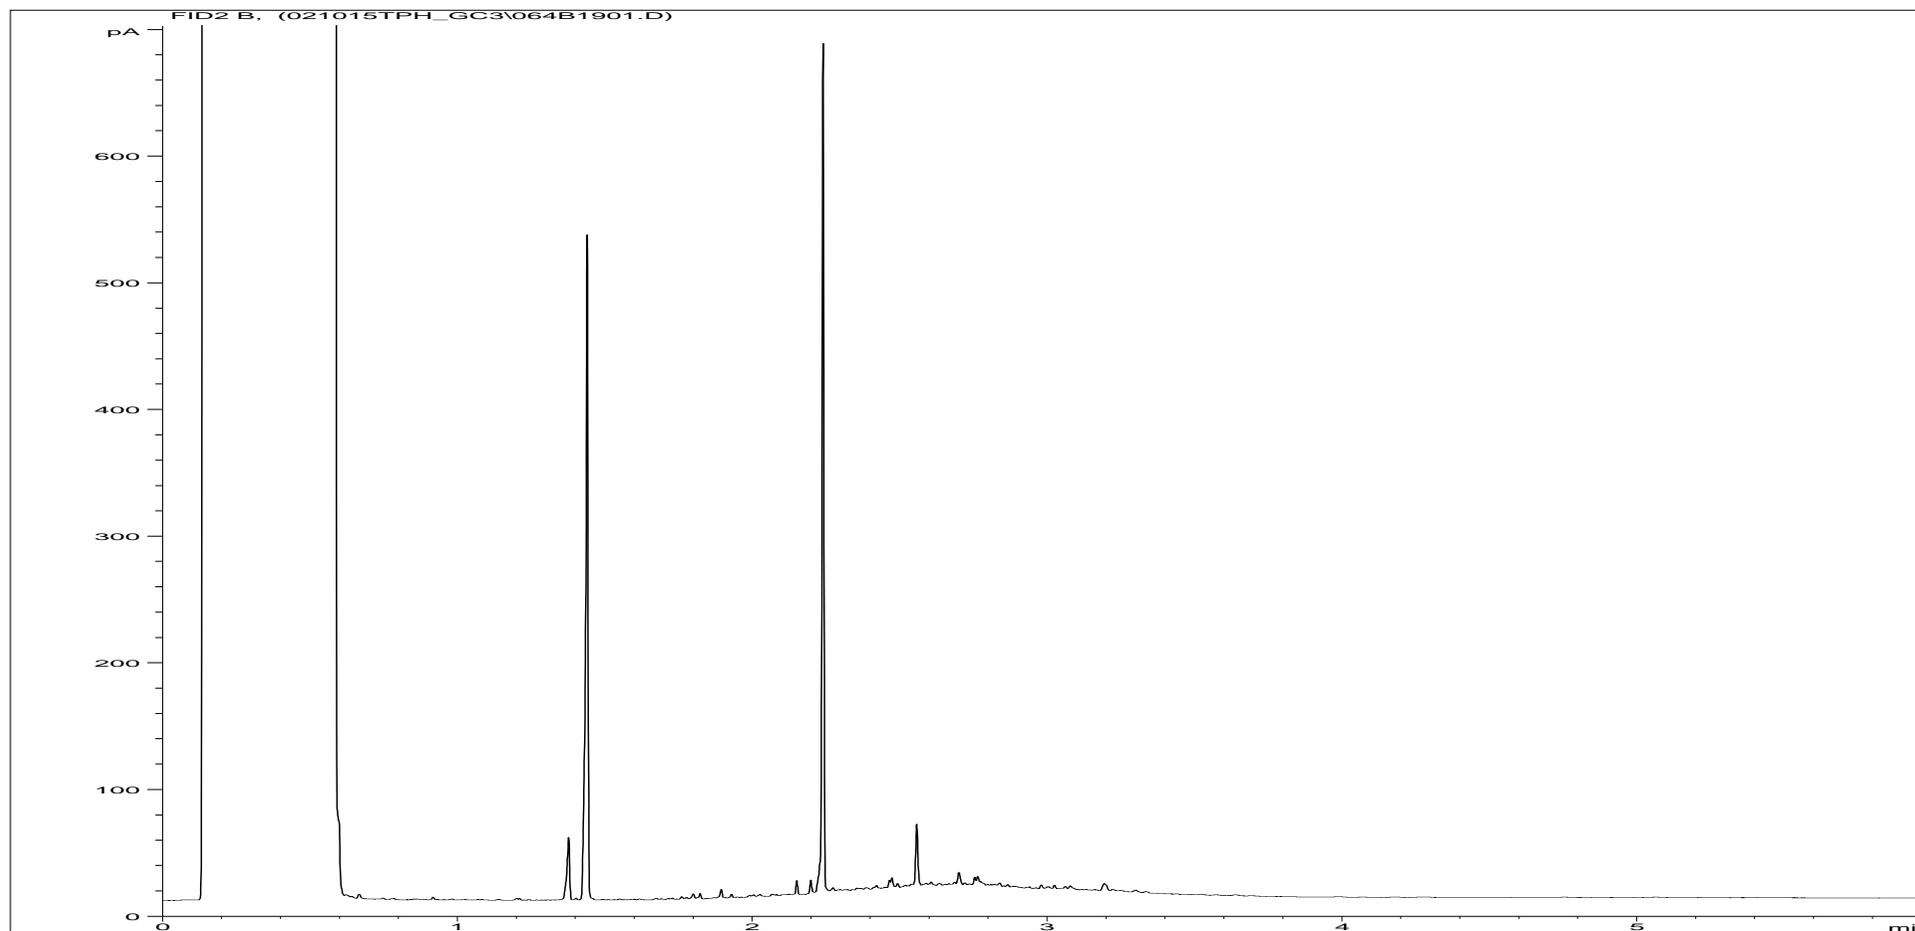
Petroleum Hydrocarbons (C8 to C40) by GC/FID Aromatics Fraction.

<b>Sample ID:</b>	CL1538968ARO	<b>Job Number:</b>	S15_1118
<b>Multiplier:</b>	11.2	<b>Client:</b>	RPS
<b>Dilution:</b>	1	<b>Site:</b>	Bayliss Metals
<b>Acquisition Method:</b>	5UL_RUNF.M	<b>Client Sample Ref:</b>	SA01 2.5m
<b>Acquisition Date/Time:</b>	10-Feb-15		
<b>Datafile:</b>	D:\TES\DATA\Y2013\02\021015TPH_GC3\064B1901.D
