## Compliance Assessment Report

Report ID:  
CAR\_NRW0026379

| Site | Site Serv Recycling Ltd | Permit Ref | JB3893HP | | |
| Assessment type | Site Inspection | | | | |

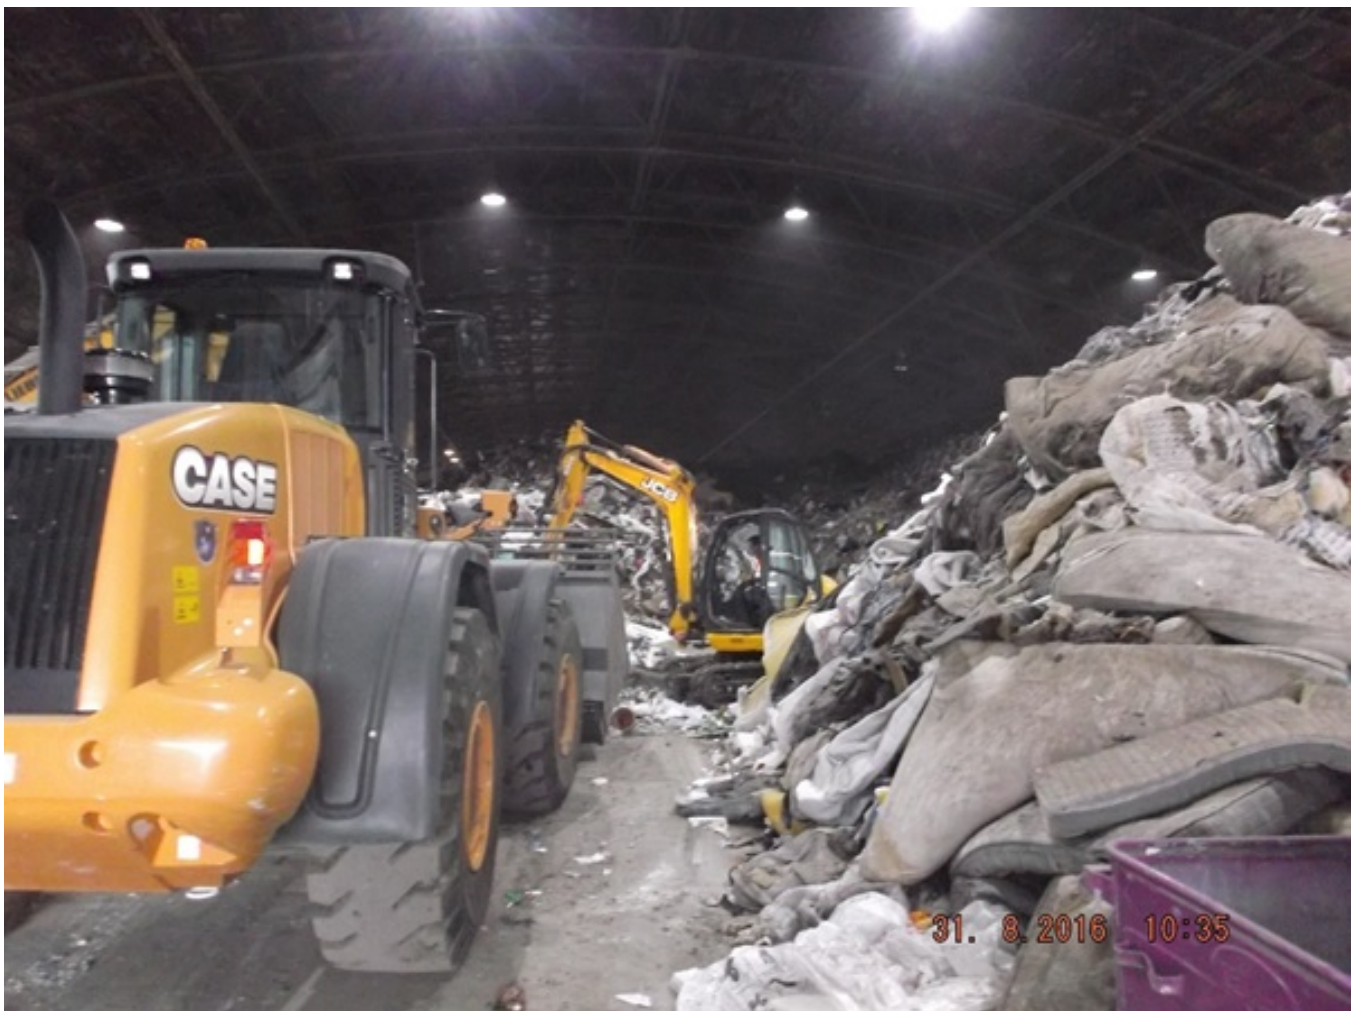
Hangar B contained a lot more waste than had been seen in the previous visit. Waste piles filled much of the central area of the hangar. At the entrance of Hangar B, a waste shredding operation was underway, with the aim to reduce the volume of the waste within the hangar. The amount of waste appears greater than July. Apart from the operational area at the front there was limited access into the Hangar, and there was no longer a gap between the piles, therefore there could be no emergency service access through the hangar. Further waste, from Unit 2 on the Llandow Trading Estate is intended to be brought back to the hangar.

*Waste piles in Hangar B; there is limited access for emergency services.*

No fire breaks in the waste have been made. Though an emergency vehicle may be able to access the front and back of the piles, there is limited access to deal with a deep seated fire. Again with such high volumes, it could take several weeks to clear the waste – excluding the incoming wastes that Siteserv will continue to receive. Priority should be given to introducing fire breaks, and ensuring there is an effective system for monitoring the temperature of piles and maintaining a turnover of the older or warmer wastes. Regular updates should be provided on the monitoring and progress at reducing the amount of waste onsite.

Waste stockpiles in Hangar B have increased, reducing Siteserv Recycling’s ability to manage the risk of fire. Stockpiles need to reduce, with a high turnaround of waste and fire breaks need to be in place, and contingency plans acted upon as per your fire prevention plan.

| Criteria Ref. | CCS Category | Action required/advised | Due Date |
|---|---|---|---|
| D2 | C3 | Reduce volume of waste, put in place fire breaks and utilise contingency plans as per Fire Prevention Plan | 31/10/2016 |

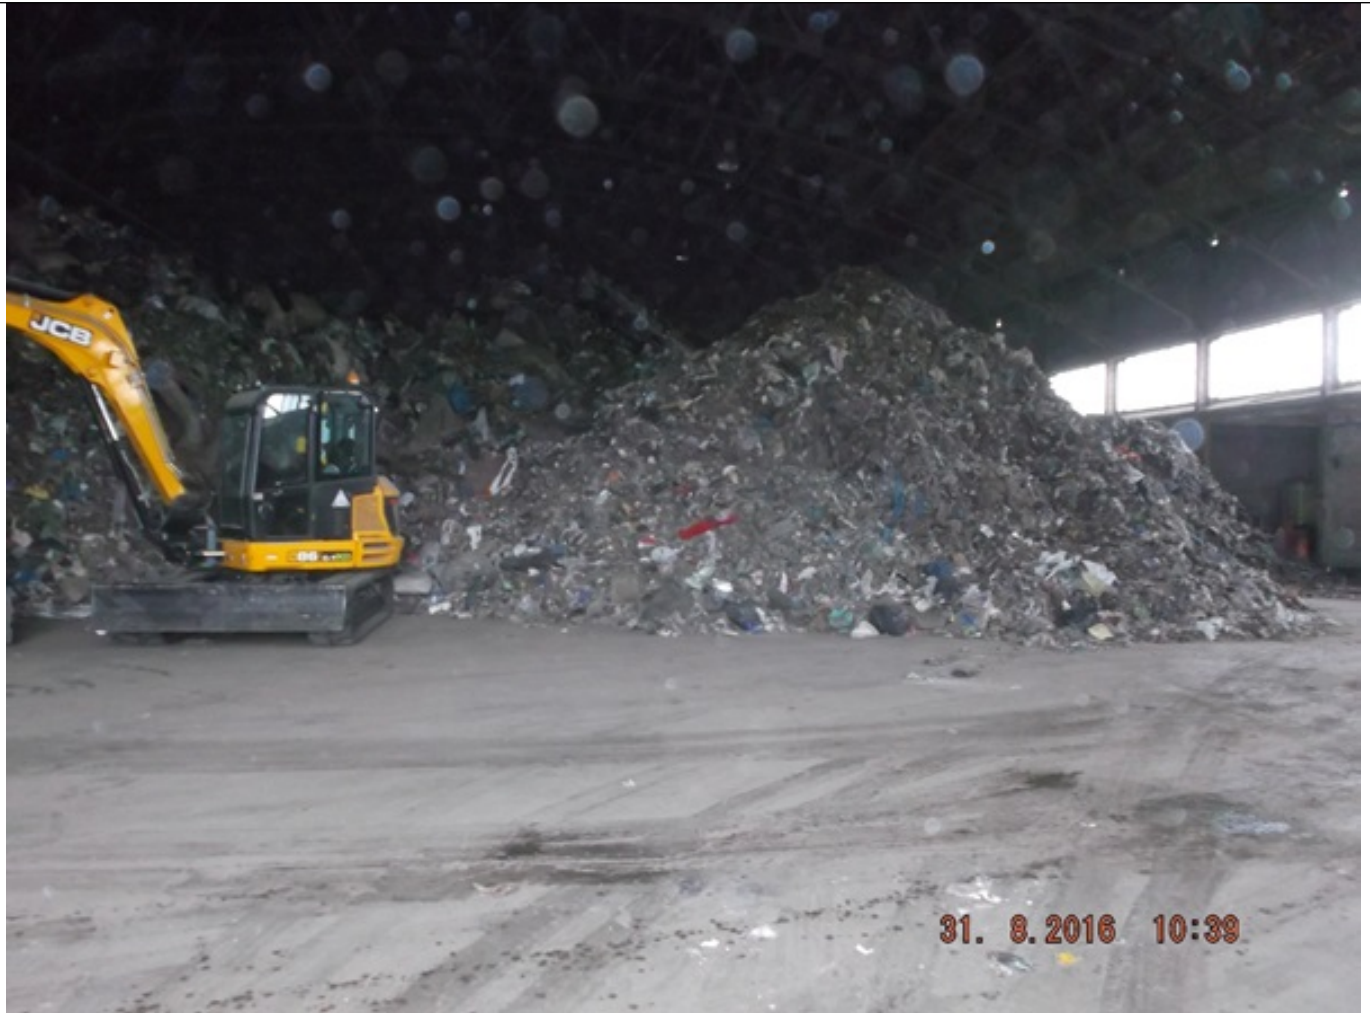
At the rear of the hangar a larger area had been cleared, and was now used to store the uPVC waste. Siteserv state they have not “stockpiled” the mixed waste that is stored on this side of the hangar; with pile heights less than 4m they can more easily be loaded into a container/lorry.

*Heights of some of the piles at the back of Hangar B are lower, so that they can be quickly loaded into containers/lorries*

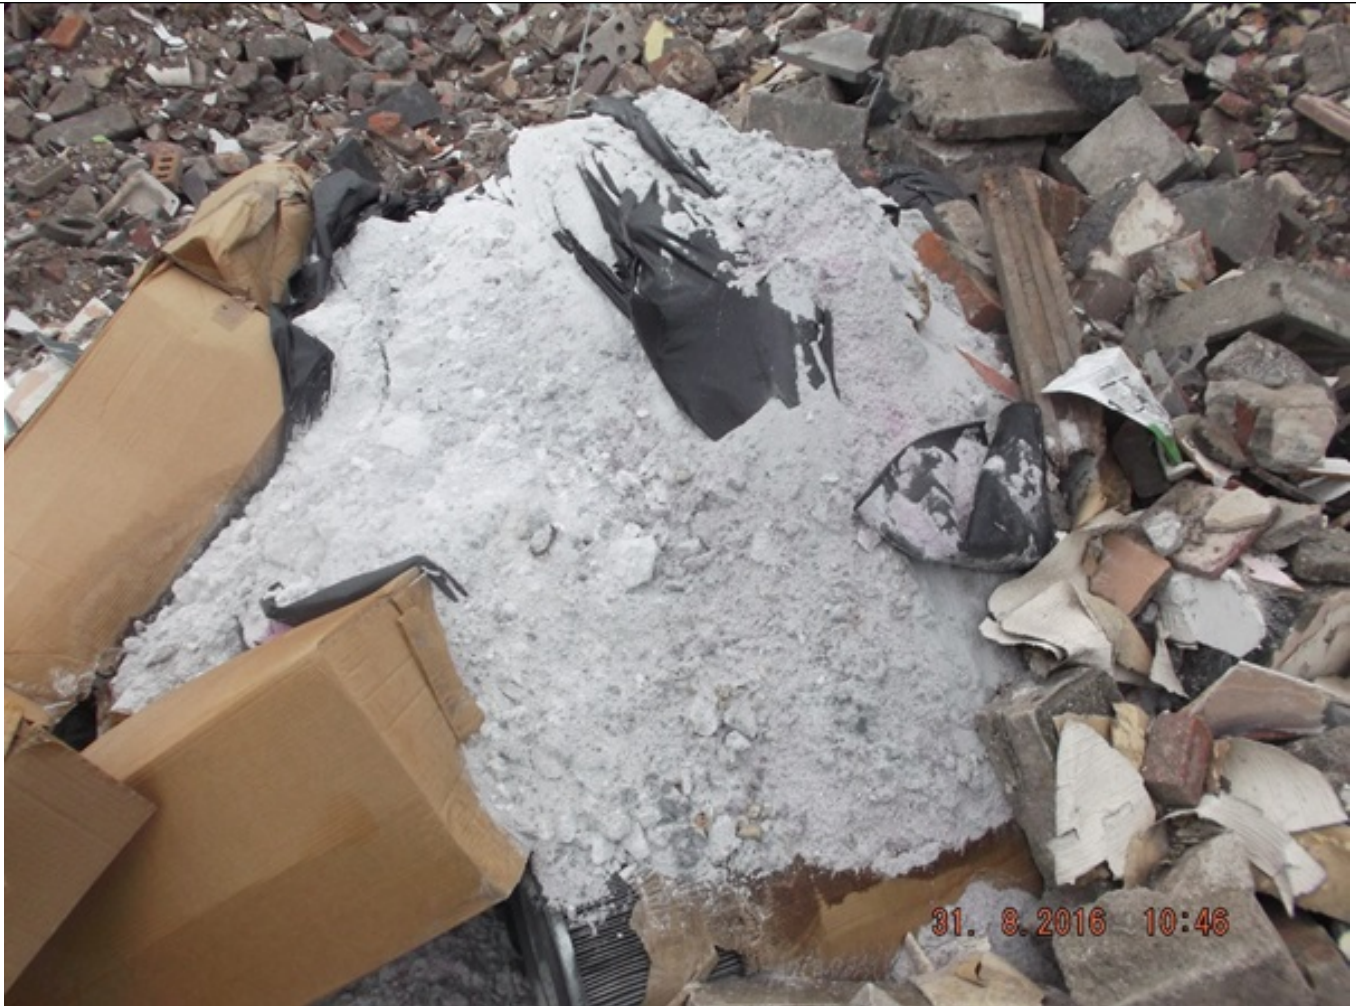
The rubble waste stored outside, near the front of Hangar B contained a fine powdery material. Please ensure this does not contribute to dust emissions.

*Powdery material amongst the rubble waste stored outside.*

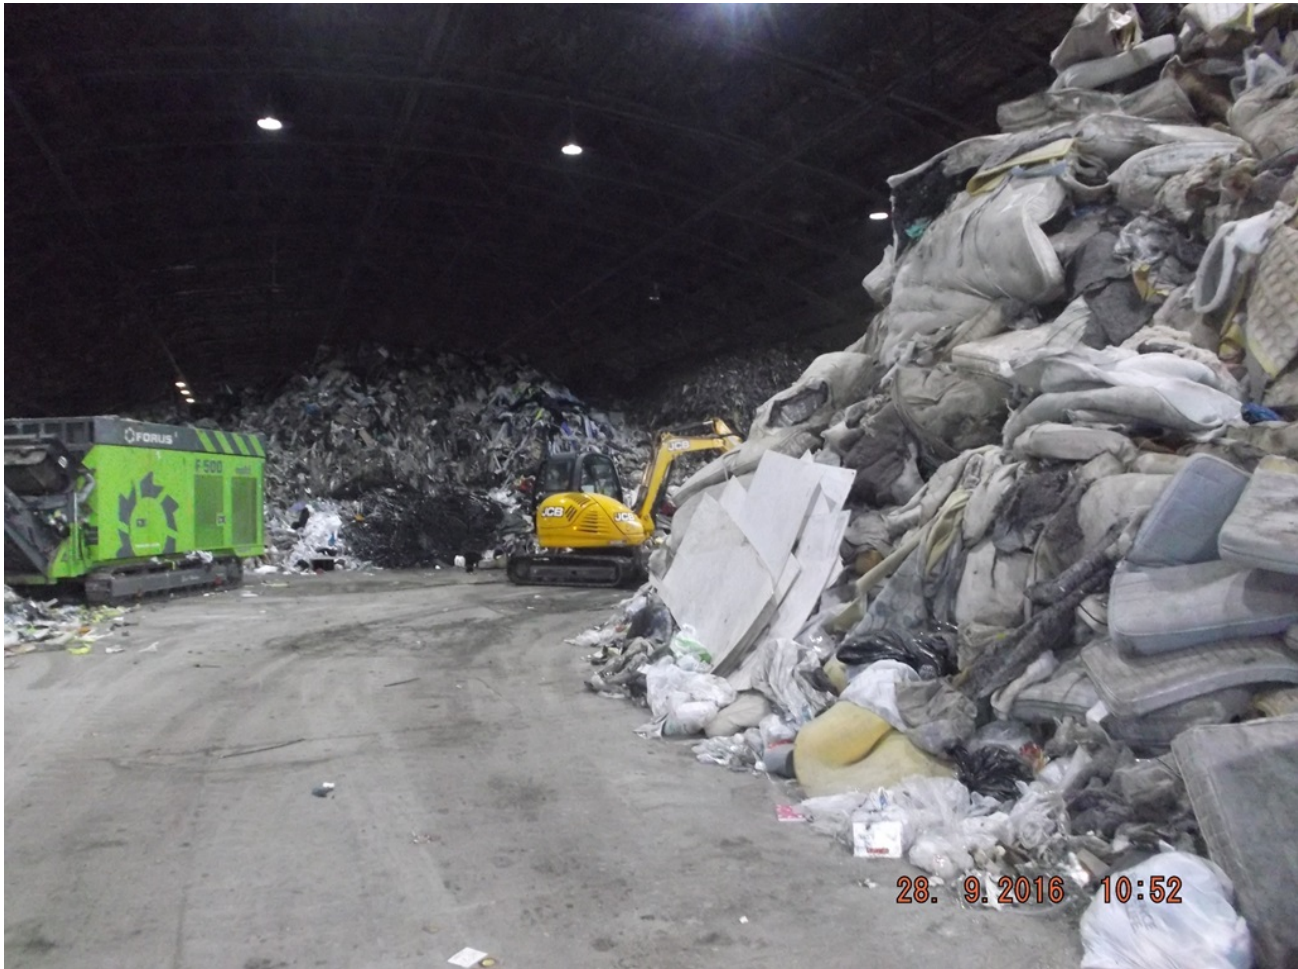
On the right hand side of the entrance, a large pile of mixed waste was ~7m high, and contained a lot of mattresses, that have been received from a local authority contract. It was noted that some of the waste was

directly under one of the hangar lamps, and appeared to be steaming. The heat of the lamp may have been warming the waste. Carl Jones said it would be actioned to lower the height of the waste pile.

*Photograph from the entrance of Hangar B. The pile on the right is mixed waste with a lot of mattresses in. The pile was seen to be steaming underneath the lamps of the hangar.*

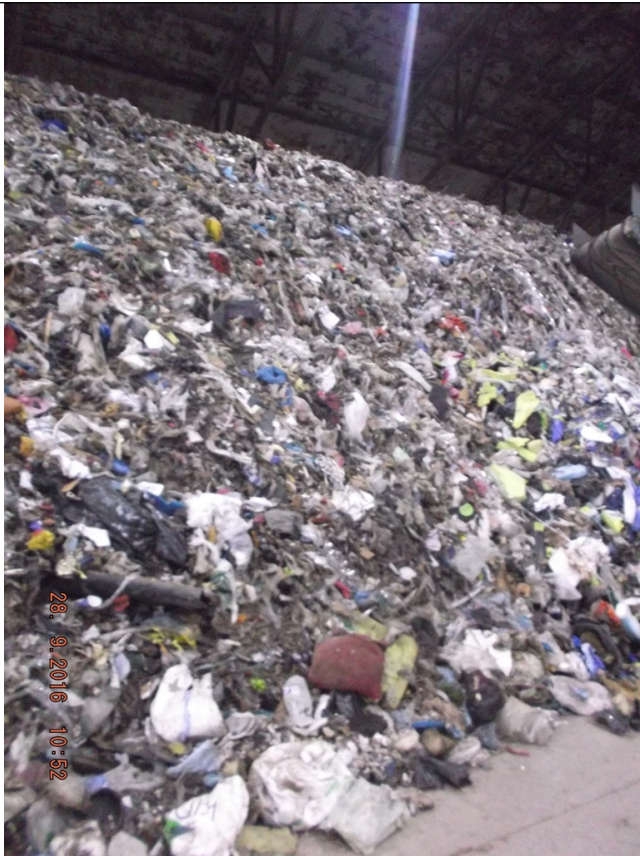
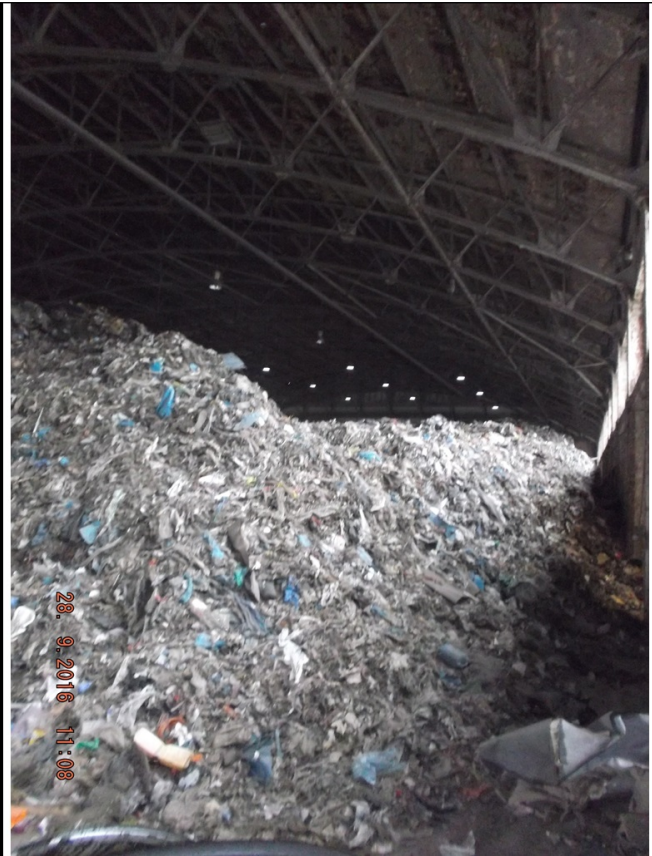
The volume of waste inside Hangar B continues to be high. As seen in the previous visit, there is an operational area near the front entrance where Siteserv are shredding their waste. There is a long pile on the left as you walk into the hangar which all looked to have been recently shredded. The pile is around 5m high and looked to be over 50m in length. Shredding the waste onsite in the hangars means less processing time at their receiving sites, which allows more transportation.

*Shredded waste pile, stretching over 2/3rds of the Hangar.*

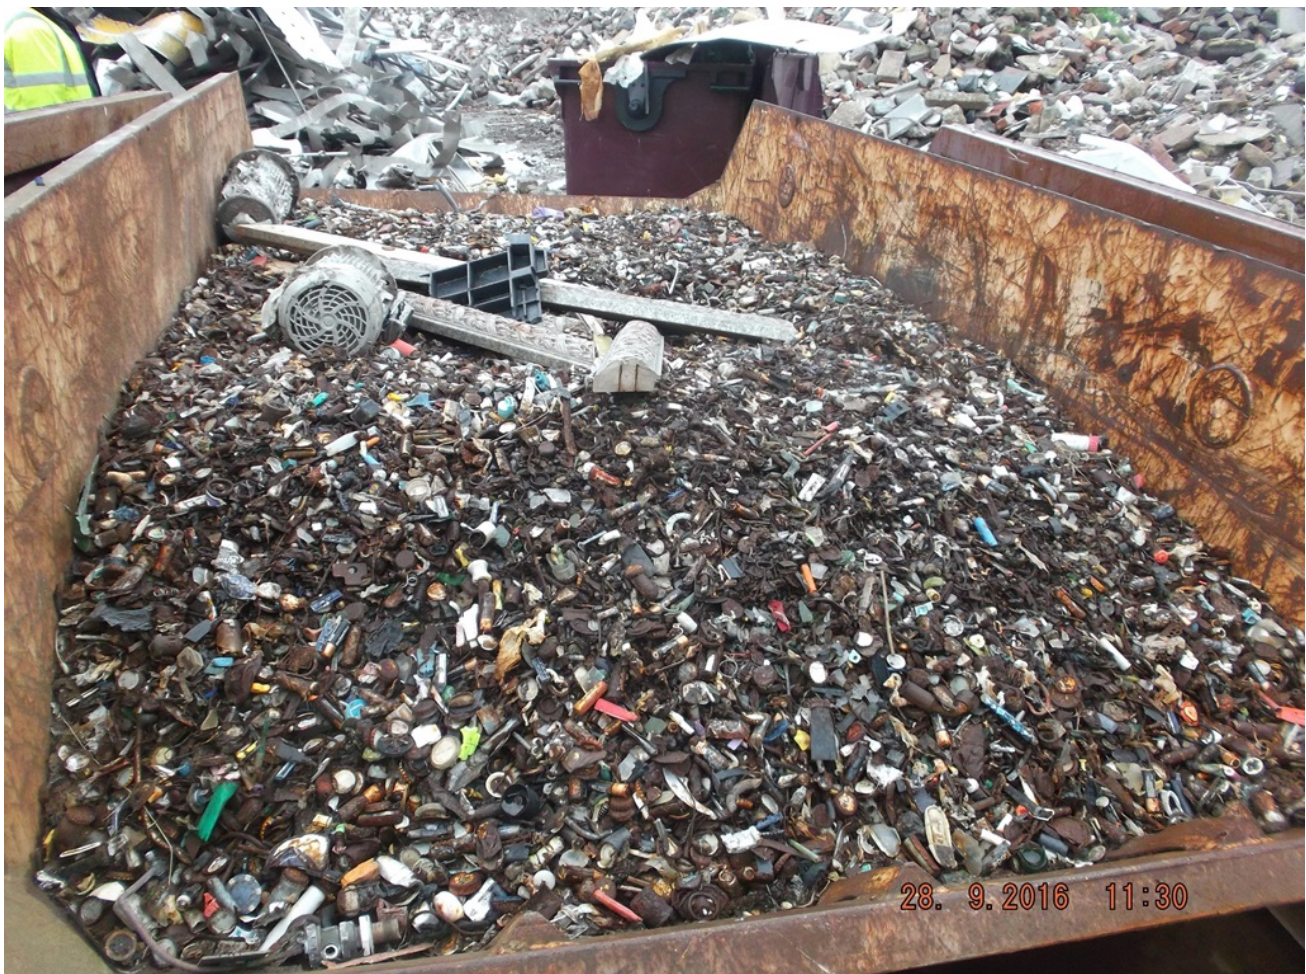
Batteries, glass, bottle caps, spent shotgun cartridges and metal fines were stored in two skips outside. Again this material should be stored inside or within a sealed container.

*Waste batteries, glass, bottle caps, spent shotgun cartridges and metal fines stored in skips outside. This*

*waste should be stored inside or in a sealed container.*

| Criteria Ref. | CCS Category | Action required/advised | Due Date |
|---|---|---|---|
| C4 | C3 | All non-specified wastes to be stored and treated inside a building or sealed container that effectively controls emissions | 31/10/2016 |

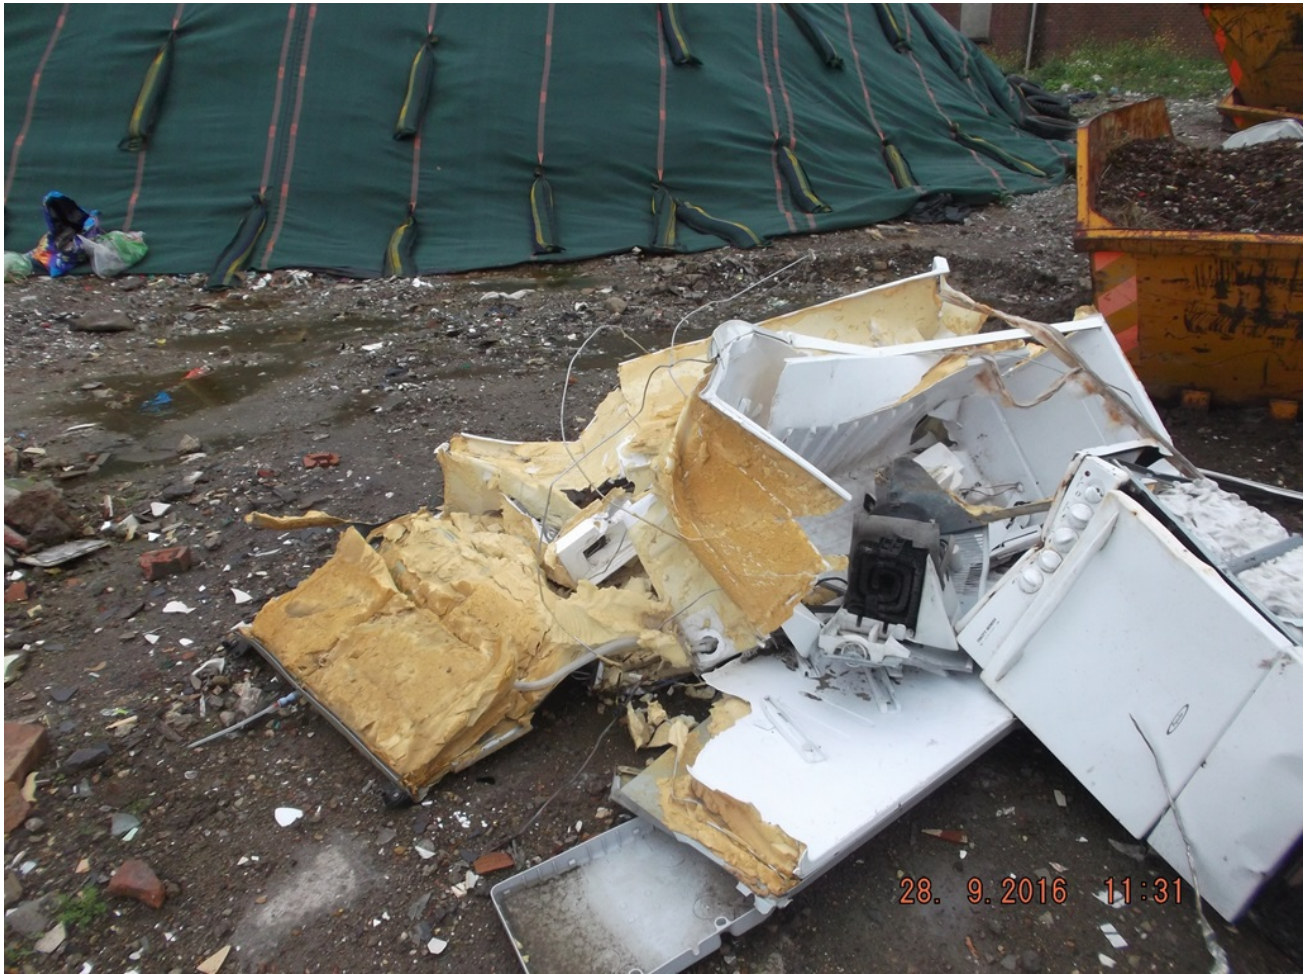
Damaged fridge accepted onsite, which is hazardous waste. Material not rejected or quarantined.

A fridge was smashed up on the hard standing. The majority of fridges are hazardous waste. Siteserv's permit does not cover the storage and treatment of hazardous waste. Hazardous waste should be rejected at source, however if fridges are accidentally accepted then they need to be suitably quarantined. Storing damaged fridges outside on made ground does not qualify.

*Waste damaged fridge stored outside on made ground.*

| Criteria Ref. | CCS Category | Action required/advised | Due Date |
|---|---|---|---|
| C3 | C3 | Suitably quarantine and remove damaged fridge from site to a suitably authorised facility | 14/10/2016 |

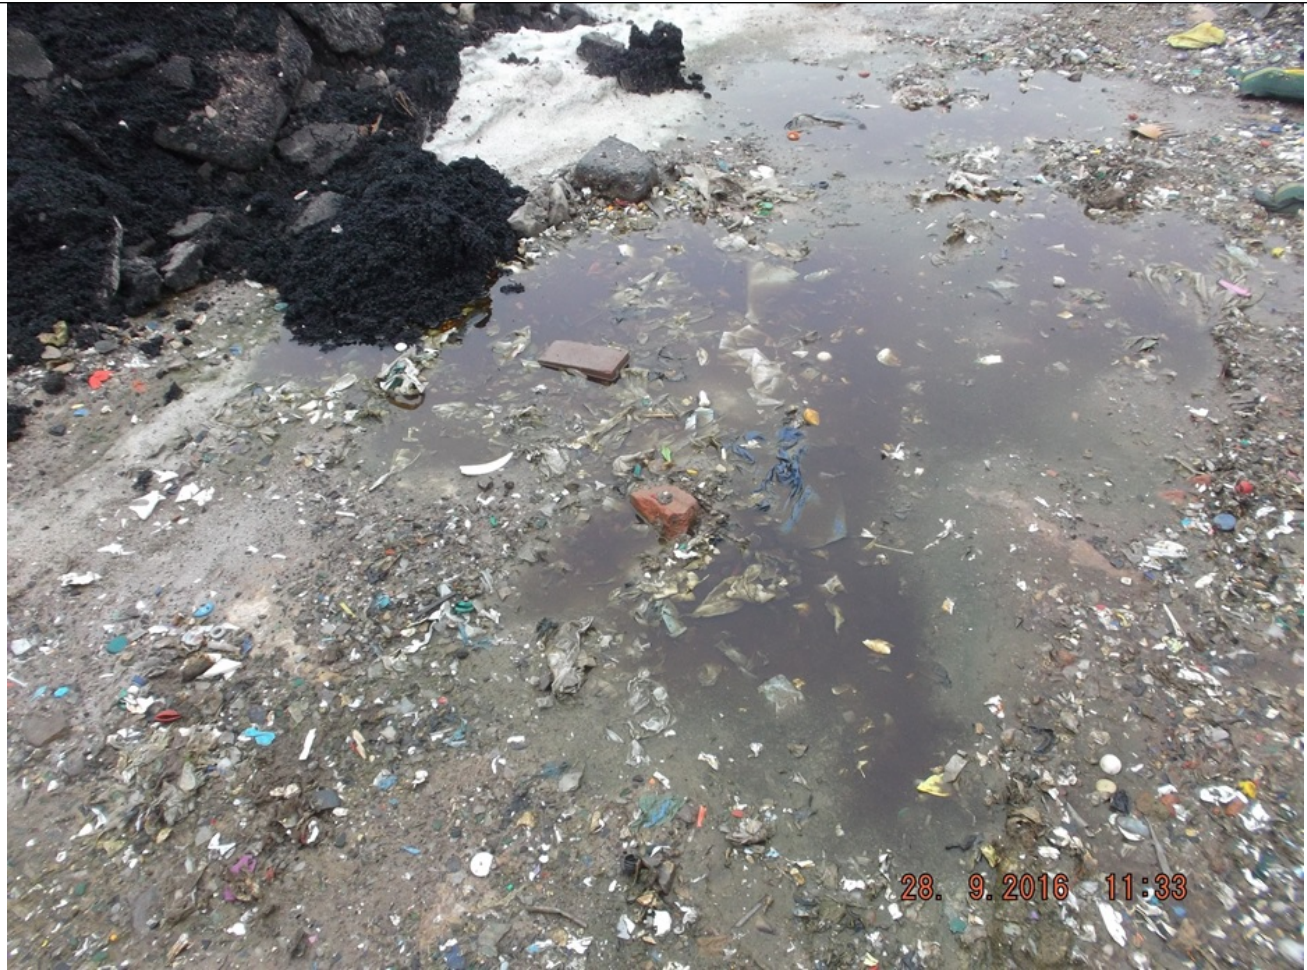
In the area alongside Hangar B, various waste material was being stored outside, including fines, plastic, scrap metal, wood and rubble. Apart from inert wastes, all other materials should be stored inside a building with sealed drainage or in a sealed container. In between the waste fines and rubble, there was a pool of dark coloured liquid that resembled leachate. If this material has been leached out from the waste trommel fines, then it would suggest that the current mitigation infrastructure is inadequate. Storing the waste fines outside of a building with a sealed drainage system is in breach of the permit conditions. If this material is leaching then the environmental risk from storing the fines outside on made ground is greater than previously understood. This issue was raised with Siteserv Recycling's SHEQ consultant who believes the liquid has come from the rubble, not the fines. Efforts will be made to clear this area up.

*Leachate-like liquid found pooling between rubble and trommel fines*

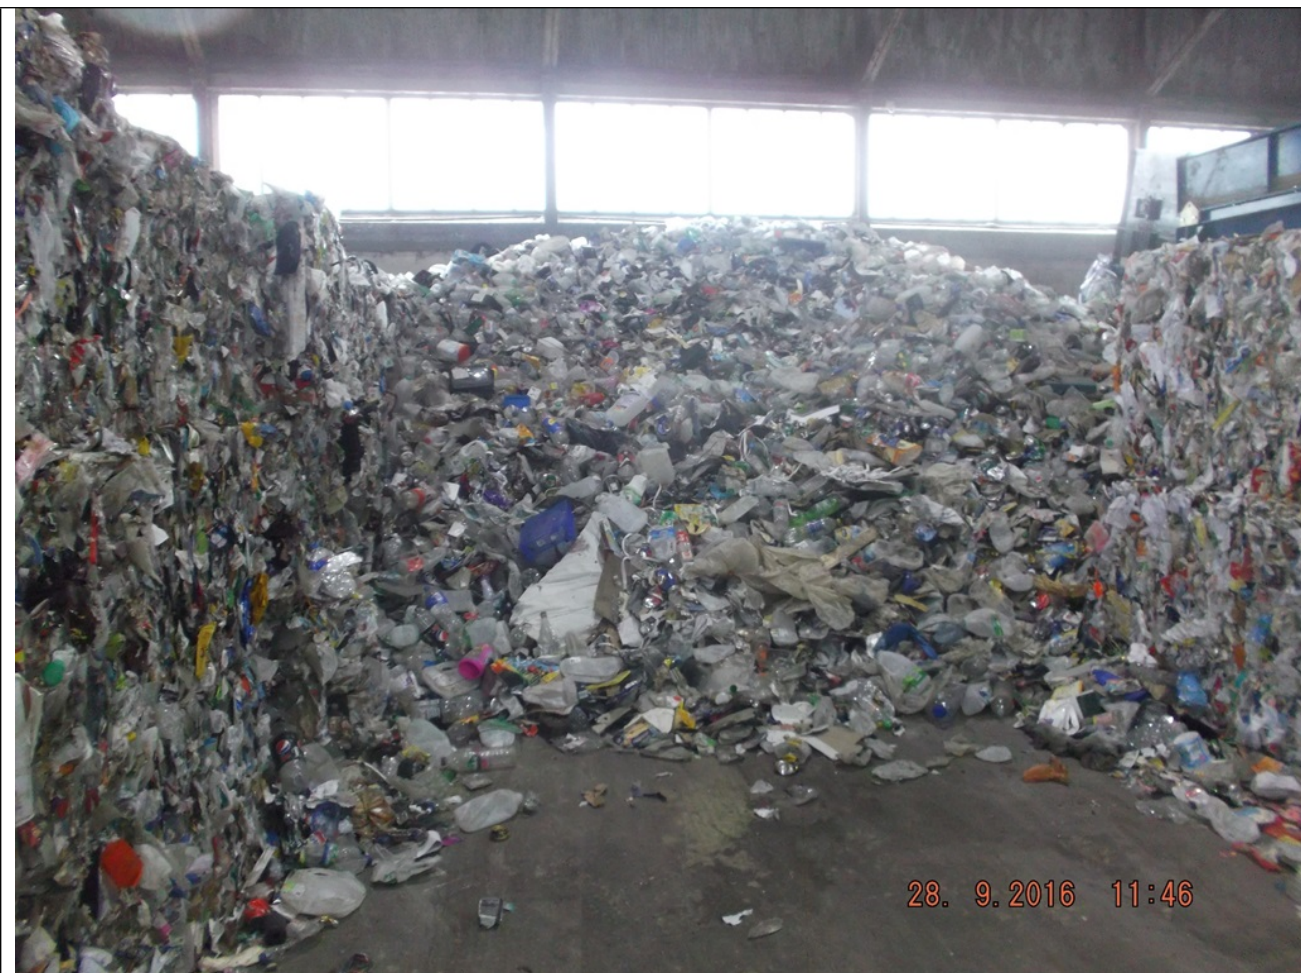
Siteserv Recycling had started to accept some co-mingled wastes; plastic bottles and tin cans. The amounts of waste were reported to be under the Material Facilities threshold, with Siteserv currently accepting around 20t a month. A number of flies were found to be attracted to the waste. If this waste is to continue to be accepted a pest management plan will be required, as unwashed food containers will attract pests. However it is understood that Siteserv Recycling will not continue with this waste stream.

*Co-mingled waste stored in hangar A. The waste was attracting a number of flies.*
