**ATLANTIC RECYCLING  
ECOPARK PAVING  
PROJECT**

**PHASE 3 CQA  
VALIDATION REPORT**

*Report Number 1379r6v1d1215*

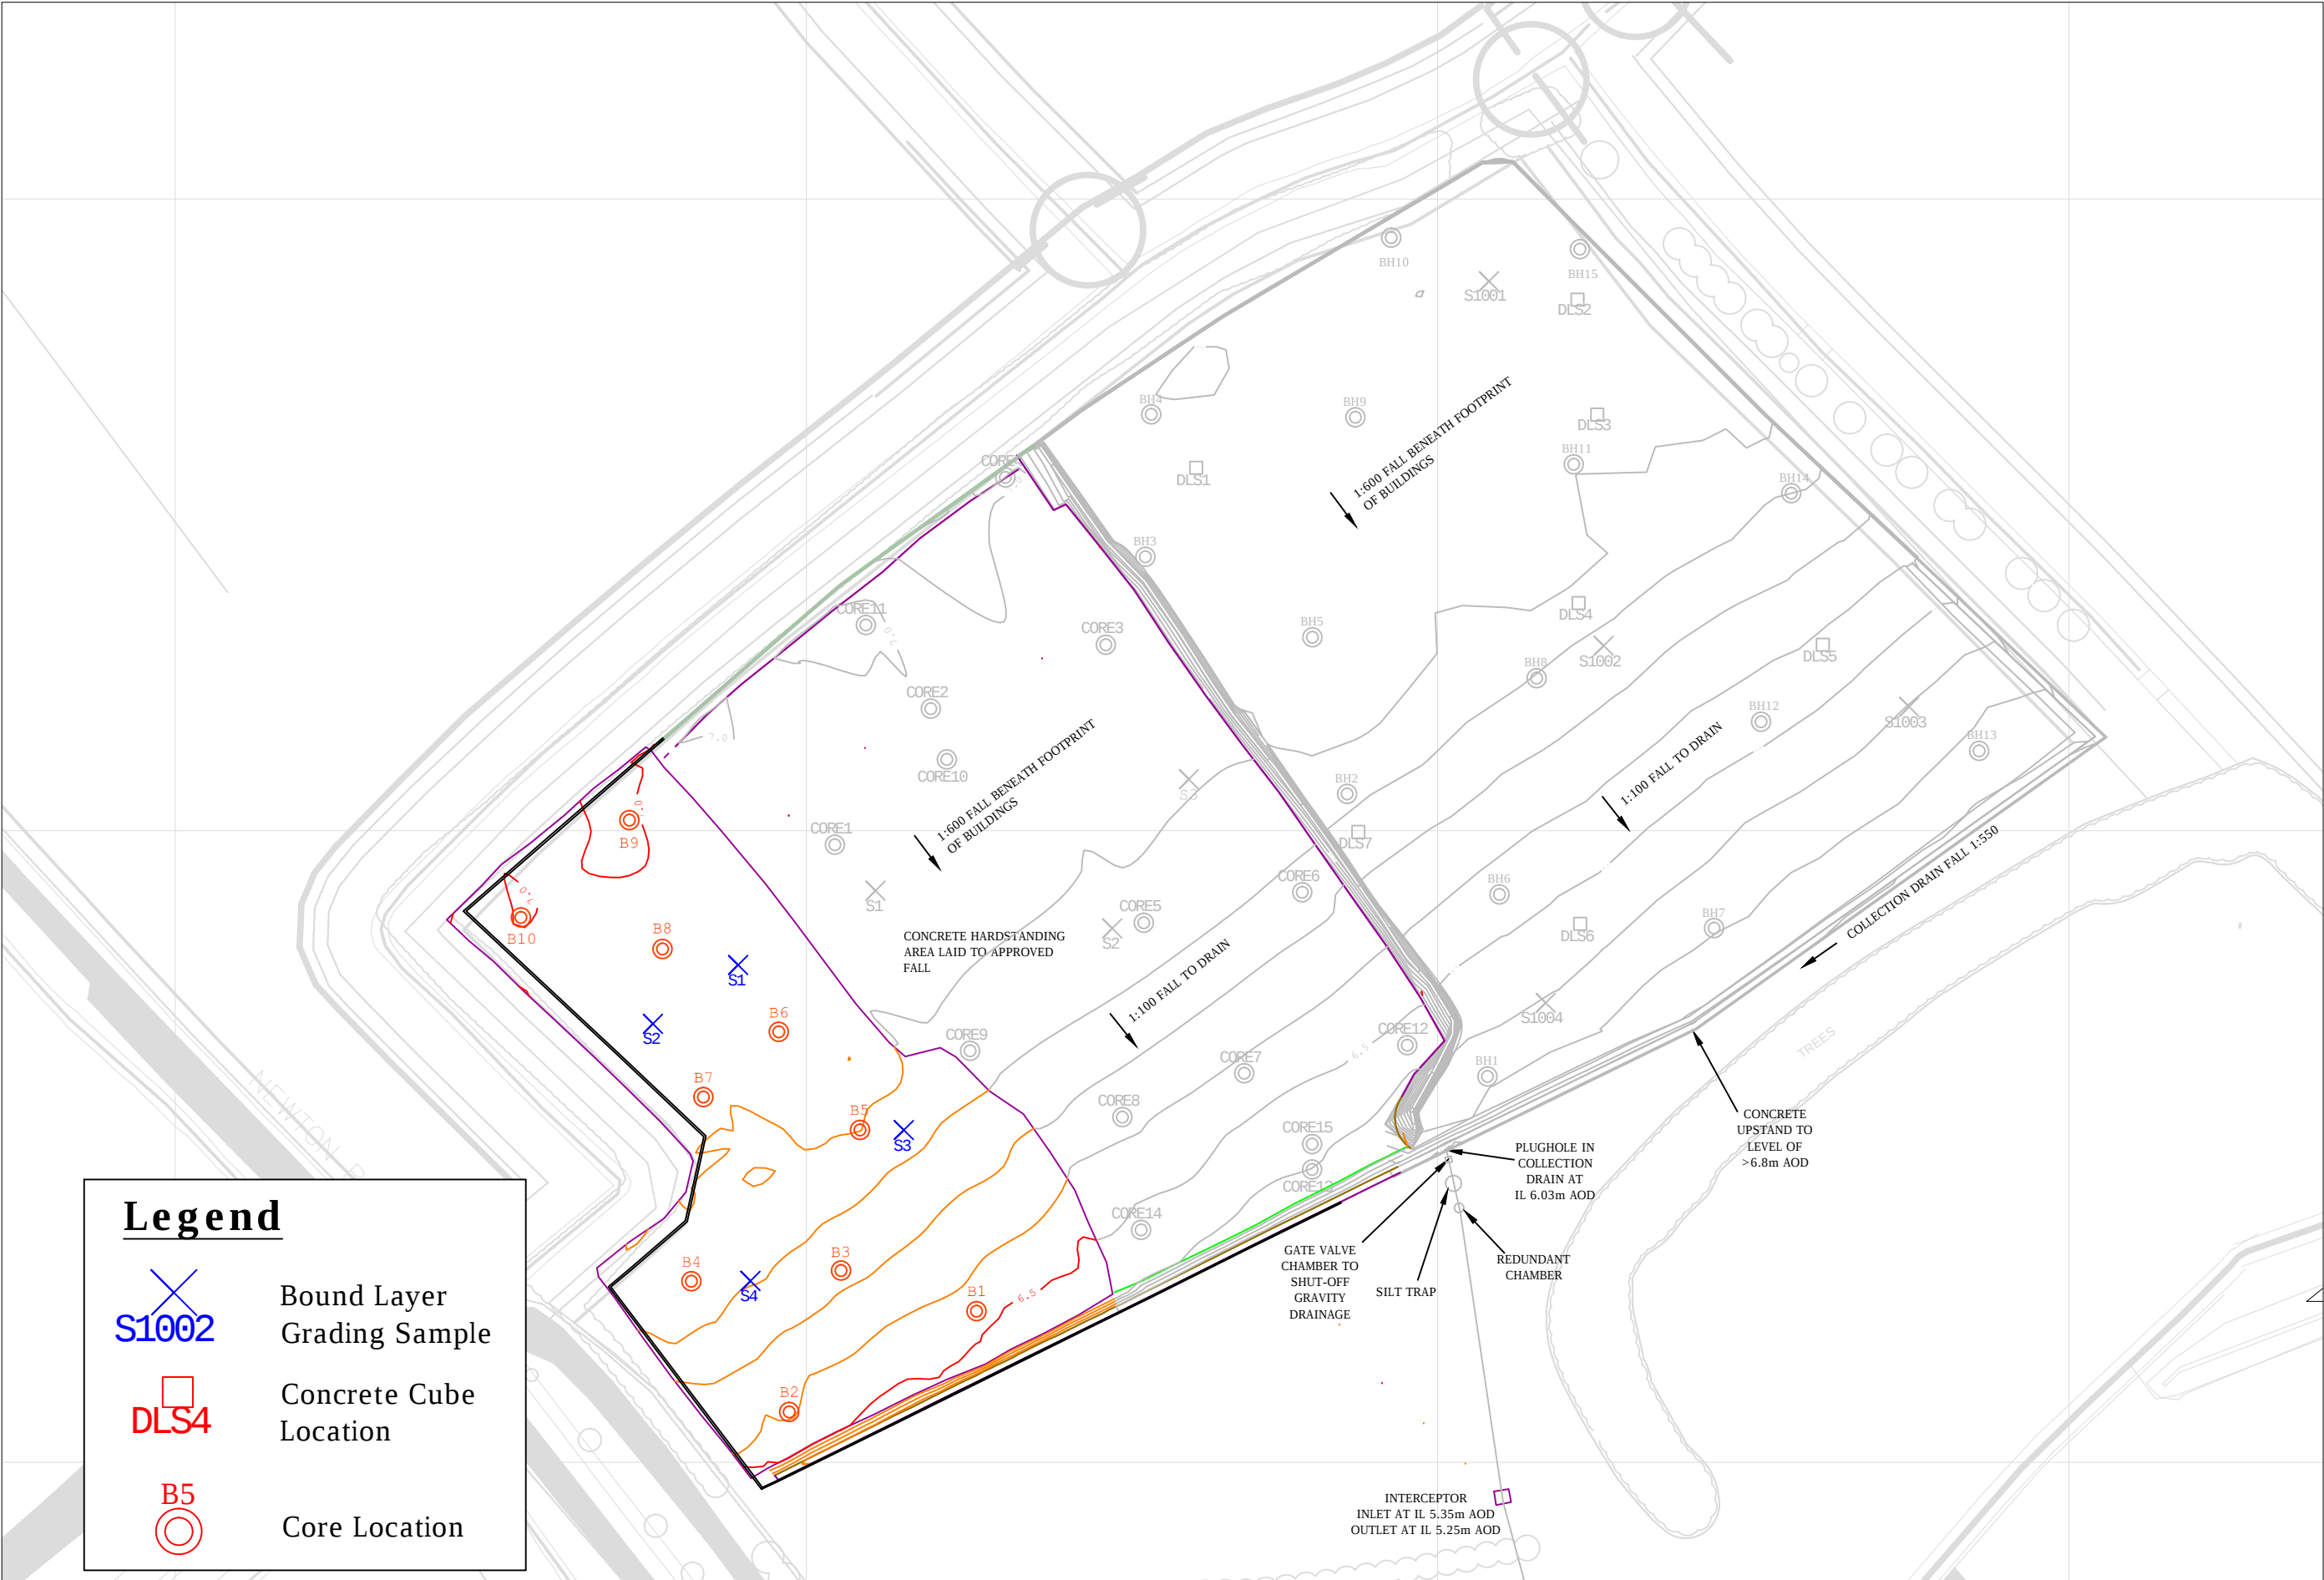
Figure 5 Final Topographic Survey of Slab with Bound Layer Testing Positions

Work was also carried out to connect the slab to the drainage culvert. This work was carried out by the principal contractor. In order to provide a continuous impermeable surface, it was first necessary to cut away a section of the slab which was only loosely bound in order to create a clean edge. This was achieved by first cutting a line with a disk cutter and then cleaning out the material between the newly cut edge and the drainage channel. All loose and excess material was removed by hand. Once this preparation work was complete the reinforcement bars protruding from the edge of the drainage channel were adjusted to the correct angle and concrete was poured into the gap. The concrete was then formed by Neal Soil Suppliers Ltd into a slope running from the edge of the slab into the drainage channel. This detail can be seen in Figure 5.

As part of the validation of the crushing process, 4 samples of crushed material were collected prior to mixing with cement powder. These samples have been sent to Apex Testing Solutions to be tested for particle size distribution. The positions of each of the samples are identified on Figure 5.

A final topographic survey of the slab and associated drainage details was completed on 16 December 2015 and is presented in Figure 5. In this figure it can be seen that the final surface meets the nominal designed fall of 1:600 on the northern section with a nominal 1:100 fall down to the drainage channel in the south. The headwall on the drainage channel and return has an elevation of 6.8mAOD allowing the slab to flood to that level when the shut off valve is closed. The northern edge of the slab is enclosed by a concrete kerb 200mm high and 300mm wide.
