**Silent Valley Landfill, Waste
Transfer Station**

Site condition report

2015/9363

Issue 1 | 17 April 2015

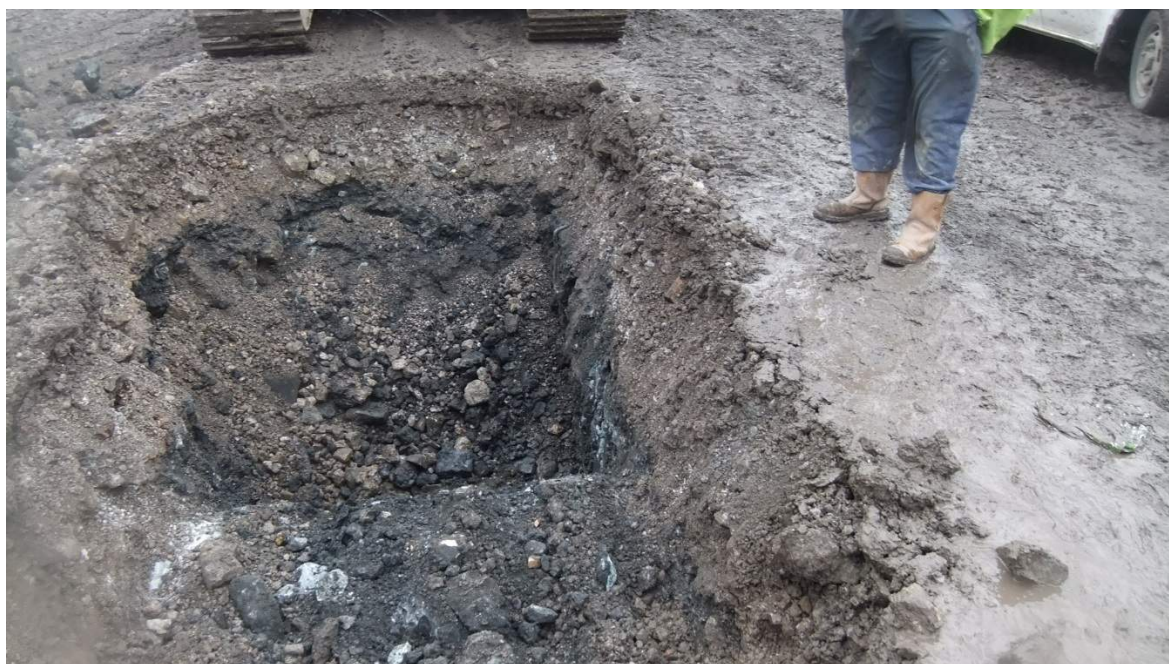
Photograph 1 – Trial pit TP1

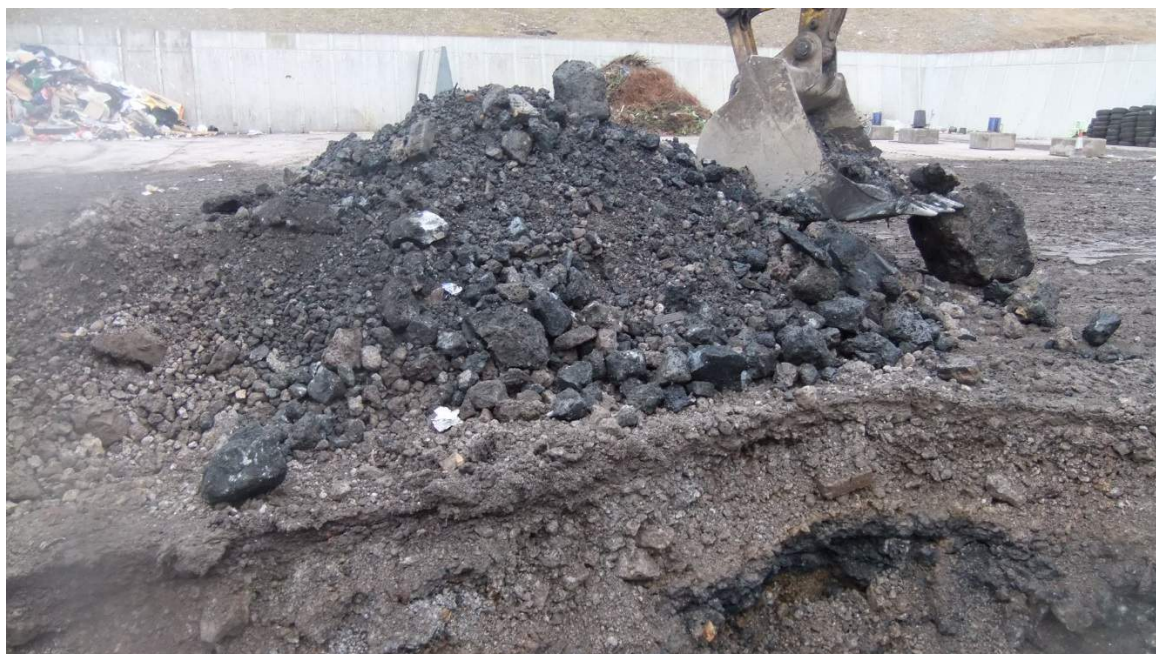
Photograph 2 – Trial pit TP1 (arisings)

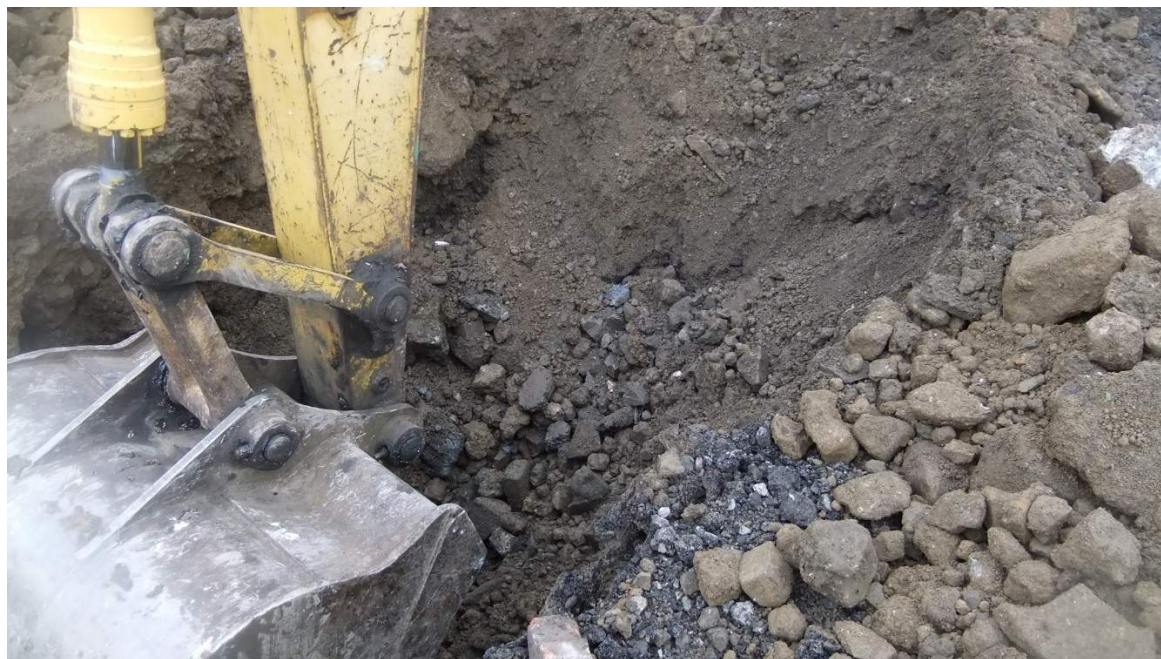
Photograph 3 – Trial pit TP2

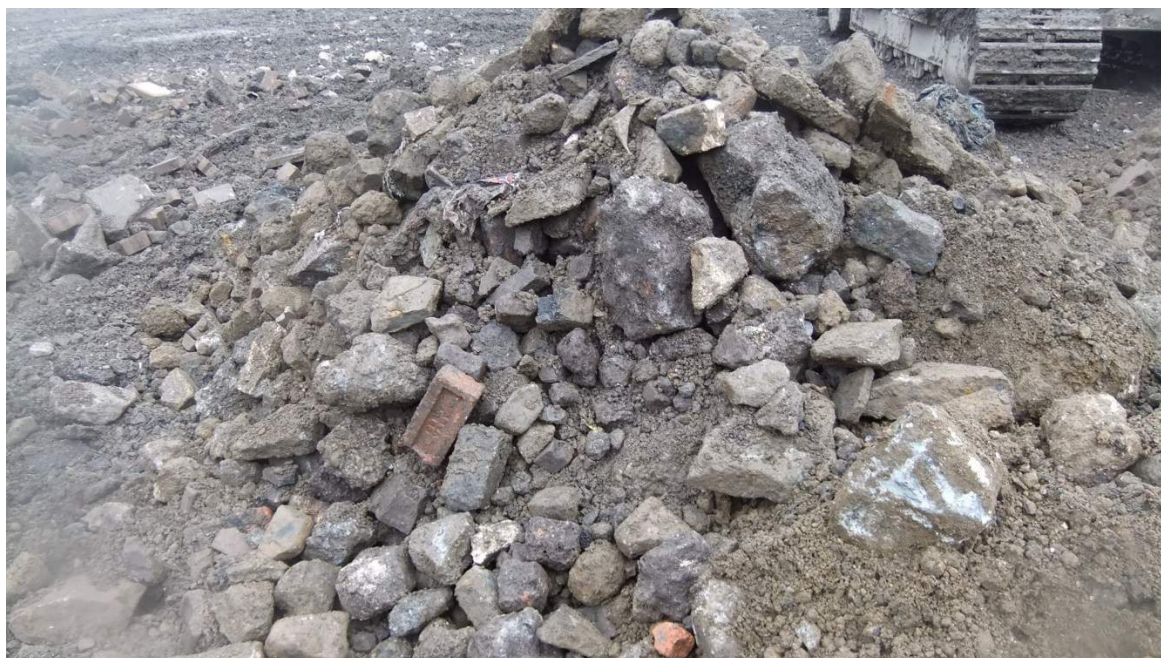
Photograph 4 – Trial pit TP2 (arisings)

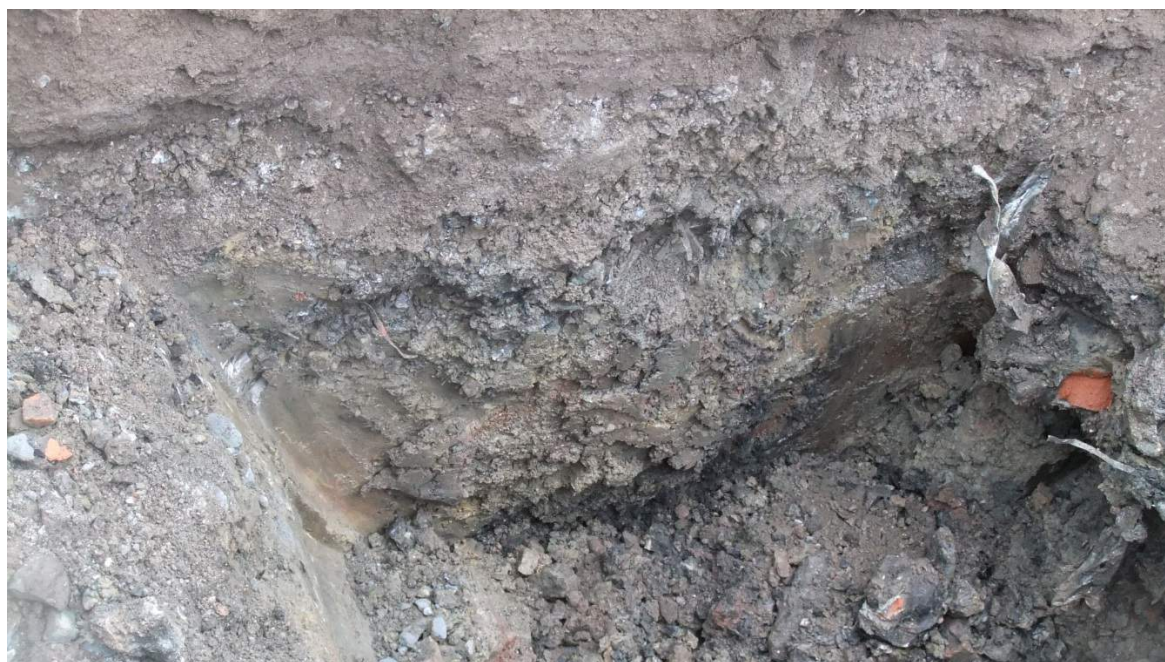
Photograph 5 – Trial pit TP3

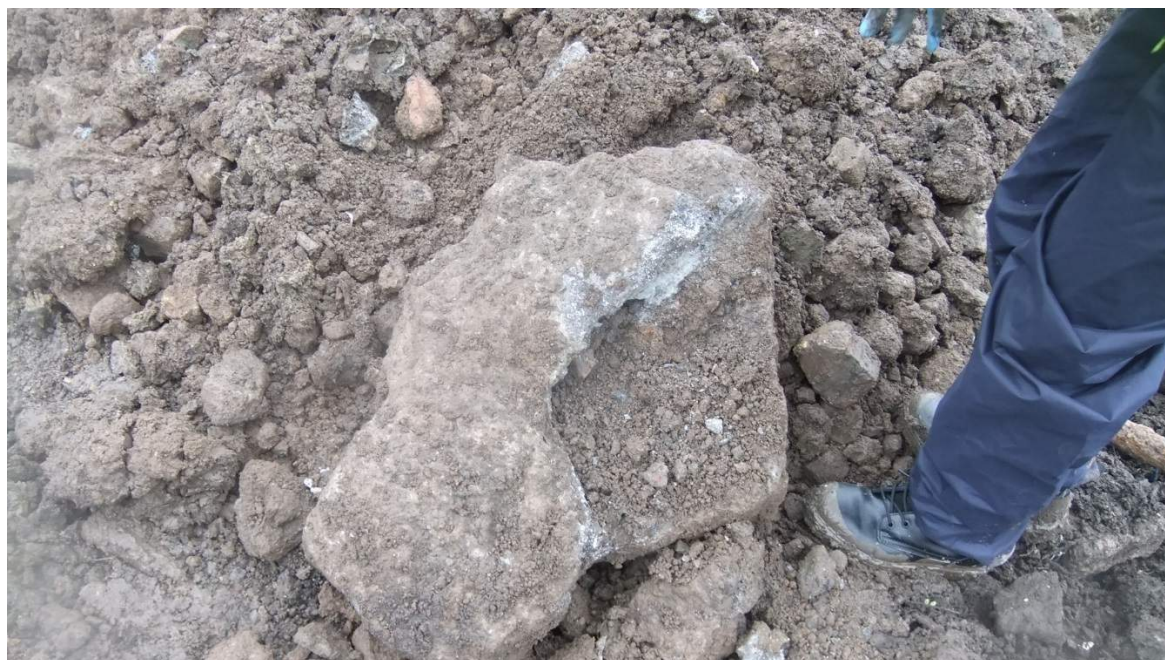
Photograph 6 – Trial pit TP3 (arisings)

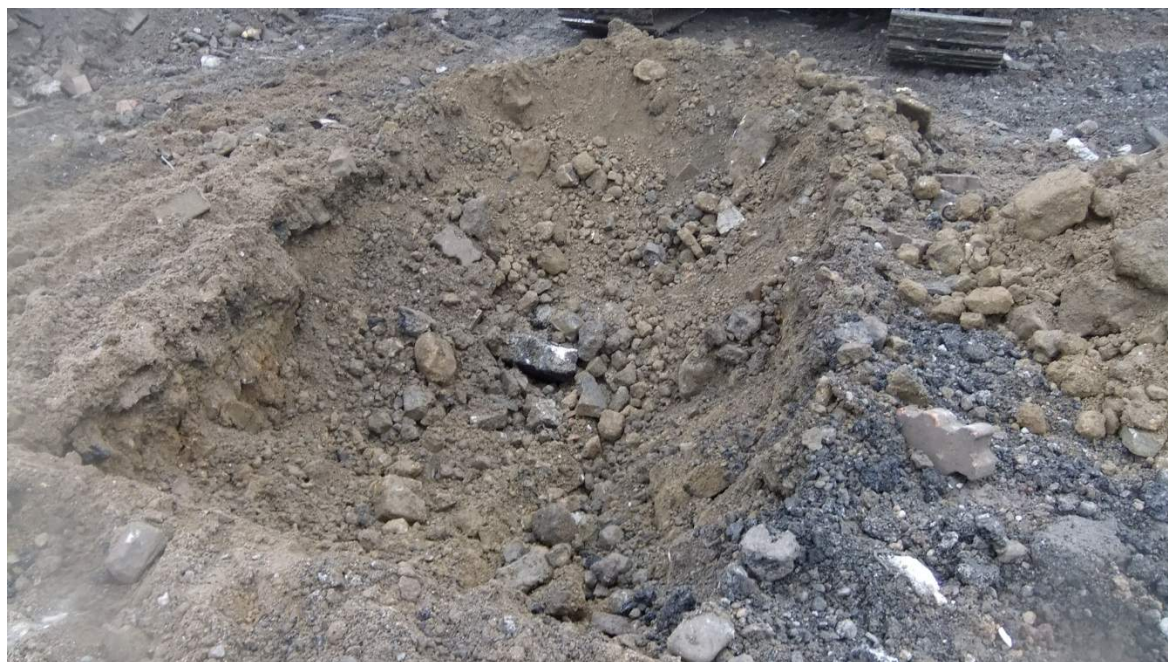
Photograph 7 – Trial pit TP4

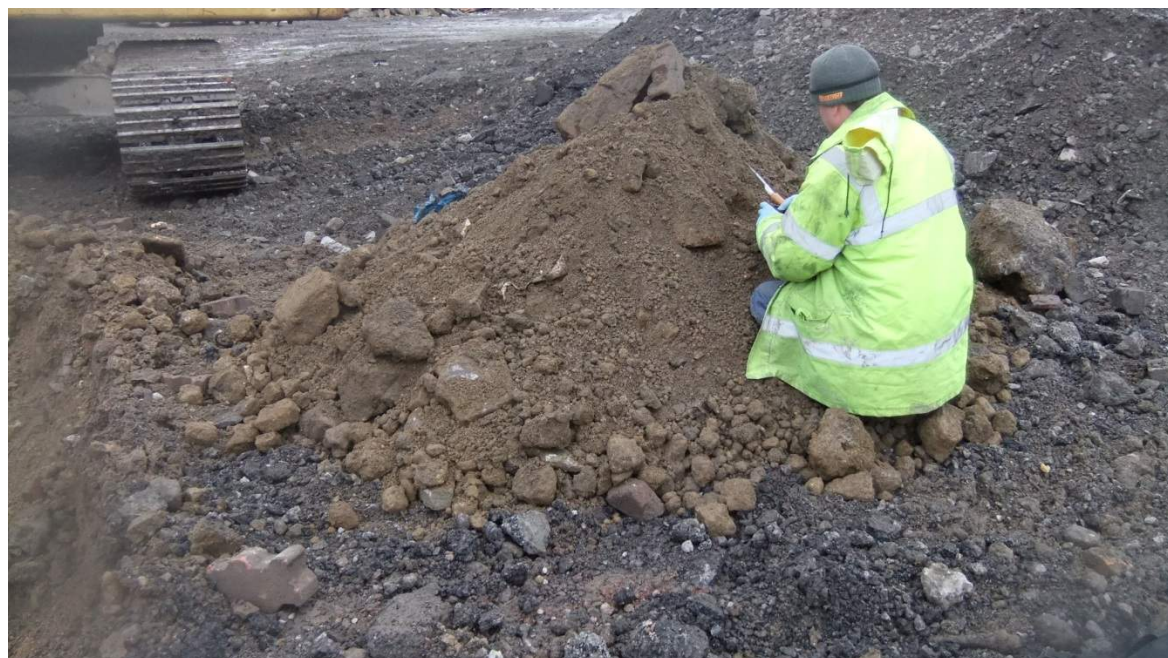
Photograph 8 – Trial pit TP4 (arisings)
