## Compliance Assessment Report

**Report ID:**  
**CAR\_NRW0032169**

| Site | Cross Hands EPR/BU8002IT | Permit Ref | BU8002IT | | |
| Parts of the permit assessed | 2.2.5.3 - Primary and secondary containment | | | | |

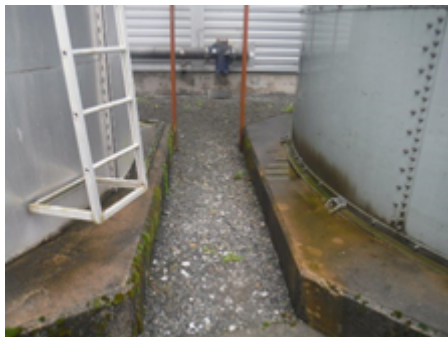
1. Sections of the bund floor adjacent to the hot and cold water tanks which are not impermeable, instead they are covered with chippings and it is unclear of the containment beneath these sections (See photo 1).

Photo 1 – Permeable surfaces around hot and cold water tanks

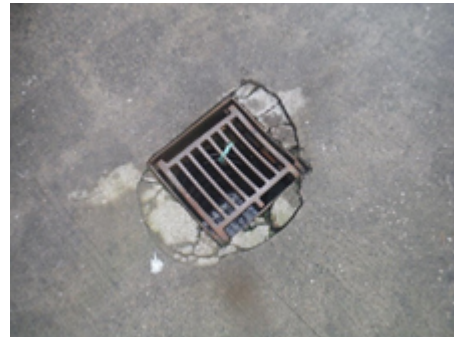
2. At least one drain point showed signs of deterioration. Dawn advised that the drain was directed back to the ETP process but it is the area around the drain which is questionable as to where any emission would travel through the bunded area (See photo 2).

Photo 2 – Cracks around drain in ETP bund

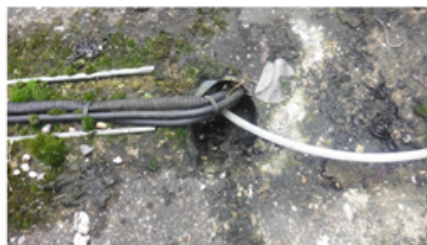
3. Electrical cabling connections transect the bund as they travel between the item of plant and the energy source. This will render the bund ineffective as there is a pathway through the cabling housing.

Photo 3 – cabling entering bund floor

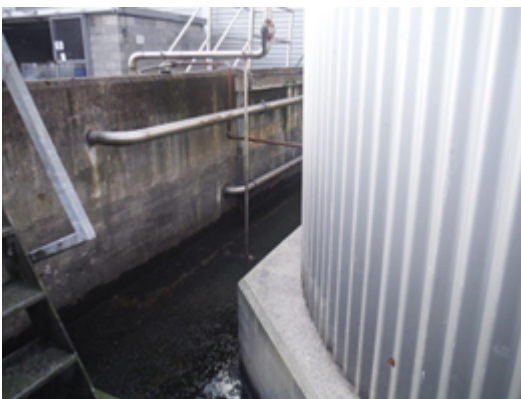
The specification of the bund was visually assessed as concrete but no other details were provided. There is pipe work which penetrates the bund and appears to be redundant. This too will influence the bund integrity. Pipework on the outside of the bund was evident and this too can pose a risk to surface waters if damaged unintentionally or chronic failure. The nature of this substance is expected to be highly viscose and is likely to have high a BOD property which will impact upon sensitive water bodies.

Photo 4 – Pipes penetrating the bund wall

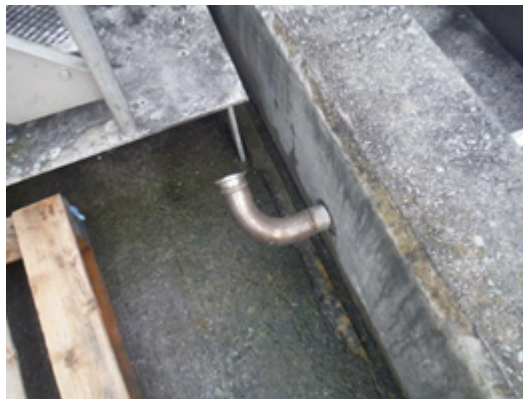
Photo 5 – redundant piping penetrating the bund
