Brookhill Landfill Site

Retro-Drilling of Leachate Wells

Construction Quality Assurance Report

November 2013

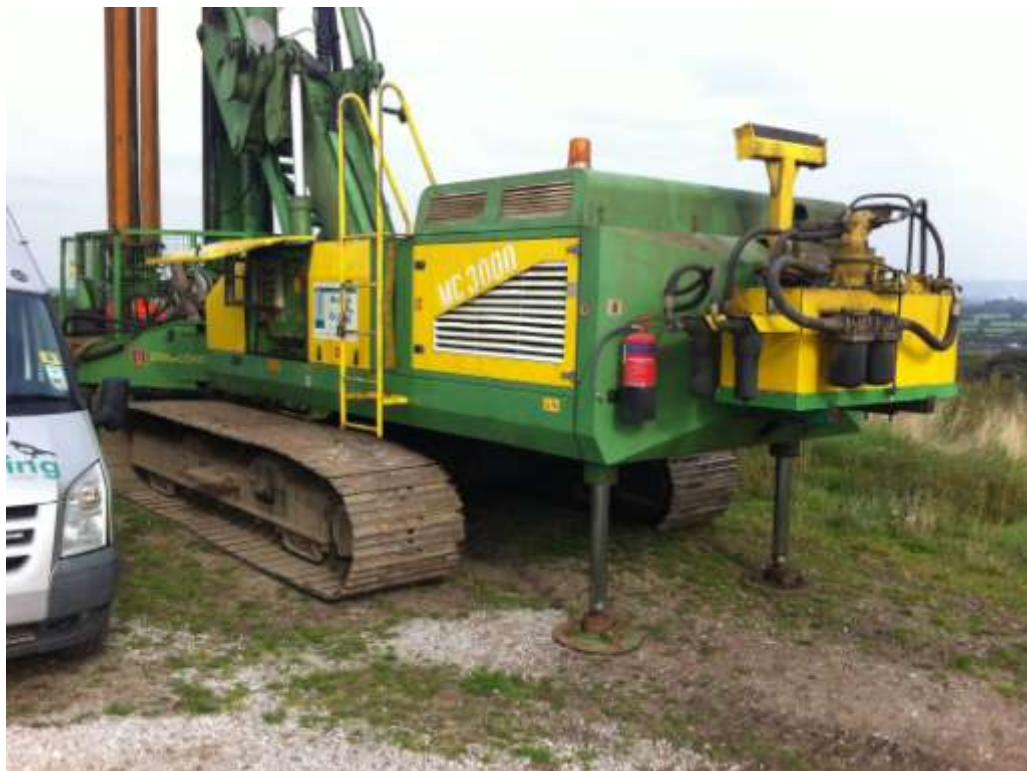
Plate 1

Plate No.	Description
1	MC3000 Drilling Rig.
2	Drilling in progress.
3	Discharging waste into dumper.
4	Installing casing and jointing.
5	Installing stone and measuring depth.
6	Installed hydrated bentonite.
7	Completed well showing bentonite and end-cap.
8	Evidence of drainage stone layer.
