**MORFA HAZARDOUS  
LANDFILL  
PORT TALBOT**

**PERMIT BW2692IM**

**2014 Annual Review of  
Environmental  
Monitoring Results**

*Report Number 1393r1v1d0215*

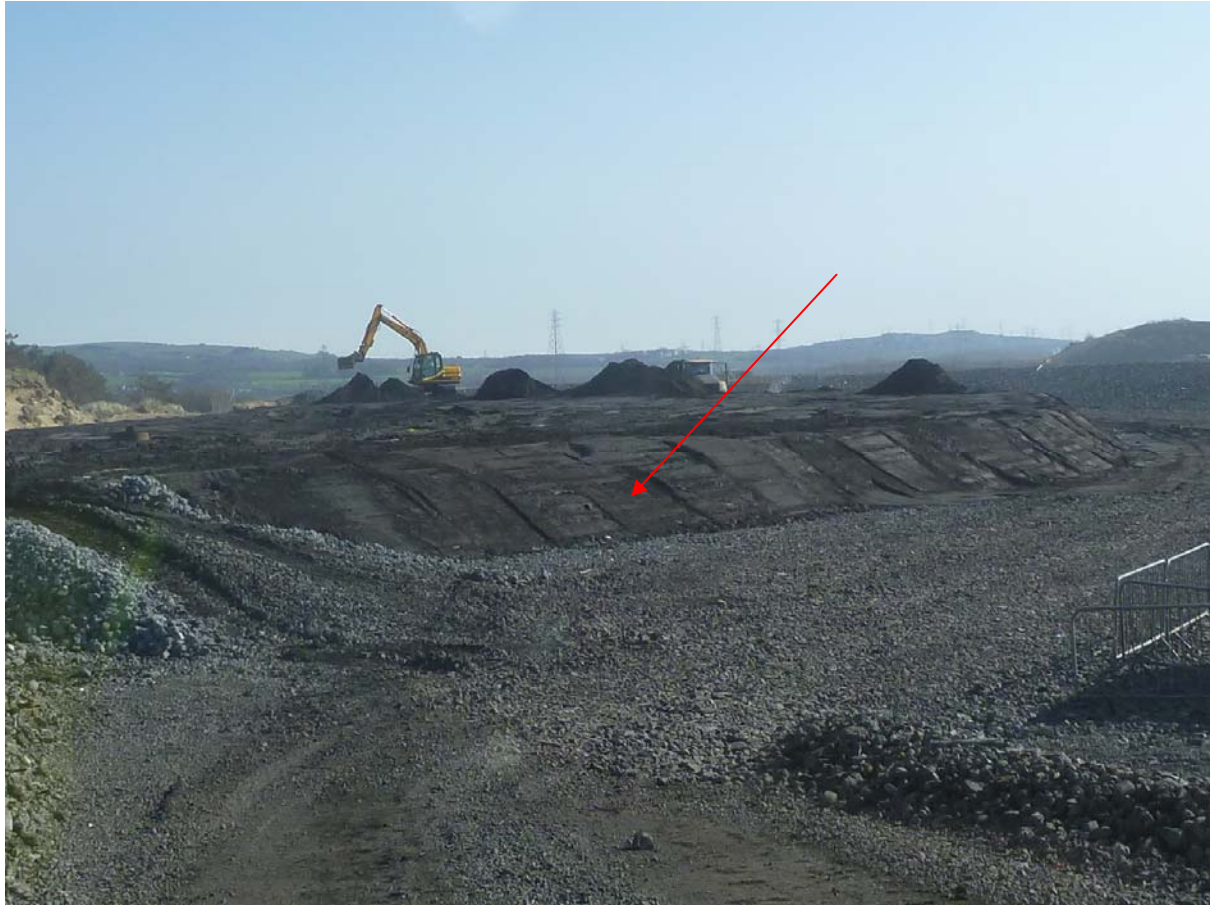
Photograph showing the fire deposit with a thick cover layer (arrow). Hazardous Landfill

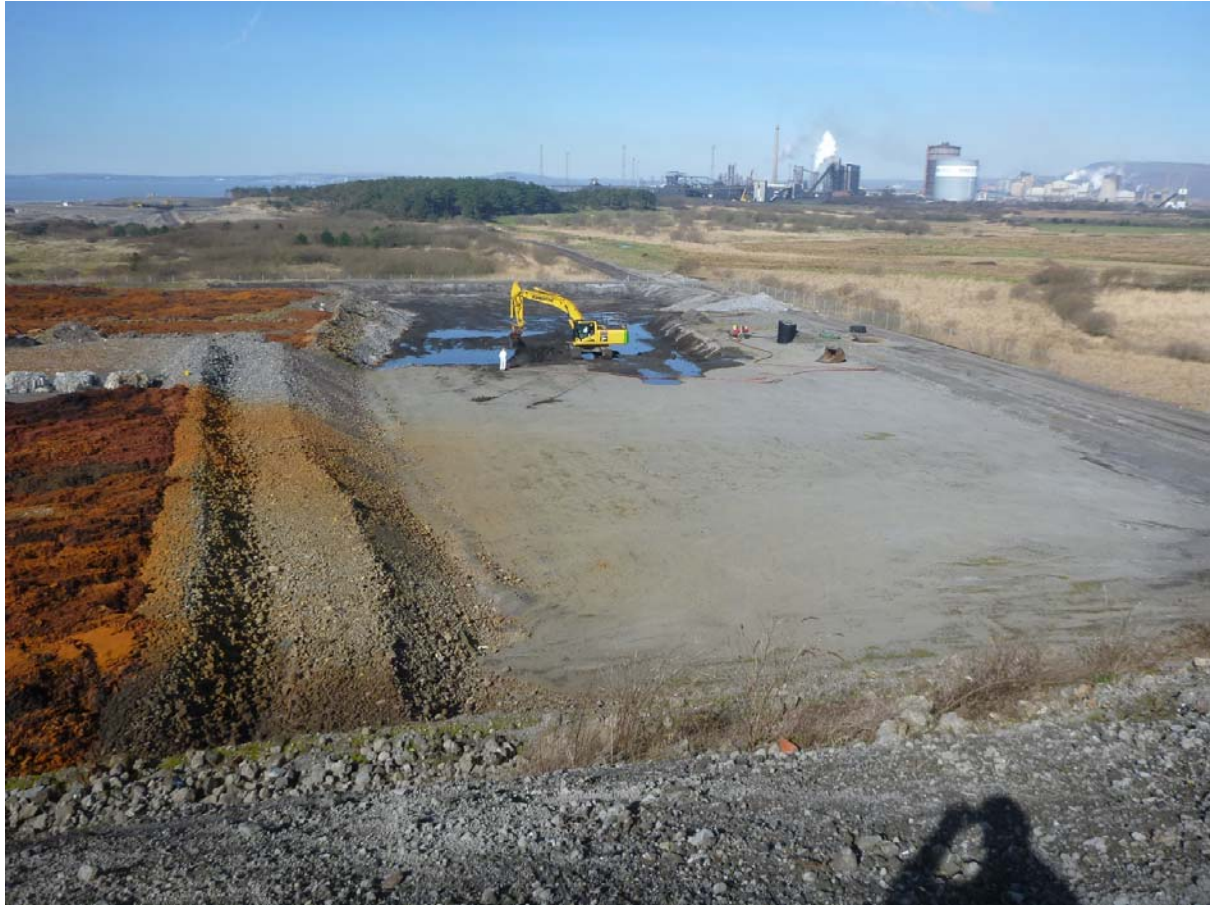
I observed the waste being carefully removed from the storage area in cell 2 and noted the presence of staff applying water to damp down the area under excavation. The work appeared compliant.

Fire wastes being carefully removed from the Non Hazardous cell for transfer top the Hazardous landfill
