## Compliance Assessment Report

**Report ID:**  
**CAR\_NRW0032017**

| Site | Nantycaws Landfill EPR/CP3735PB | | Permit Ref | CP3735PB | |
| Assessment type | Audit | | | | |

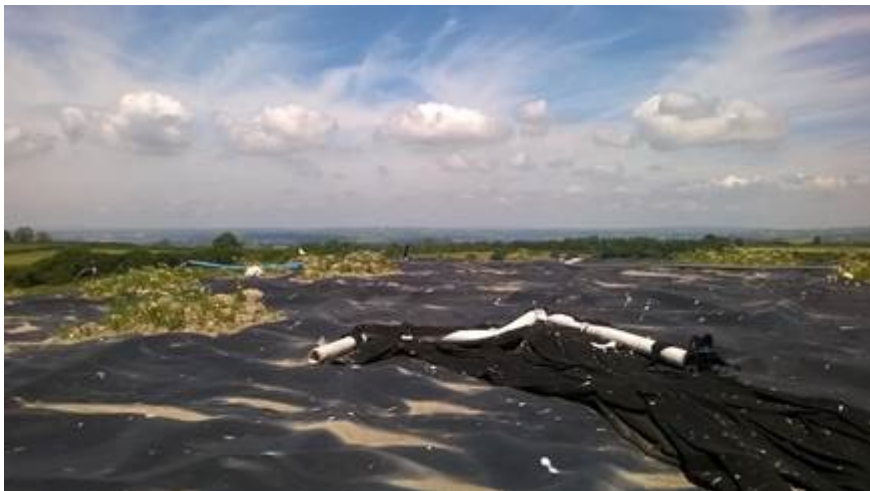
Pic 1. The tipping face of the current operational cell 7. The site has been temporarily capped off since Dec 16 and weighed down by 1 tonne piles of earth which have now sprouted vegetation. Seagull and pest activity was at a minimum at the visit and little to zero odour was observed coming from the landfill site.

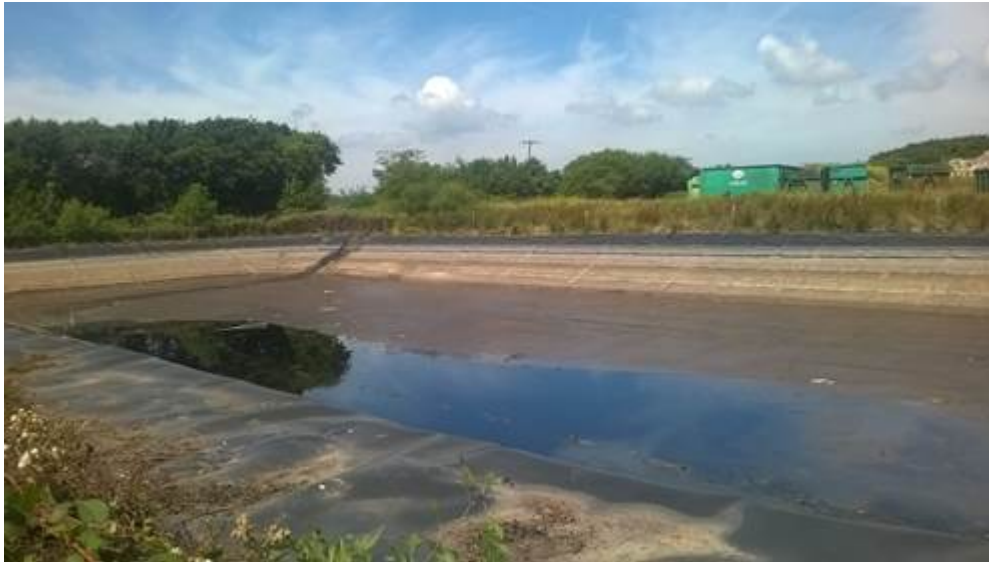
Pic 2. Site main leachate holding lagoon. At the time of the inspection the temperature was hot. No rain had occurred for several days resulting in the lagoon being nearly empty.

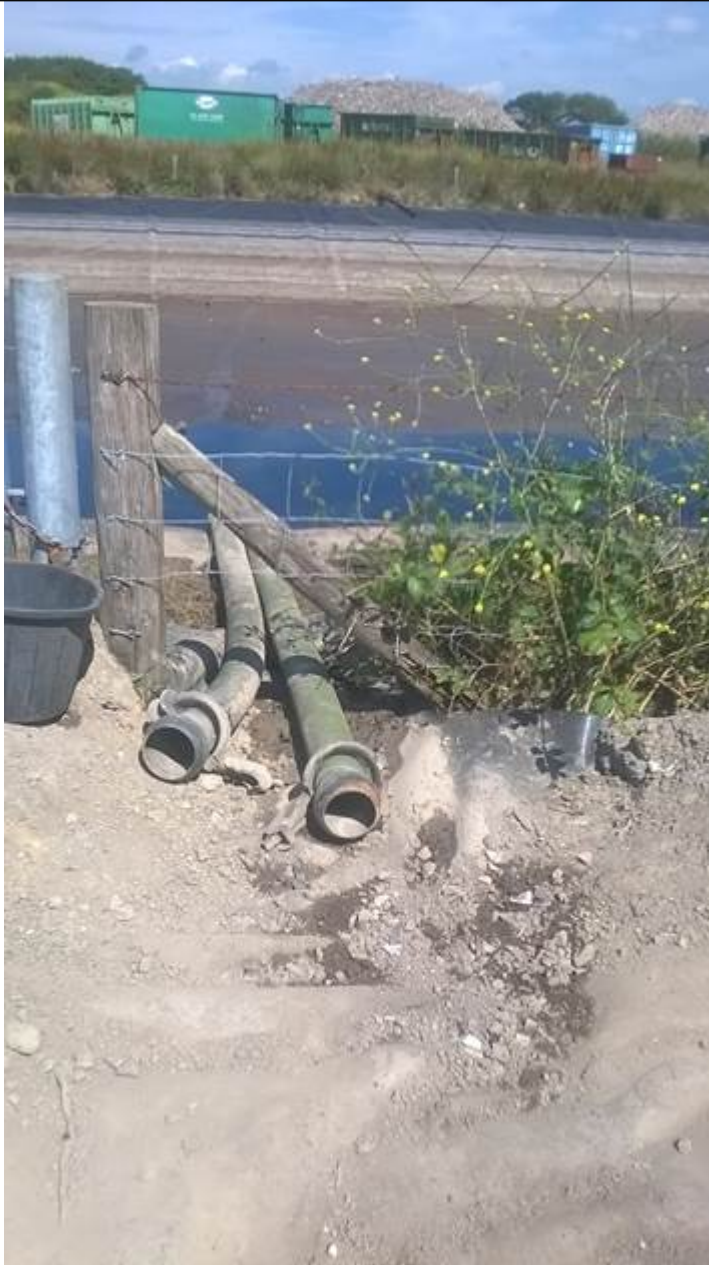
Pic 3. The tanker connection takes place within an engineered bowl which is geotextile lined and flows back to the lagoon. No spillage evidence was seen in this location and the system in place was robust.

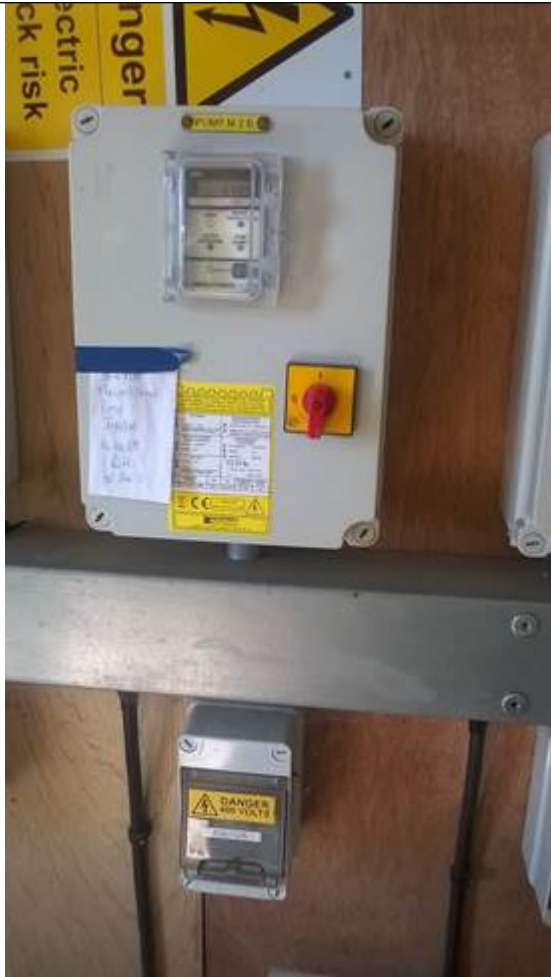
Pic 4. Cell 7 leachate pump control. This is one of 14 similar boxes located between phase 2 and 3. The boxes each log the hour of operation which form the basis of their scheduled maintenance regime. The power supply for the pump control house is via an external generator which is run off diesel which uses approximately 300 litres of diesel per week. Site have previously conducted a feasibility study to run this operation off grid electricity but on balance the generator option is preferred at present.

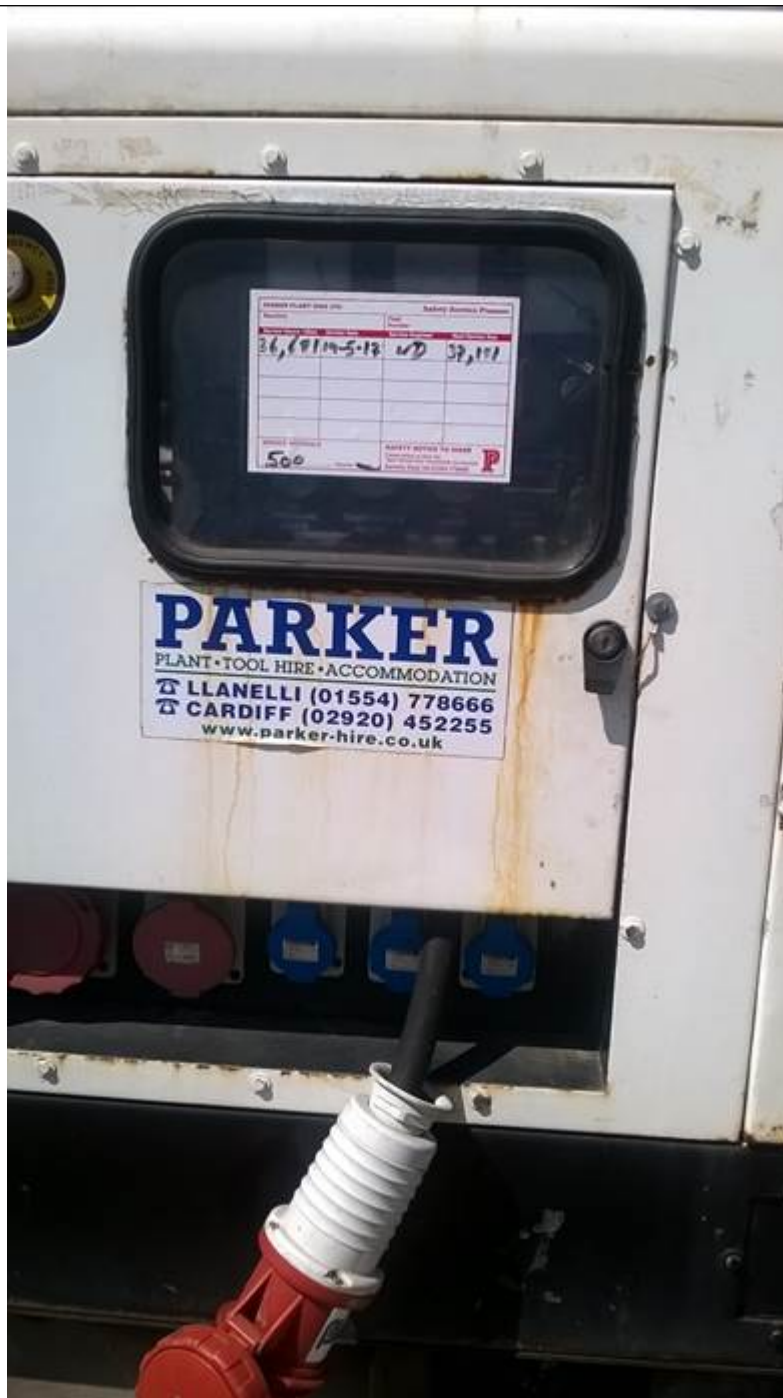
Pic 5. External diesel generator to the leachate pump house. This is filled on a weekly basis and uses approximately 300 litres of diesel per week. Service schedule and hours run are shown on the service window. Site needs to ensure that this essential piece of equipment remains within the service schedule. Lack of maintenance on essential equipment constitutes a permit non-compliance to condition 2.3.5 where ***all plant and equipment used in the permitted installation, the failure of which could lead to an adverse impact on the environment, shall be maintained in good operating condition.***

Note the service schedule requires the generator to be serviced after 500 hours running. This is 20.8 days of constant running. The day of the inspection was 6<sup>th</sup> July – and the last service was 19<sup>th</sup> May – some 47 days after the last service. The time difference suggests that the next service may be imminent.

Therefore to ensure compliance is met site are required to provide information on the hours run by the next service of this generator.

**Action – Site to confirm scheduled service of this generator remains within the service schedule.**

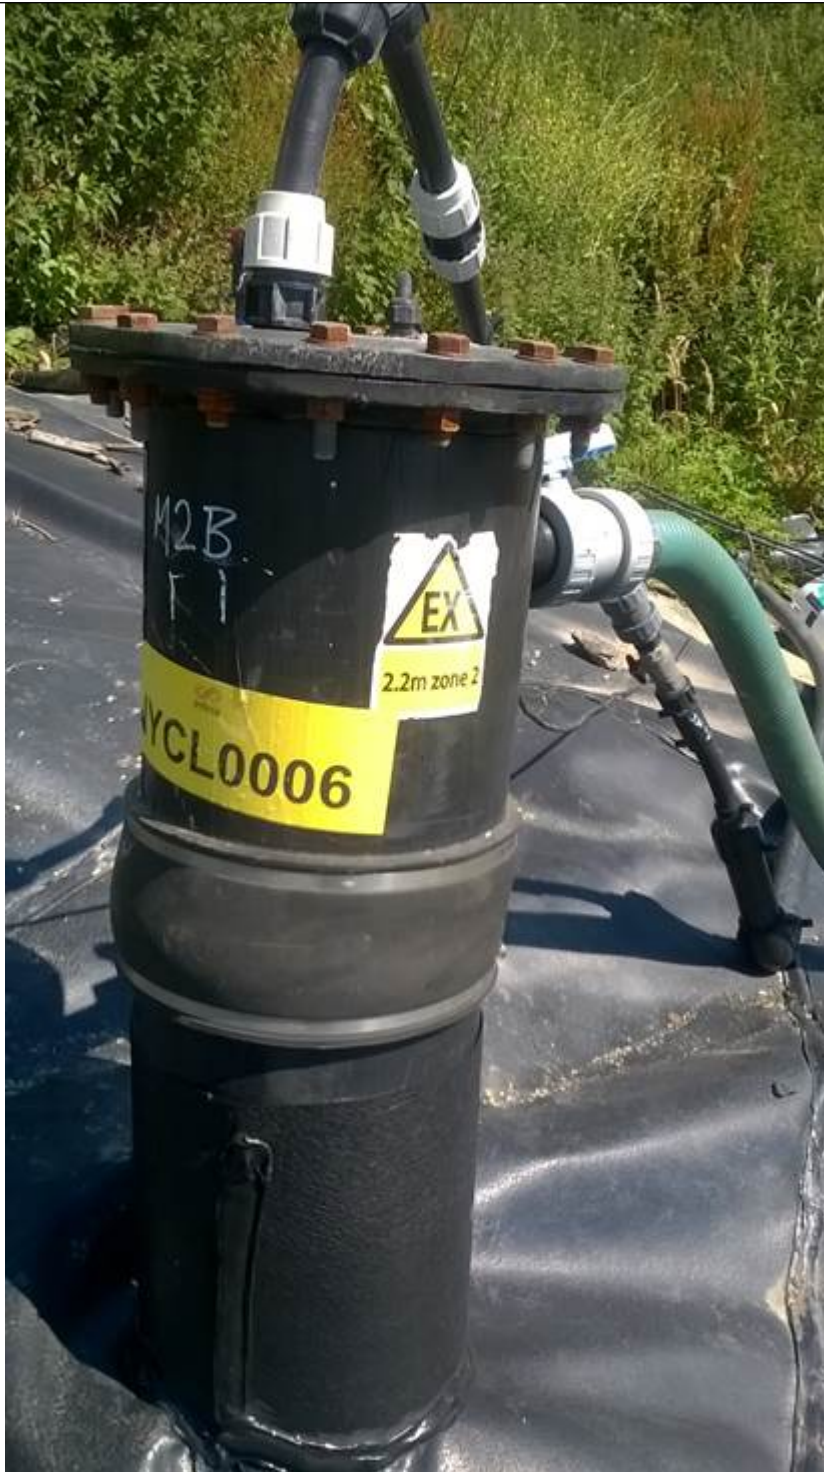
Pic 6. M2B leachate well reacts to the rising leachate level and pumps off the excess to the main holding lagoon. The well pump is powered by an electricity junction box.

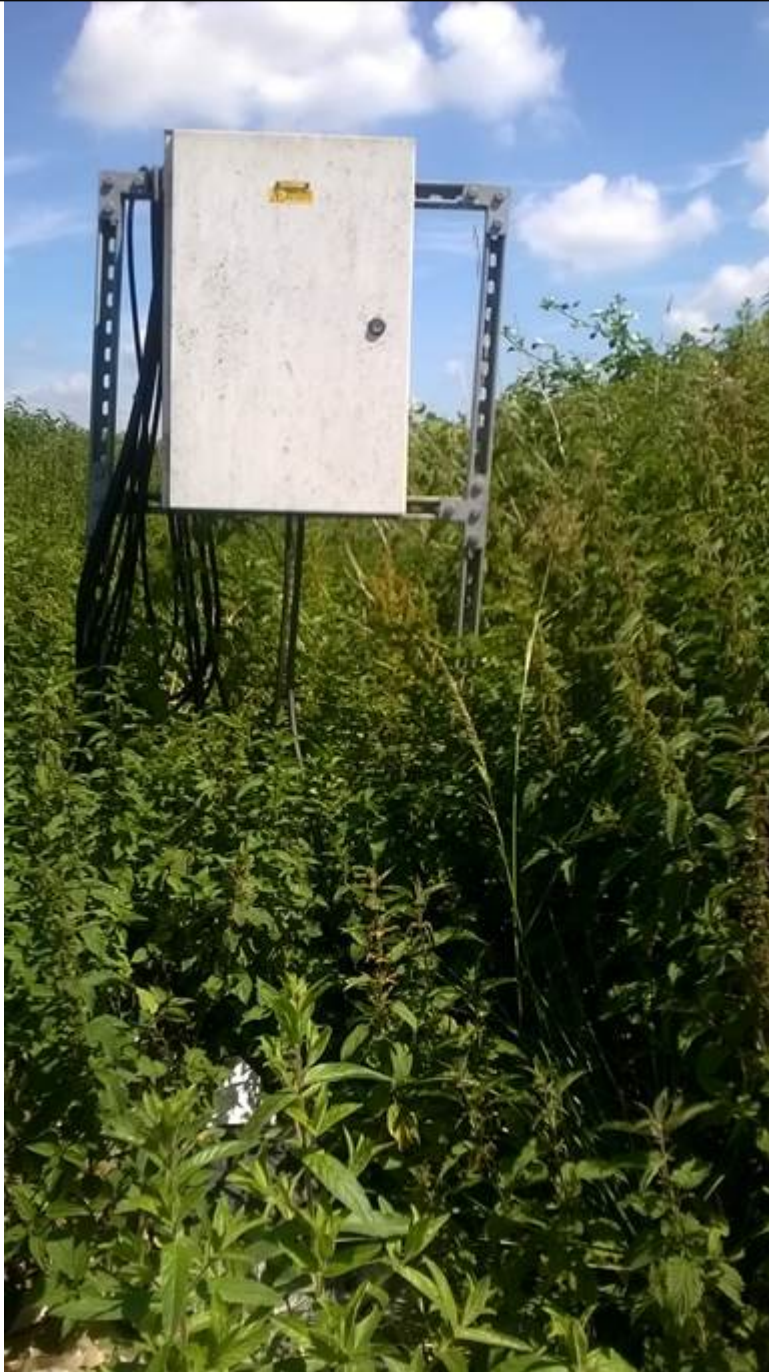
Pic 7. M2B electricity junction box. Site needs to ensure that access remains open to site infrastructure by clearing back the obstructive vegetation.

Management needs to remain vigilant in the maintenance of infrastructure notably vegetation blocking access to monitoring equipment.

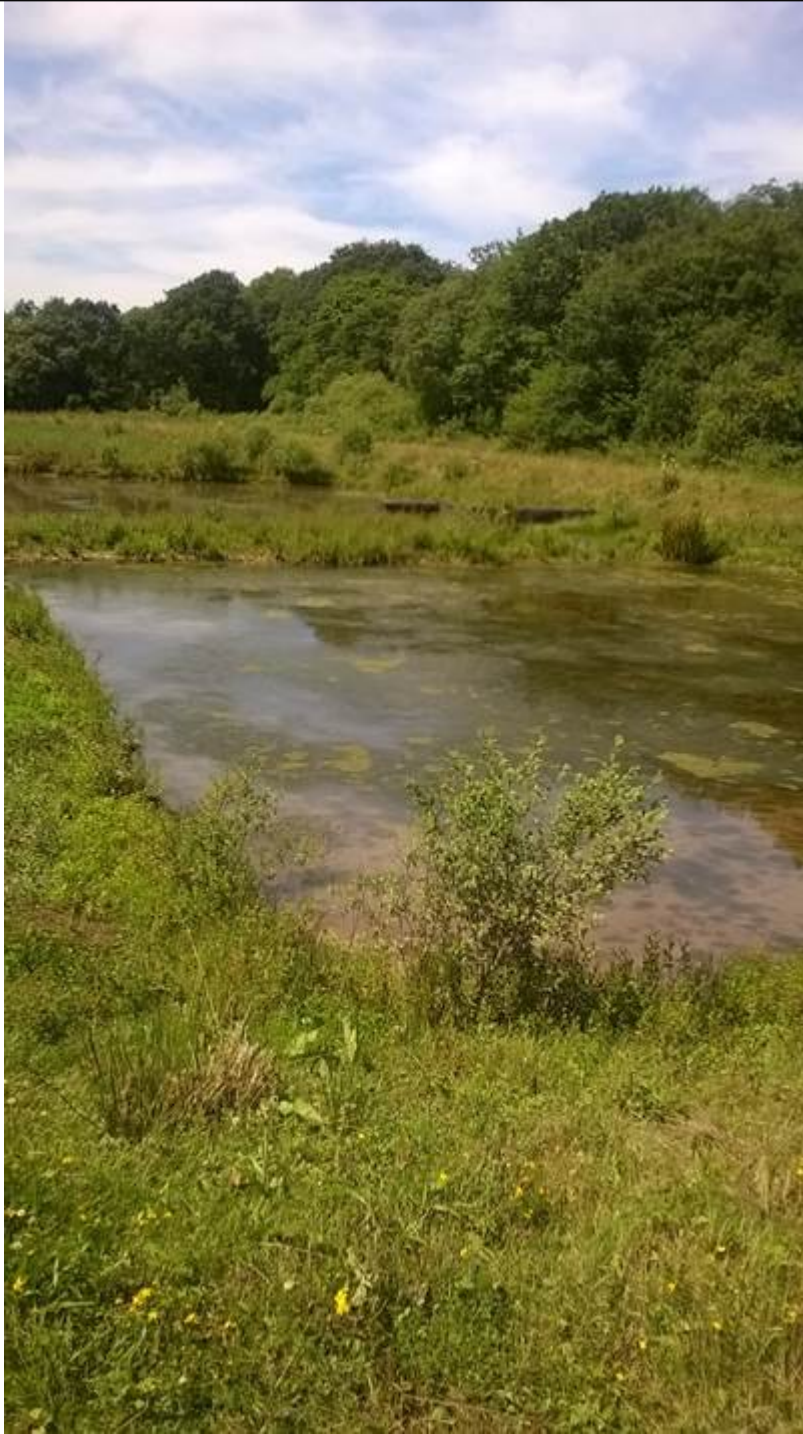
Pic 7. Surface water ponds drain site at the SW corner of the site. Access to the site showed signs of vegetation control.

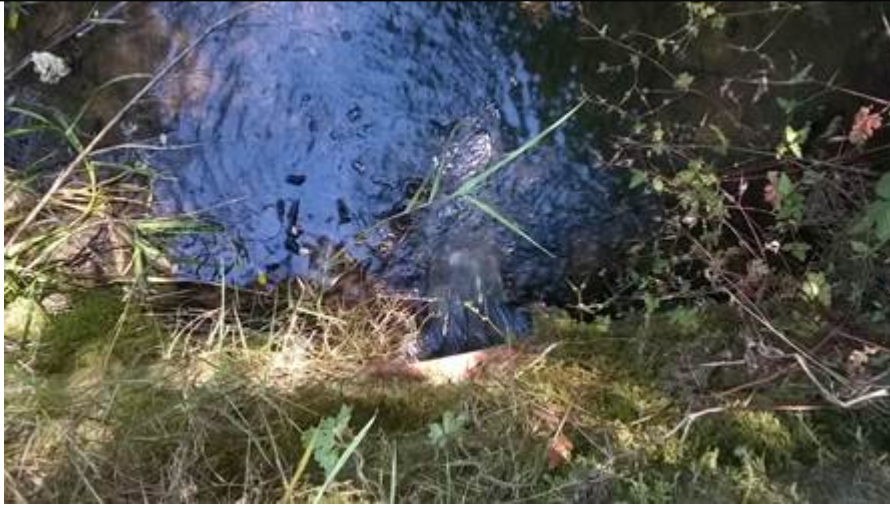
Pic 8. The water flows out of the lagoon into a tributary of the afon y bantwen. At the time of the inspection flows were constant and clear without odour.
