**MORFA NON HAZARDOUS  
LANDFILL, PORT TALBOT**

**PERMIT BV7311IE**

**2014 Annual Review of  
Environmental  
Monitoring**

*Report Number 1392r1v1d0215*

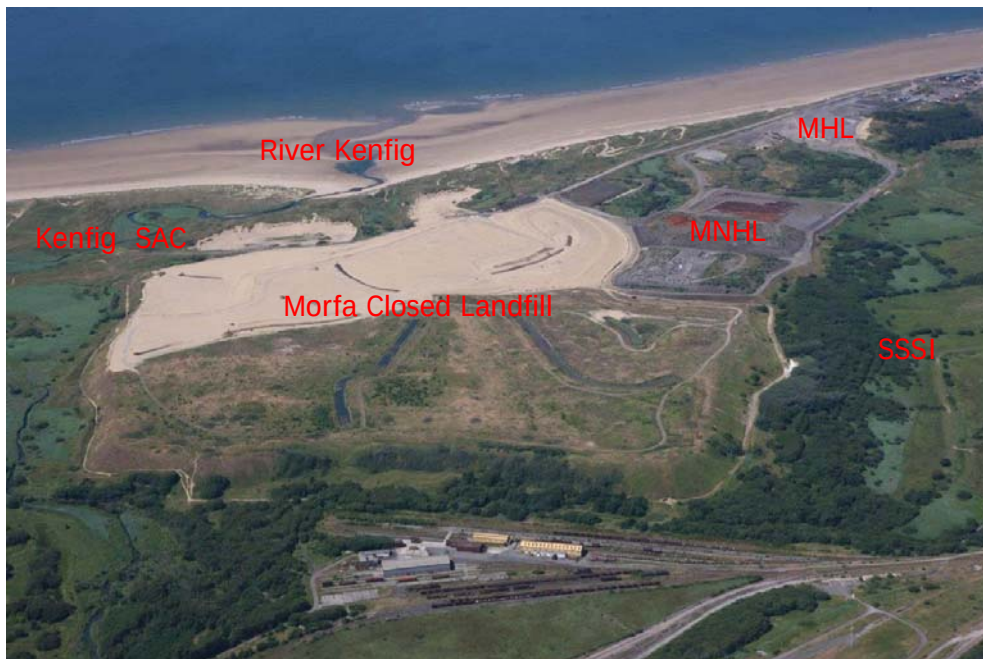
**Aerial view west over site. Note recently restored areas on MCL**

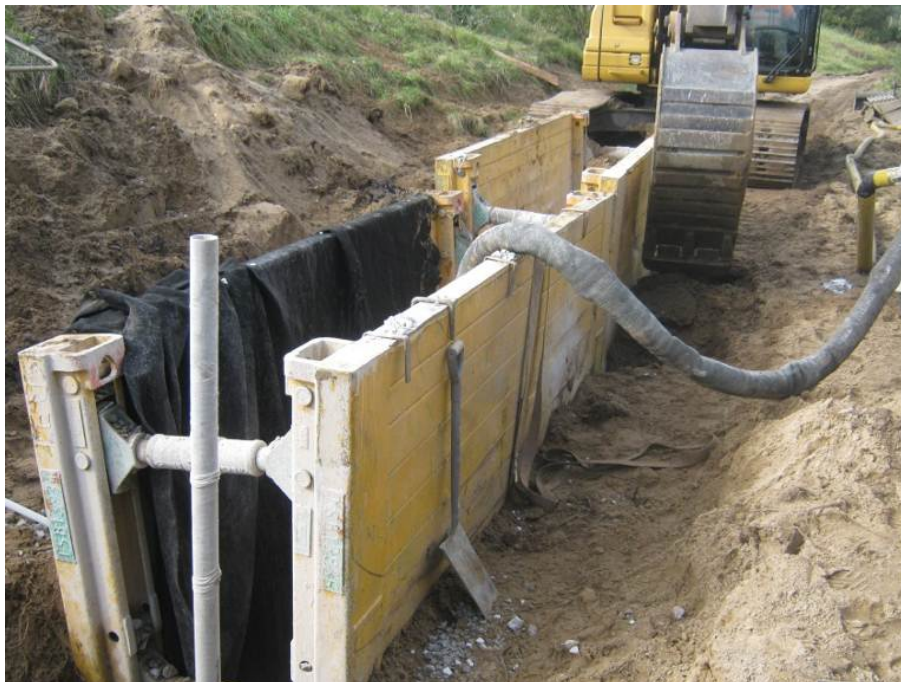
During 2013, a recharge trench system was partly constructed as shown in the photograph below. Ultimately, the trench is designed to capture rainfall from the capped areas and direct it along the boundary with Margam Moors.

**Construction of Recharge Trench**

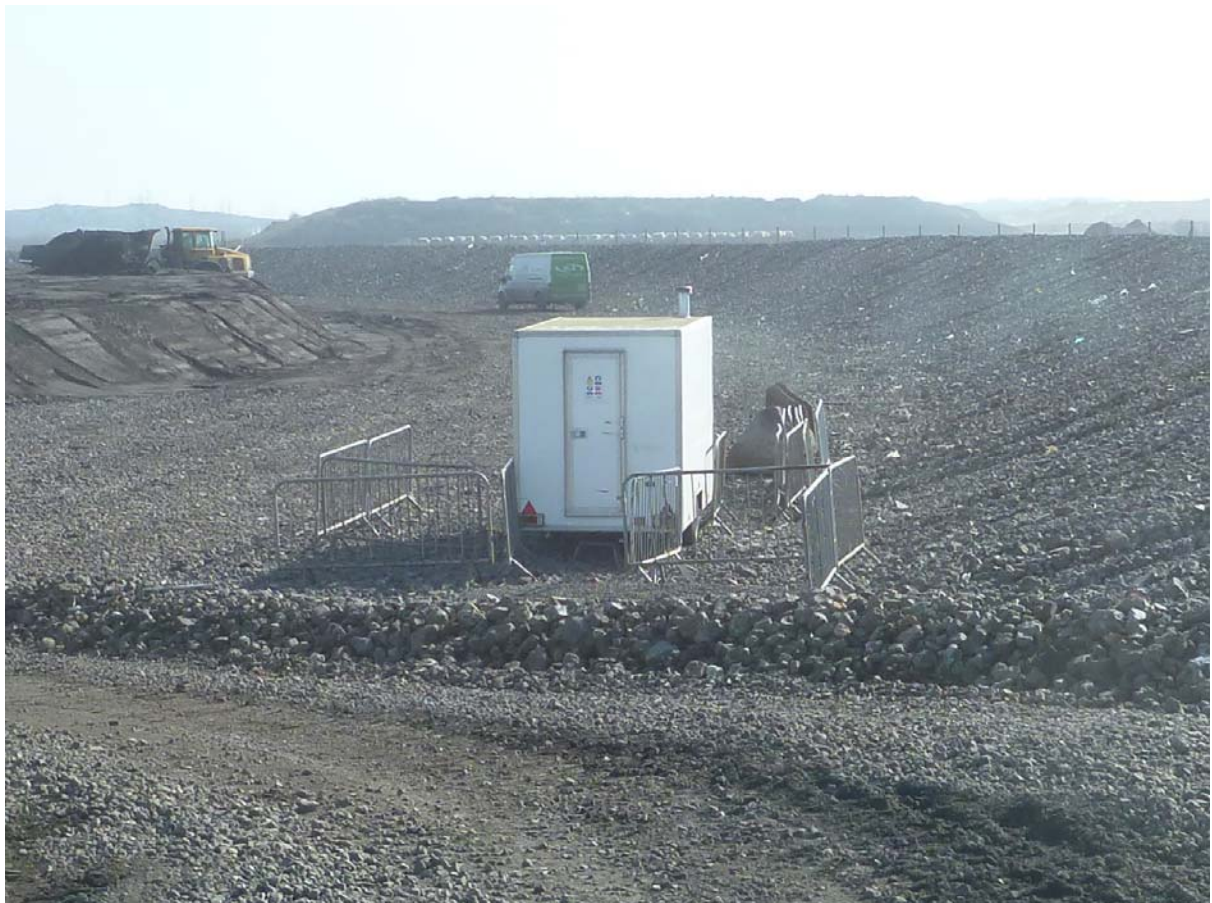
Asbestos decontamination unit.

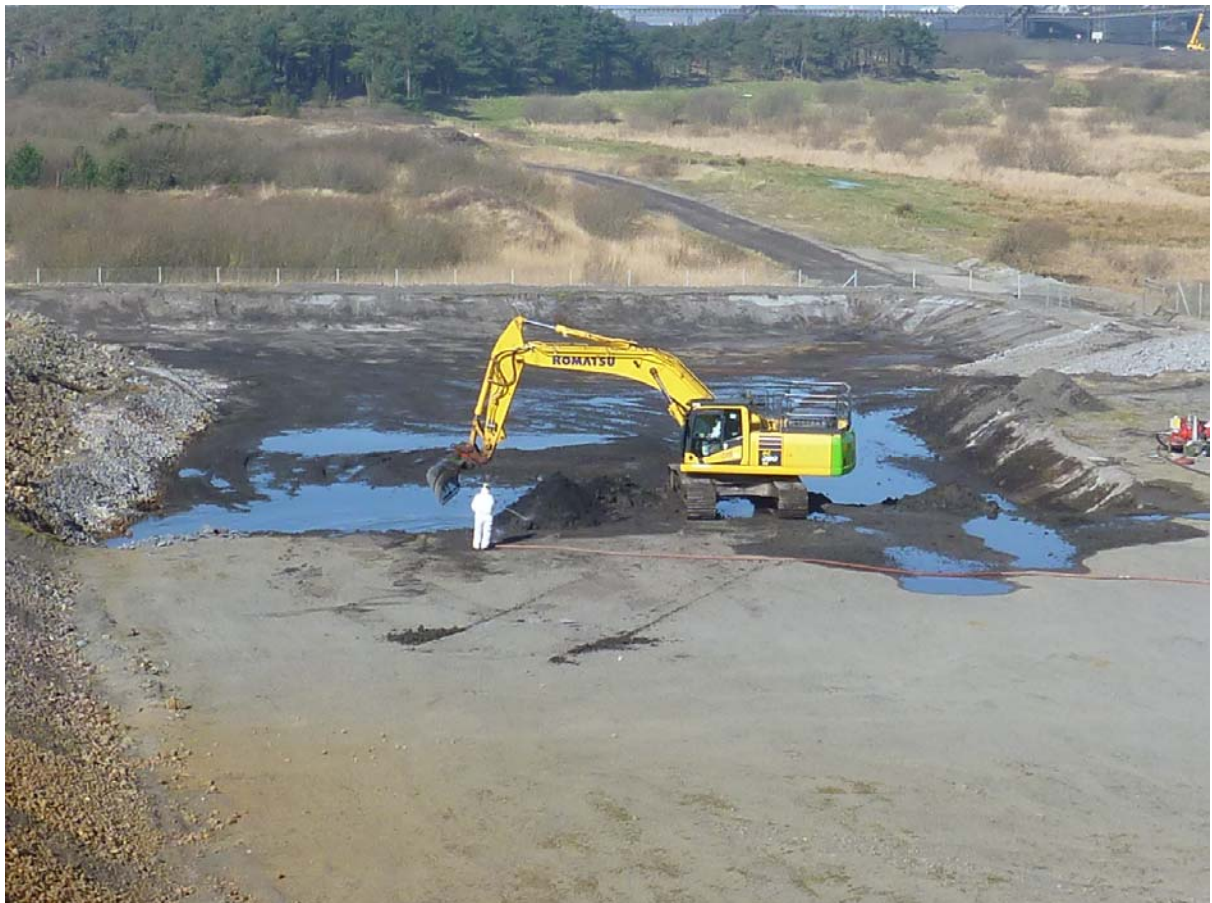
I observed the waste being carefully removed from the storage area in cell 2 and noted the presence of staff applying water to damp down the area under excavation. The work appeared compliant.

Fire wastes being carefully removed from the Non Hazardous cell for transfer top the Hazardous landfill
