HANSON CEMENT

Acoustic Camera Assessment of Site Noise Levels

Padeswood Works, Flintshire

MAY 2013

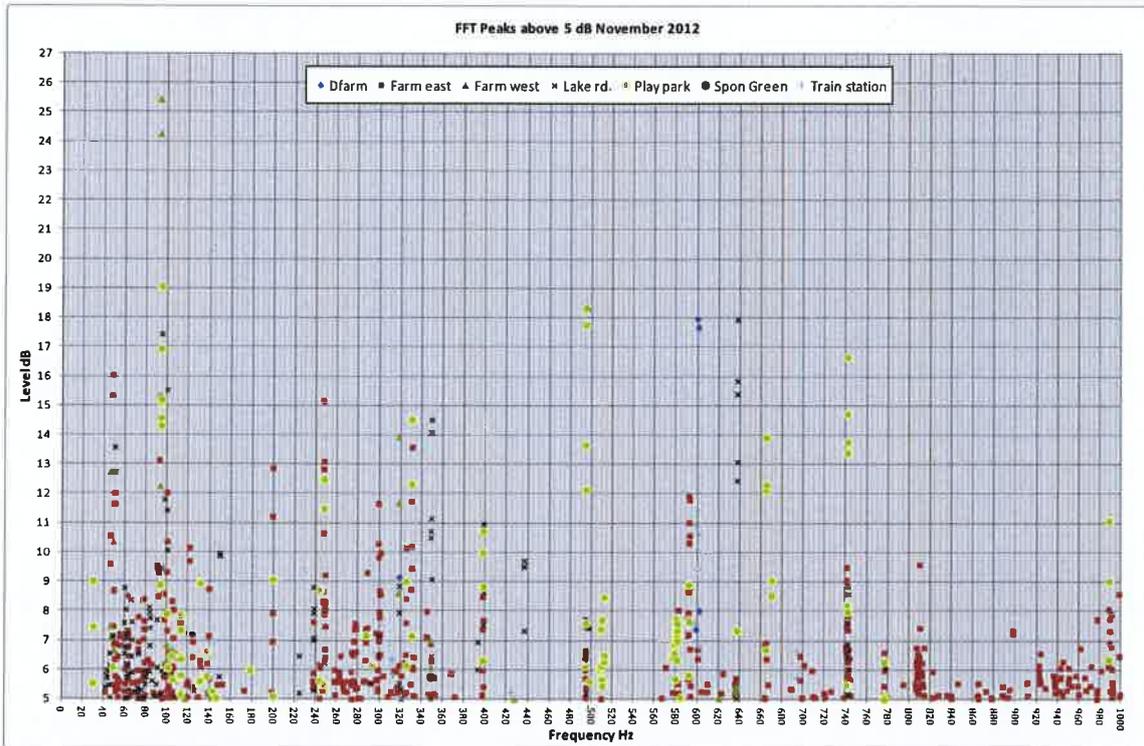
Receptor FFT Measurements November 2012

Measurements were taken during the night of 7th-8th November 2012. The weather conditions at the time of measurement were still at ground level with a slight breeze blowing stack gas the east towards the centre of Pen-y-ford.

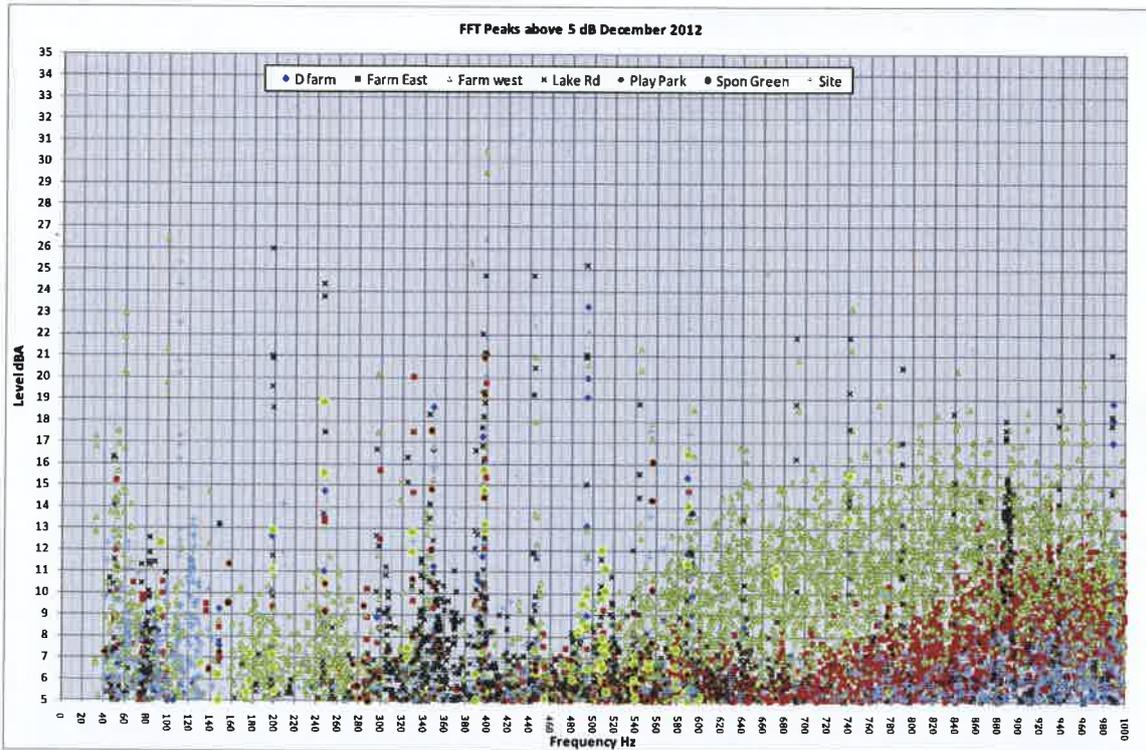
Receptor FFT Measurements December 2012

Measurements were taken during the night of 5th-6th December 2012. The weather conditions at the time of measurement were cold and still at ground level with a slight breeze blowing stack gas the east towards the layby area in Pen-y-ffordd.

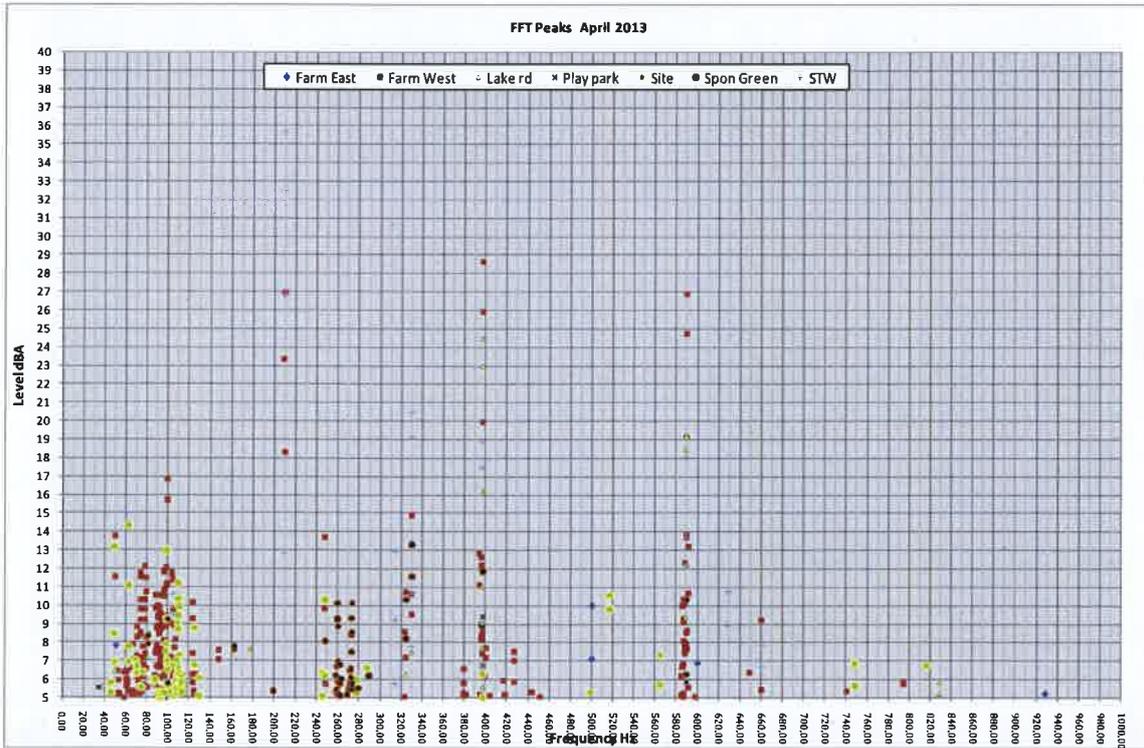
Receptor FFT Measurements April 2013

Measurements were taken during the night of 9th-10th April 2013. The weather conditions at the time of measurement were cold and still at ground level with a slight breeze blowing stack gas from the SSE direction towards the Spon green area.

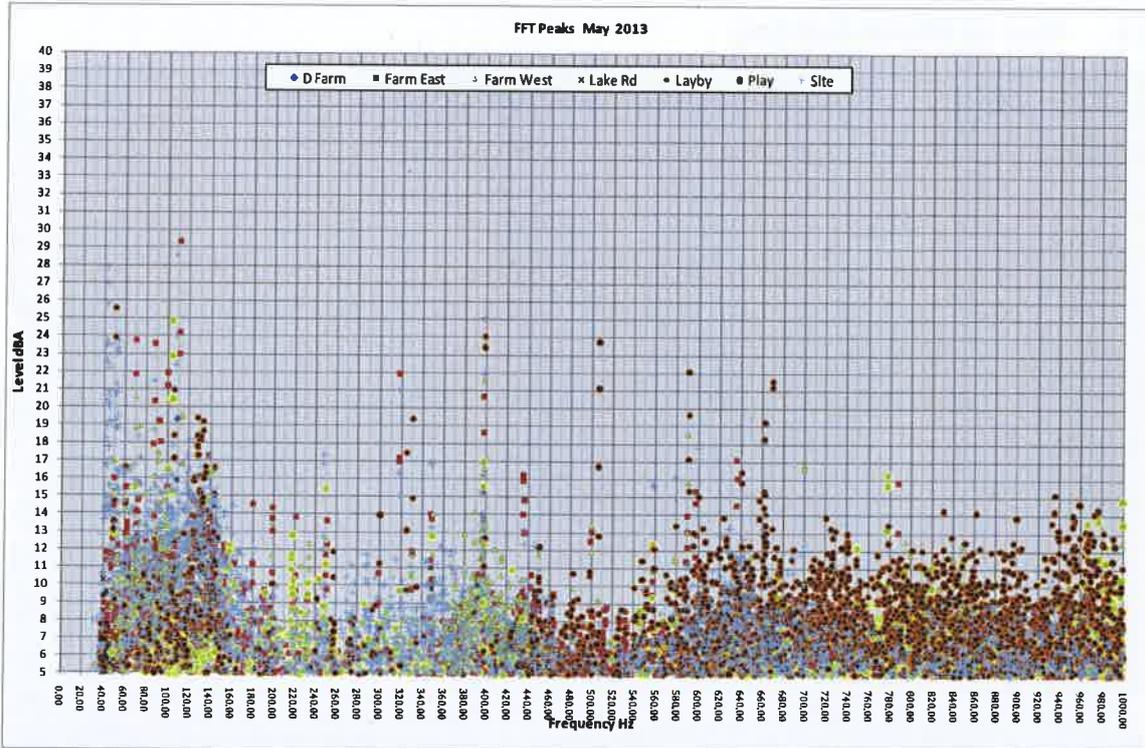
Receptor FFT Measurements May 2013

Measurements were taken during the night of 15th-16th May 2013. The weather conditions at the time of measurement were cold and still at ground level. There was a slight breeze blowing stack gas from the WNW towards the Lay-by area.

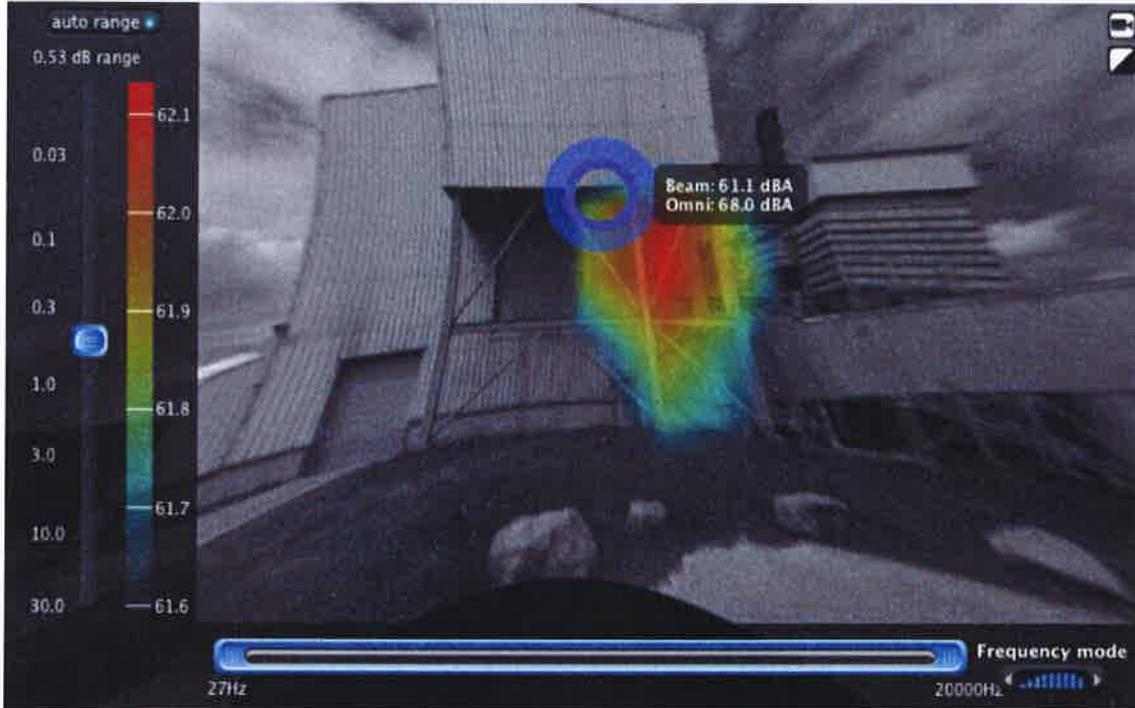
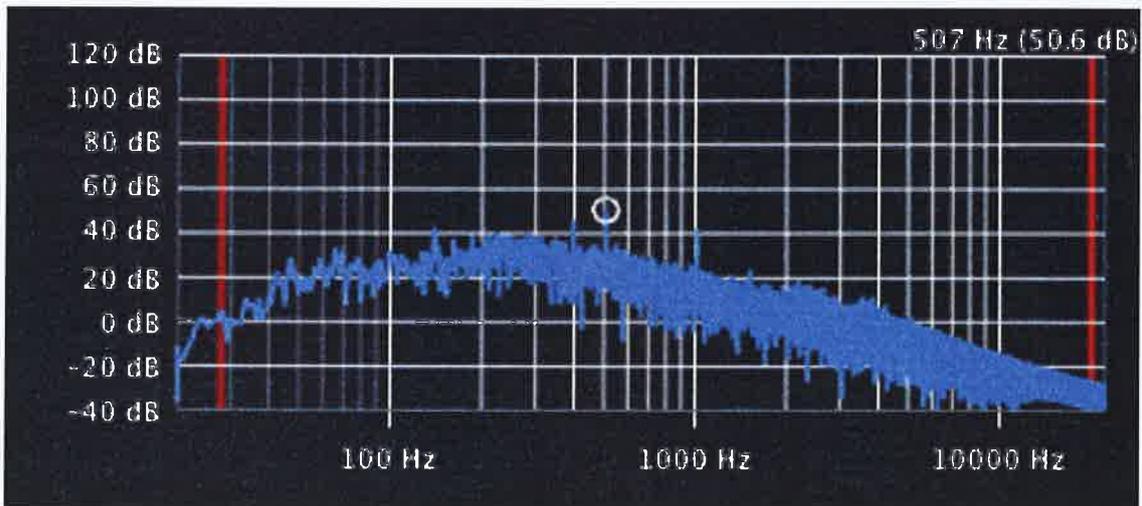
5.1 Rear of clinker building

The red lines highlight the measurement range on the plot above. In this plot a broadband measurement (The whole frequency range) was taken and highlights the area where the majority of the noise is coming from. 507Hz is also highlighted as the dominant tonal frequency.

The clinker building has a dominant tonal source at 507 Hz and a level of 57dB at the measurement location. The 507Hz peak was observed at the at the play park location during the FFT measurements taken during the boundary measurements in May 2013. The level of the 507Hz tone at the play park was 24dB. The 507Hz has been identified coming from the pipe exiting the rear of the building. The source of this tone may be from the fan/motor associated with the pipe. The tone was also observed braking out from the overhanging floor this may indicate that the unit is not isolated from the structure. Further investigation may be required within the building to identify the source. Remediation is recommended at source. If fans/motors attached to the pipe work within the building are found to be attached directly to the floor then this should be replaced with the appropriate rubber isolation mounts. Isolation can also be applied to the pipework if supports mounted directly to the structure. Fans and motors should also be well maintained and checked for any balance problems which could produce a tonal problem.

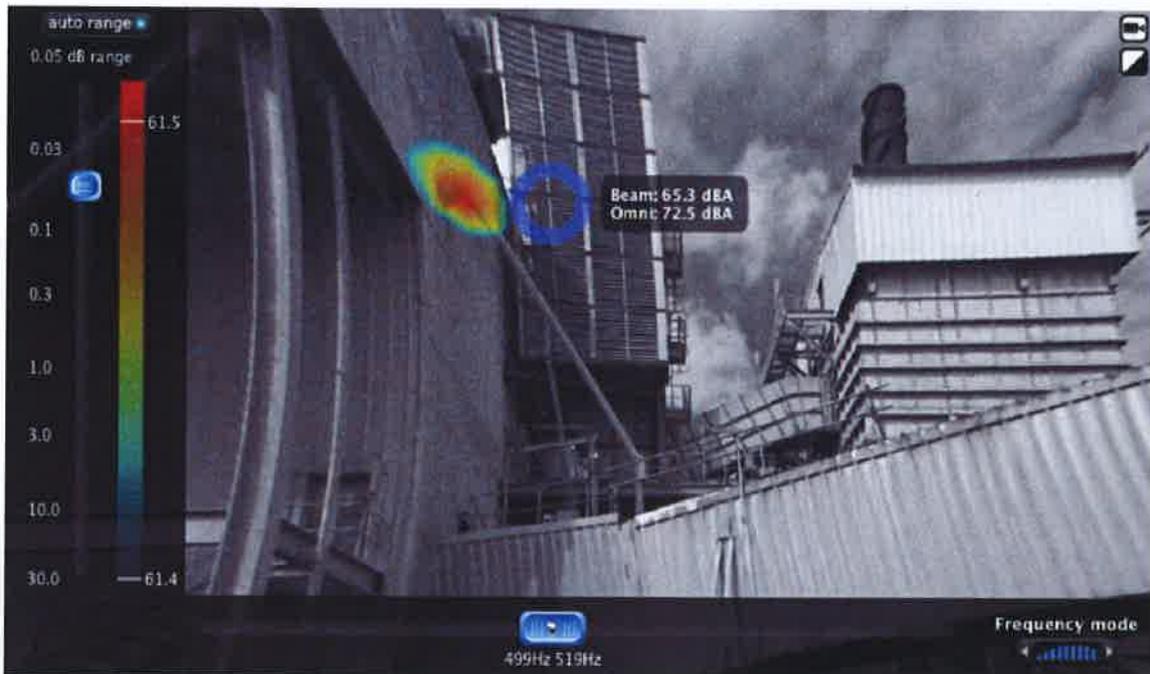
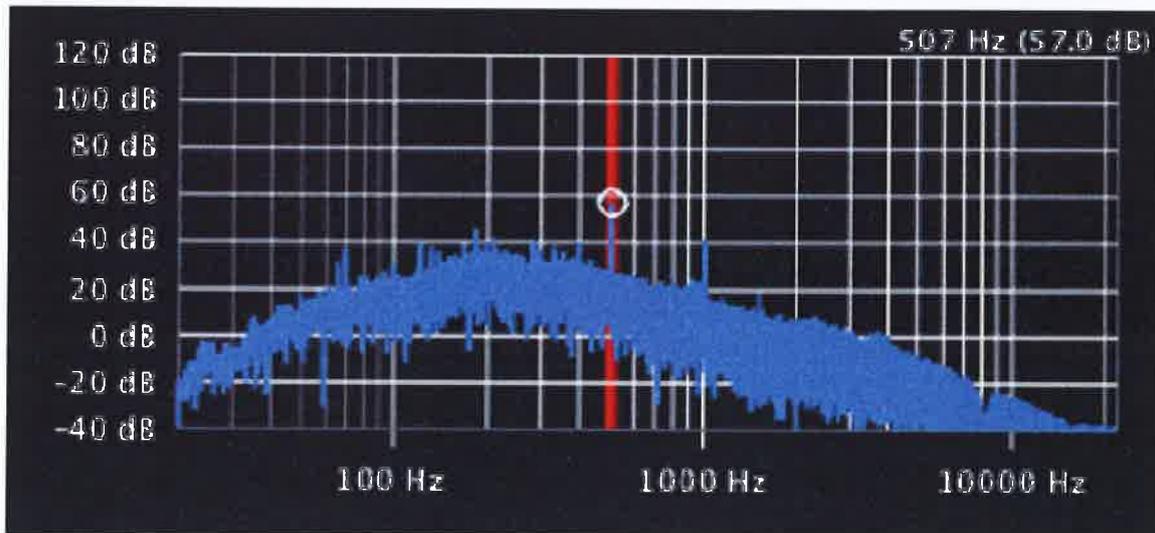
The source of the 507Hz tone was found to be a pipe protruding from the clinker building and dropping down to the clinker conveyor.

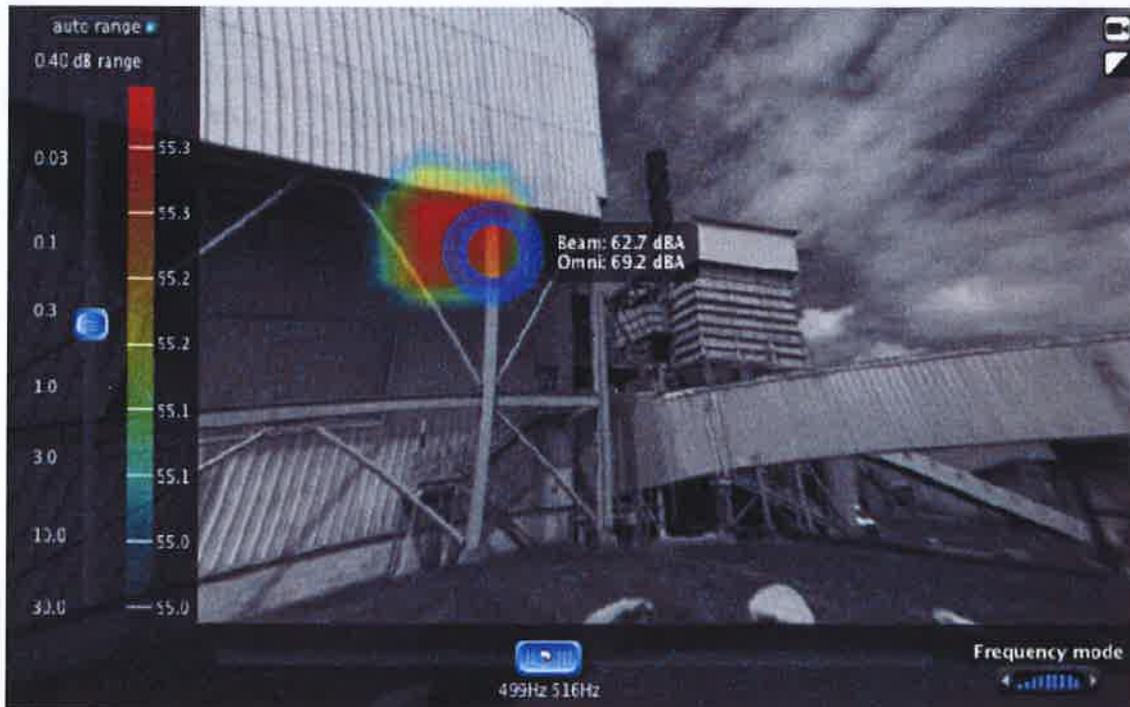
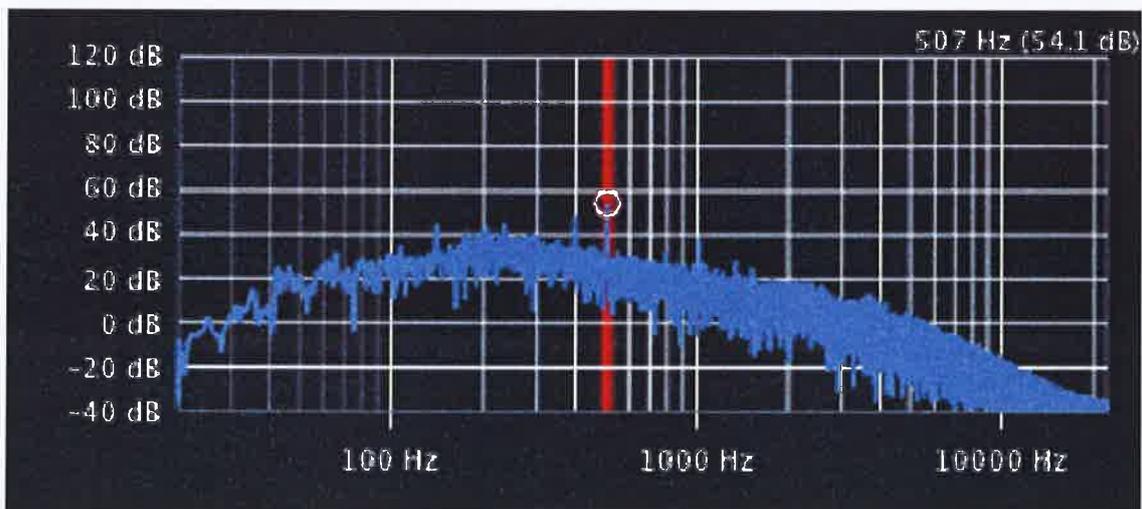
The 507Hz tone is also evident from the rear upper floor of the building and may indicate that the source is located within the building and could also indicate structural transmission.

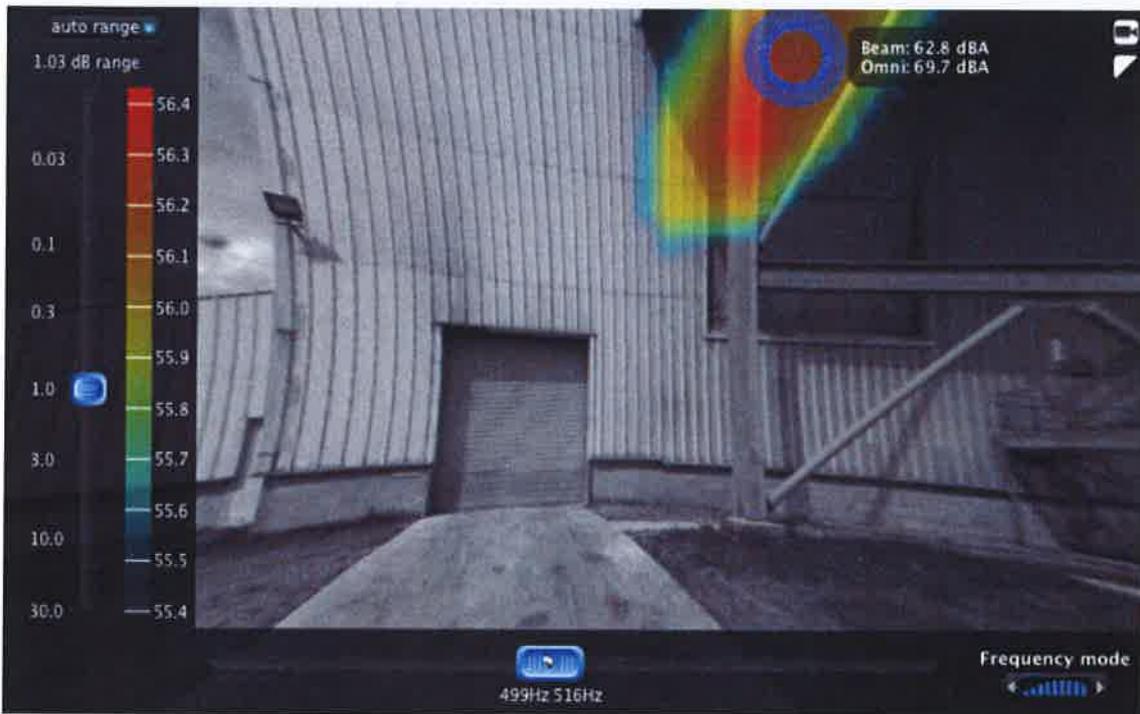
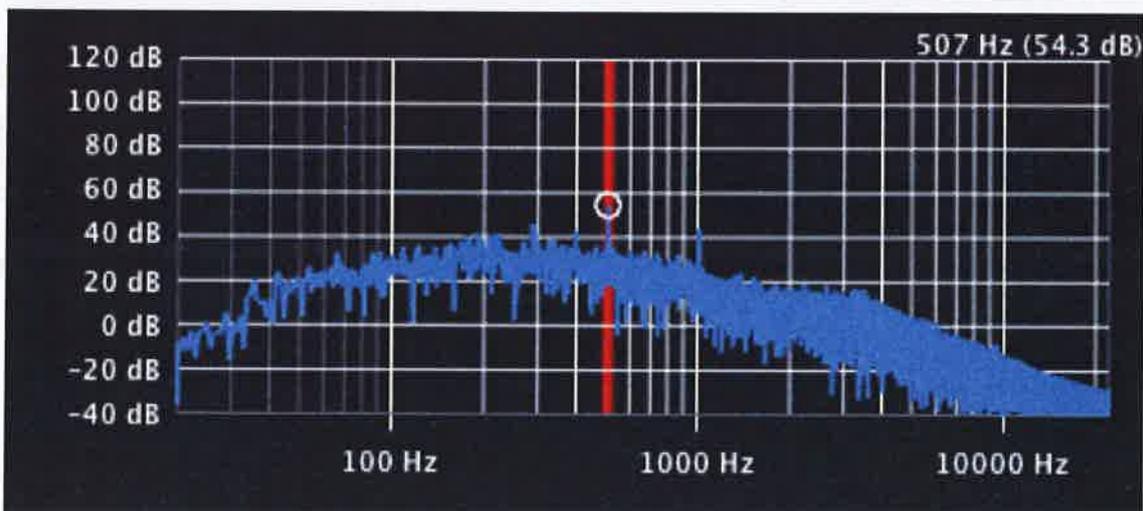
This plot highlights that the dominant 507Hz tonal source is from the protruding floor above.

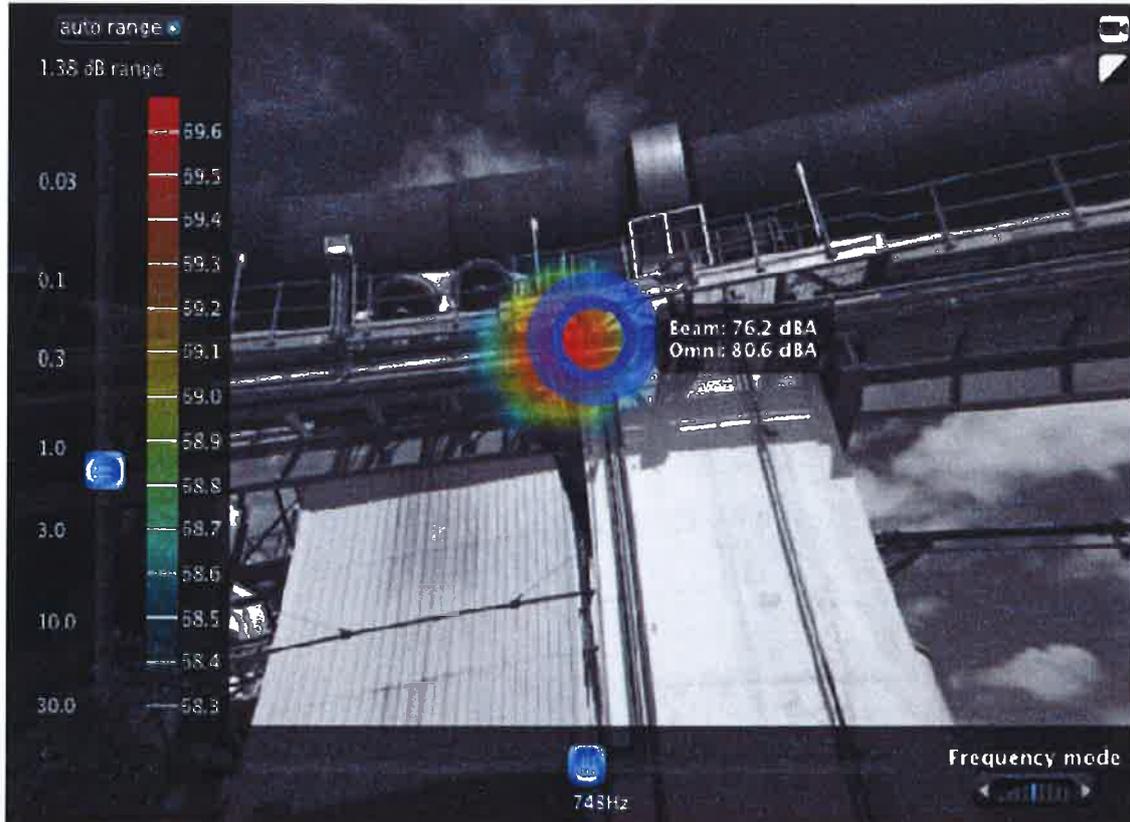
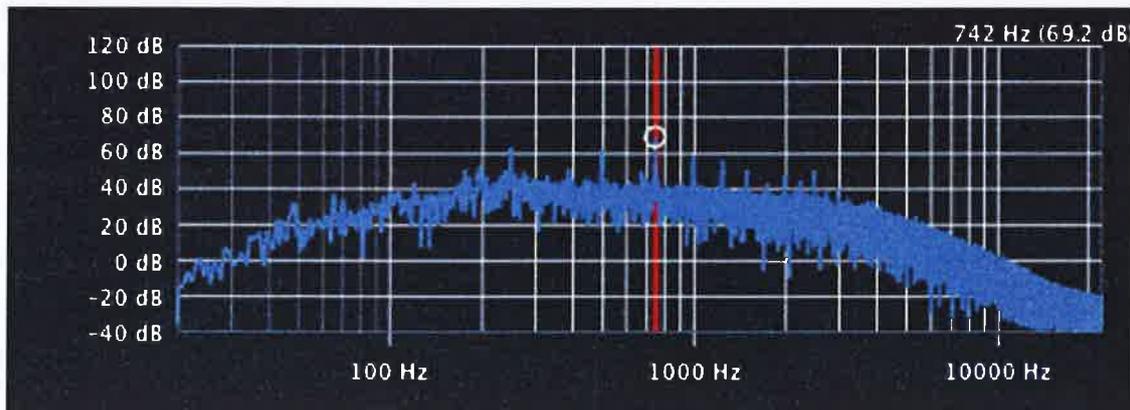
5.2 Kiln Cooler Fan

Kiln cooler fan has a number of tonal elements and harmonics. The 742Hz peak is dominant at distance but the 495Hz is dominant at source. It is thought that the 742Hz is from the exhaust and the 495Hz is from the motor/fan.

The mobile kiln cooler fans have several tonal elements, the dominant low frequencies which are most likely to be seen at receptor locations are 247,495 and 742Hz. From the FFT measurements taken at receptor locations these frequencies are observed at number of locations during the November and December 2012. Levels at 742Hz were observed up to 22dB at the lake rd. Toll Bar Location. Attenuation measures could be applied on the inlet and outlet of the fan but this may limit mobility.

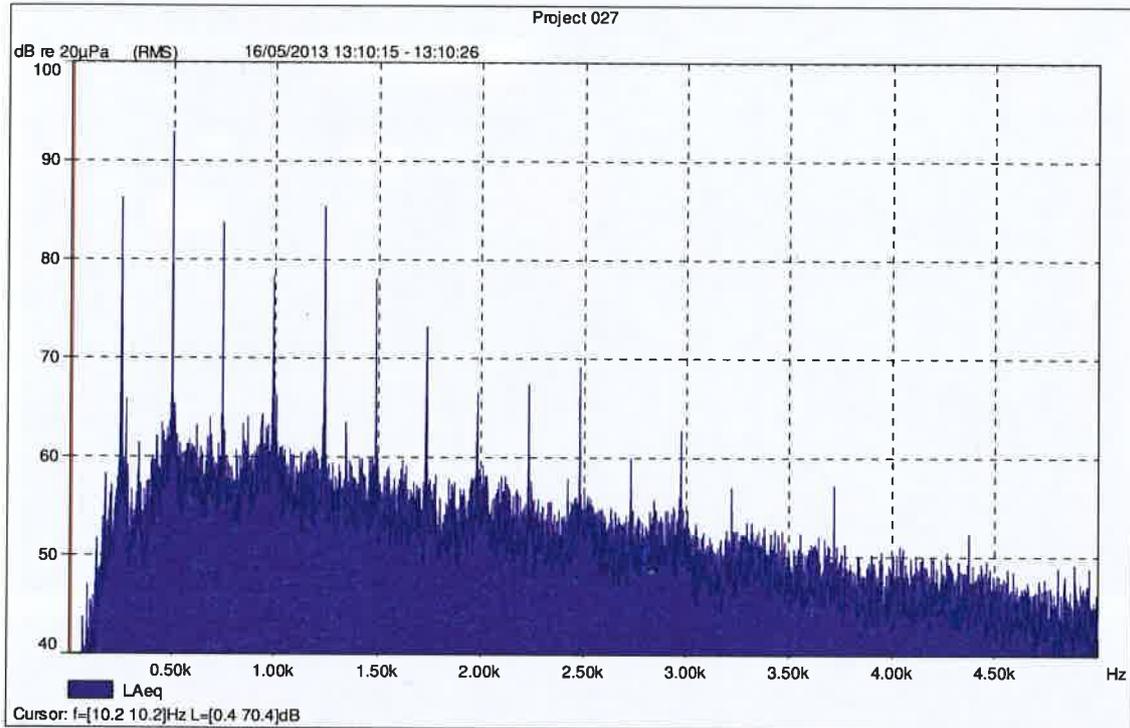
FFT measurements @ 1m from inlet

A number of resonant frequencies can be seen but the low frequencies are most likely to be seen at receptor locations.

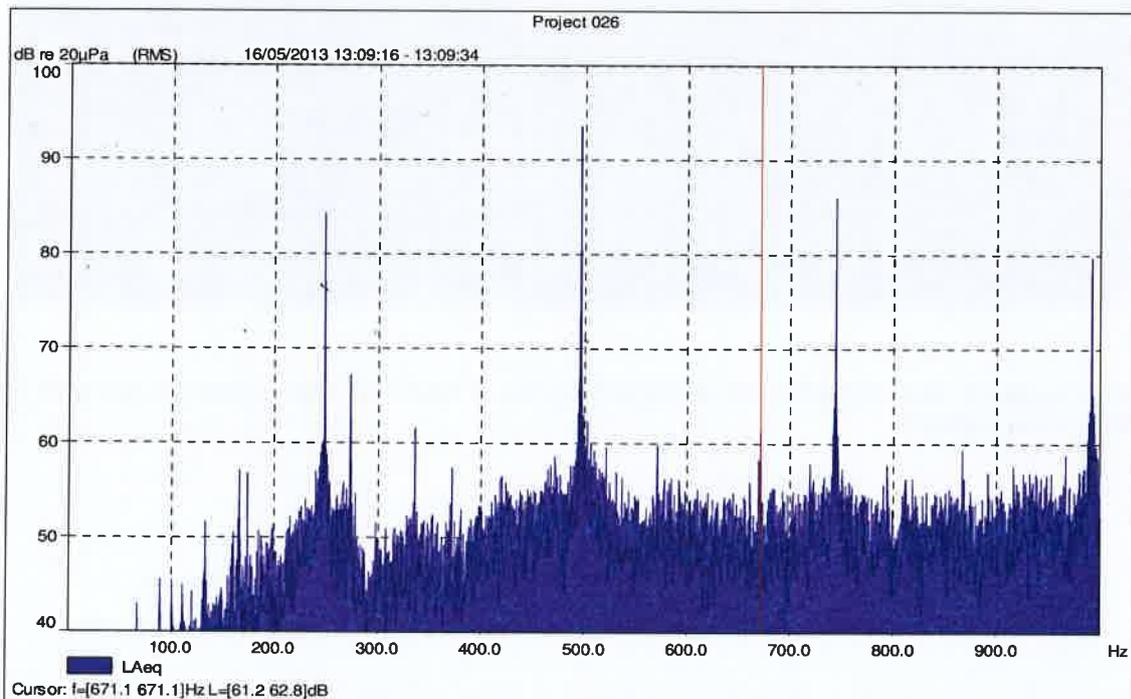
FFT measurements taken with sound level meter highlights the 247,495 and 742Hz

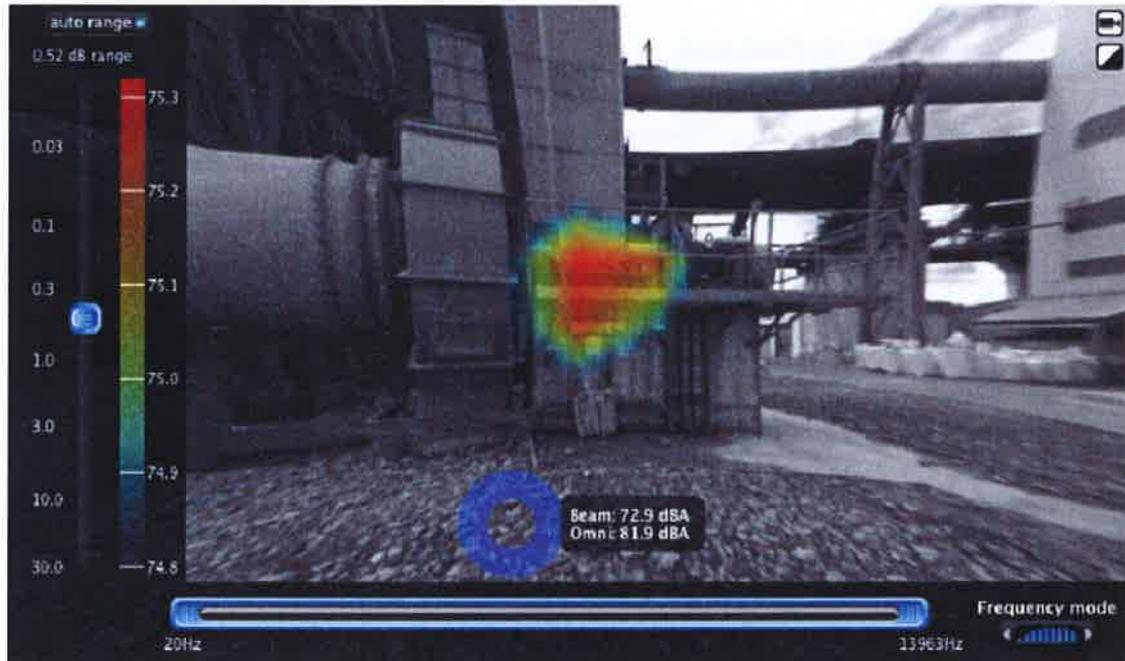
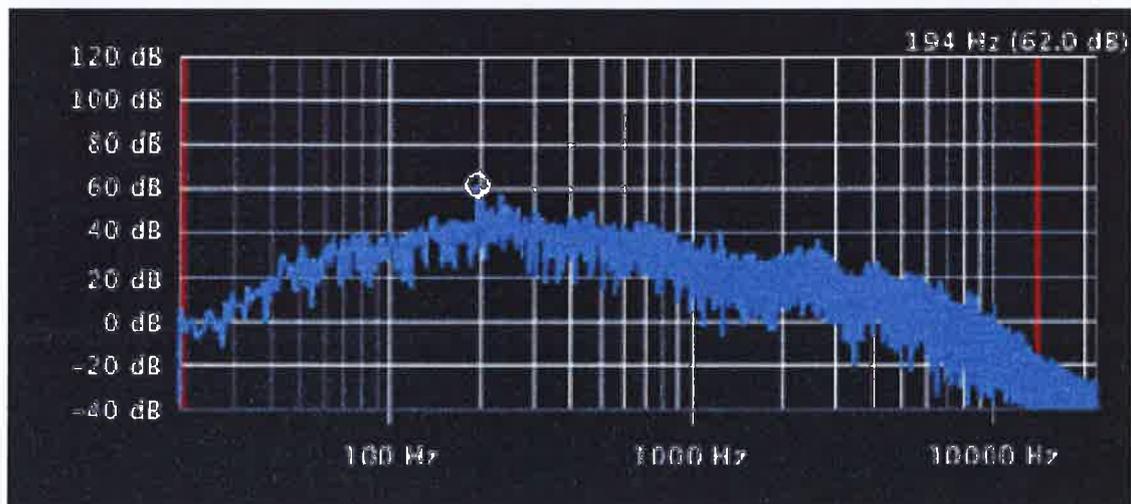
5.3 Cooler Stack Area

This broadband plot highlights the dominant source is from the motor drive source with a 194Hz tonal element.

The cooler stack area highlighted dominant sources at the cooler stack fan drive with a small 194Hz peak and the fan exit to the stack with a tonal peak at 1134Hz. A number of tonal sources have been observed on site around 200Hz and this is not thought to be the dominant source. The 1134Hz is evident as a whine close to the stack but is thought unlikely that the 1134Hz frequency will be seen at receptor locations. Any future FFT assessments a 0-2000Hz range will be used in to identify if this is the case. A tone at 209 Hz was also observed at the base of the three cooler fans and was observed braking out from both east and west directions. This 209Hz was observed at a number of offsite receptor locations during April 2013 FFT measurements with a level of 35dB measured at the STW/Dog kennel location. Insulation of duct work from clinker building to filter may reduce the impact of the 209Hz. Further investigation will be required to identify the source of the 209Hz tone which could be from a fan within the building.

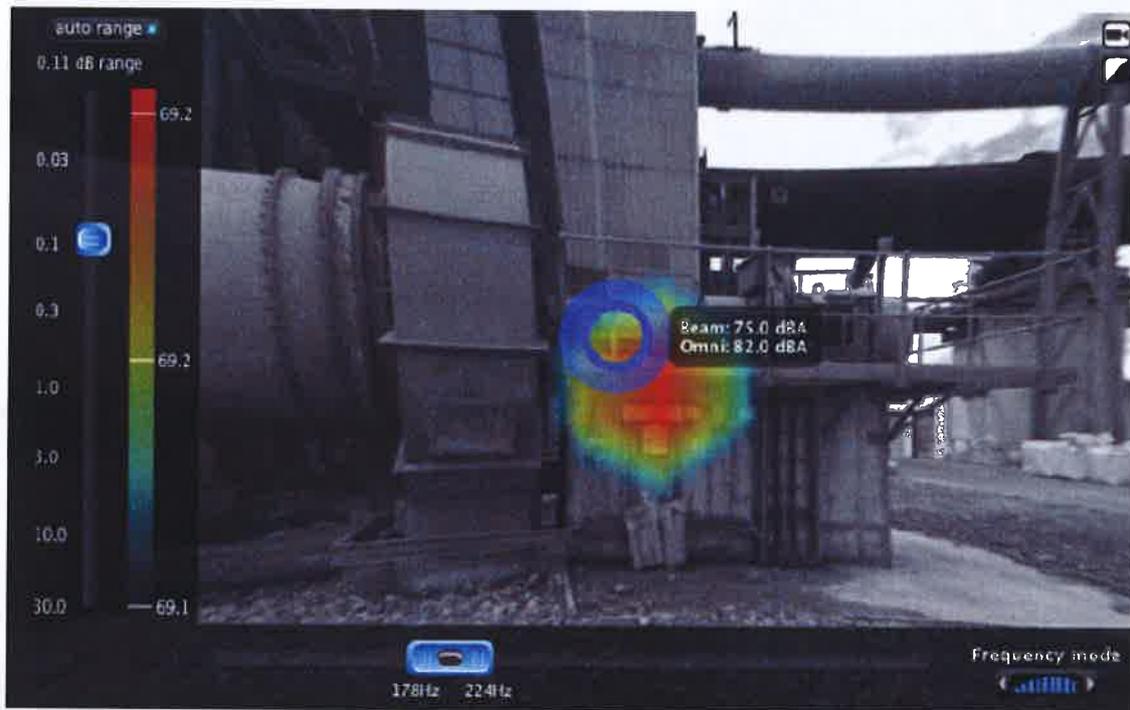
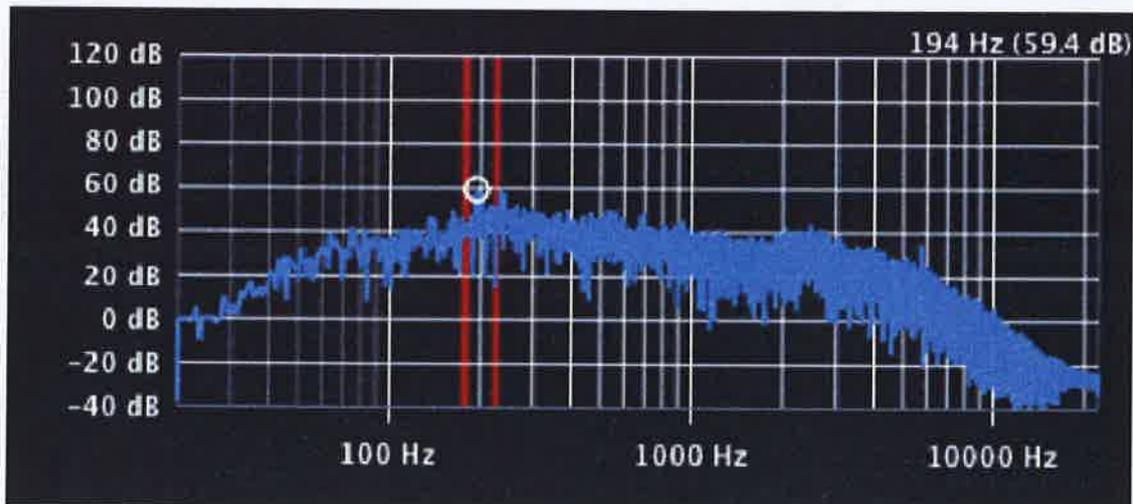
This plot highlights the 194Hz frequency as the dominant tone associated with the motor drive.

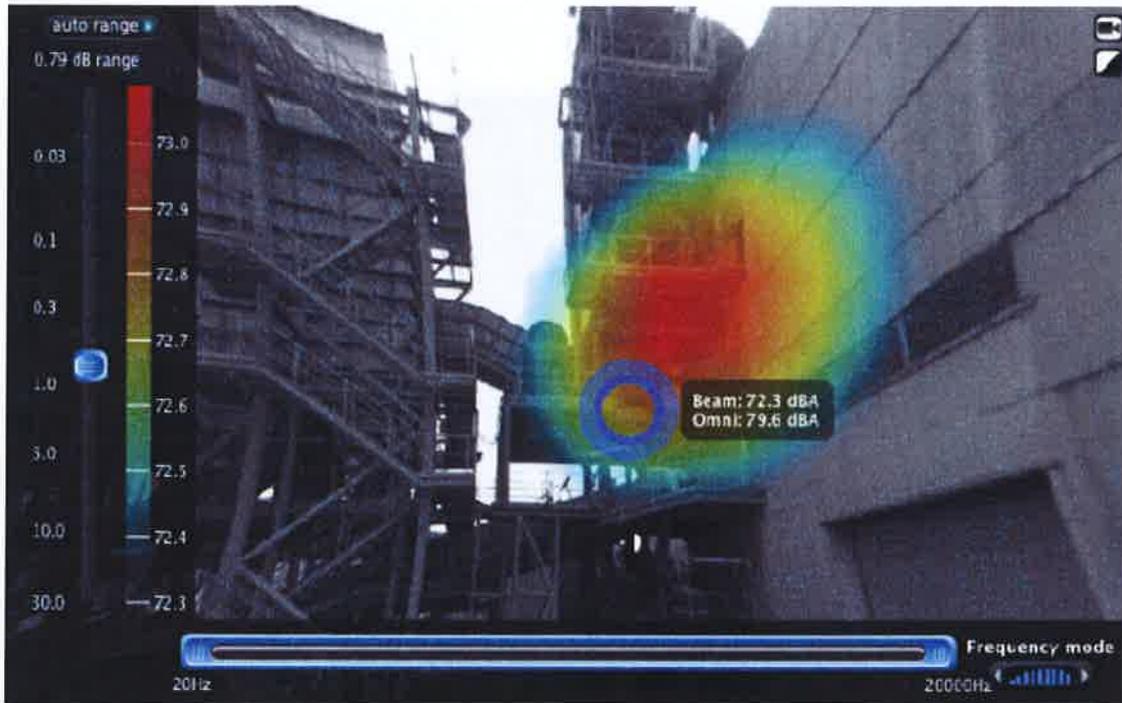
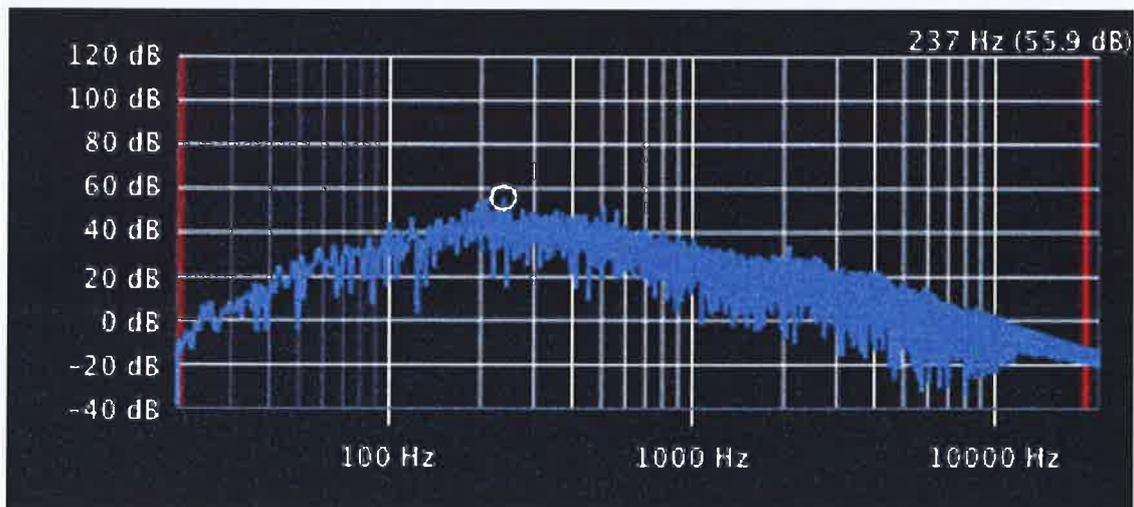
Broadband highlights dominant area as the base of the three cooling fans.

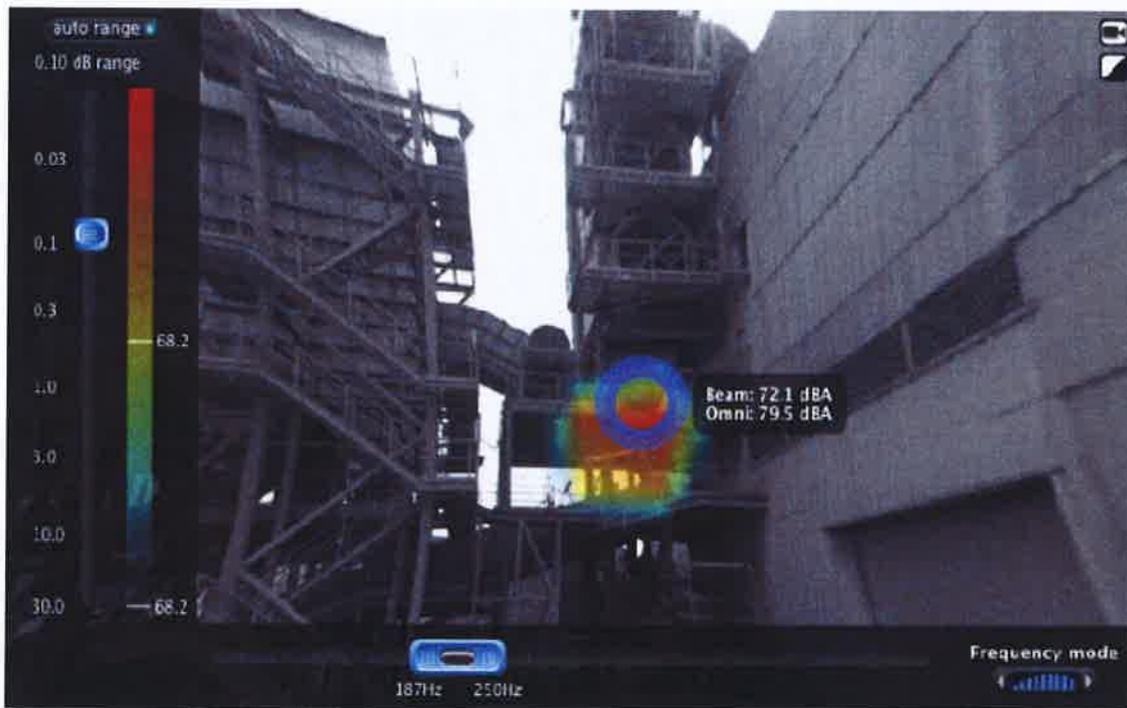
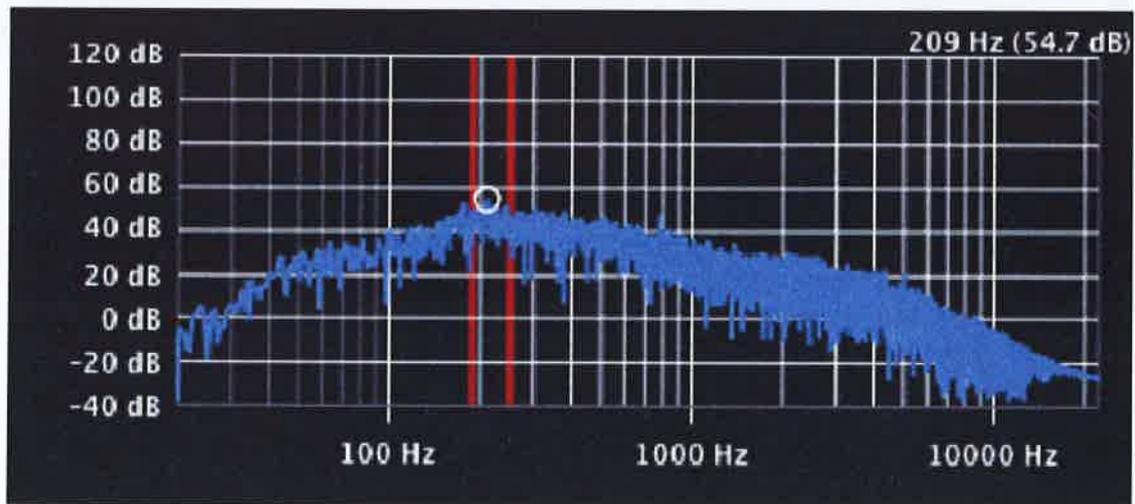
Plot with dominant frequencies highlighted. 209 Hz was the highest observed

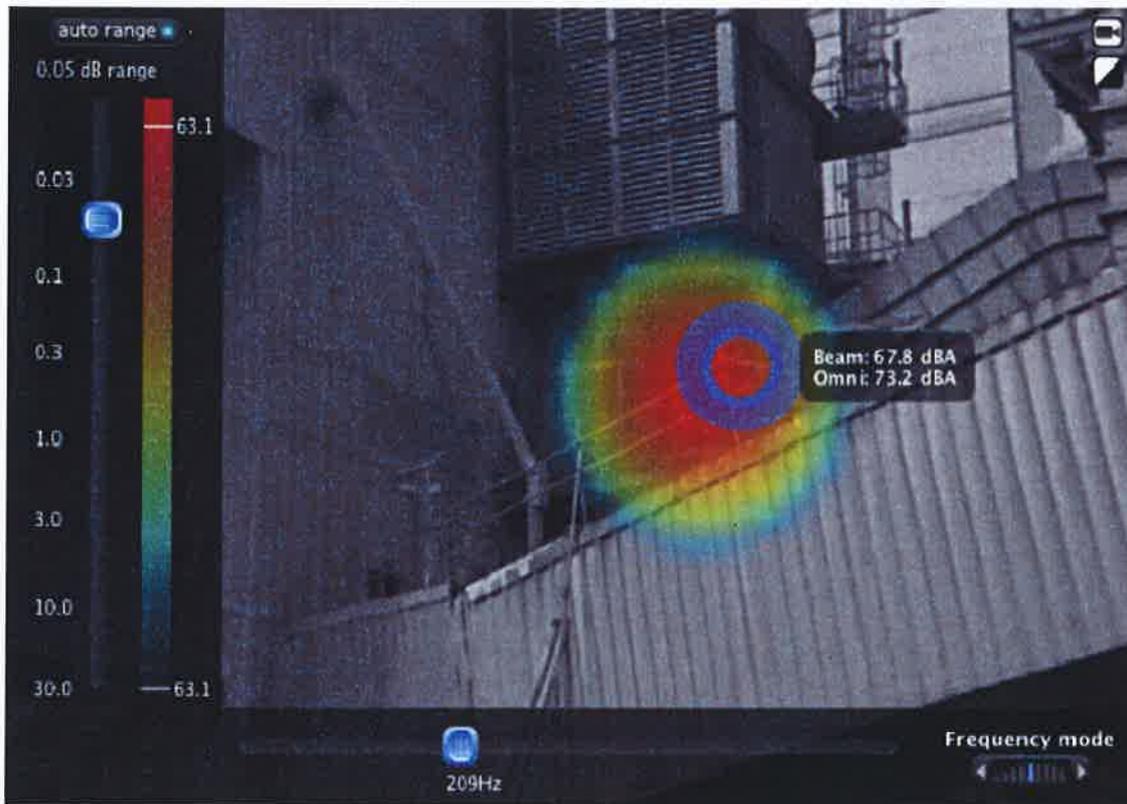
209 Hz was also measured from the rear of the building.

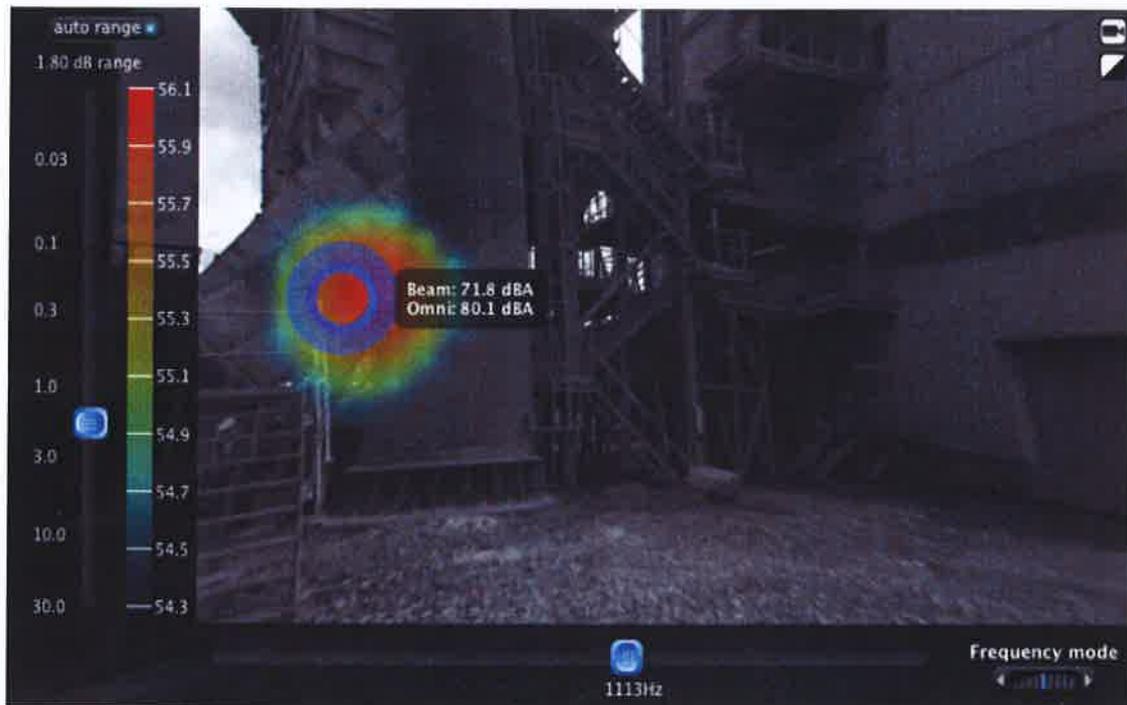
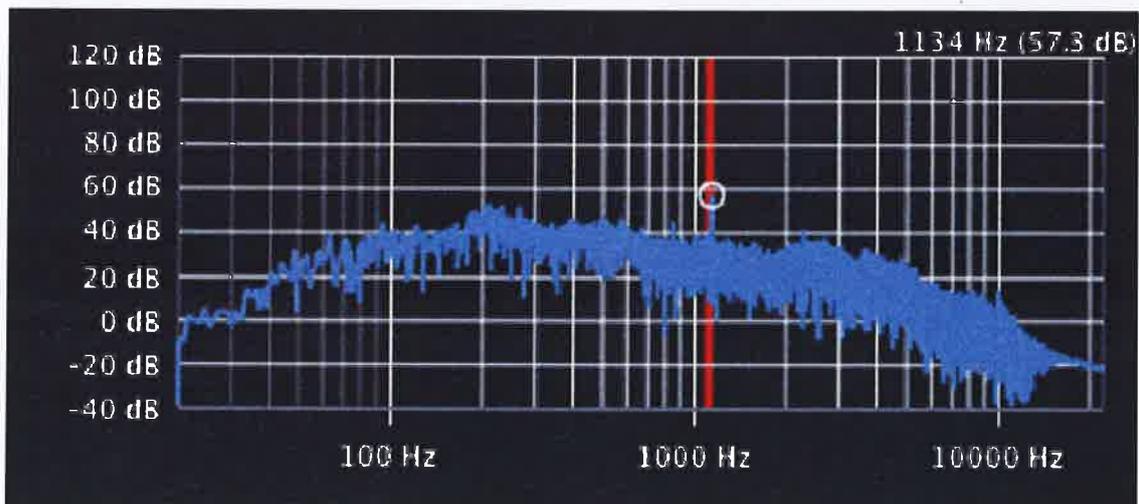
1134 Hz tone was highlighted on the inlet of the cooler stack. This has not been identified during the FFT measurements as 0-1000Hz measurement range was set to identify lower frequency sources. It is thought unlikely that this Frequency will be seen at receptor locations but a 0-2000Hz range will be used in any future FFT assessments to identify if this is the case.

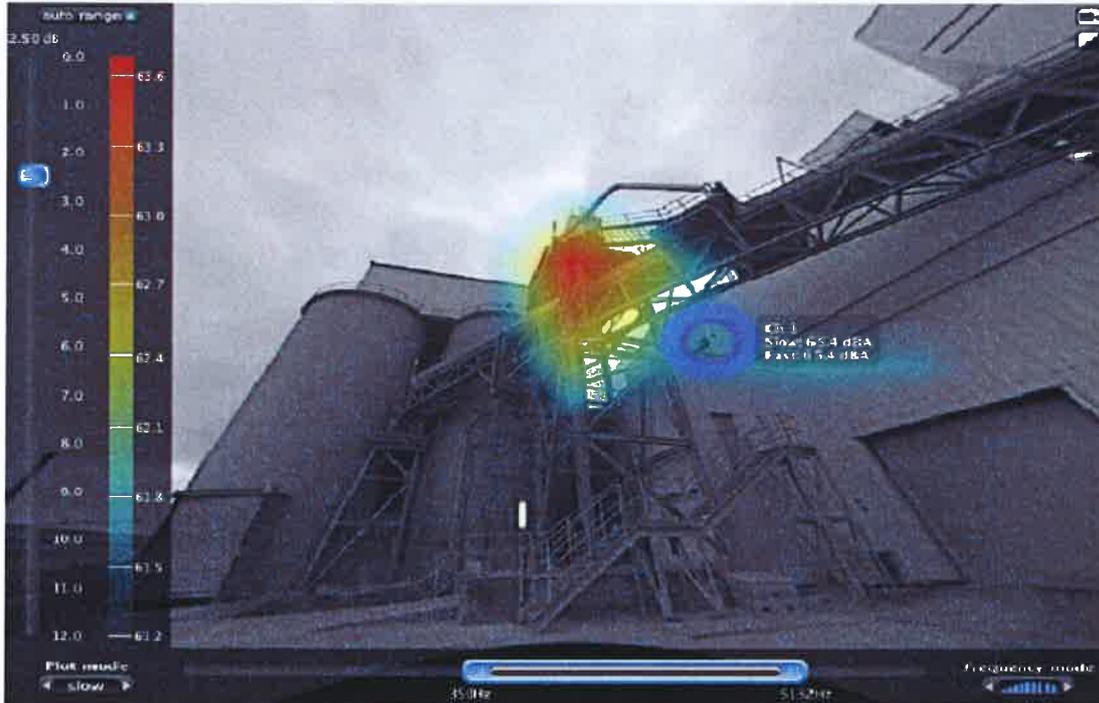
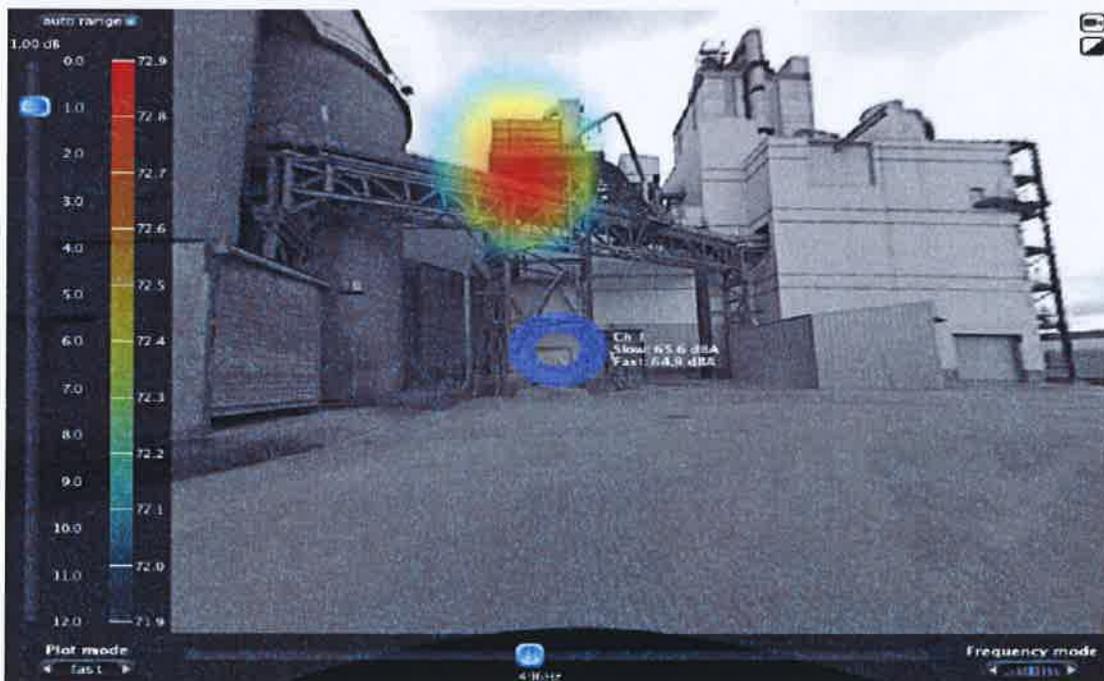
5.4 RAW MILL ELEVATED CONVEYOR

Data from assessment in August 2012 highlighting a high level source.

Levels observed during previous assessment identified high level noise source with a tonal element at 496Hz.
