HANSON CEMENT

Acoustic Camera Assessment of Site Noise Levels

Padeswood Works, Flintshire

MAY 2013

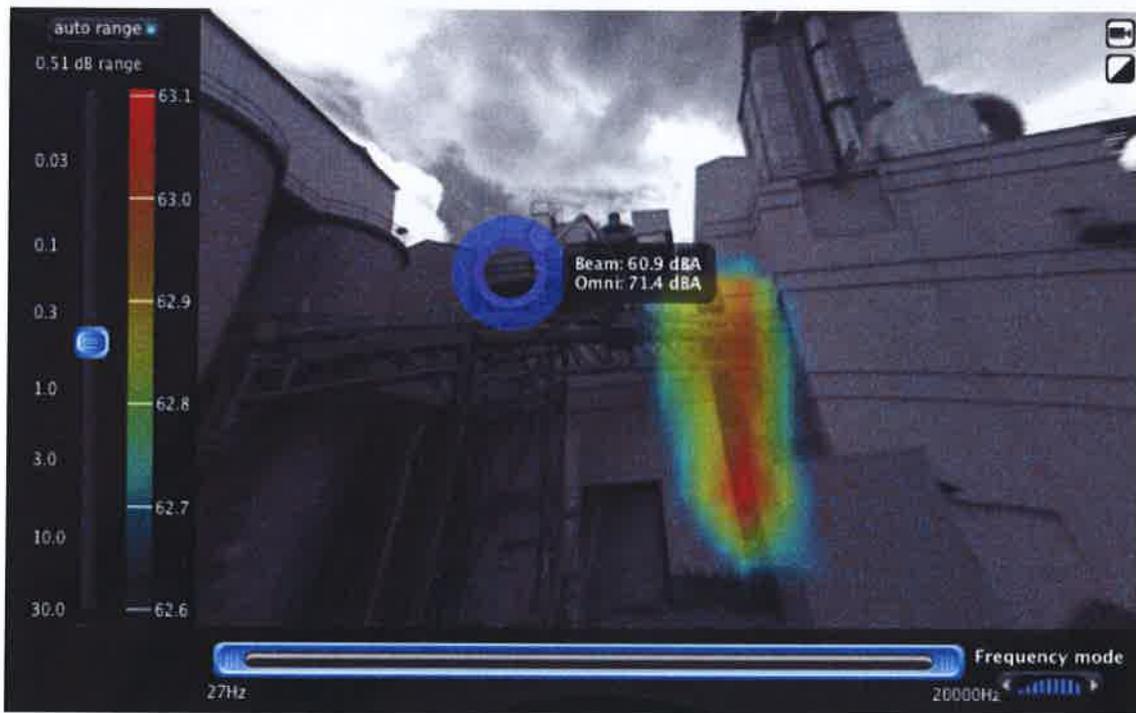
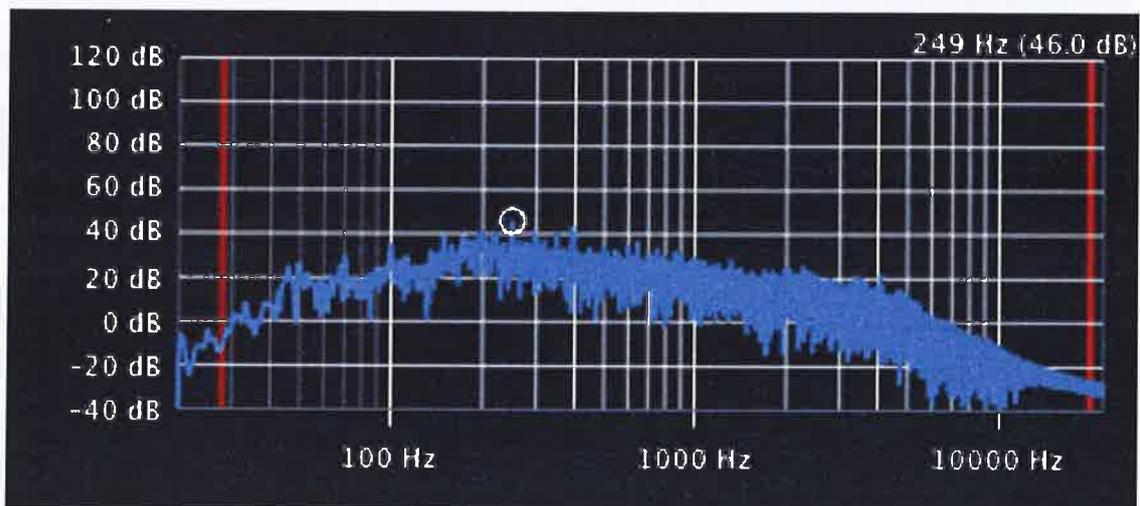
Measurements taken in May 2013 after maintenance on fan and system on platform

The broadband level identifies the dominant source of noise coming from the Coal mill area. Background noise levels are similar but the tonal element has been significantly reduced.

Measurements taken on the raw mill elevated conveyor platform in August 2012 showed a dominant tonal source at 496Hz. After remedial works on the fan and motor the tone is now not evident the noise level has been reduced from around 72dB to around 50dB at the monitoring location. The dominant source is now coming from the gaps in the coal mill façade located behind the platform.

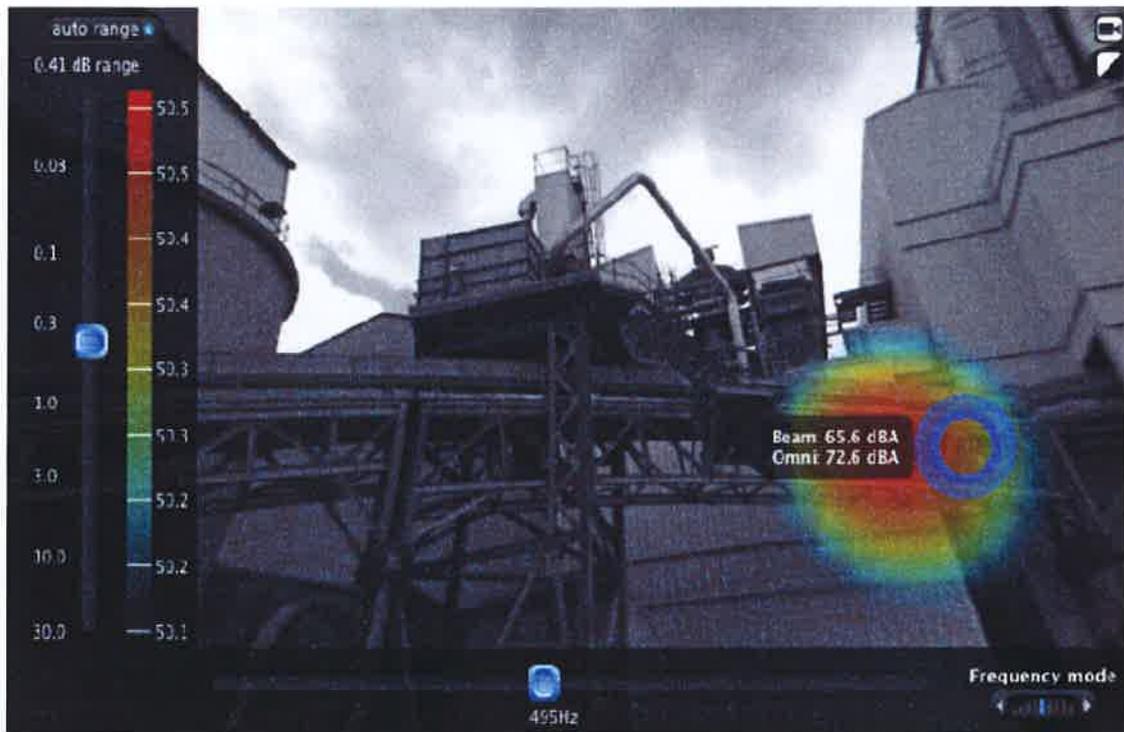
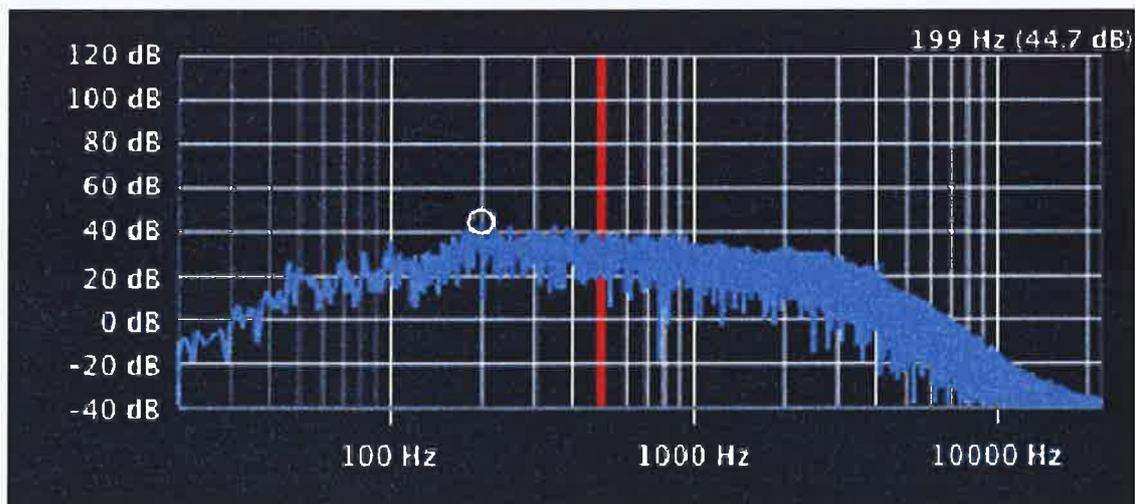
The dominant frequency observed from the platform is now not evident. The 496Hz in this plot is part of the general broadband noise coming from the coal mill. It can be assumed that the fan and motor at 496Hz are less than 50dB at his measurement location a significant reduction from 72dB before maintenance.

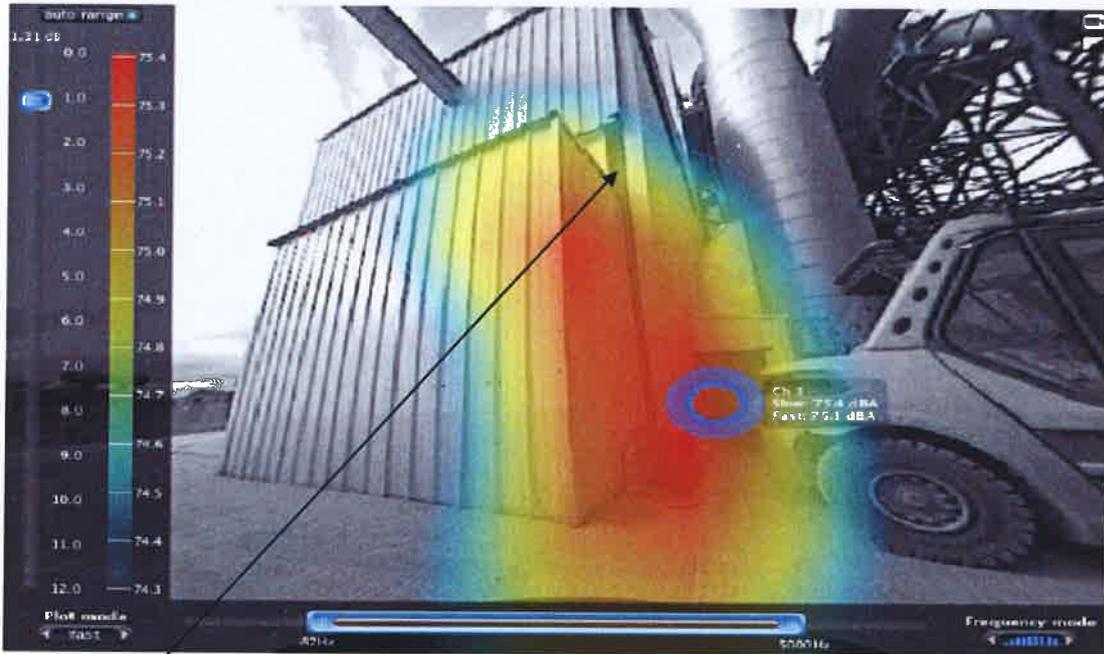
Noise breakout at areas where the façade is damaged measurements taken August 2012.

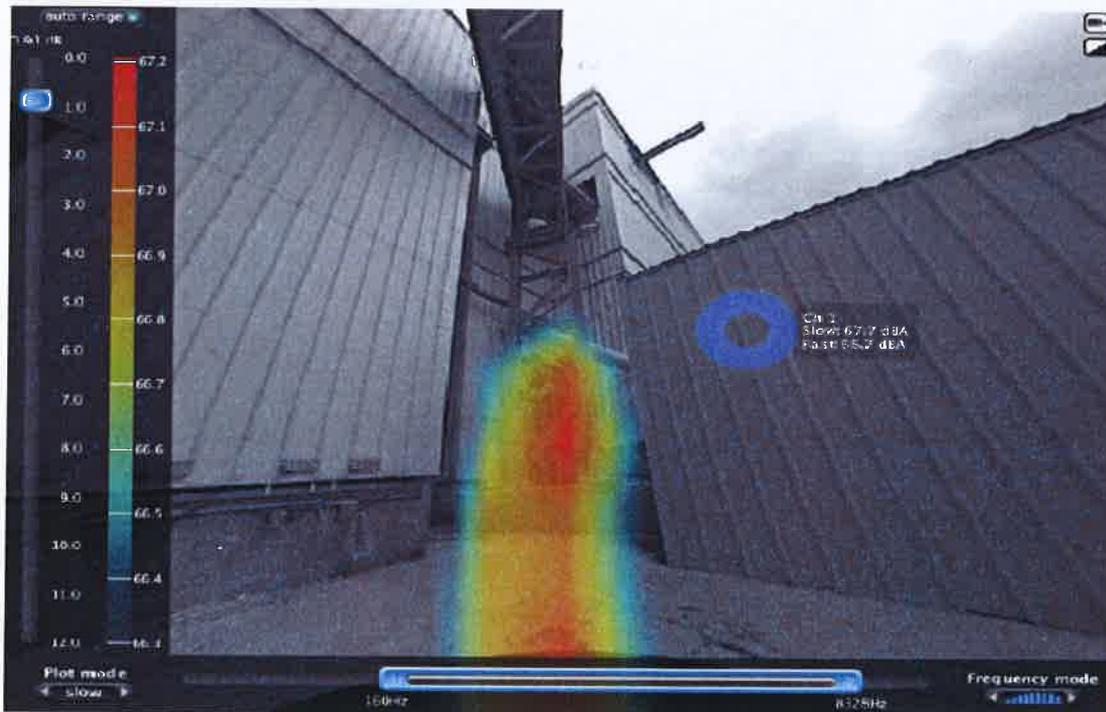
Missing panel on building

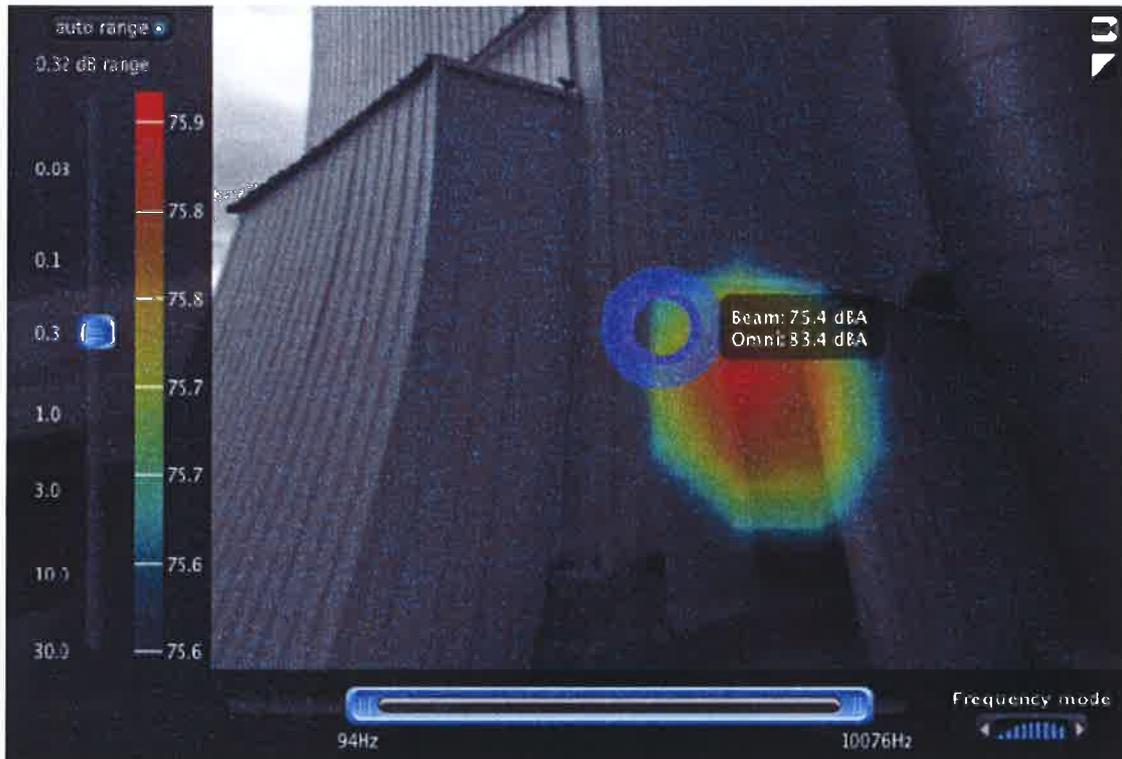
Noise breakout from damaged wall

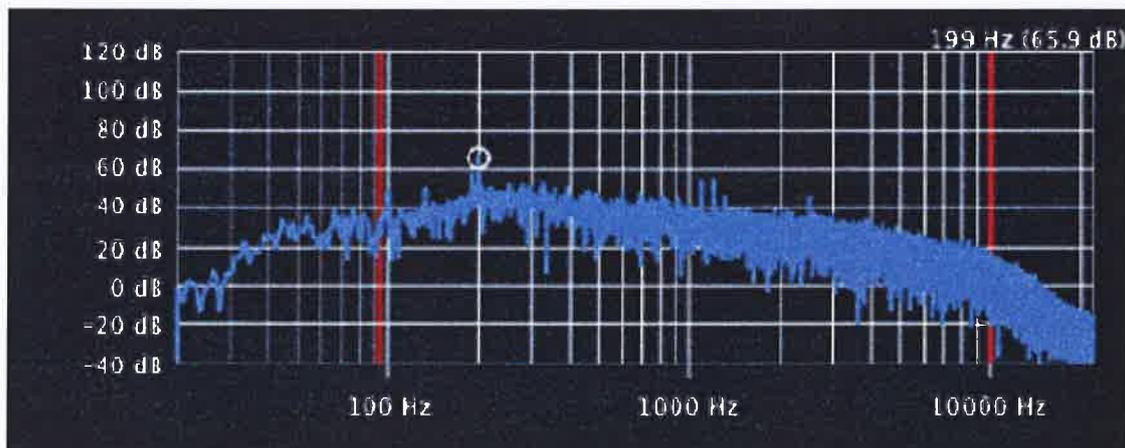
FFT Measurement

Panel replaced has had little affect on the overall noise level. Fitting a door on the building may reduce the high frequency noise breakout but will not have much impact on the dominant 200Hz tone from fan/motor within the building.

The raw mill ID fan building façade repair has not reduced the overall noise impact. The doorway should be closed and will reduce the overall broadband/ high frequency noise level at source. The dominant tone from this area is the fan exit area within the building at 200Hz this tone can be seen at number receptor locations. Closing the doorway is unlikely to reduce the dominant 200Hz tone. The fan, motor and fan exit flue could be further insulated to reduce the noise level from source. Building insulation could also further reduce any noise breakout.

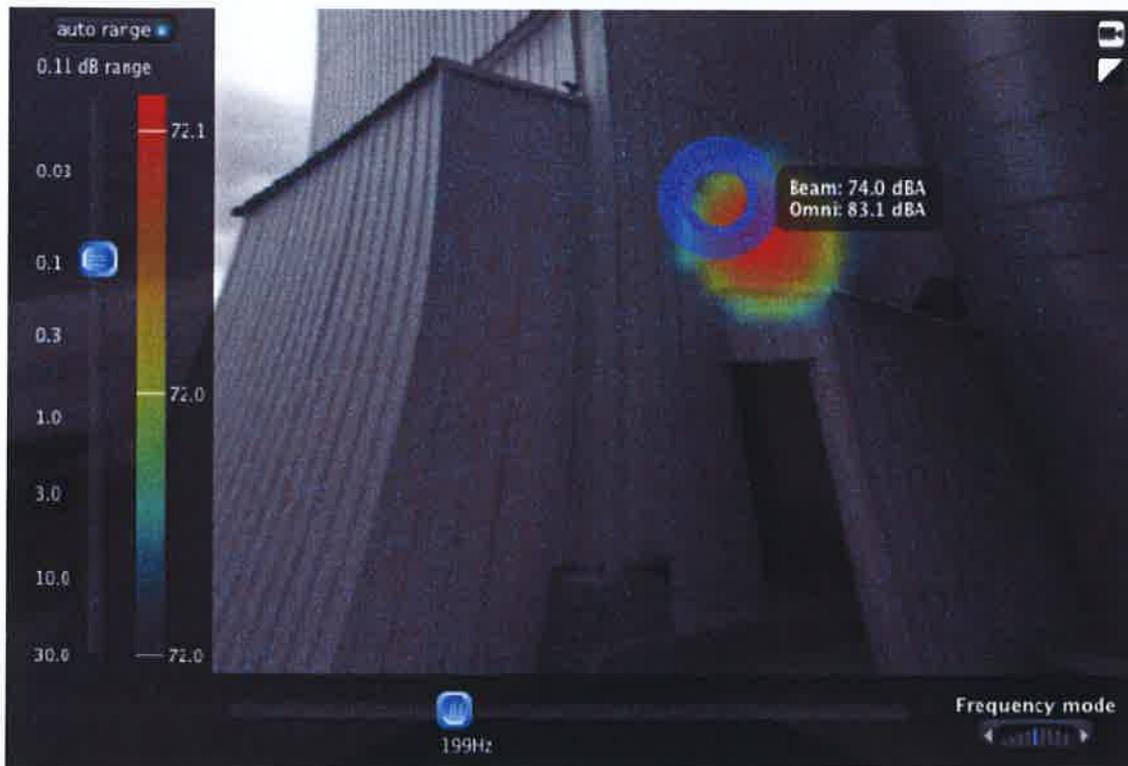
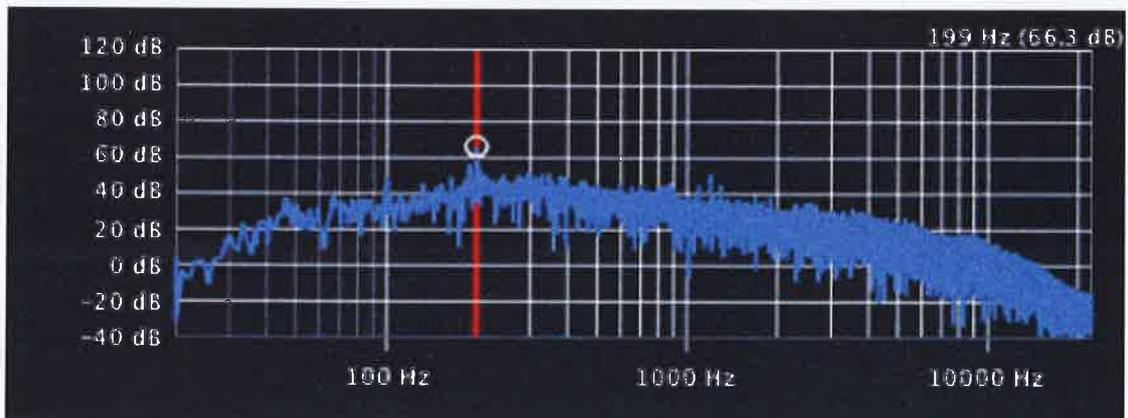
This plot highlights the dominant 200Hz tonal source. The 200Hz source within the building and is not contained by the structure. Further attenuation will be required to reduce the impact of this source.

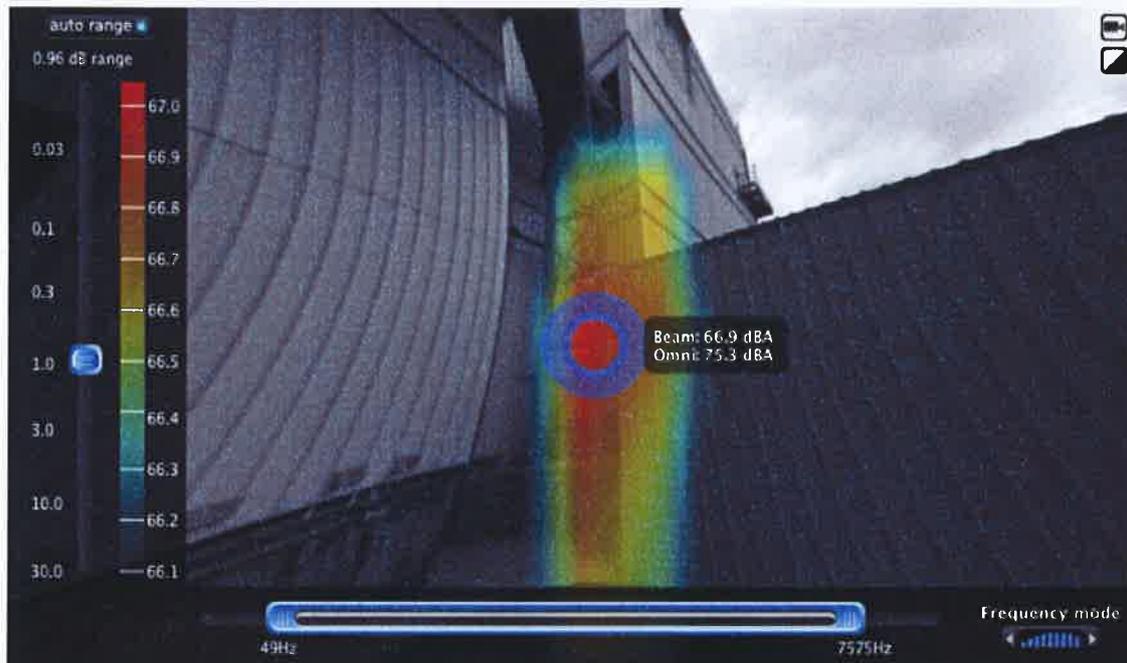
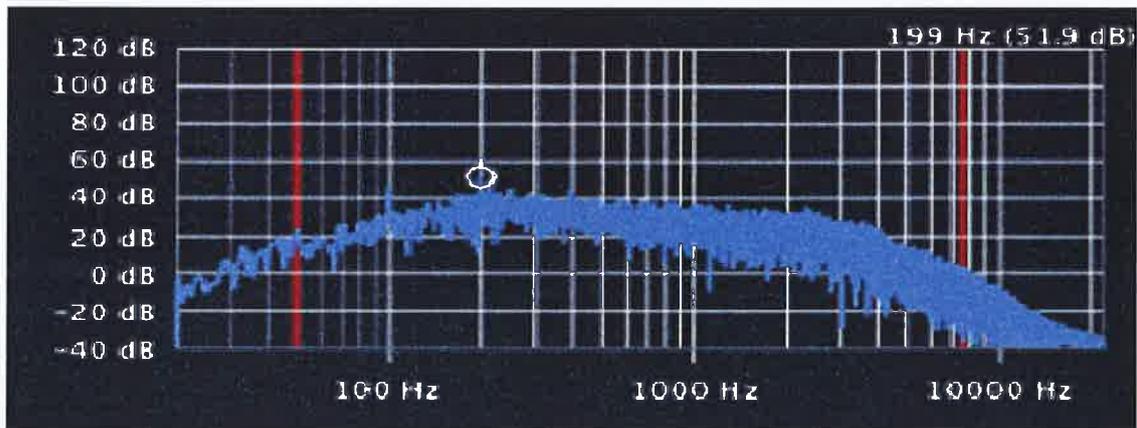
Noise breakout is still evident after new panels are fitted. Gaps in the façade for cables and conveyor will be the path for the noise breakout also the high level sources within the raw mill building may not be contained by the facade.

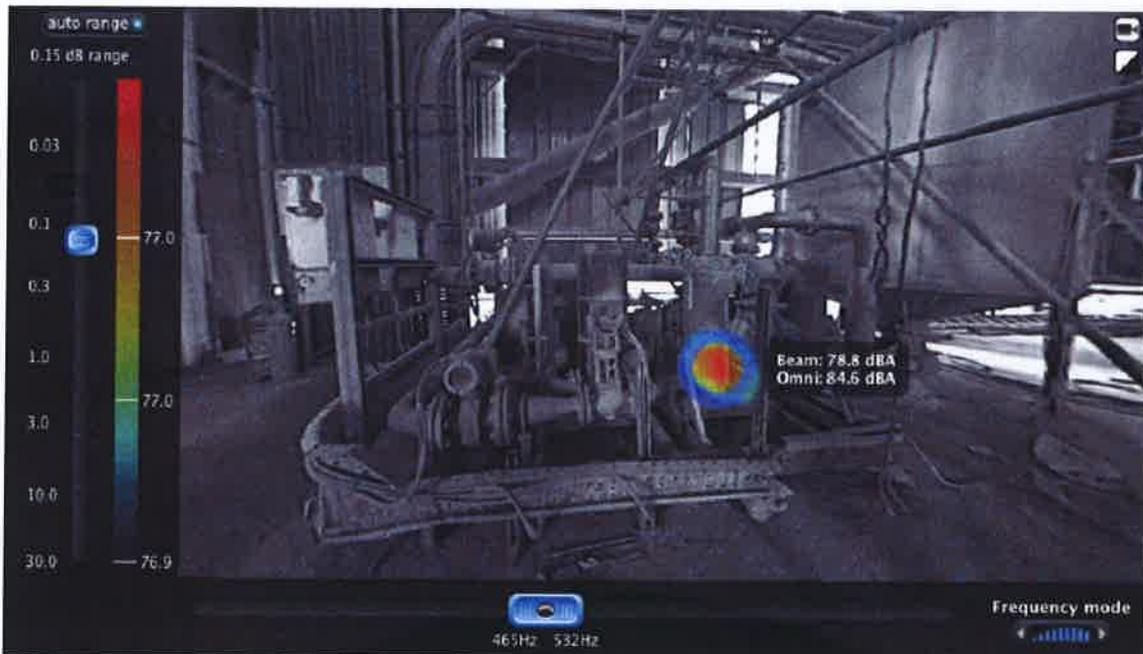
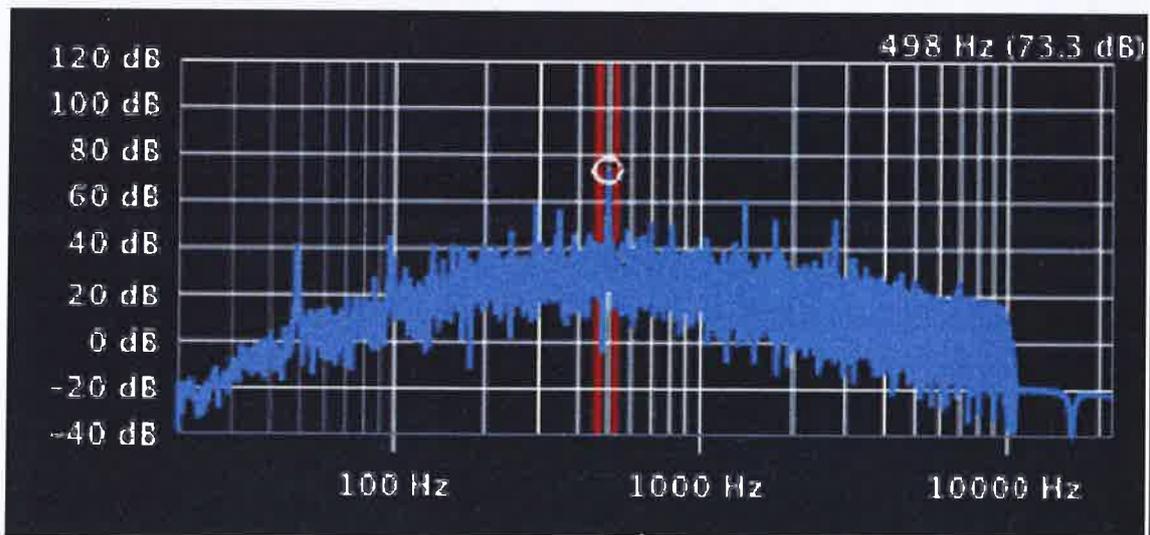
5.6 WATER PUMP IN TOWER

Water pump in the tower has a number of tonal elements. The dominant tonal element is the 498 Hz tone.

The water pump on the tower is an elevated source with a dominant tone at 498Hz. This was observed as a dominant tonal peak at the Farm East location during April and May 2013 FFT monitoring with levels up to 13dB. To reduce the noise impact the unit should be isolated from the structure and enclosed in an acoustic enclosure.
