**PERMIT REVIEW DOCUMENT**

**REGULATION 60 NOTICE**

**Permit reference:** EPR/EP3738NG

**Facility:** Bridgend Paper Mill, Llangynwyd, Maesteg, Mid-Glamorgan CF34 9RS

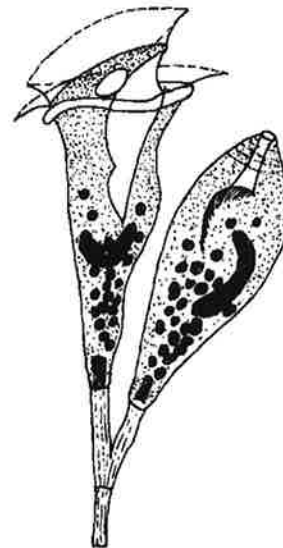
*Epistylis* has somewhat 'vase' -shaped cells. They have a diameter of 70-100  $\mu\text{m}$ . The stem is usually branched, which causes colonies to arise, but does not contain a 'muscle'. Therefore, the stems cannot contract (the cell actually does). The colonies can reach macroscopic dimensions (mm).

*Epistylis* sp. occur commonly in activated sludge, especially at sludge loading levels of 0.1 to 0.2 kg BOD/kg MLSS.day.

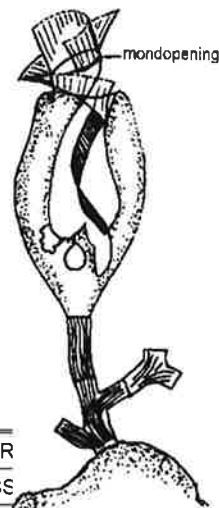
### ***Opercularia***

*Opercularia* has somewhat bell-shaped cells. The cell diameter is approximately 140  $\mu\text{m}$ . The stems are branched, causing colonies to form. A non-contracting 'muscle' is present in the stem. In comparison with the other sessile ciliates, *Opercularia* has a small mouth opening.

*Opercularia* sp. mainly occur at higher sludge loading levels (0.2 to 0.3 kg BaD/kg MLSS.day).

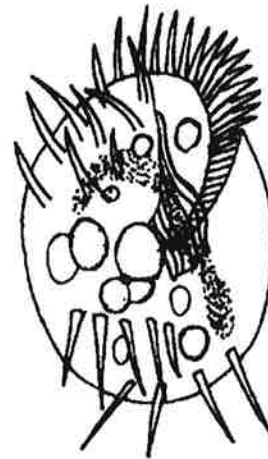
*Euplotes* resembles *Aspidisca*, but is usually bigger and is free swimming.

*Euplotes* commonly occurs in activated sludge, principally at sludge loading levels of 0.1-0.2 kg BOD/kg MLSS.day.

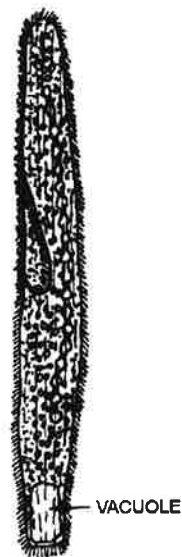
### ***Spirostomum***

*Spirostomum* has a markedly elongated, flexible cell covered with cilia, with a characteristic vacuole present at the extremity. *Spirostomum* usually moves quickly through the liquid between the flocs. It is the largest ciliate present in activated sludge, the cell length varying from 500 to 900  $\mu\text{m}$ .

*Spirostomum* commonly occurs in activated sludge, particularly in treatment plants with sludge loading levels less than ca. 0.2 kg BOD/kg MLSS.day.

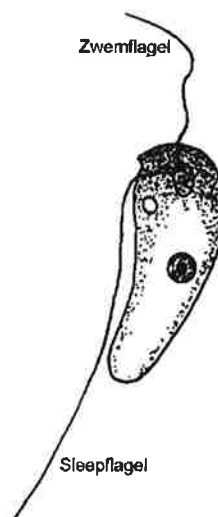
*Bodo* is a free-swimming flagellate, which propels itself with a characteristic jerky movement. There are two flagella present, one swimming flagellum and one trailing flagellum at the rear. The flagella are longer than the oval cell. The cell wall is dented at the point where the flagella are implanted. The flagella are not always clearly visible. The cells are approximately 15 µm in length.

The presence of *Bodo* sp. indicates a high sludge load (> ca. 0.4 kg BOD/kg MLSS.day) and/or a lack of oxygen.

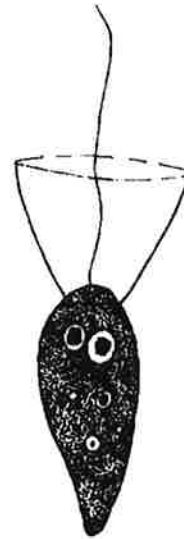
The cell is spherical to oval. A collar is present on its 'top' through which the flagellum emerges. *Monosiga* is usually fixed to a sludge floc. The cells are 1-15  $\mu\text{m}$  in length.

The presence of *Monosiga* indicates a high sludge load (> ca. 0.4 kg BOD/kg MLSS.day) and/or a shortage of oxygen

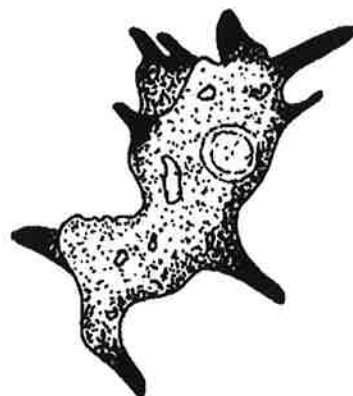
Amoeba are single-celled organisms possessing a flexible cell membrane which allows the shape of the cell to constantly change. They absorb nutrient particles (bacteria cells, other protozoa, etc.) by engulfing them. This resembles the uptake of food by a mouth opening. The sizes of the various strains range from 50 to 400 µm. Amoeba can be as big as a sludge floc and their particular structure sometimes resemble sludge flocs. Apart from the odd exception, amoeba move extremely slowly (by means of the pseudopoda).

Amoeba are characteristic of somewhat higher sludge loading levels (0.1-0.4 kg BOD/kg MLSS.day) and/or shortages of oxygen. They are seldom observed in low loaded nutrient removal plants.
