**This form will report compliance with your permit as determined by an NRW officer**

| Site | Bridgend Paper Mills | | | Permit Ref | EP3738NG | | |
| Operator/ Permit holder | Northwood and Wepa Ltd | | | | | | |
| Date | 5 June 2015 | | | Time in | 10:00 | Out | 14:00 |

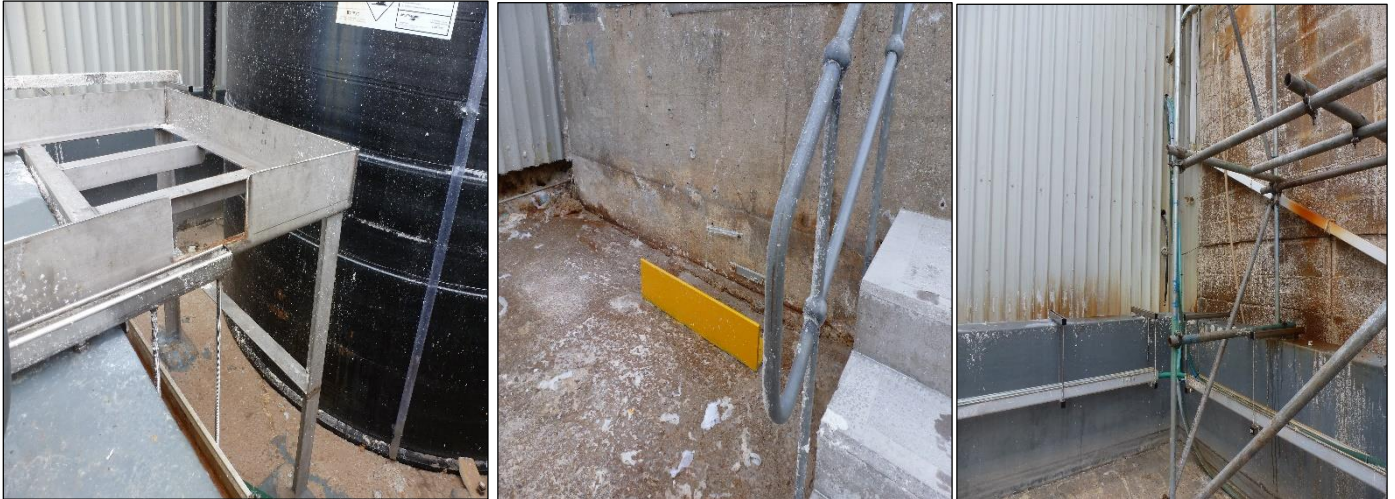
#### Sodium Hypochlorite (NaClO) Tank and Bund

The dust discharging into the secondary fibre yard from above the broke trimmings had collated in the bottom of the sodium hypochlorite tank bund and was wet and brown in colour. Since the last visit a structure had also been built on the side of the bund for placing intermediate bulk containers (IBC) on, when decanting sodium hypochlorite for use elsewhere in the process. This can be seen in the photograph bottom left. SB explained this activity is only undertaken by the most experienced staff on a certain shift. The photograph bottom middle shows a stop plate that has been installed just outside the bund to prevent a vehicle from driving too far into the structure while decanting. A discussion was had in respect of this activity and the pipework from the tank to the pulper (photograph bottom right) particularly where it enters

the corrugated cladding in the building as this is outside the bund and unprotected. Types of pipework and their preventative maintenance was briefly discussed with SB who explained was considered in the tank improvements. The inspecting officer would like to revisit this area of discussion during the next site audit.

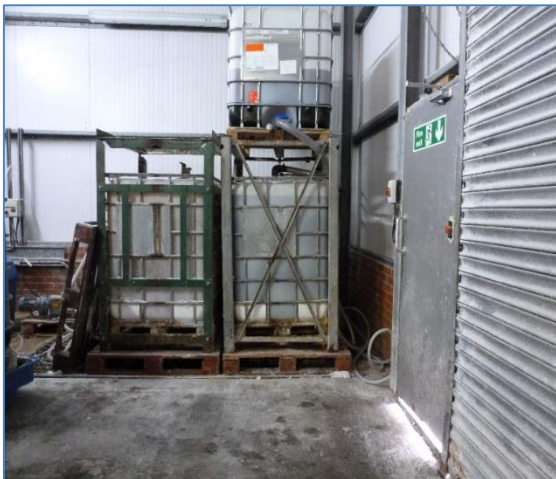
Leaving the secondary fibre yard and entering the chemical store for the paper machine or 'Jupiter Kitchen' it was immediately evident that the house keeping in this area had improved.

The store had been cleaned down however It was unfortunate that a spill had since taken place in the area. Absorbent pads were in place over the spill which looked like it had happened on a changeover of an IBC of softening agent rather than from a leaking pipe. KD enquired about the spill procedure on site and the 'clean up' of the agent. SB explained earlier in the audit that he has put a presentation together to raise further environmental awareness with the staff on site and this will be given soon.

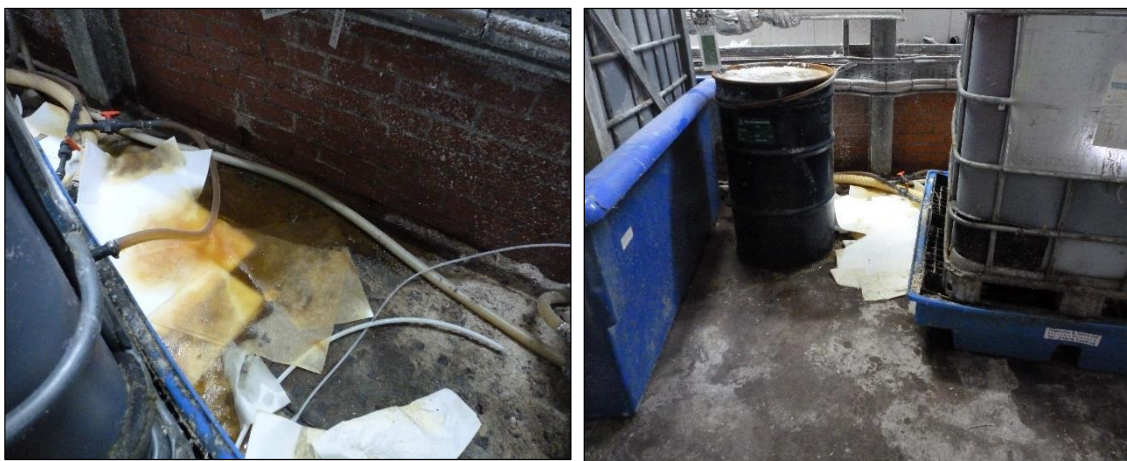
The photograph opposite was taken in the chemical store. The damage to the bottom of the door which had also been discussed previously is not that clear in the photograph (light can be seen coming in through the damage at the base of the

door). Although the door was shut on inspection dust was also still coming in and this can be seen on the floor of the store in the photograph. Prior to the capital investment on the broke baler with dust filtration the operator has to prevent the accumulation of dust and a new door will help keep this area clean, preventing water ingress and dust filling the bund and coating the IBC's. The photographs below show the spill of softening agent in this location which needed to be cleaned up. SB agreed to follow this up immediately

after the NRW visit. The lattice in the floor of the store had also been lifted and the bunded area beneath cleaned out following the last NRW visit and this was evident. However water had since collected, but

again it was unclear where this had come from. NRW will re-visit this with the operator in the next audit following the operator's on-site training.

**Action:** Operator to investigate how the bund in the floor of the Jupiter Kitchen is filling up with water as this can compromise the capacity of the bund in this area.

| Section 4- Action(s) | | | |
|---|---|---|---|
| NA | | <b>Action:</b> Operator to investigate how the bund in the floor of the Jupiter Kitchen is filling up with water as this can compromise the capacity of the bund in this area. | 8 August 2015 |

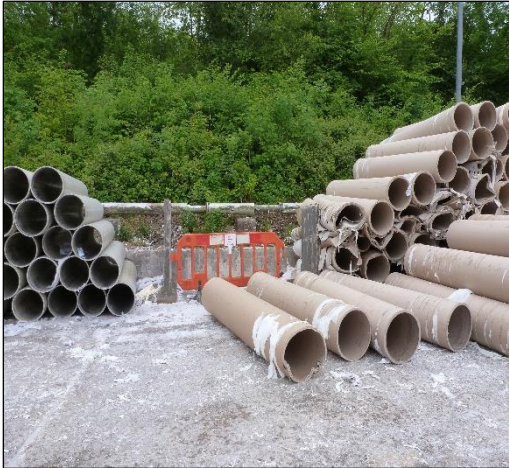
During the last visit it was noted and raised with the operator that the storage of tissue cores appeared to block access to emergency services in the secondary fibre yard. SB had explained that concrete kerbs had been put in place either side of the services. The photograph below shows the temporary isolation of the services however a stack of cores had partially collapsed in front of the kerbed area. SB explained that this had been a problem and a permanent solution was being sought.
