**WYNNSTAY GROUP PLC  
LLYSONNEN MILL, CARMARTHEN**

**INTEGRITY ASSESSMENT**

**MAY 2011**

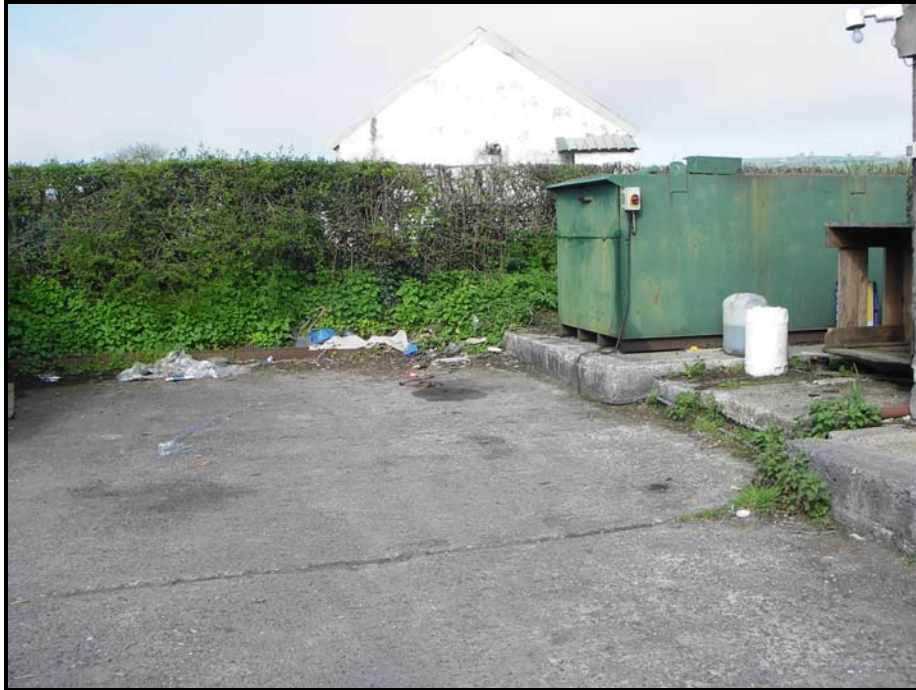
**Picture 1 – Installation of ACO Drainage required to ensure capture and treatment of possible fuel spills.**

Where areas of kerbing are unsuitable, ACO surface water drainage should be installed as an alternative to capture any fugitive release of surface waters.

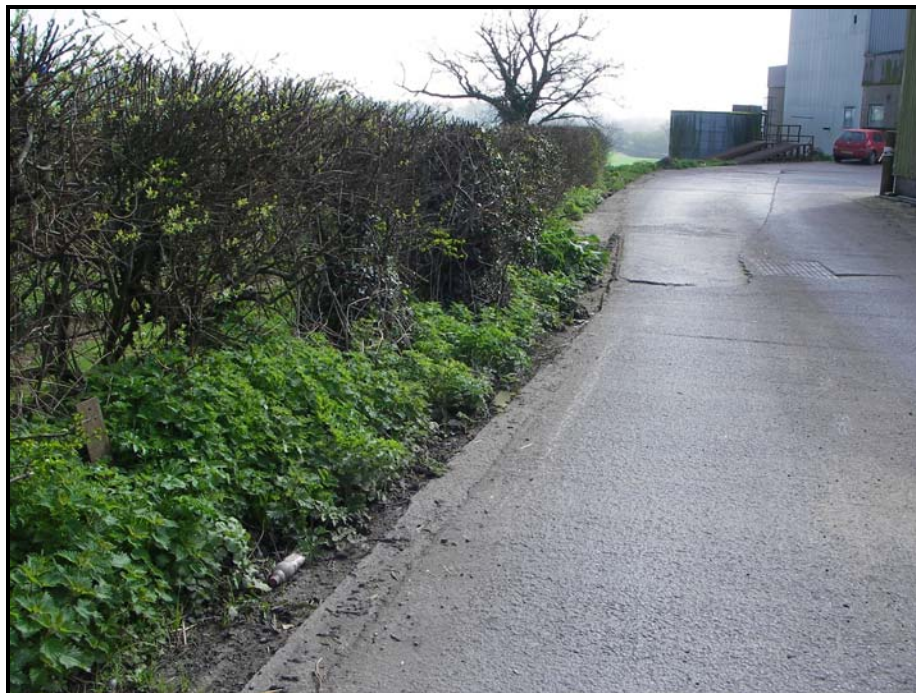
**Picture 2 – Installation of Surface Kerb required to ensure the on-site containment and treatment of surface waters.**

Kerbing surrounding areas of hardstanding is required in order to control surface waters. The installation of kerbing ensures that any surface waters produced during periods of rainfall are contained on the hardstanding and are disposed of via the appropriate treatment and surface water drainage systems.

The site assessment identified that there are currently no areas of hardstanding with kerbing.

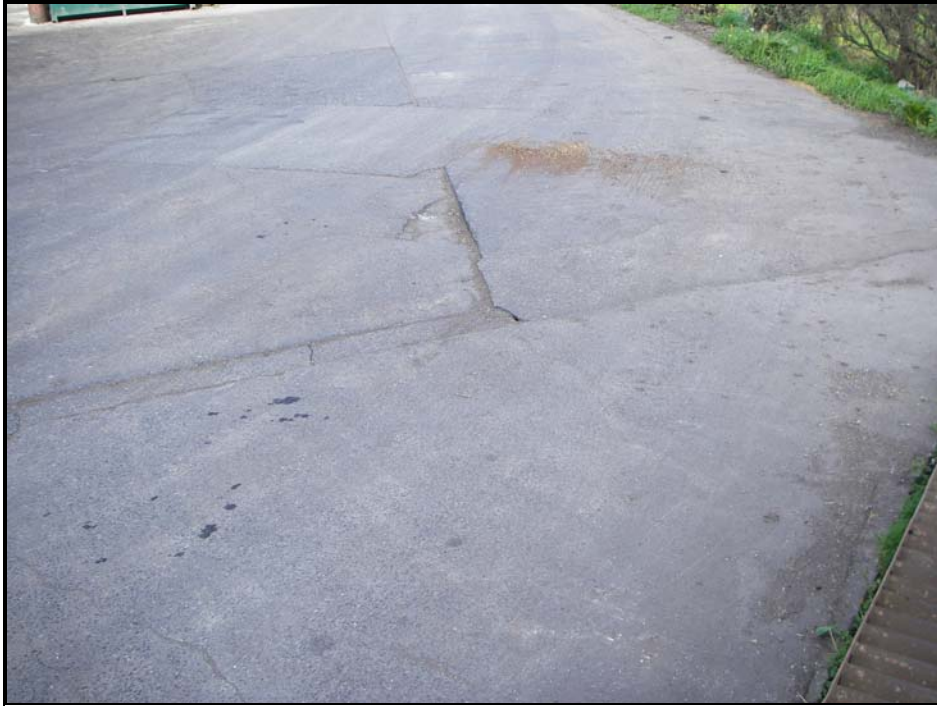
During the assessment, a number of areas were identified that are in need of repair in order to restore the impermeability of the hardstanding. The damage identified consisted of cracking to the concrete slab and general degradation of the expansion joints.

**Picture 3 – Slab Area A highlighted in drawing 129-01-03.D01**

Drawing 129-01-03.D01 In Appendix A identifies the areas of the hardstanding which require repair, whilst drawing 129-01-03.D02 In Appendix B provides a typical design specification for the repair works.

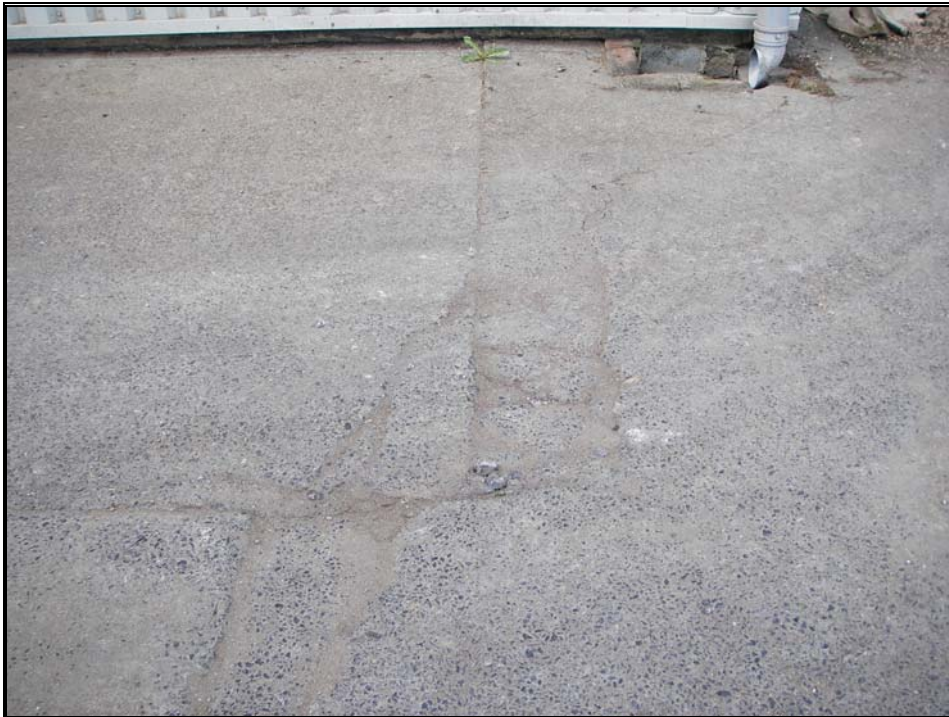
**Picture 4 – Slab Area B highlighted in drawing 129-01-03.D01**

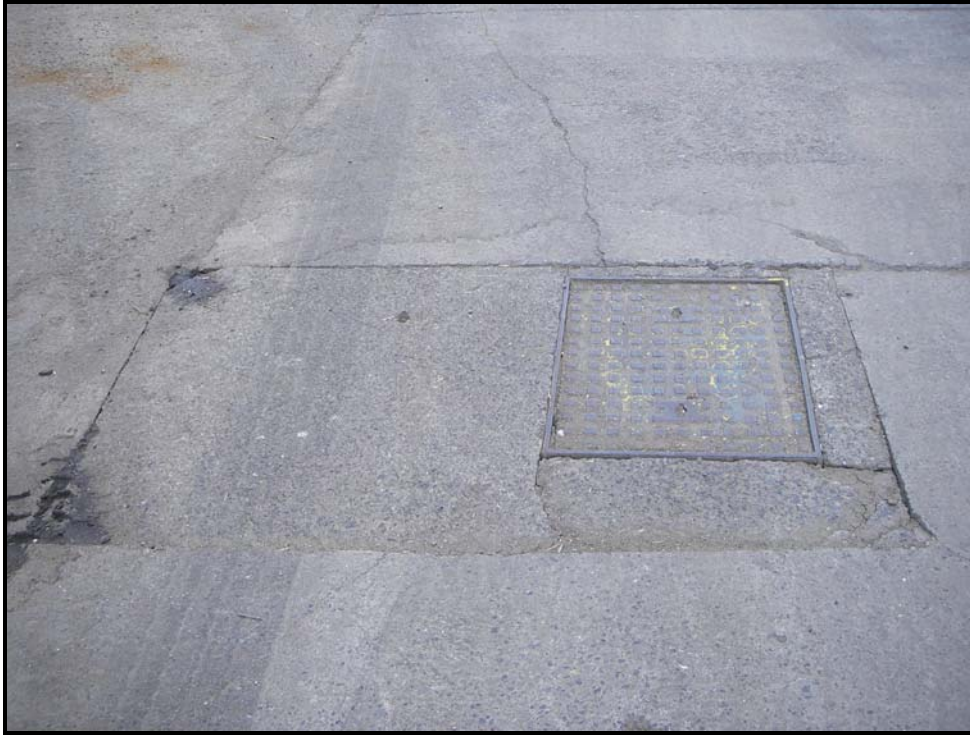
**Picture 5 – Slab Area C highlighted in drawing 129-01-03.D01**

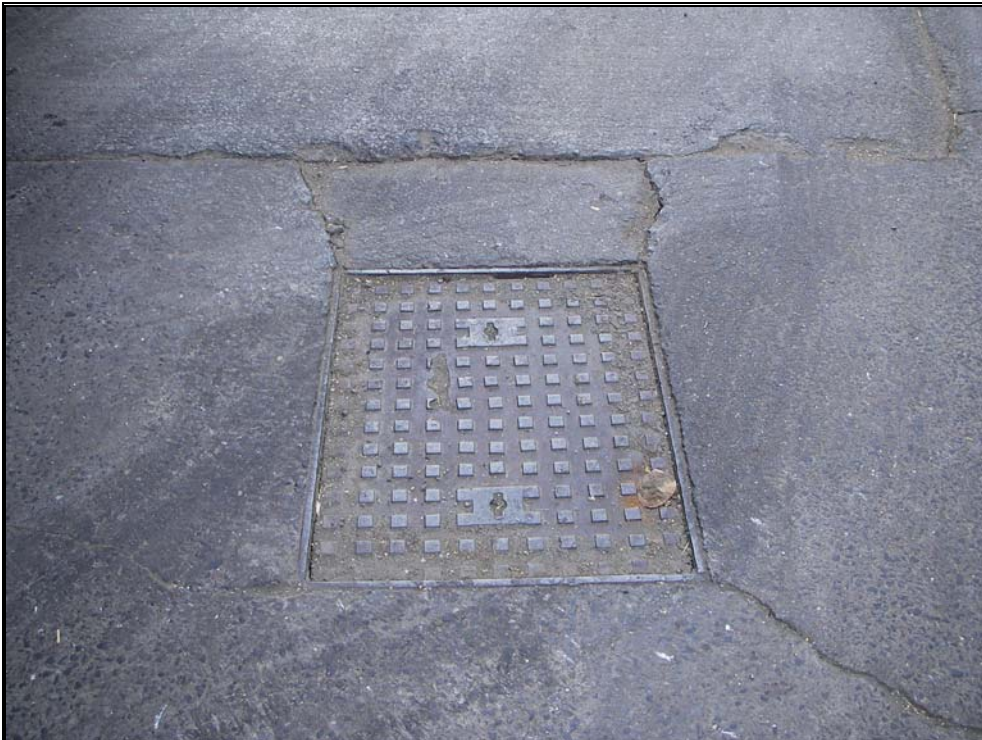
**Picture 6 – Slab Area D highlighted in drawing 129-01-03.D01**

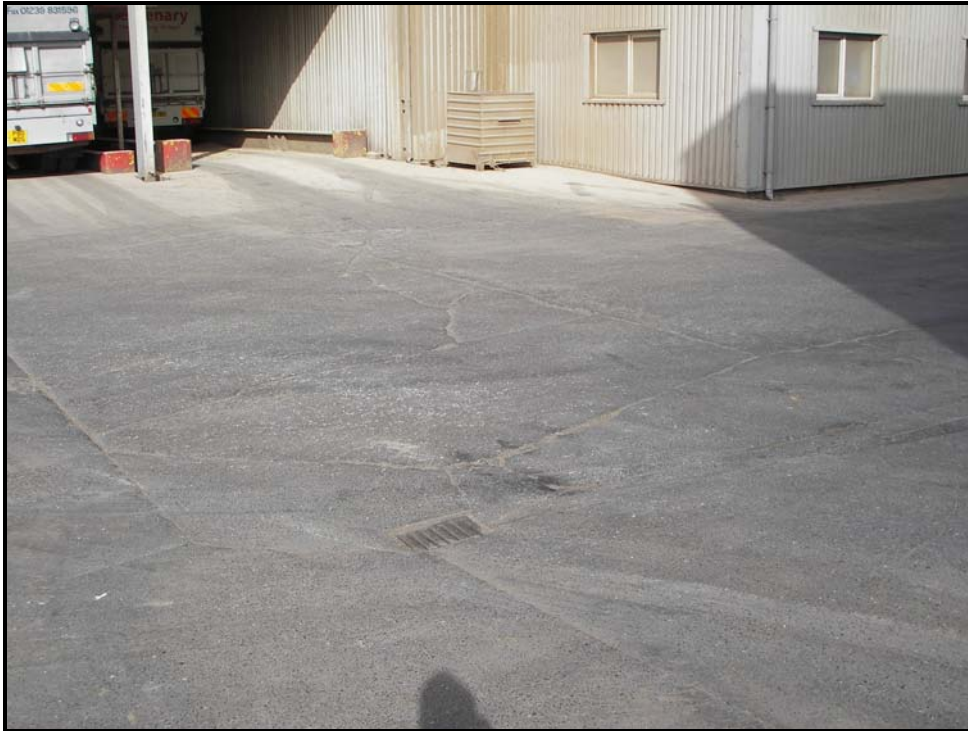
**Picture 7 – Slab Area E highlighted in drawing 129-01-03.D01**

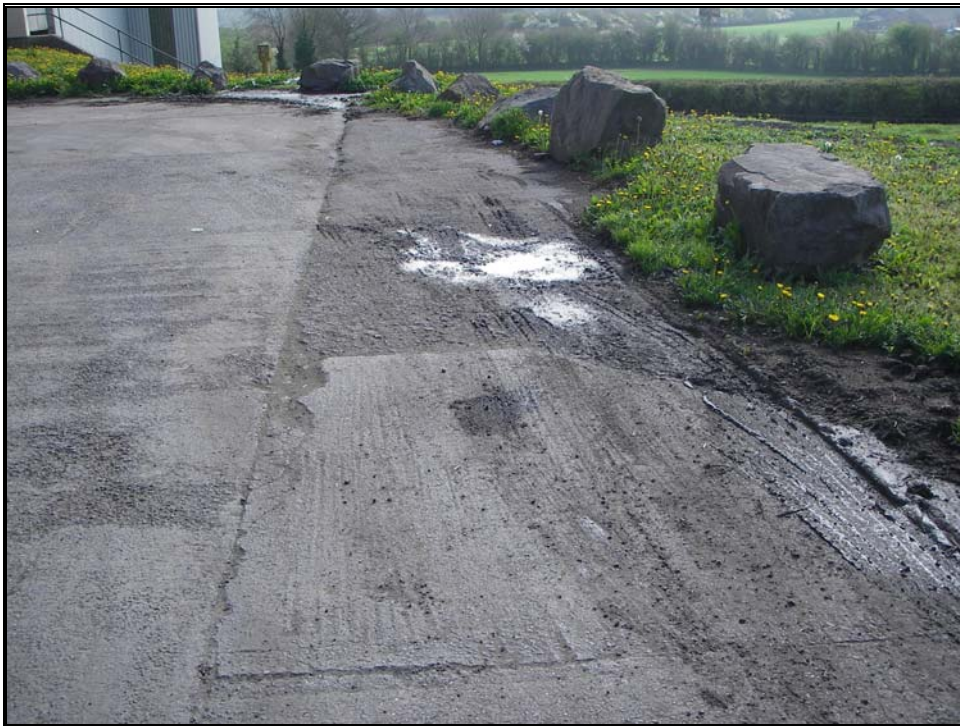
**Picture 8 – Slab Area F highlighted in drawing 129-01-03.D01**

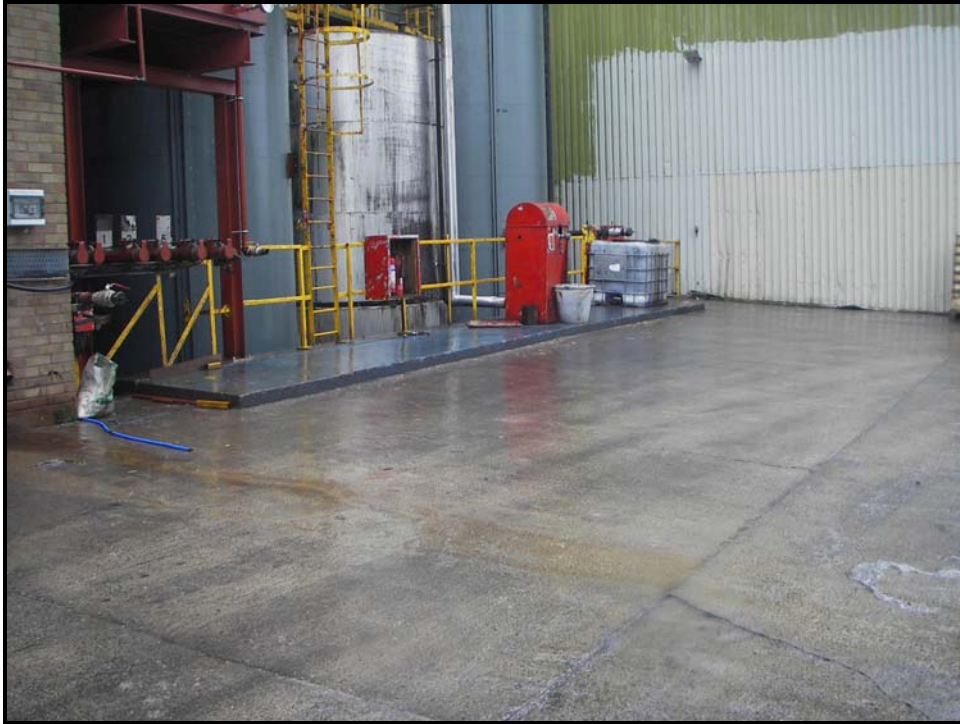
Due to the currently prevailing construction details, it would be possible for the contents of the bund to drain into the surface water drainage system via existing rainwater connections.

This would allow potentially contaminated water or product to be discharged directly into a drainage ditch.

**Picture 9 – Installation of Containment Bund required to ensure the capture of potential spills.**

In order to ensure that the bund will contain either rainfall or any product from the tanks, remedial works are necessary. These include: -

- Sealing existing surface water drainage connections within the bund,
- Bund extension to capture potential spills of pipework currently outside the bunds' catchment area.
- Sealing of construction expansion joint at surface level.

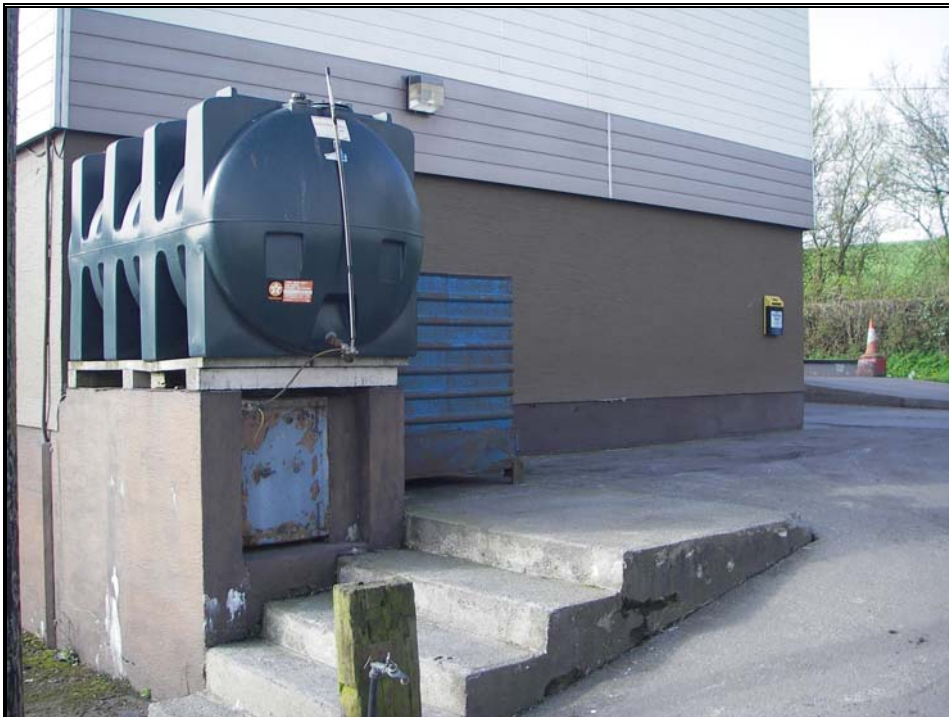
The fuel oil storage tank adjacent to the main office is not placed within a bunded area. If a release occurred via damage to the tank or associated pipework, the spill would not be contained.

**Picture 10 – Installation of Fuel Tank Bund with 110% Capacity to ensure the capture of potential spills.**

Drawing 129-01-03.D01 in Appendix A and drawing 129-01-03.D03 in Appendix B highlight the location and typical design specification of the improvement works required to restore the integrity of the Secondary containment at this location.

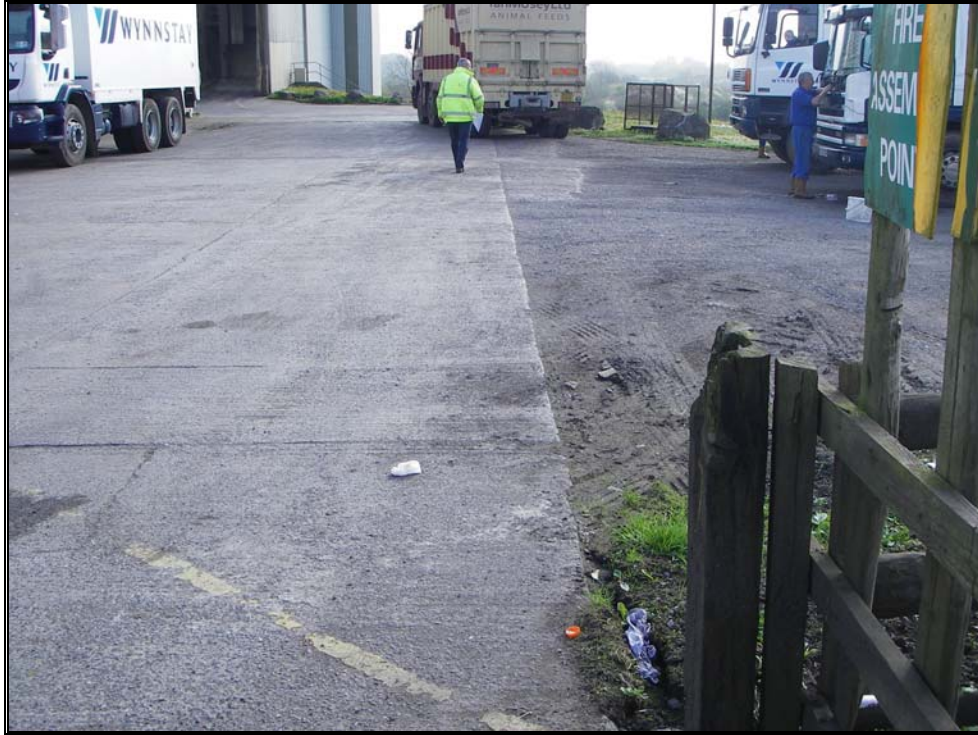
**Picture 11 – Installation of ACO surface water drainage required to ensure the on-site capture and treatment of surface waters.**
