## Compliance Assessment Report

Report ID:  
CAR\_NRW0031972

| Site | Pembroke Power Station | Permit Ref | DP3333TA | | | |
| Assessment type | Audit | | | | | |

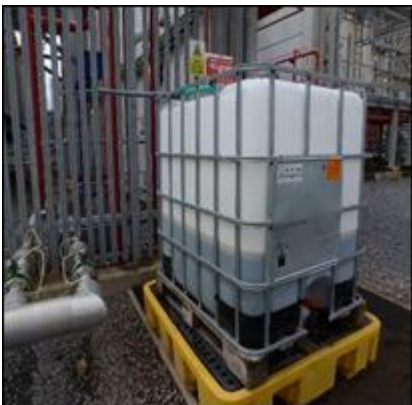
The photographs below were taken during the on-site tour. The picture left shows the belt skimmer on the transformer bund trialled on Unit 51. The skimmer was in operation at the time of the visit and was seen to be successfully removing surface water oily residue from the bund. The central photograph shows the water in the bund into which the skimmer descends and coats the belt for

recovery into an intermediate bulk container (IBC) which can be seen below right.

During this visit the operator outlined the investigation findings and actions taken to prevent oil arising at discharge point W2. As notified in line with the Environmental Permit and following a full internal investigation it was considered that the source of the oil had originated from the transformer bunds. An oil skimmer had been trialled on one of the 5 bunds and found to be a success, this has subsequently resulted in their proposed installation on all transformer bunds.

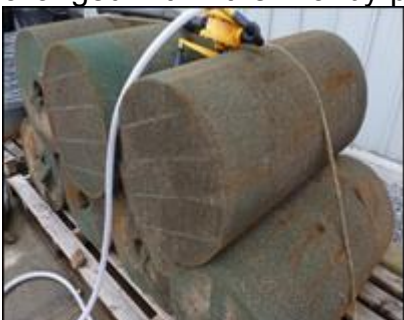
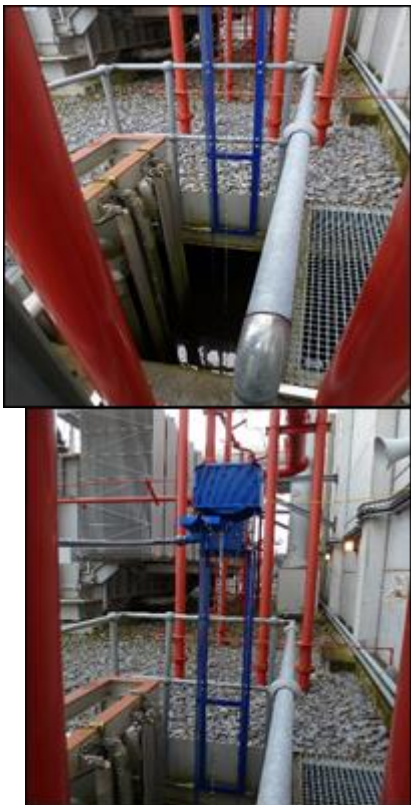
It was confirmed during this visit that the action is now complete and the filters have also been changed within the final by-pass interceptor. The old filters were evident during the site tour and were photographed in the new waste reception area (photograph opposite). Prior to going on site the operator explained that the valves on the final interceptor had also been trimmed back as a temporary modification until a permanent change can be made to

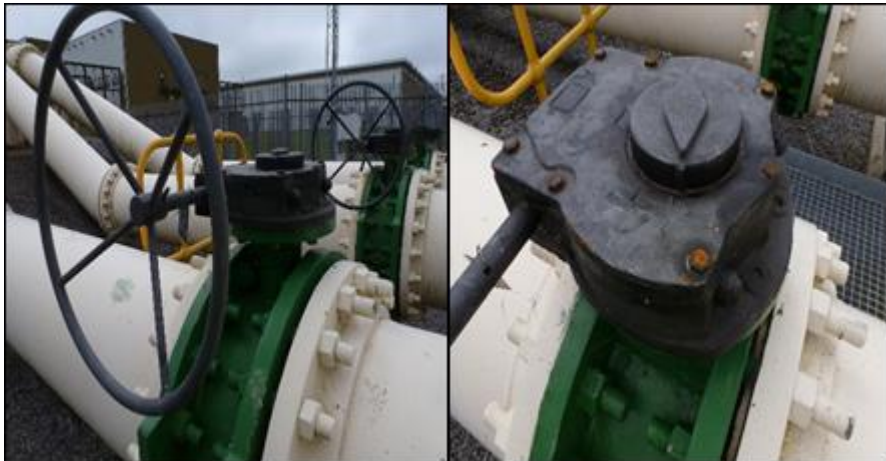
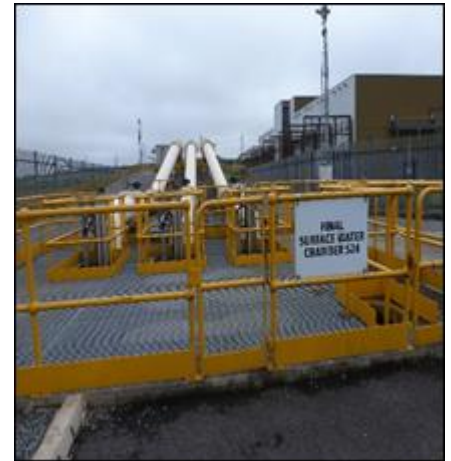
the interceptor by raising the weir in the first chamber allowing for the required retention time and preventing it by-passing the system. The investigation has discovered that the volume of water when pumped to the interceptor was resulting in the by passing of the system. When the valves were fully open the surface water was flowing over the top of the weir so by trimming back the valves and restricting the flow on the outlet pump the retention time for separation was achieved. The operator explained that the work to raise the weir would require the entry of a confined space and the need to work in a dry interceptor. The pumps used in the system are sized to prevent the flooding of the power station and large enough to cope in the event of such a situation. Preventative maintenance of the interceptors were discussed and the operator explained that they have a new on-going contract with an oil 'clean up' specialist.

The photographs above were taken on site and shows the final surface water chamber and the valves on the surface water system that have been trimmed back ( the central pointer in the above right photograph indicates the trimming back of the valve). The surface water then leaves the site via discharge point W2.

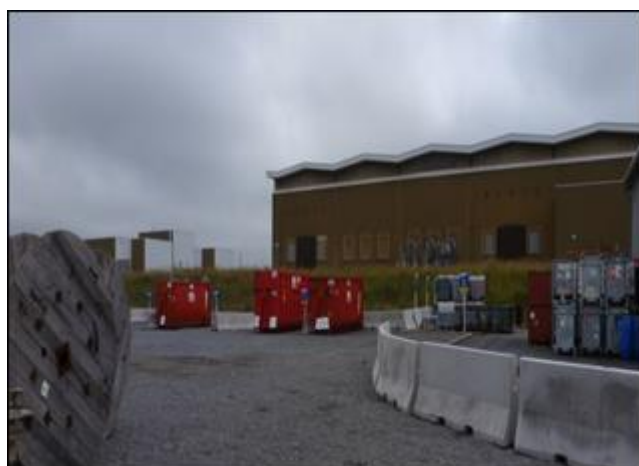
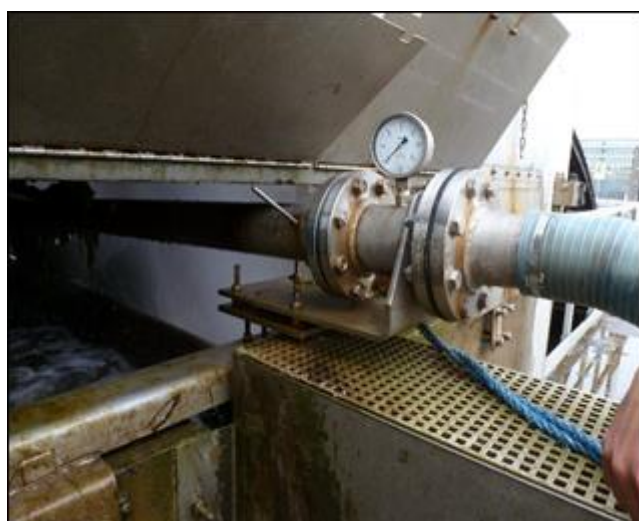
The photographs below were taken which clearly show the labelled designated areas.

The 2017 objectives are similar to those in 2016 however it is clear on review that progress has been made due to the change in targets for the year. The programme includes internal audits on waste, implementation of the central EMS and improvements to the Fish Return and Recovery System. Evidence against the 2017 objectives was evident during the site tour which included the new waste storage area with associated labelled segregated areas and the trials concerning the foam with the front penstocks only. Although waste did not form part of this audit the new compound was visited during the site tour and the
