**Reference:** Closure Device Inspection at Protherics UK, Llandysul

#### **Closure Device 1 (Main Yard Discharge point )**

| Natural Solutions Annual Inspection | | | | | | |
|---|---|---|---|---|---|---|
| Closure Device Initial Assessment | | | | | | |

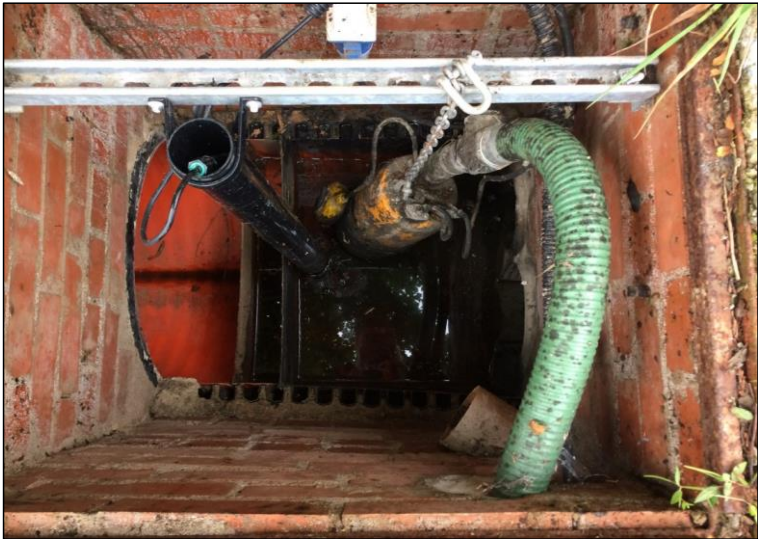
The high oil alarm failed to activate the closure device and requires a new oil probe to return the system to full working condition.

| Activate high oil alarm and check function | Fail | High | High oil alarm fails to activate. New probe required. |

Upstream chamber containing high oil probe and sump pump

- Replace the probe on the high oil alarm.
- Continue inspecting the closure device on an annual basis.

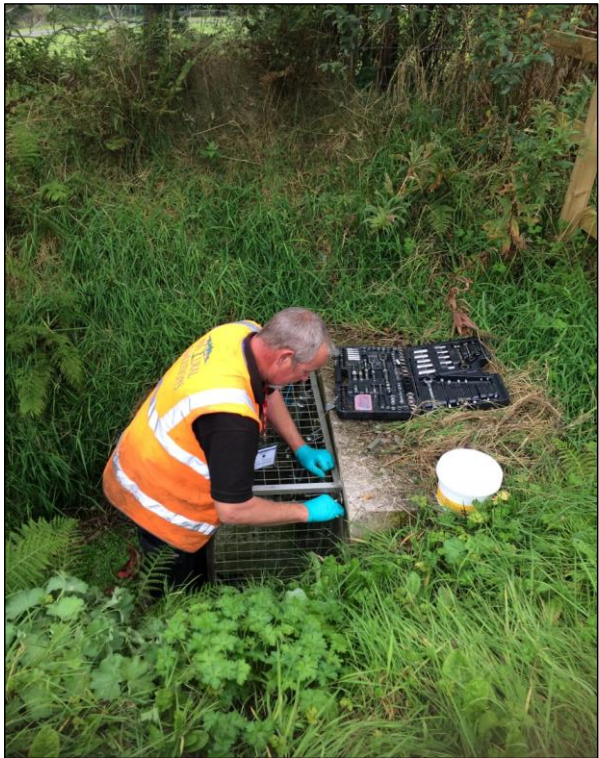
Location of closure device
