**TIR JOHN LANDFILL  
CELL 16 DETAILED  
DESIGN & CQA PLAN**

*Report Number 1575r1v2d0617*

Geotechnology Ltd  
Ty Coed  
Cefn-yr-Allt  
Aberdulaish  
Neath  
SA10 8HE

**JUNE 2017**

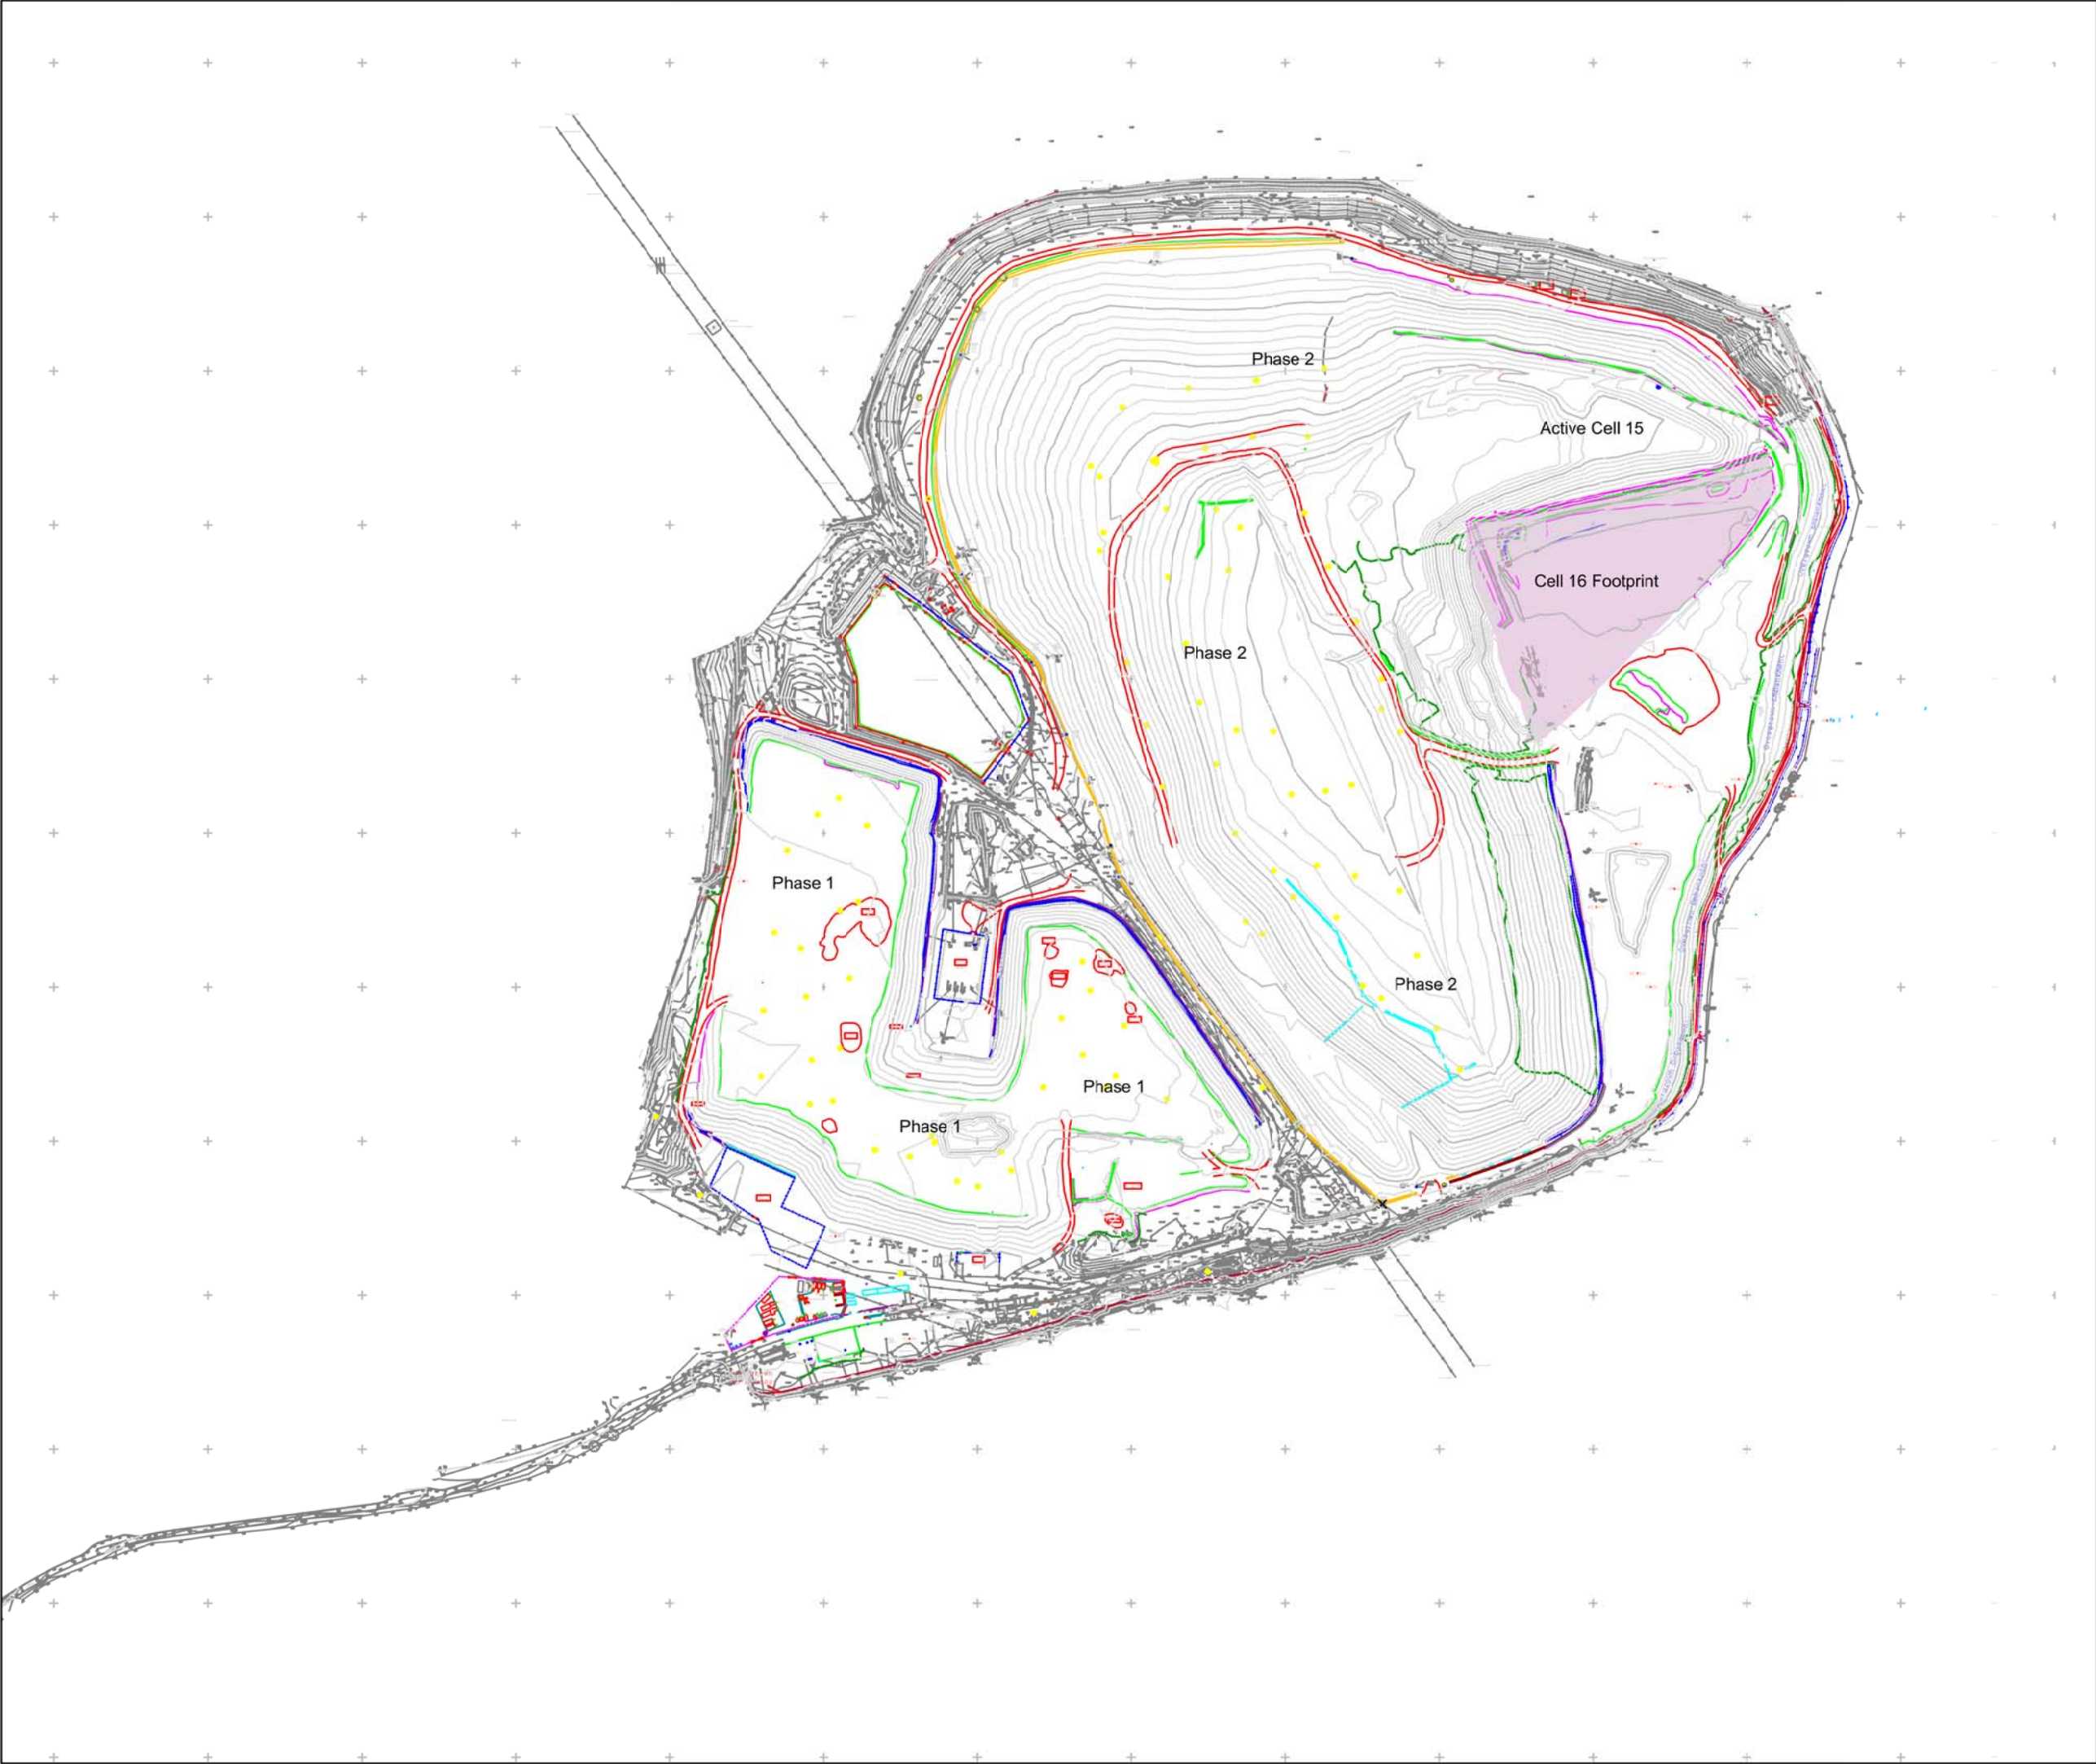
Drawing Number 1575/3

FORMATION LEVELS

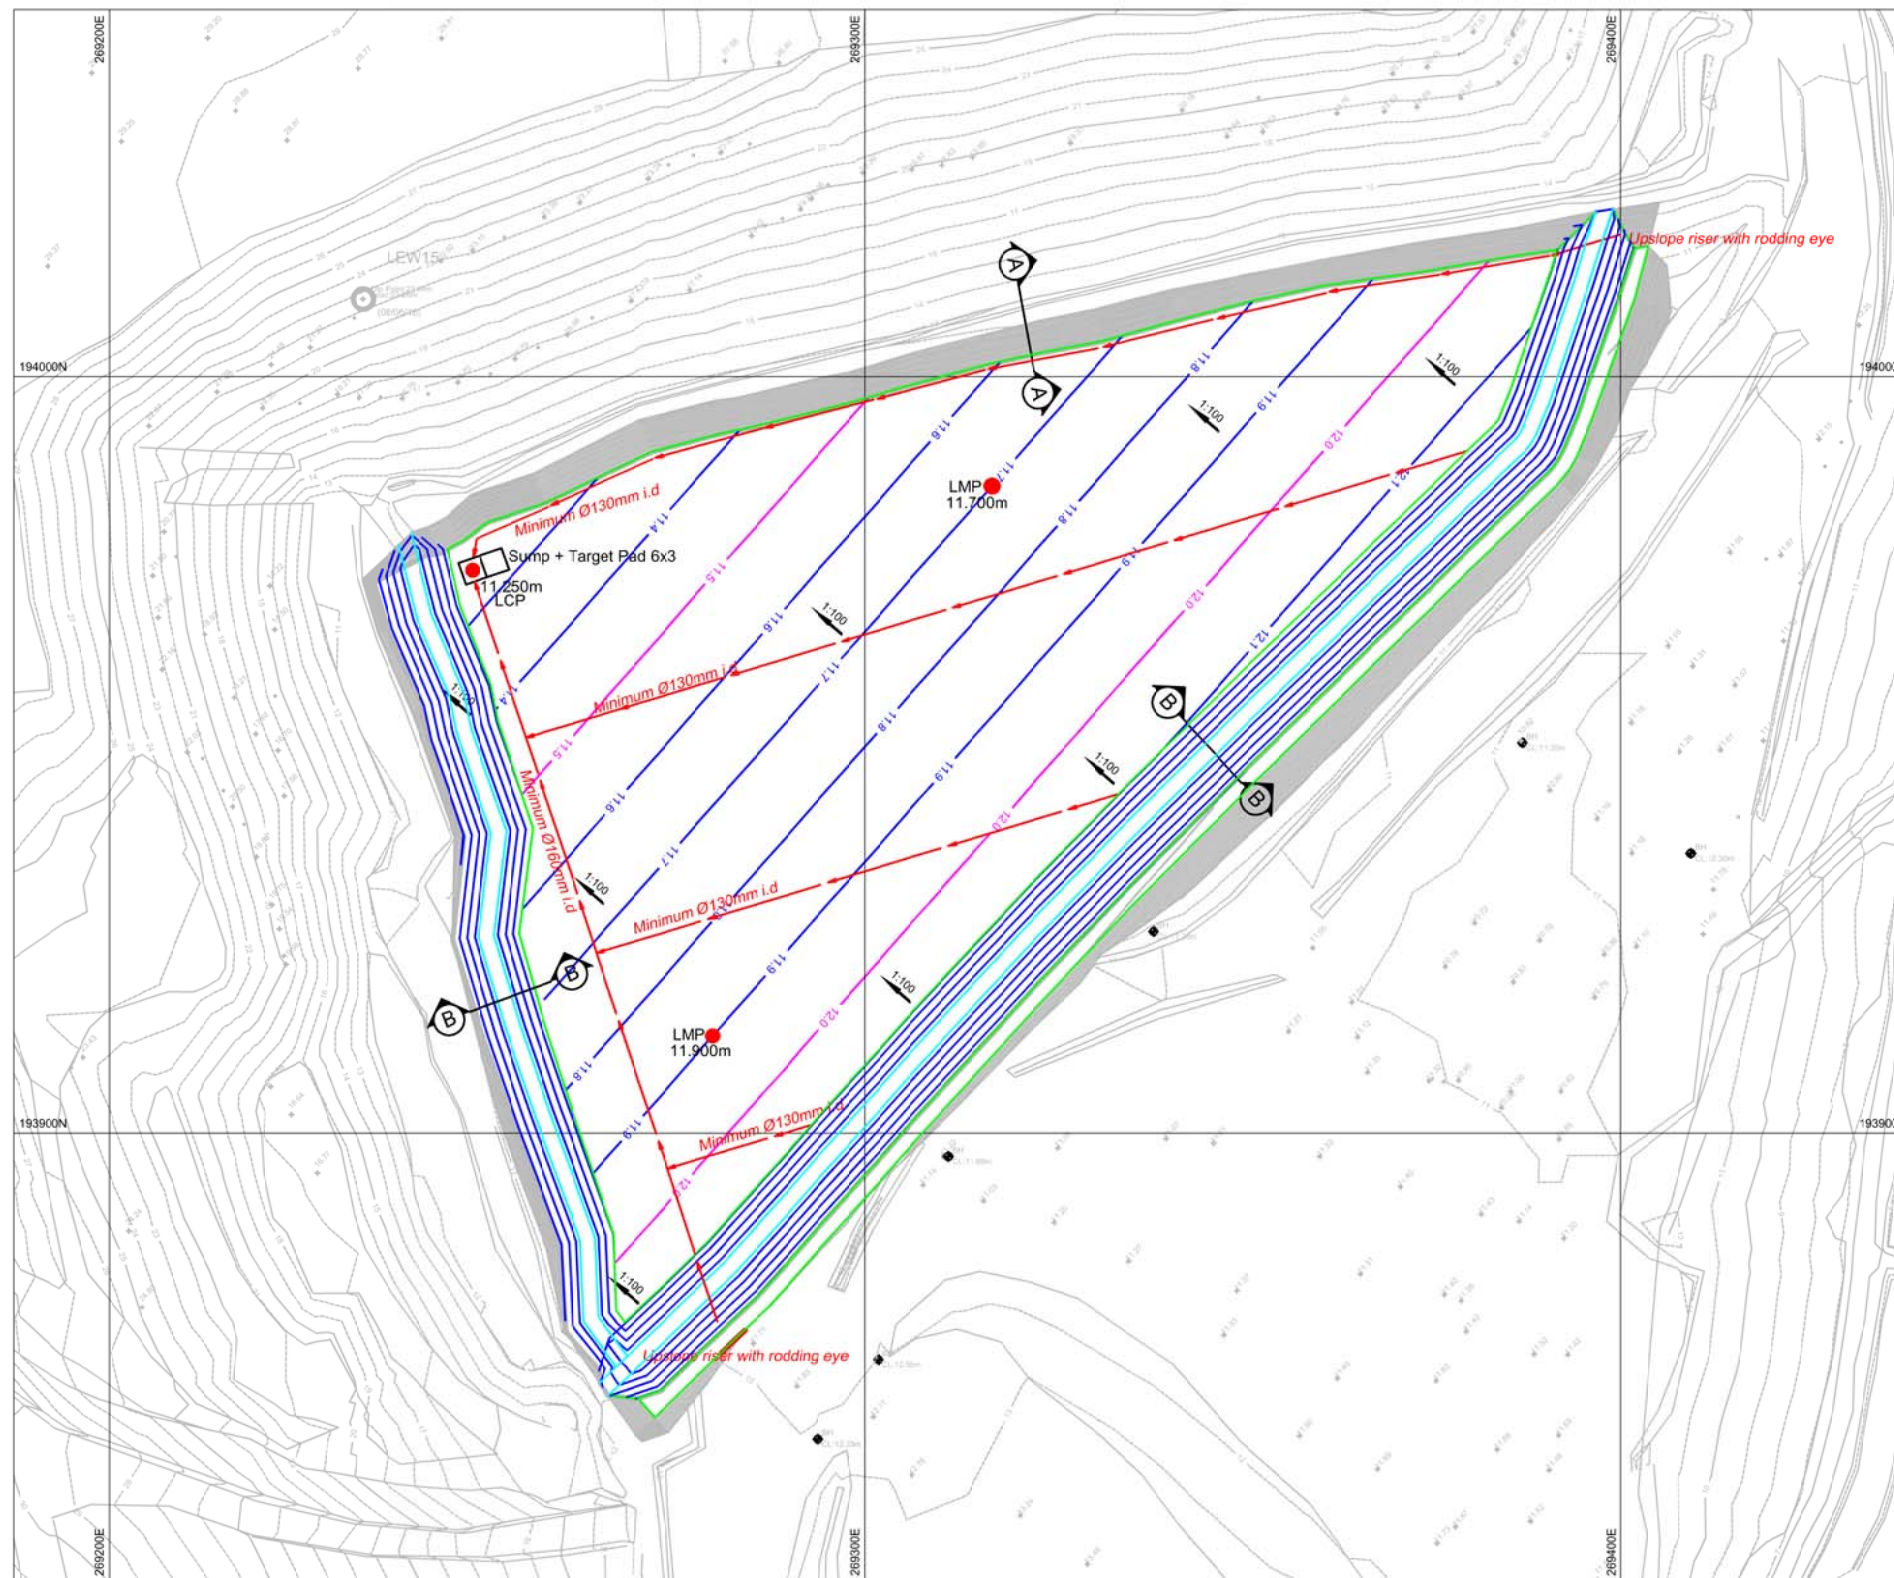
Drawing Number 1575/4

TOP OF CLAY LEVELS & LEACHATE CONTROL SYSTEM
