H5 Site Condition Report for Tomlinson's Dairy, Unit D, Five Crosses Industrial Estate, Wrexham, LL11 3RD

Version 1.0

In support of Application Reference: PPN-00061

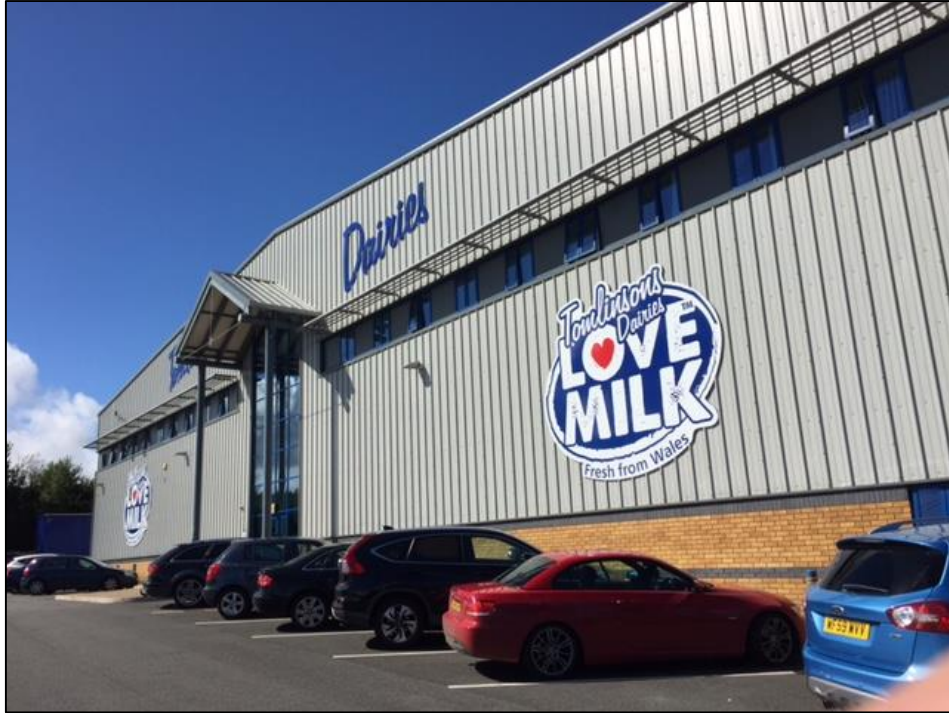
Photograph 1: Hard standing, carp parking and main building

Hard standing should be inspected on a regular basis to identify cracks and wear and tear. Where identified these should undergo maintenance and repair to maintain a low permeability surface reducing the potential of vertical migration into the sub surface. The hard standing minimises infiltration of precipitation and therefore reduce the risk of mobilising any unforeseen unidentified contamination in the sub surface; and

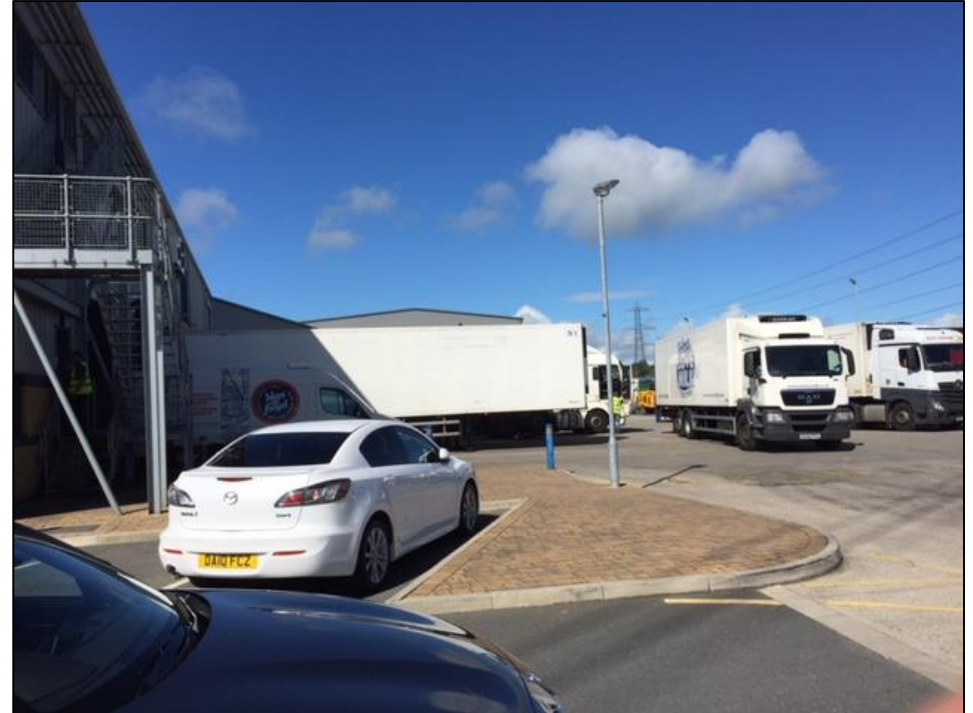
Photograph 2: Lorries on site, reinforced concrete hard standing

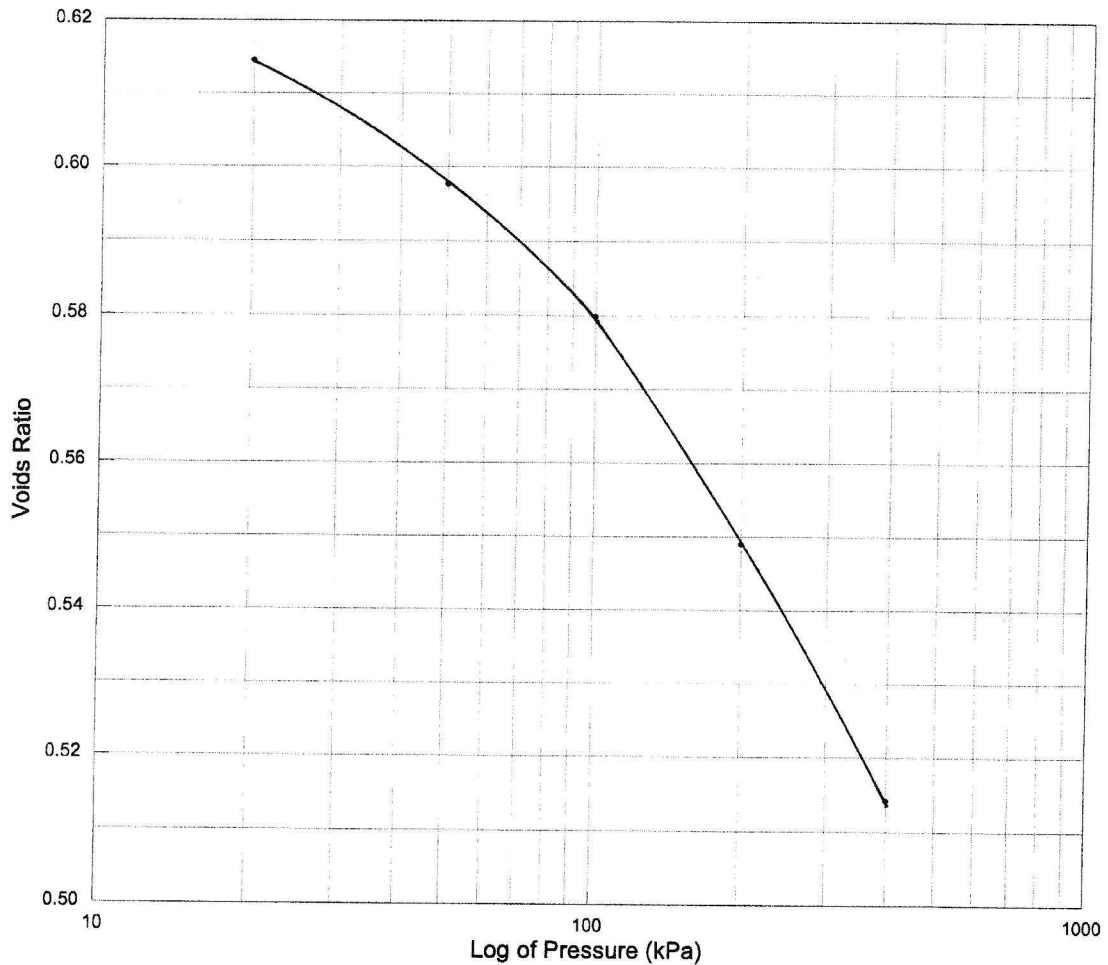
Description:

Soft to firm brown slightly sandy CLAY with occasional fine to coarse gravel.

Initial Conditions:

Moisture Content (%) 25
 Voids Ratio 0.627
 Diameter (mm) 76.2
 Height (mm) 18.6
 Bulk Density (Mg/m³) 2.05
 Dry Density (Mg/m³) 1.64

Final Conditions:

Moisture Content (%) 22
 Voids Ratio 0.514
 Particle Density (Mg/m³) 2.67 (Assumed)
 Laboratory Temperature (°C) 19.1

Consolidation tests carried out at a depth of 1.00 metre in borehole 3 and 4 indicate that the near surface weathered boulder clays have a medium compressibility (section 8.0). Allowing for the fact that the clays are over consolidated, total settlements are unlikely to exceed an order of 25 mm, provided the required bearing capacities for a particular depth and foundation type are kept within those loadings mentioned in the table.

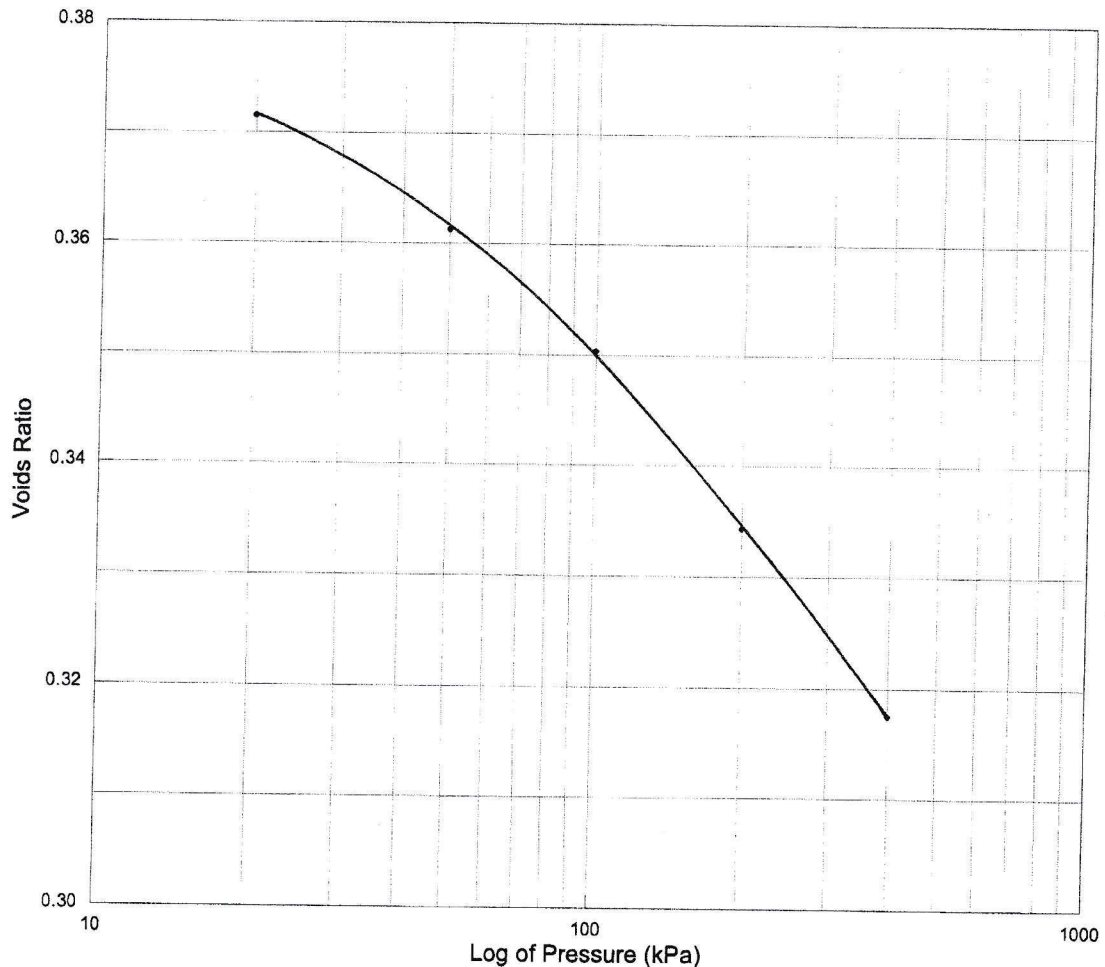
Description:

Firm mottled grey and brown silty CLAY with occasional fine to coarse gravel.

Initial Conditions:

Moisture Content (%) 15
 Voids Ratio 0.382
 Diameter (mm) 76.2
 Height (mm) 18.7
 Bulk Density (Mg/m³) 2.24
 Dry Density (Mg/m³) 1.94

Final Conditions:

Moisture Content (%) 15
 Voids Ratio 0.317
 Particle Density (Mg/m³) 2.68 (Assumed)
 Laboratory Temperature (°C) 19.1
