Doc Ref: MECL/F8 Site Setting

Morganite Electrical Carbon Ltd.

VP3339PD/As Varied.

Partial Site Surrender (Surrender of Vacated Land).

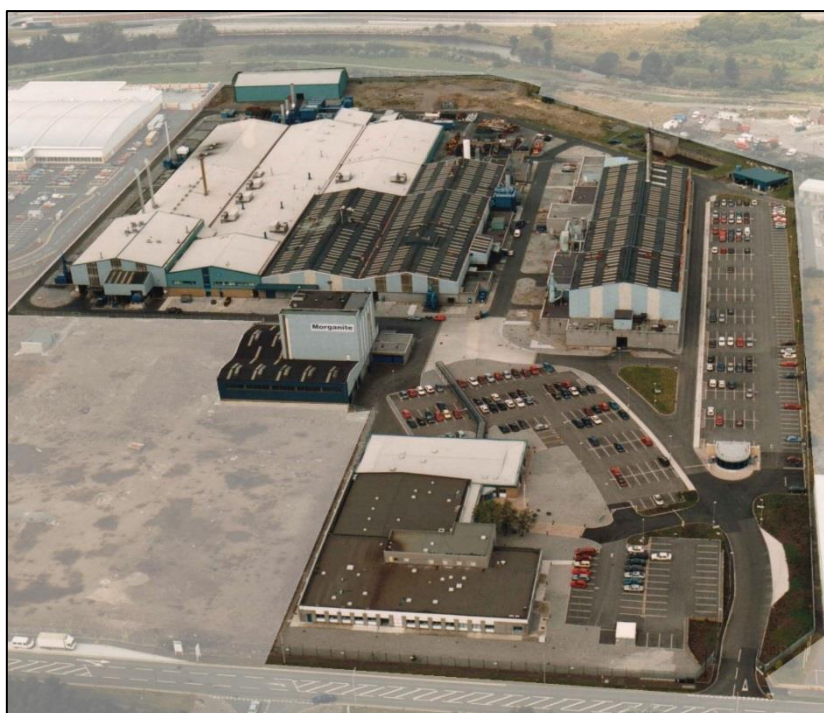
Aerial Photograph of site: circa 1998.

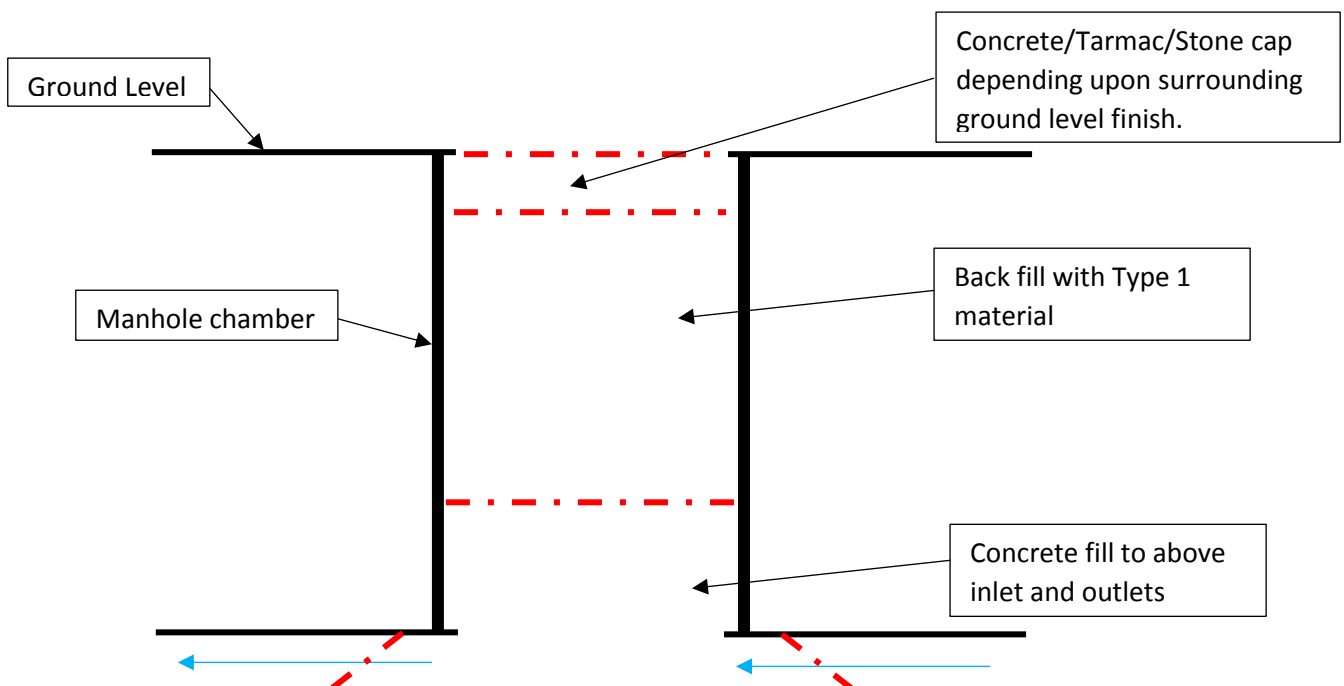
The site Trade Effluent Systems drains into a single outfall point (S1). Sources, manholes and pits feeding into this drainage system which fell outside of the retained site boundary have been capped using the method below and thus only effluent sources from the retained site permit boundary now drain into this outfall point.

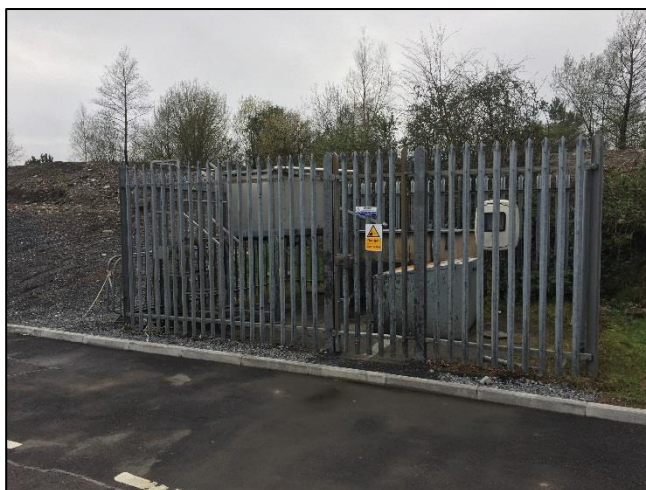
Trade Effluent Compound (Emissions point S1)

The emissions point (S1) was removed as a monitored point by V010 of the permit (VP3339PD) in November 2018.

Note: This emission point (S1) will continue to be monitored as part of the sites Welsh Water sewer discharge consent.

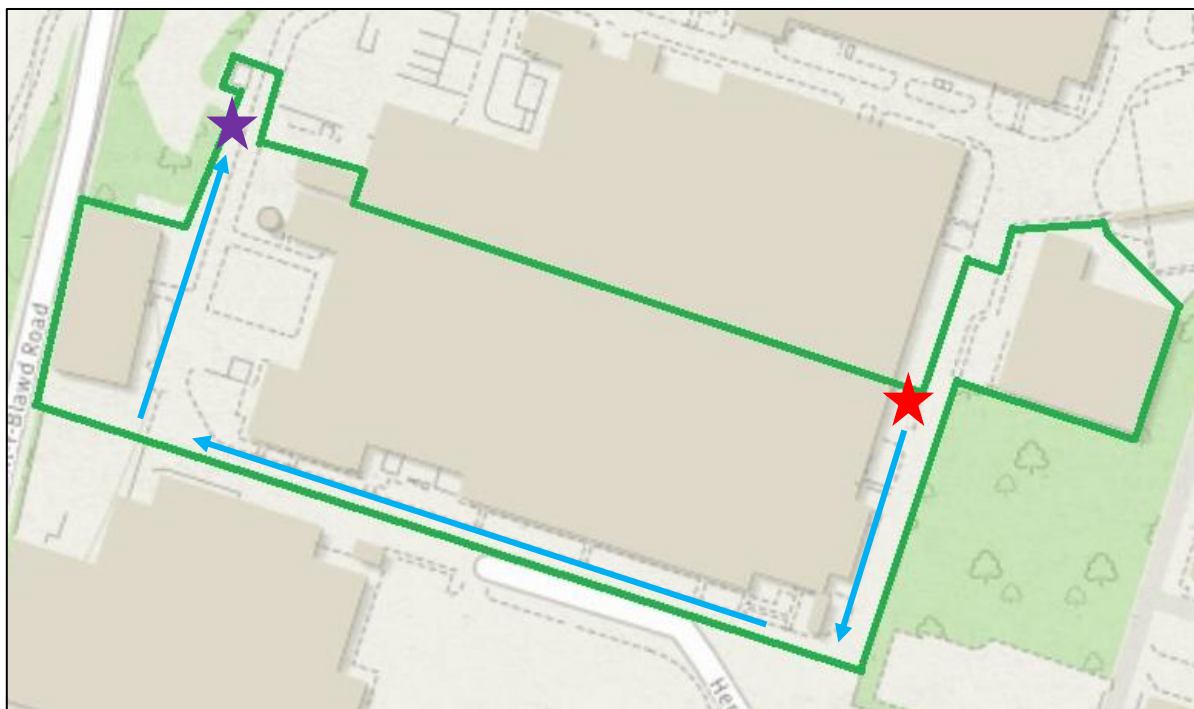
The drainage system enters the site at the North-East Boundary and Flows in a clockwise direction around the perimeter and exits through the North-West Boundary, as shown below. Regular visual checks of the manholes will be taken and if determined that possible contamination is present, water samples will be taken to determine the source of pollutant from the first and last identified manhole chambers to identify if any pollution/contaminates are entering or leaving the site boundary.

Entry Point – Just inside fence line on Green Walkway

Exit Point – In Grass in front of Security Cabin
