## **Afon Alice Hydro Scheme**

### **Ecology Report**

<b>Client</b>	Greenearth Hydro
<b>Author of Report</b>	Chris F. Brown MCIEEM
<b>Date of Report</b>	26th September 2018

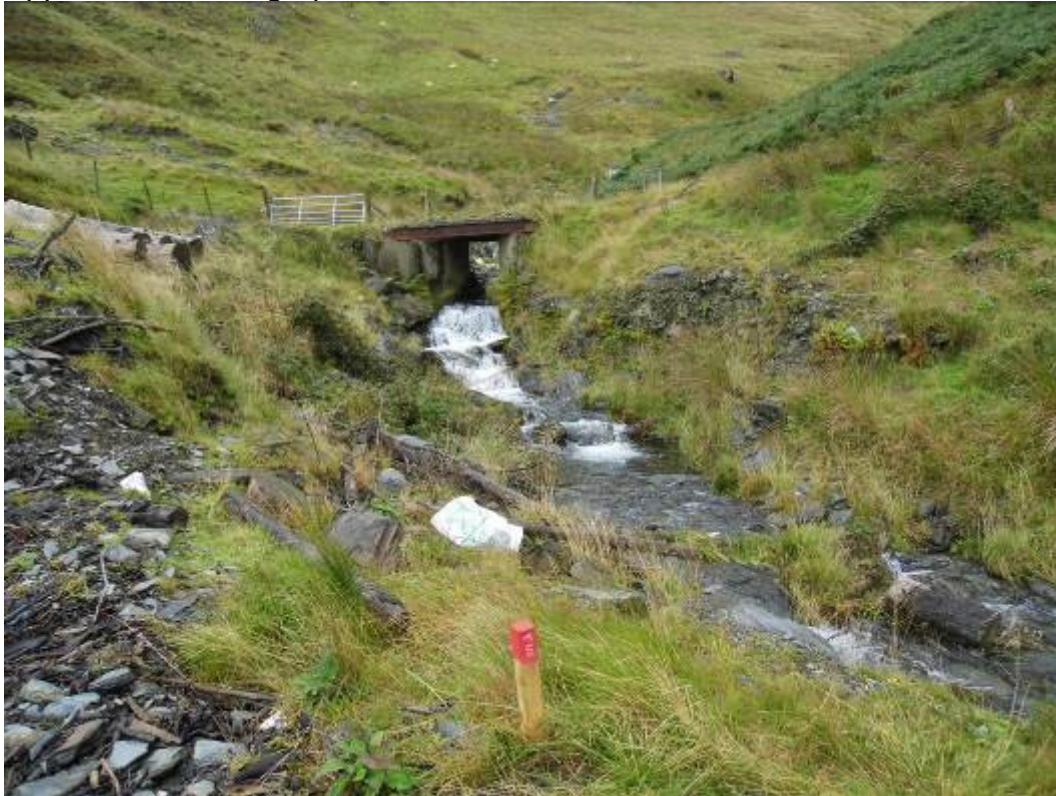
Photo 1: Intake 1 location

The proposed penstock route is close to the Afon Alice, which forms a narrow upland stream, with forested banks for much of its length. Photo 1 (Appendix 3) shows intake 1 location. The area immediately adjacent to intake 1 (Photo 2, Appendix 3) largely consists of acid grassland vegetation, grading to low scrub and plantation forestry just downstream.

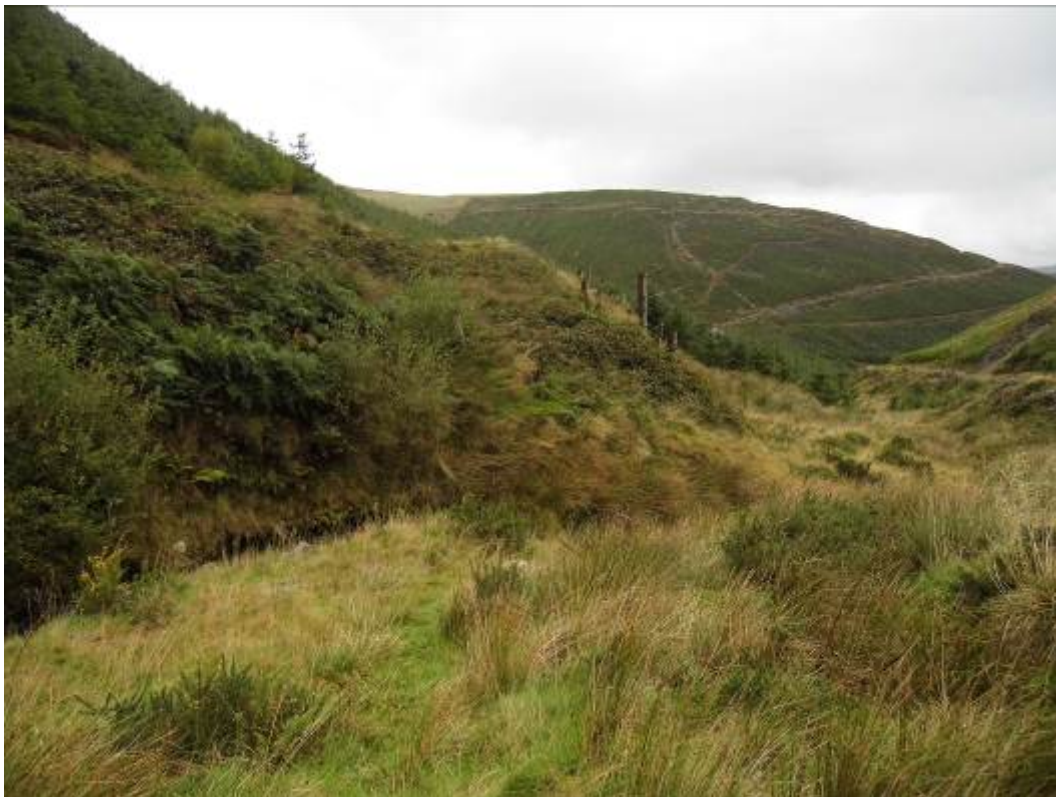
Photo 2: Penstock route from Intake point 1 showing acid grassland (some bracken) and running into low plantation forestry

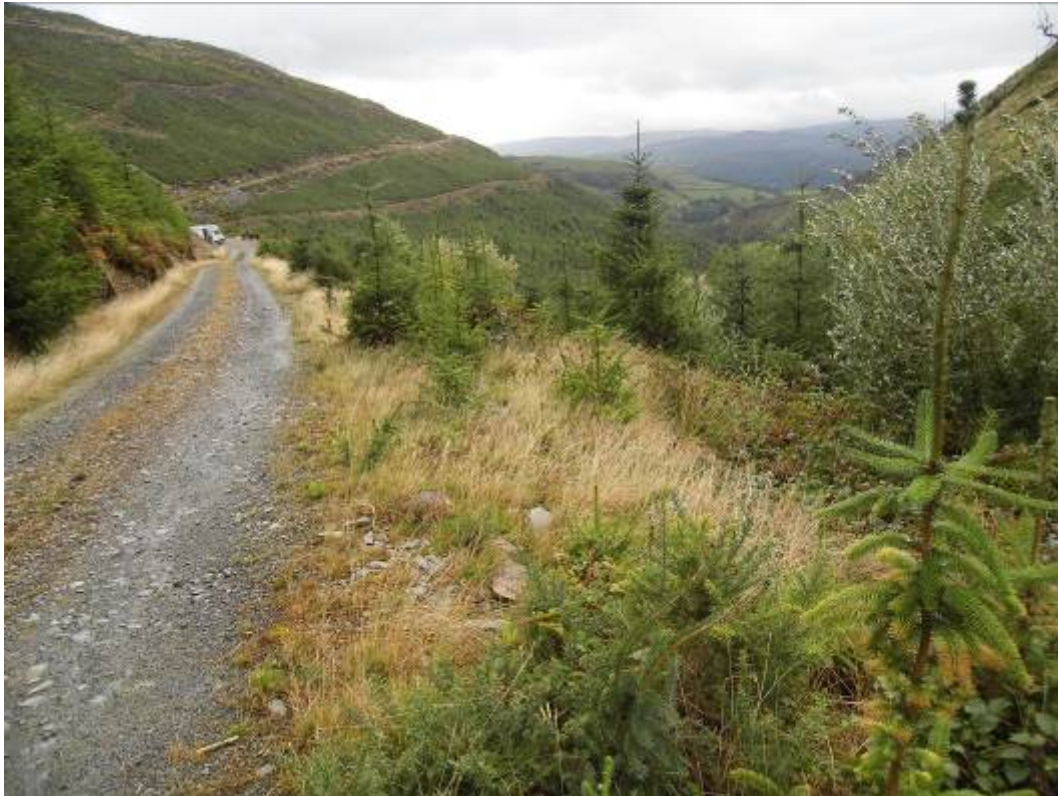
Photo 3: Forestry track (penstock route) from intake

Travelling east, the penstock route from intake 1 runs through low forestry plantation and at the edge of a forestry track (Photo 3, Appendix 3), to join the main intake, intake 2 (Photo 4, Appendix 3). Intake 2 is more wooded than intake 1, with young birch and willow (Photo 5, Appendix 3). The penstock route leaves this broadleaved wooded area within 50m of Intake 2 where it enters into conifer plantation and then, approximately 300m from Intake 2, it follows a forestry track through low growth plantation forestry (Photo 6, Appendix 3). It runs through this forestry for approximately 600m before entering bracken-dominated acid grassland. It passes through this bracken for approximately 150m, before arriving at the proposed powerhouse location (Photo 7, Appendix 3). The proposal is for the penstock from Intake 2 to the power house to be over-grounded throughout. The powerhouse location is in damp acid grassland. The cable route from the powerhouse largely runs through semi-improved acid grassland. After approximately 250m, the cable route passes over a more flushed area, consisting of sharp-flowered rush *Juncus acutiflorus* and various sedge species. After crossing this flushed area, the cable route continues to run through semi-improved acid grassland.

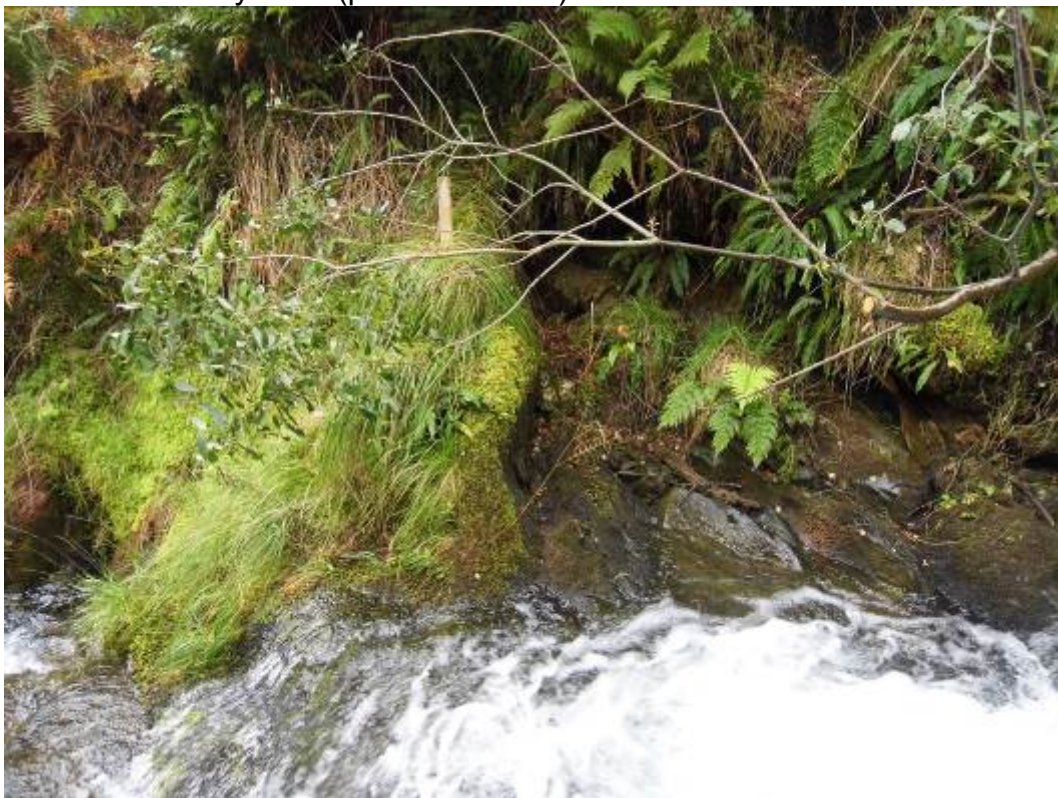
Photo 4: Intake 2

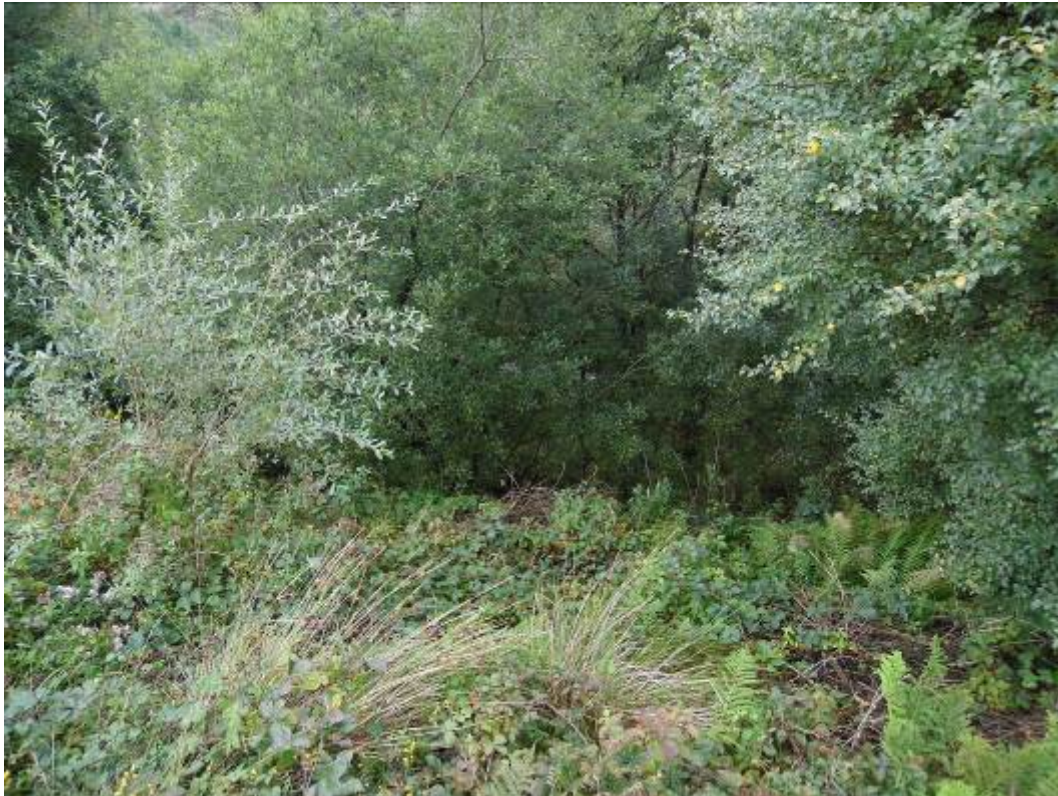
Photo 5: Birch and willow woodland close to intake 2

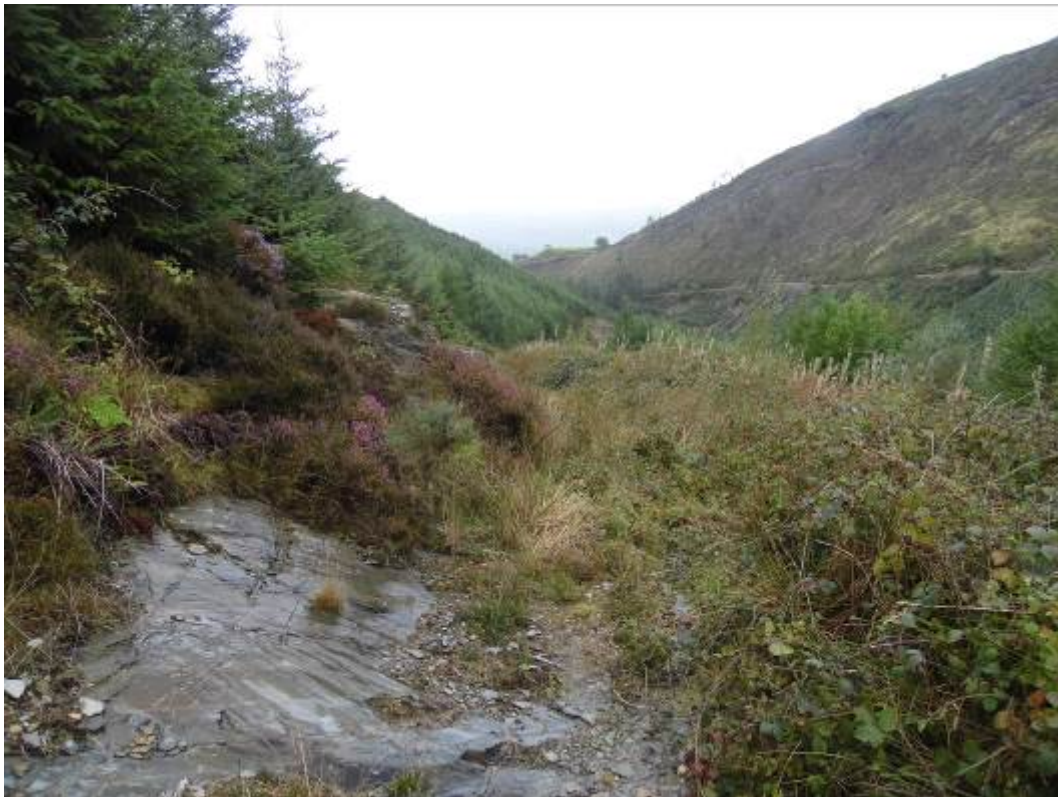
Photo 6: Forestry track (bramble, some heather, soft rush)

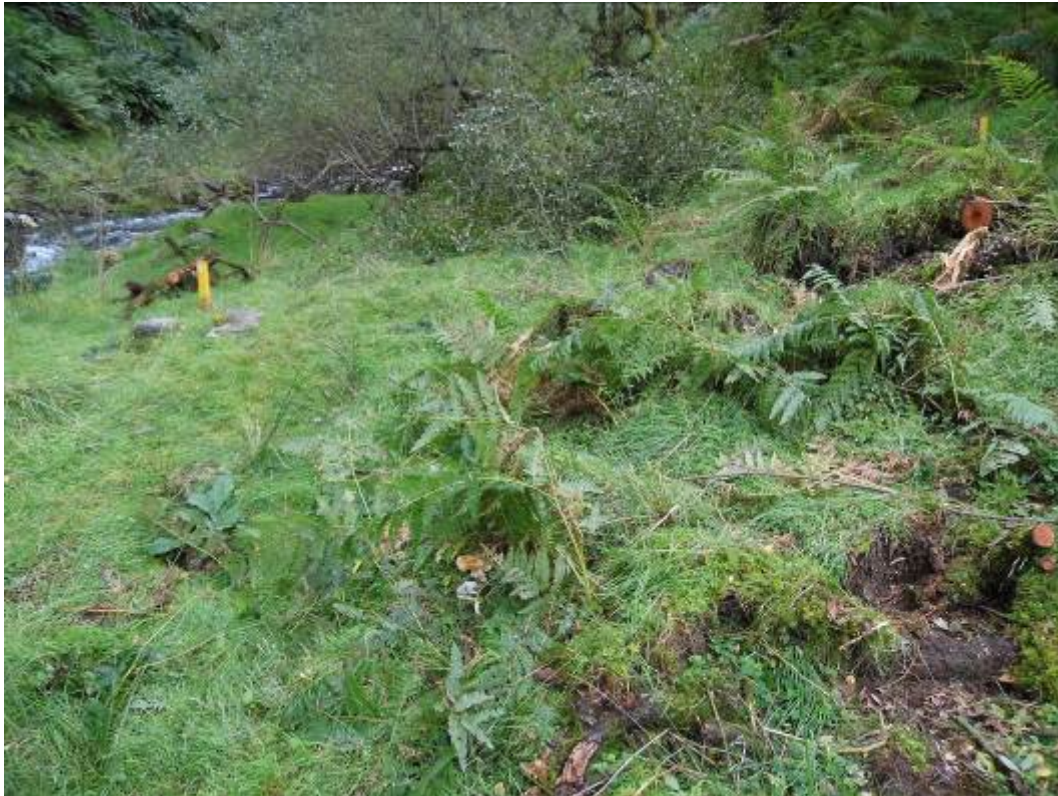
The acid grassland at the site comprised relatively impoverished examples, entirely typical and characteristic of heavily grazed conditions in the Welsh uplands. The main area of unimproved acid grassland was around intake 1. This supported the grasses common bent *Agrostis capillaris*, purple moor-grass *Molinia caerulea* and tufted hair-grass *Deschampsia cespitosa*. A representative photo of this acid grassland is provided as photo 2 (Appendix 3). Other species, typical of steep acid banks, included foxglove *Digitalis purpurea*, male-fern *Dryopteris filix-mas* and the mosses *Polytrichum commune* and *Pogonatum urnigerum*. A photo showing this steep acid bank vegetation is provided as photo 8 (Appendix 3). A small quantity of cross-leaved heath *Erica tetralix* was present. A very small quantity of ivy-leaved bellflower *Wahlenbergia hederacea* was also present close to intake 1. Damp acid grassland of a similar species composition was found at the proposed powerhouse location (photo 7, Appendix 3).

Photo 7: Power house location (damp acid grassland)

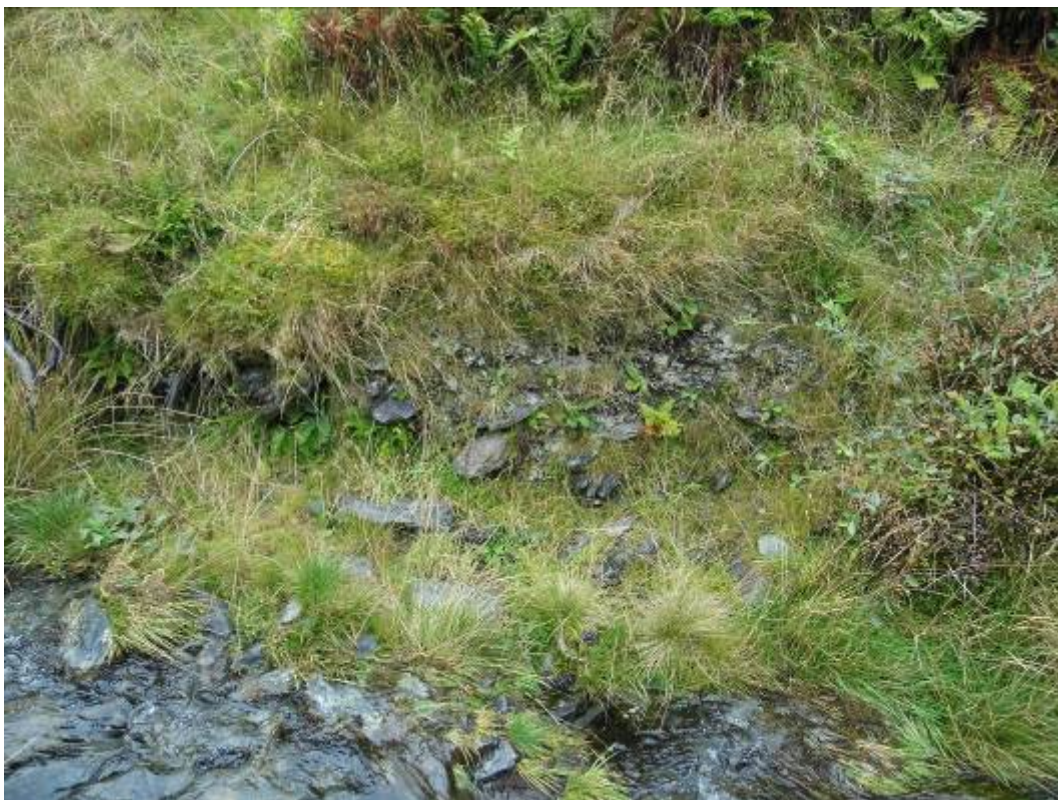
Photo 8: Acid grassland vegetation on steep bank next to watercourse

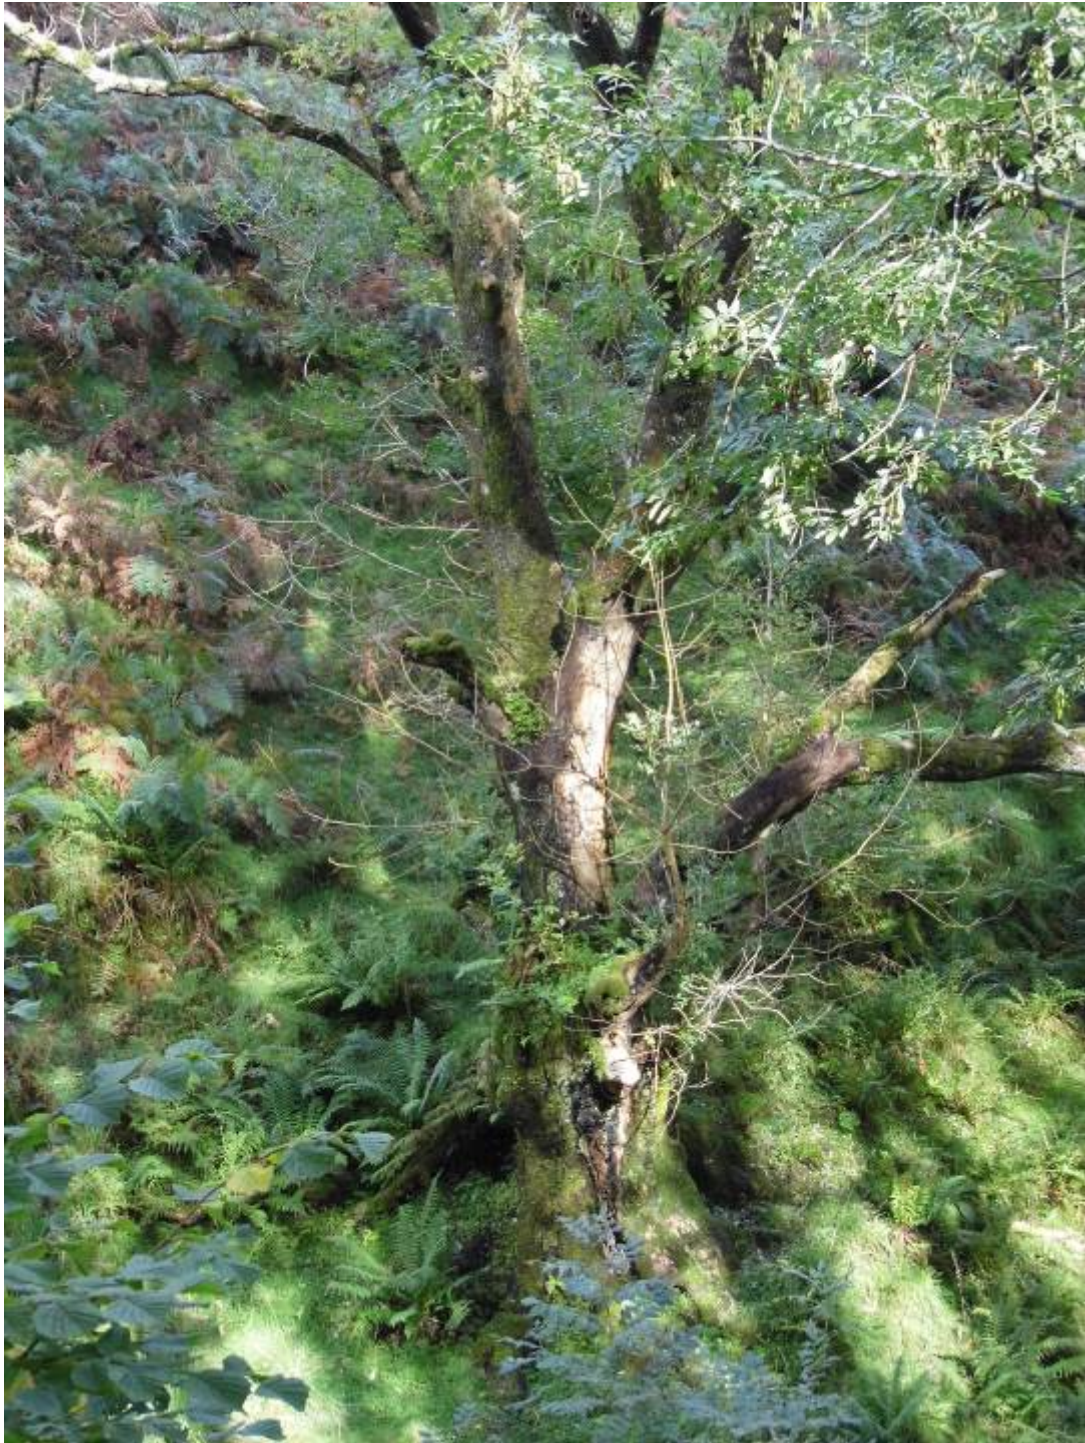
All bryophytes recorded were common and widespread species. The commonest species within the woodland areas were *Rhytidiadelphus loreus*, *Thuidium tamariscinum* and *Mnium hornum*. The rocks in the watercourse supported typical species for the area and setting. Dominating these rocks were *Hyocomium armoricum* (close to intake 2), *Racomitrium aciculare* and *Nardia compressa*. This last was found close to the water level and submerged in the river itself. It is a good indicator of acidic (base-poor) conditions. Other typical waterside species were *Marsupella emarginata*, *Pellia epiphylla* and *Rhizomnium punctatum*. Only one species was recorded that is listed under the Section 7 community. This is *Hyocomium armoricum* and falls under criterion 4. The site therefore clearly fails to qualify as one supporting the Section 7 oceanic ravine community. A single 'old forest' lichen was recorded. This is *Sticta limbata* which was found in quantity on an old ash approximately 25m from the powerhouse location. This tree will not be affected by the powerhouse construction. A photo showing the tree is provided as photo 9 (Appendix 3).

Photo 9: Old ash supporting the lichen *Sticta limbata*

There will be negligible impact from the proposed works on lower plant species. No individual species of conservation significance were recorded and the site also clearly fails to meet the criteria for the Section 7 oceanic ravine community. The tree supporting the old forest lichen *Sticta limbata* will not be impacted by the works.
