## **Nant Maesglase Hydro Scheme**

### **Ecology Report**

<b>Client</b>	Greenearth Hydro
<b>Author of Report</b>	Chris F. Brown MCIEEM
<b>Date of Report</b>	20th October 2018

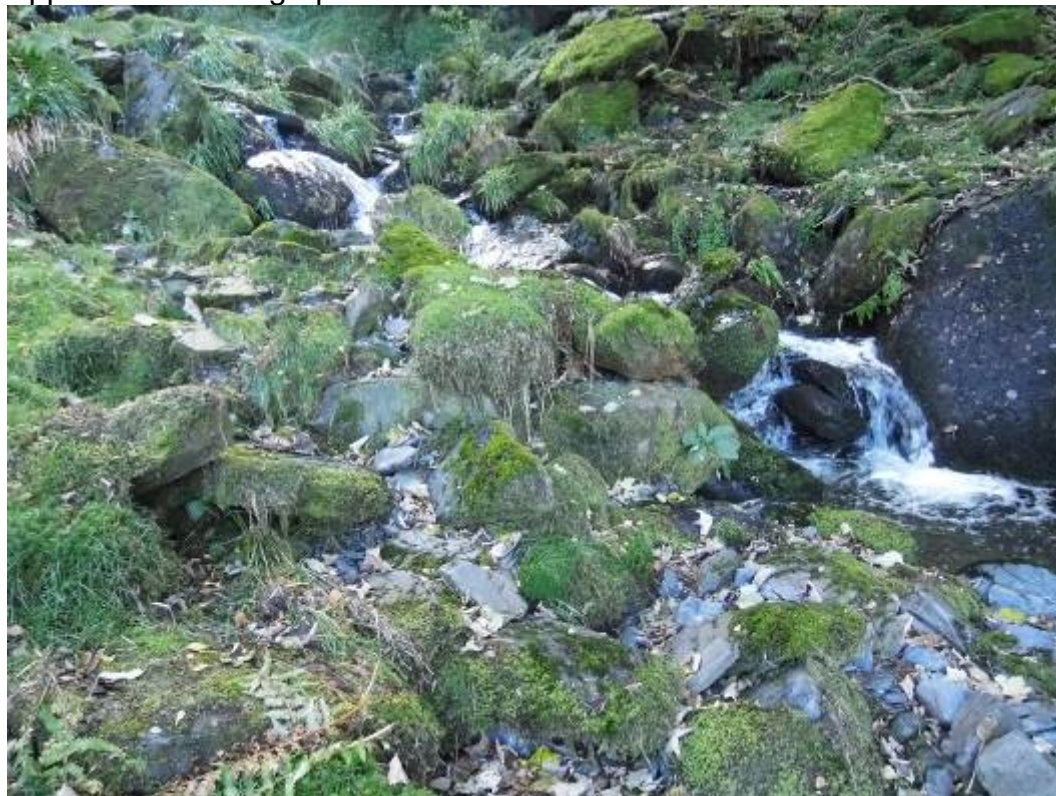
Photo 1: Intake location

The proposed penstock route runs relatively close to the Nant Maesglase, which forms a narrow upland stream, with wooded banks for the first 250m of its length. Photo 1 (Appendix 3) shows the intake location. The area immediately adjacent to the intake (Photo 2, Appendix 3) comprises open, rocky, semi-natural broadleaved woodland.

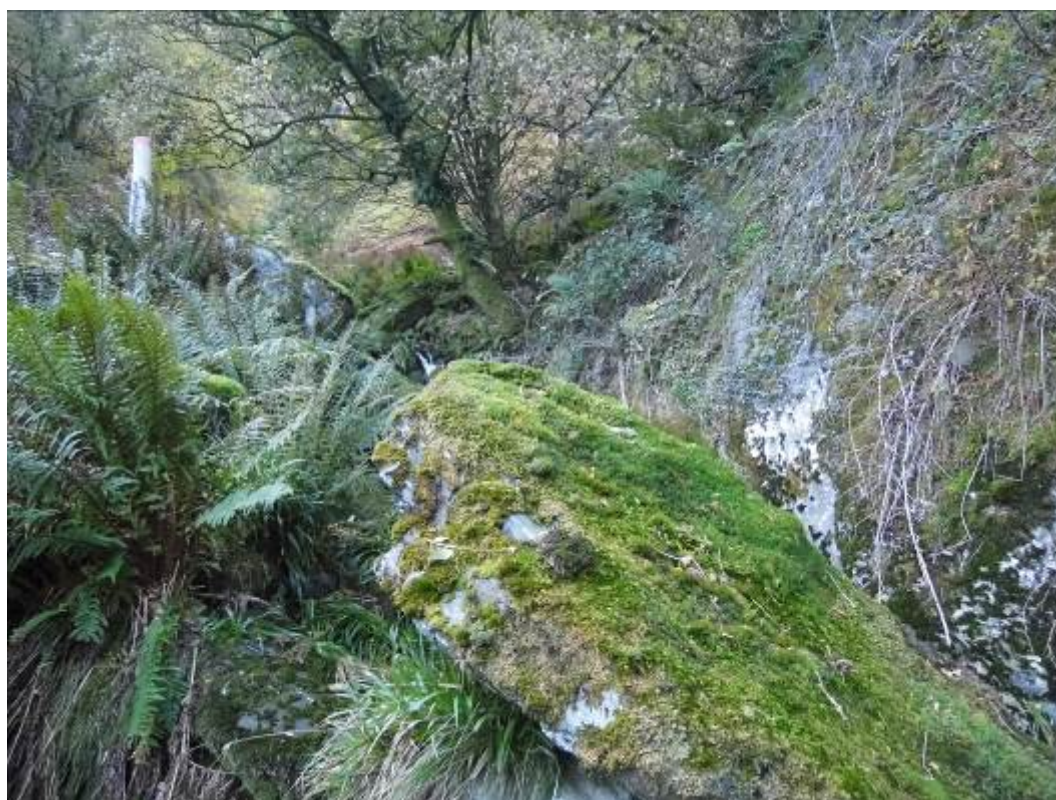
Photo 2: Semi-natural broadleaved woodland, open and rocky in character

The first 125m of the penstock route lies in semi-natural broadleaved woodland. This is open in character and rather overgrazed. The main tree species are downy birch *Betula pubescens*, goat willow *Salix caprea* and occasional sycamore *Acer pseudoplatanus*. Hazel *Corylus avellana* and hawthorn *Crataegus monogyna* were also sparsely present. The field layer in the majority of the woodland is quite sparse and representative of acidic conditions. Thus species such as male-fern *Dryopteris filix-mas* and common polypody *Polypodium vulgare* were prominent. Scattered bracken was also present at the edge of the woodland area. Steep acid rocks close to the intake point also supported the species climbing corydalis *Corydalis claviculata*. Photos of the semi-natural broadleaved woodland are provided as photos 2 and 3 (Appendix 3).

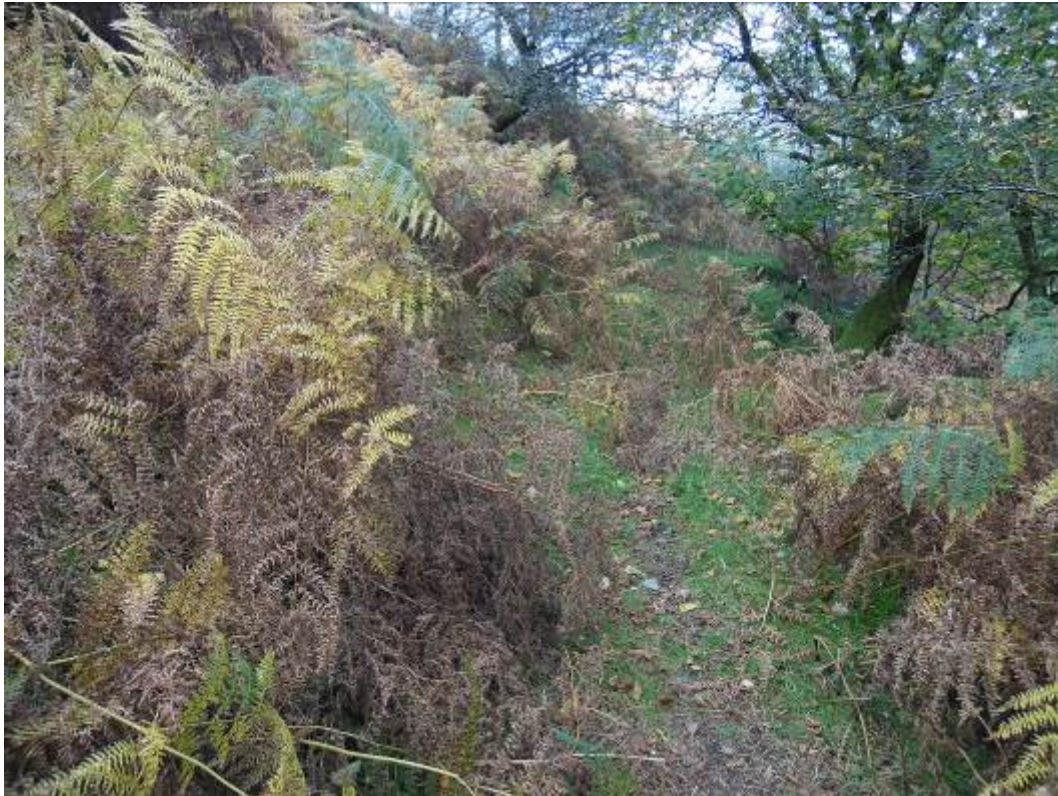
Photo 3: Open broadleaved woodland (bracken, hawthorn, hazel)

Heading north-east from the intake, the penstock route runs through similar open semi-natural broadleaved woodland (Photo 3, Appendix 3), for approximately 125m. The penstock route leaves the broadleaved wooded area and for the remainder of its length, crosses fields of poor semi-improved improved and semi-improved neutral grassland (Photo 4, Appendix 3). Small areas are more akin to marshy grassland, with frequent soft rush (Photo 5, Appendix 3). The cable route lies in similar poor semi-improved and improved grassland (with one field of semi-improved neutral grassland).

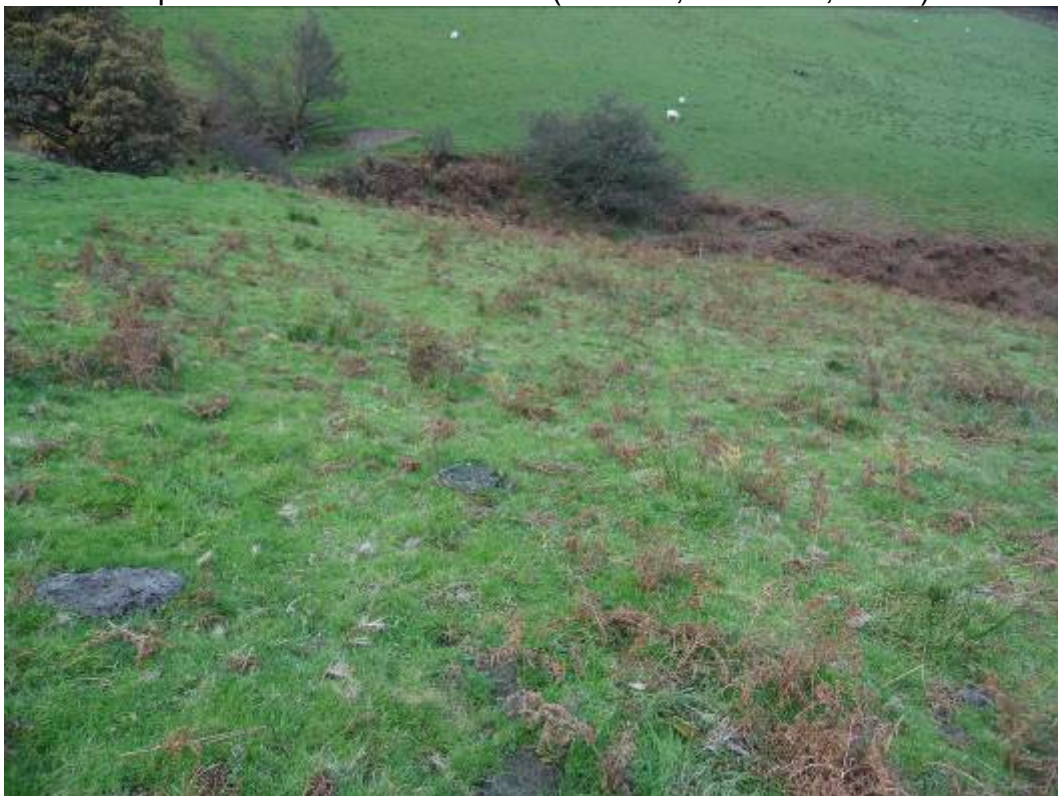
Photo 4: Semi-improved neutral grassland

Between approximately 125m and 450m, the penstock route crosses two fields of semi-improved neutral grassland. This contains similar species to the improved/poor semi-improved sections, but also includes indicators of a less improved status. These include common bent *Agrostis capillaris*, common sorrel *Rumex acetosa* and yarrow *Achillea millefolium*. The cable route also includes a section of semi-improved neutral grassland, between approximately 200m and 400m. A representative photo of semi-improved neutral grassland is provided in Appendix 3 (Photo 4).

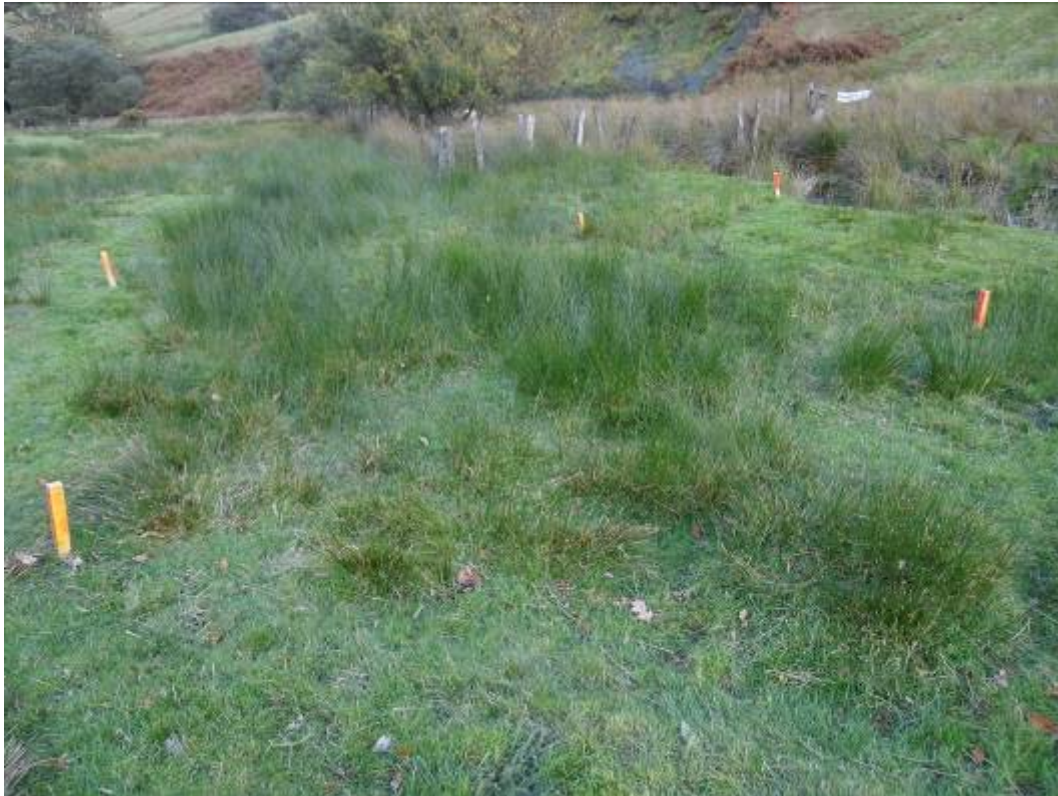
Photo 5: Poor quality marshy grassland/poor semi-improved grassland (powerhouse location)

The section of the penstock route between 625m and 650m lies in poor quality marshy grassland. This is dominated by soft rush *Juncus effusus* with few associated species. The powerhouse location and first section of the cable route also lie in poor quality marshy grassland. It is found in a mosaic here with poor semi-improved grassland. A representative photo of this grassland (powerhouse location) is provided in Appendix 3 (Photo 5).
