## **Afon Las Hydro Scheme**

### **Ecology Report**

| <b>Client</b> | Greenearth Hydro |
| <b>Date of Report</b> | 18th October 2018 |

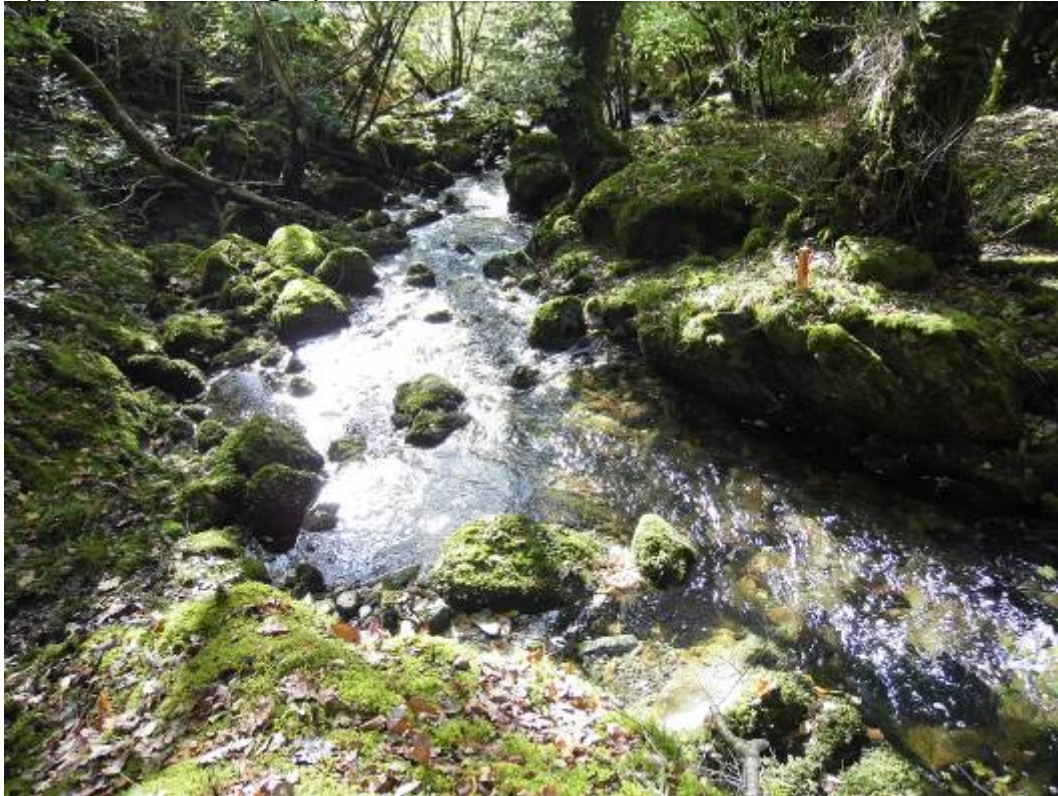
The proposed penstock route is close to the Afon Las, which forms a narrow upland stream, with wooded banks for much of its length. Photo 1 (Appendix 3) shows the intake location. The area surrounding the intake and downstream of here (Photo 2, Appendix 3) comprises open semi-natural broadleaved woodland.

Photo 1: Intake location

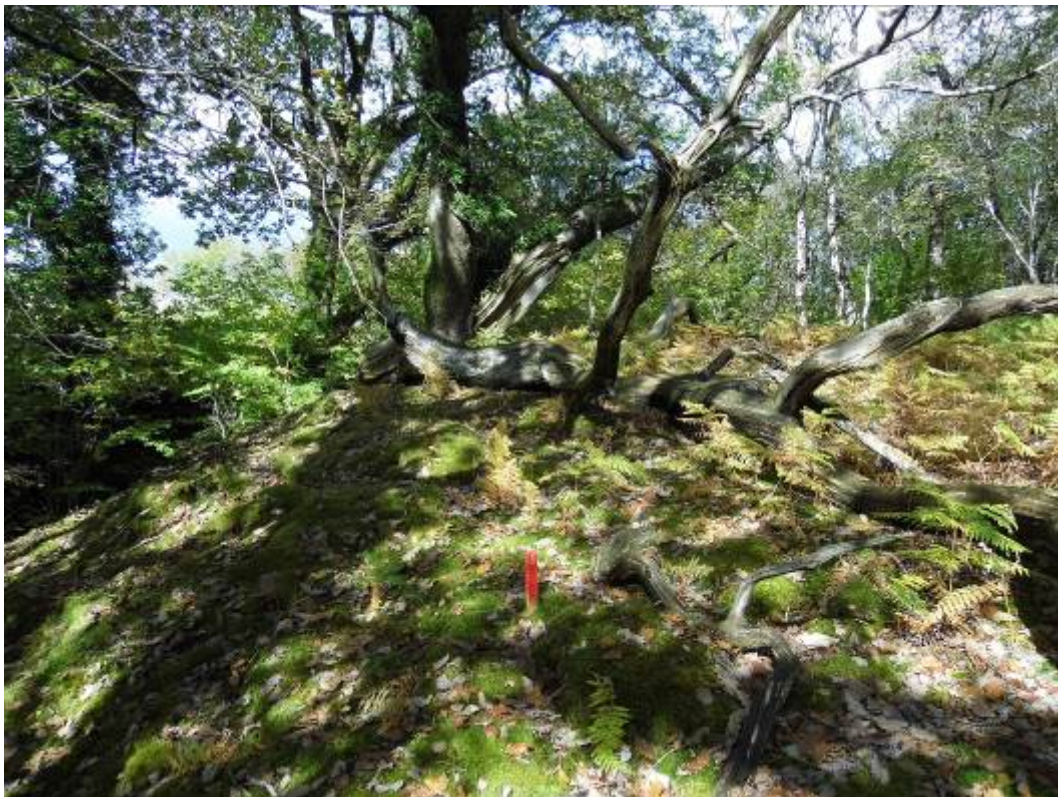
The first 200m of the penstock route lies in semi-natural broadleaved woodland. This is open in character and rather overgrazed (Photo 2, Appendix 3). The main tree species are sessile oak *Quercus petraea* and, closer to the watercourse, ash *Fraxinus excelsior*. Hazel *Corylus avellana* is frequent in the 'shrub' layer. A damper area (away from the penstock route) supports frequent alder *Alnus glutinosa*. Small flushed areas close to the watercourse support meadowsweet *Filipendula ulmaria* and opposite-leaved golden-saxifrage *Chrysosplenium oppositifolium*. The field layer in the majority of the woodland is quite sparse. Open woodland (scattered trees) is also found to the south of the minor road, in an area with associated bracken.

Photo 2: Open semi-natural broadleaved woodland close to intake point (downstream). Photo also shows potential bat roost tree and dead wood.

should notify the ecologist prior to the works commencing if it is likely that any large trees will be impacted. An initial roost assessment (in line with the BCT Guidelines) can then be carried out on the impacted tree, and from this, decisions can be made with regard to emergence surveys and further assessment. In general, felling should take place in the winter when roosts are least likely to be present. It is possible however that hibernation roosts may be present at this time of year, and the ecologist should be notified of any large trees that could potentially be felled.

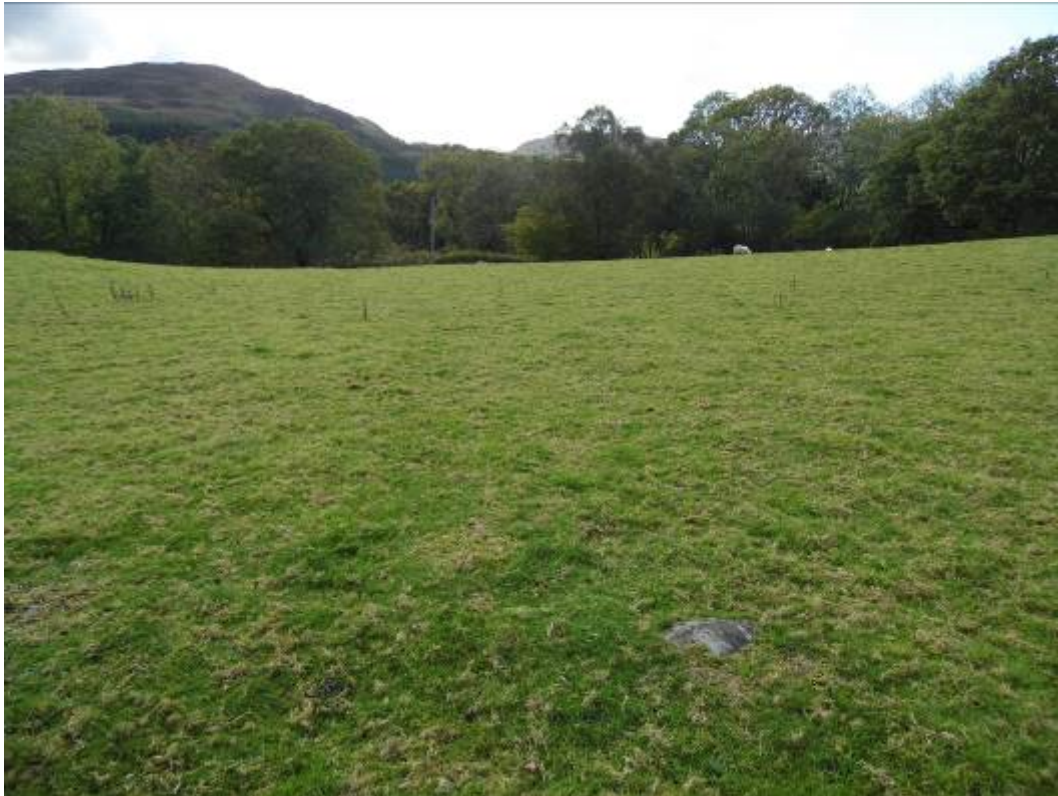
Semi-improved grassland is found along approximately half of the penstock route. The penstock route crosses two fields of semi-improved neutral grassland (after leaving the woodland area and before crossing the minor road). This grassland is rather species-poor and contains a high proportion of indicators of agricultural improvement (in particular perennial rye-grass *Lolium perenne*). Other species indicated less improved status. These included common bent *Agrostis capillaris*, common sorrel *Rumex acetosa* and yarrow *Achillea millefolium*. The semi-improved acid grassland at the site was largely found south of the minor road, and particularly in the powerhouse area (Photo 6, Appendix 3). This comprised common species such as common bent, sheep's-fescue *Festuca ovina* and occasional heath bedstraw *Galium saxatile*. Purple moor-grass *Molinia caerulea* was found sparsely in this grassland.

Photo 3: Semi-improved neutral grassland

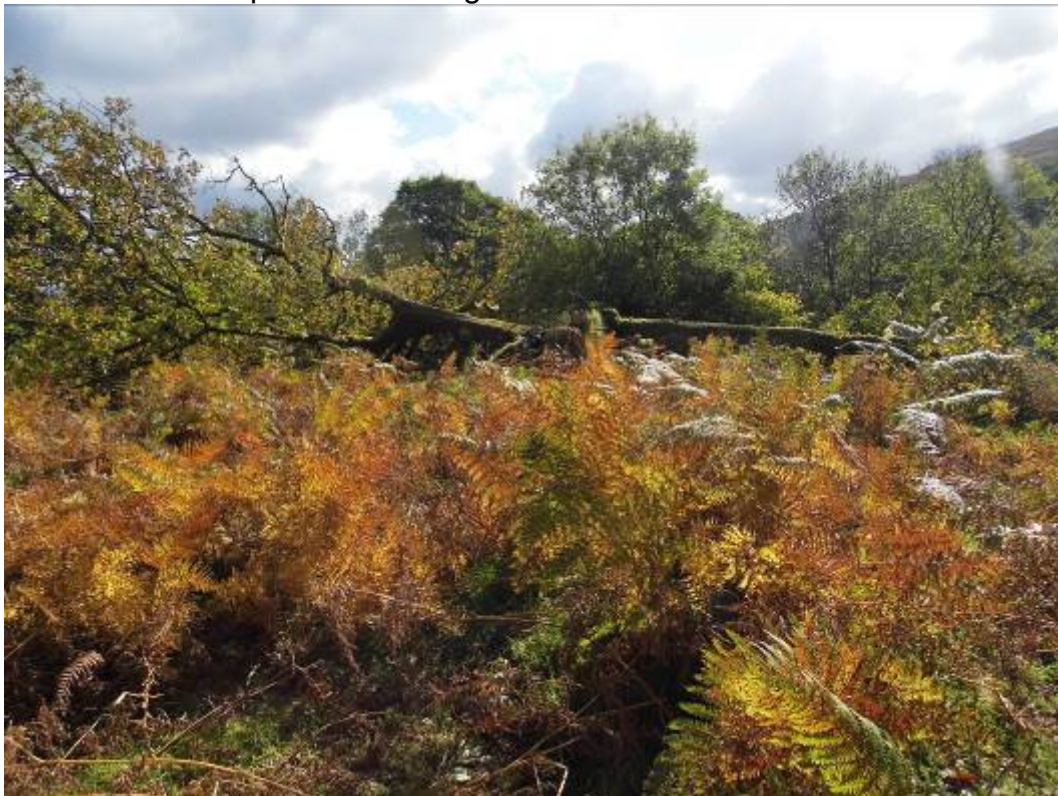
Bracken *Pteridium aquilinum* is found in the area to the south of the minor road and shortly downstream. The example at the site is species-poor and supports few associated species (Photo 4, Appendix 3). It is found in association with open broadleaved woodland.

Photo 4: Open woodland area with bracken (south of minor road)

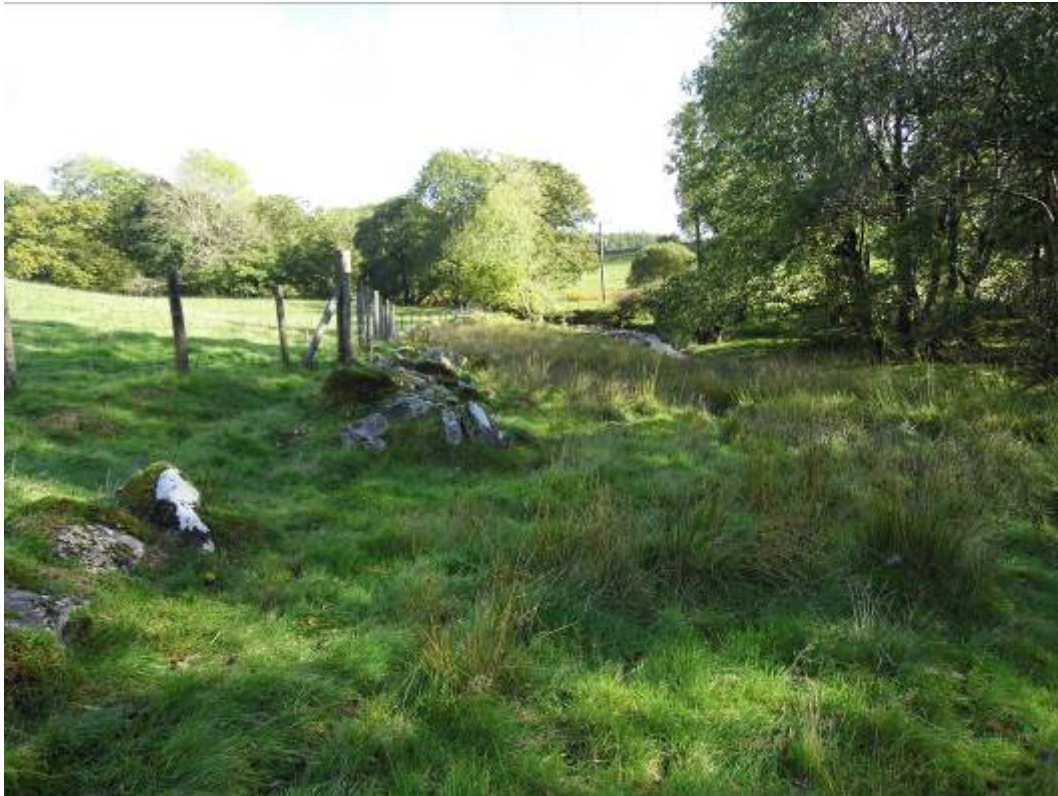
Photo 5: Cable route

Mitigation measures for vegetation are outlined above i.e. routing of the cable route carefully through the semi-natural woodland area. In addition, all dead wood should be left *in situ*. No other mitigation measures for vegetation are considered necessary, as the penstock route and other infrastructure will avoid all vegetation of ecological value (the penstock route largely runs through poor quality habitat).

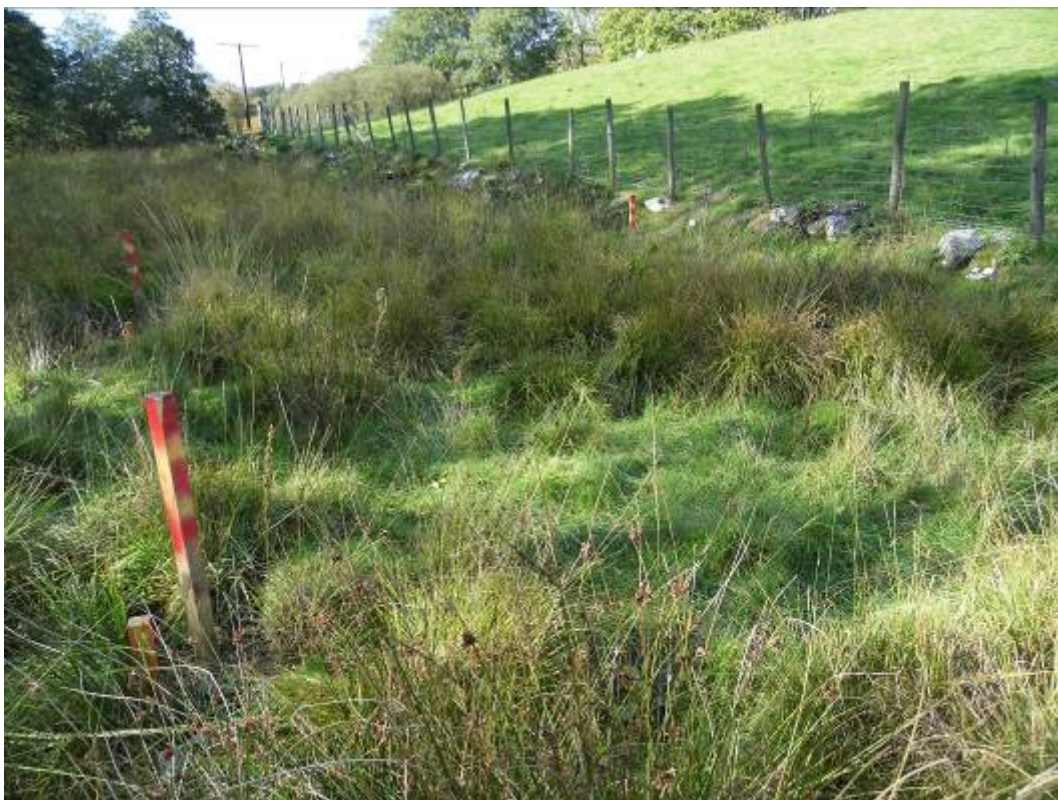
An area shortly to the south of the powerhouse location (approximately 15m) was dominated by purple moor-grass. This appeared to be species-poor with few associated plants. The area close to the cable route (and comprising the first section of cable route) also consisted of this same species-poor purple moor-grass (Photo 5, Appendix 3).

Photo 6: Powerhouse location; semi-improved acid grassland and marshy grassland

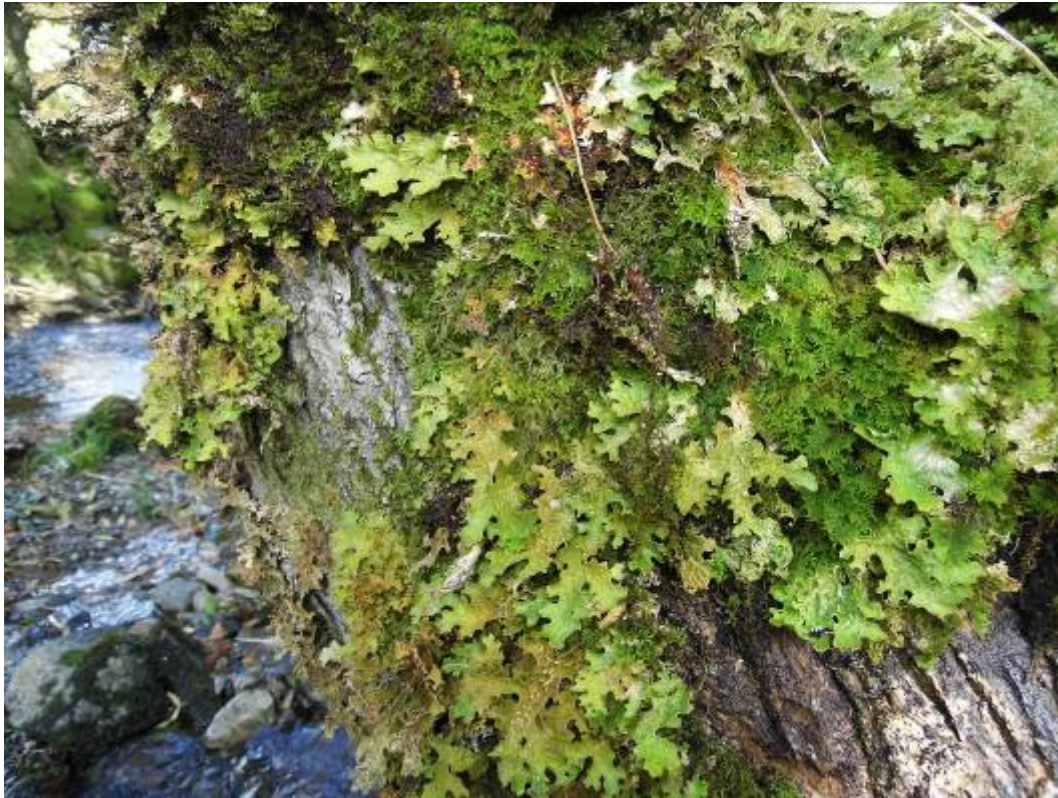
There will be negligible impact from the proposed works on lower plant species, provided trees and large rocks are avoided. The few 'old forest' lichens that were recorded are away from the penstock route and will not therefore be impacted. The site does not meet the criteria for the Section 7

Photo 7: *Lobaria pulmonaria* (lungwort); healthy specimen on ash
