Natural Resources Wales
Salmon For Tomorrow 2
Clywedog Geomorphology
Assessment

277161 - ARP - 10 - XX - RP - XX - 1001

Issue | 24 May 2021

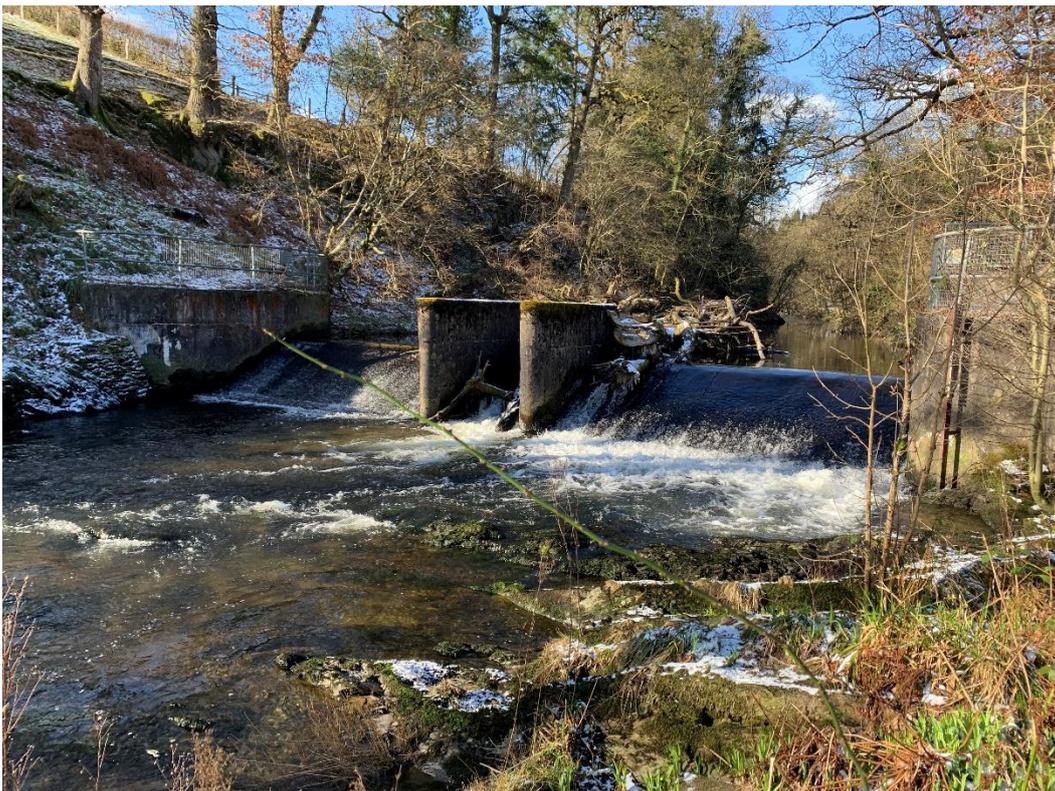
Figure 1: Disused gauging weir on the Clywedog – the asset under consideration for removal. Looking upstream from the true left bank.

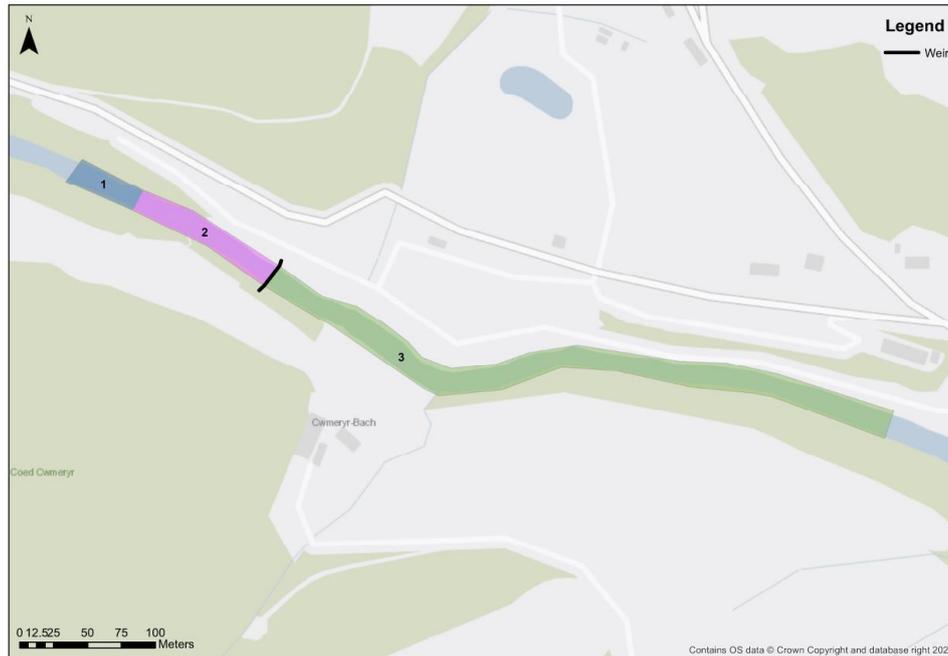
Three geomorphic reaches were delineated during the walkover survey, two upstream and one downstream of the weir. These are shown on Figure 2 and the characteristics of each are described in the following sections.

Figure 2: Distinct geomorphic survey reaches (1-3) mapped during the walkover.

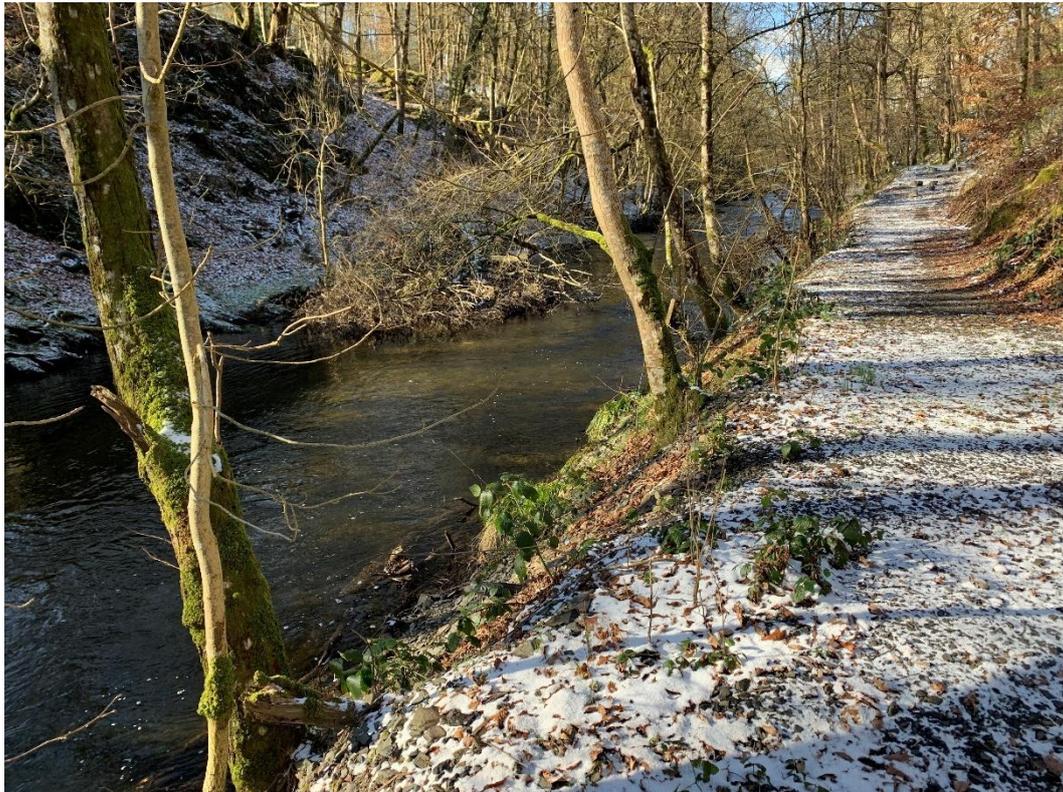
Feature		Description
Channel dimensions		Bankfull width ~ 11m Bank height ~ 2m Water width on day of survey ~ 7m Water depth on day of survey ~ 0.5m
Bank features	Left	Established trees, well vegetated. Significant channel shading. Steep, uniform bank.
	Right	Established trees, well vegetated. Steep hillslope. Significant channel shading.
Land use	Left	Woodland and footpath at top of bank – access from caravan site. No fencing.
	Right	Rough pasture, fencing at top of hillslope.
Flow type(s)		Glide-run sequences upstream of weir impoundment.
Substrate type(s)		Cobble and boulder sized material with significant bedrock outcrops. Limited structure and sorting.
Vegetation		No in-channel vegetation. Time of year may have prohibited seeing this.
Bars		None
Other features of interest		None noted.

Figure 3: Looking upstream at a uniform section of the Clywedog in Reach 1.

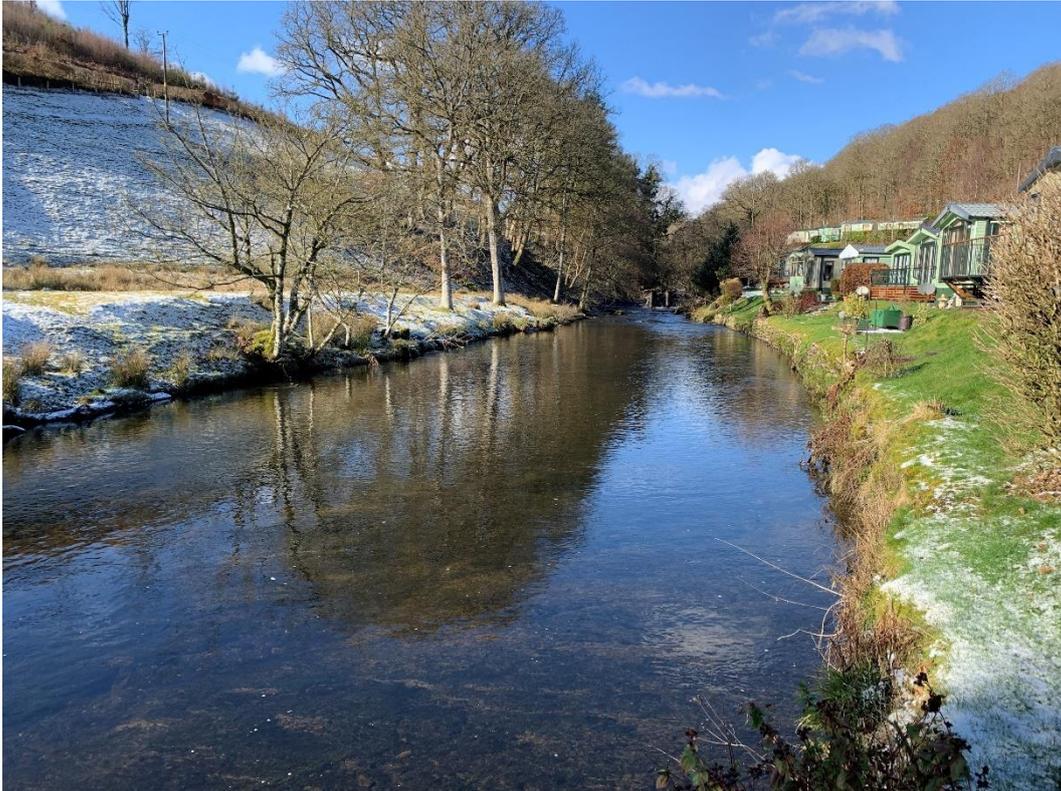
Feature		Description
Channel dimensions		Bankfull width ~ 11m Bank height ~ 2m Water width on day of survey ~ 7m Water depth on day of survey ~ 0.5m
Bank features	Left	Uniform, grassed bank.
	Right	Established trees, well vegetated. Steep hillslope. Significant channel shading. Some fallen wood in the channel.
Land use	Left	No fencing. Caravan site to edge of bank.
	Right	Rough pasture, fencing at top of hillslope.
Flow type(s)		Glide-run sequences with occasional bedrock riffle sections.

Feature	Description
Substrate type(s)	Cobble and boulder sized material with significant bedrock outcrops. Some structure and sorting to form riffle features.
Vegetation	No in-channel vegetation. Time of year may have prohibited seeing this.
Bars	None
Other features of interest	Disused gauging weir (the focus of the study) at the top of the reach. Large concrete structure with 3 sections across the channel.

Figure 5: Looking upstream mid-way along Reach 3.

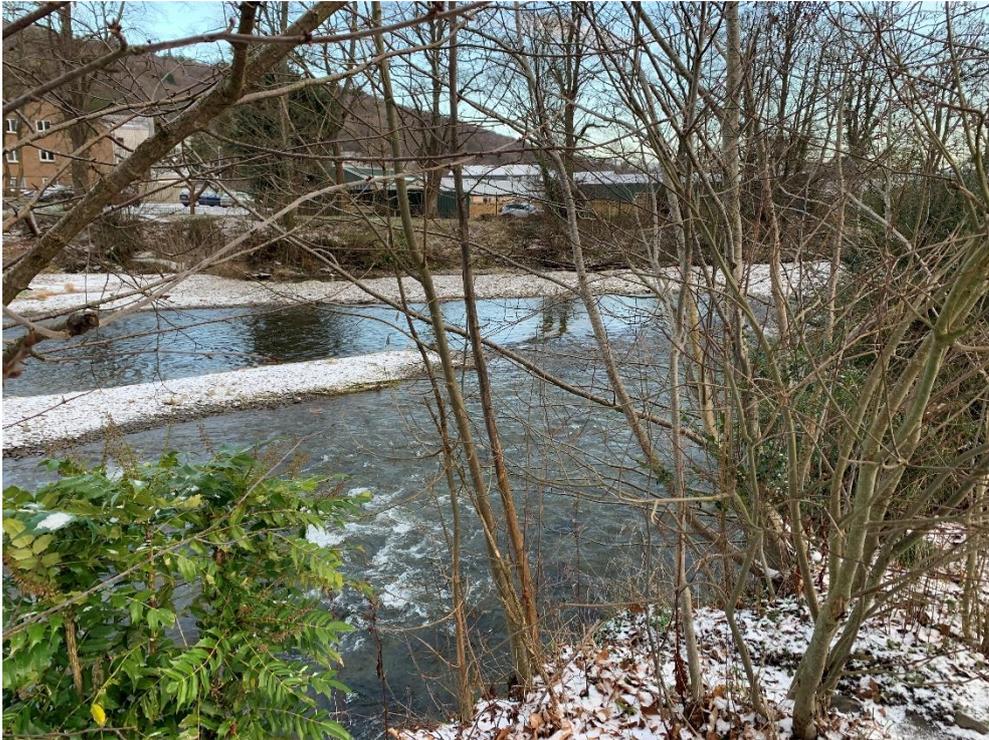
Significant gravel accumulation is noted immediately downstream of Long Bridge in Llanidloes, ~100m downstream of the Severn-Clywedog confluence (Figure 6). NRW have indicated that this presents an ongoing maintenance concern related to flood risk and performance of the nearby river gauging station. In the long term, the increase in sediment reaching this location as a result of weir removal is likely to be minimal as most of this sediment is likely derived from the Severn. Despite this, shorter-term issues related to the initial sediment pulse moving downstream should be considered during the design.

Figure 6: Accumulated gravel downstream of the Severn-Clywedog confluence in Llanidloes.

Additionally, the accumulated sediment behind the weir should be tested for contaminants prior to any works to ensure the initial 'pulse' of sediment that could be released does not result in pollution. In the longer term, the sediment supply of the Clywedog is inhibited by the dam upstream.

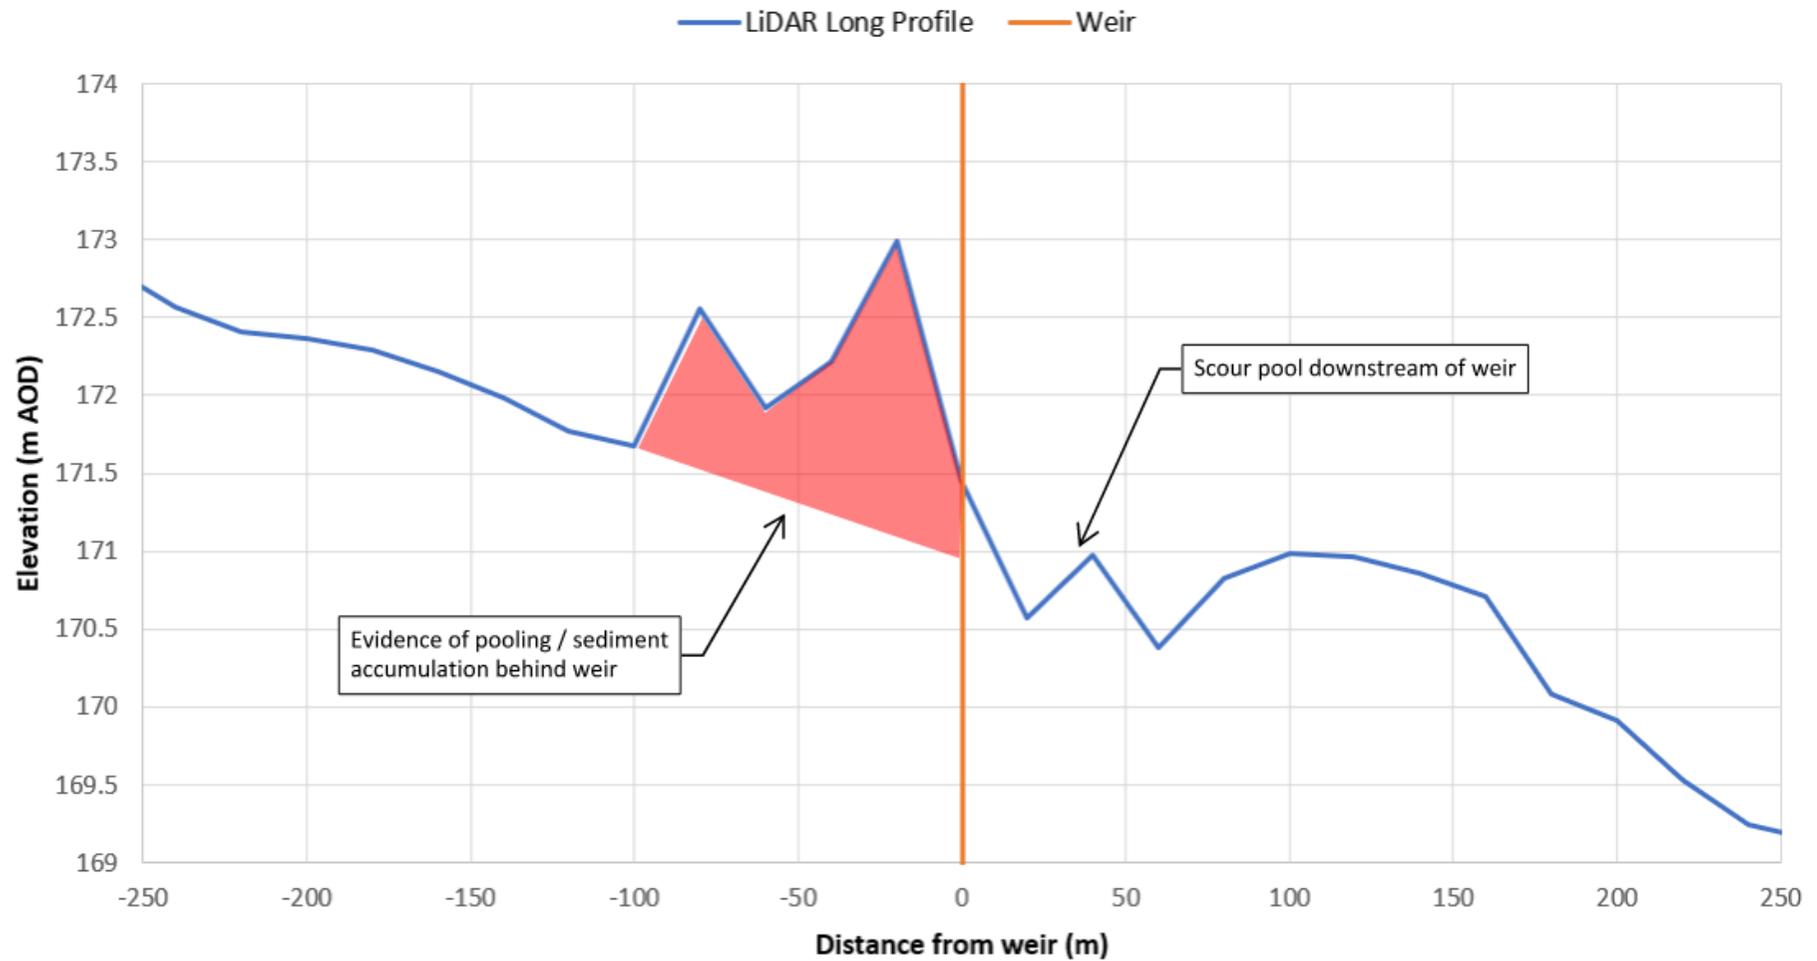
This long section is shown on Figures 7 (reach scale) and 8 (sub-reach scale). It shows that the weir has had a very limited effect upon the long section of the river and therefore it can be assumed that the river's long section response to weir removal would be limited to the immediate vicinity of the weir (i.e. ~150m upstream / ~100m downstream) of the structure.

Figure 8: Riverbed levels with distance downstream obtained from LiDAR (blue line). At this reach scale the long profile shows some accumulation of sediment behind the weir (red box), although this is limited to an approximate 100m length of river.

The gradient of the Clywedog is relatively steep (0.0075 m/m) through the reach containing the weir and therefore the impounded reach created upstream of the structure only extends ~100m upstream (Figure 8). This gradient is commonly associated with a pool-riffle or plane-bed morphology. The Clywedog exhibits a plane-bed morphology due to channel and flow modification and its lack of upstream sediment supply (inhibited by the dam).

- **Riverbed reprofiling in the vicinity of the weir** – to achieve a stable profile the sediment that has accumulated behind the weir should be reprofiled as part of the works. This may require some disposal of material offsite. Contamination testing of this material is recommended to ensure it is suitable for disposal. It is also recommended that the riverbed reprofiling is supervised by a geomorphologist.
