## Compliance Assessment Report CAR\_NRW0040087

**Permit being assessed:** AW1002901

For: LLANDRINDOD WELLS STW PARK LANE, held by DWR CYMRU CYFYNGEDIG  
At: LLANDRINDOD WELLS STW, PARK LANE, LLANDRINDOD WELLS, POWYS, LD1 5NN.

**Type of assessment carried out:** Site Inspection, Reason: Routine.

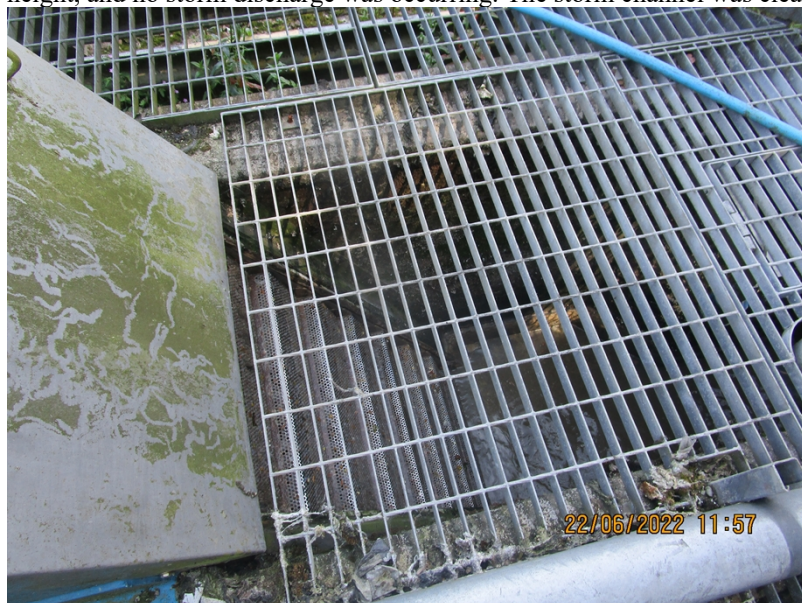
The inlet of the works is raised and the top of the site. There is a step/elevator screen in place to remove any rag and large solids. At the time of visit this was not raising as expected. When questioned on this DCWW staff confirmed that they in the process of getting the screen repaired, an OPNOT may have been raised for this issue. The screen was still in situ and was therefore screening material from the incoming flow. There did not appear to be any significant solids passing through.

There is a bypass screen which flow can be diverted through if required. This is activated manually using penstocks to change the flow channel at the inlet of the works. This was not being used at the time of inspection.

The inlet appeared to be running clear of any contamination or blockages. There were not signs of solids or rag present at the inlet. The storm weir in place is hard-set. At the time of inspection, incoming flows were well below the weir height, and no storm discharge was occurring. The storm channel was clear of any solids or rags,

The UWWTD Sample point was signposted and easily accessible

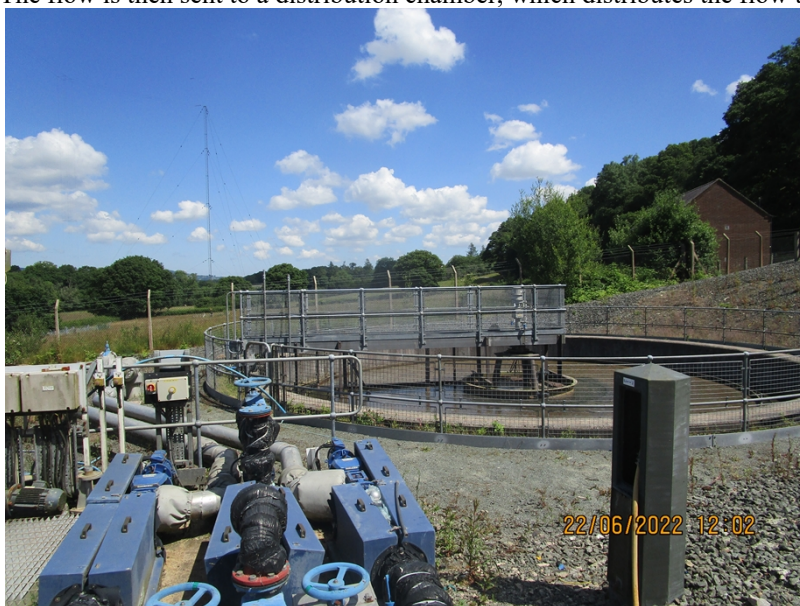
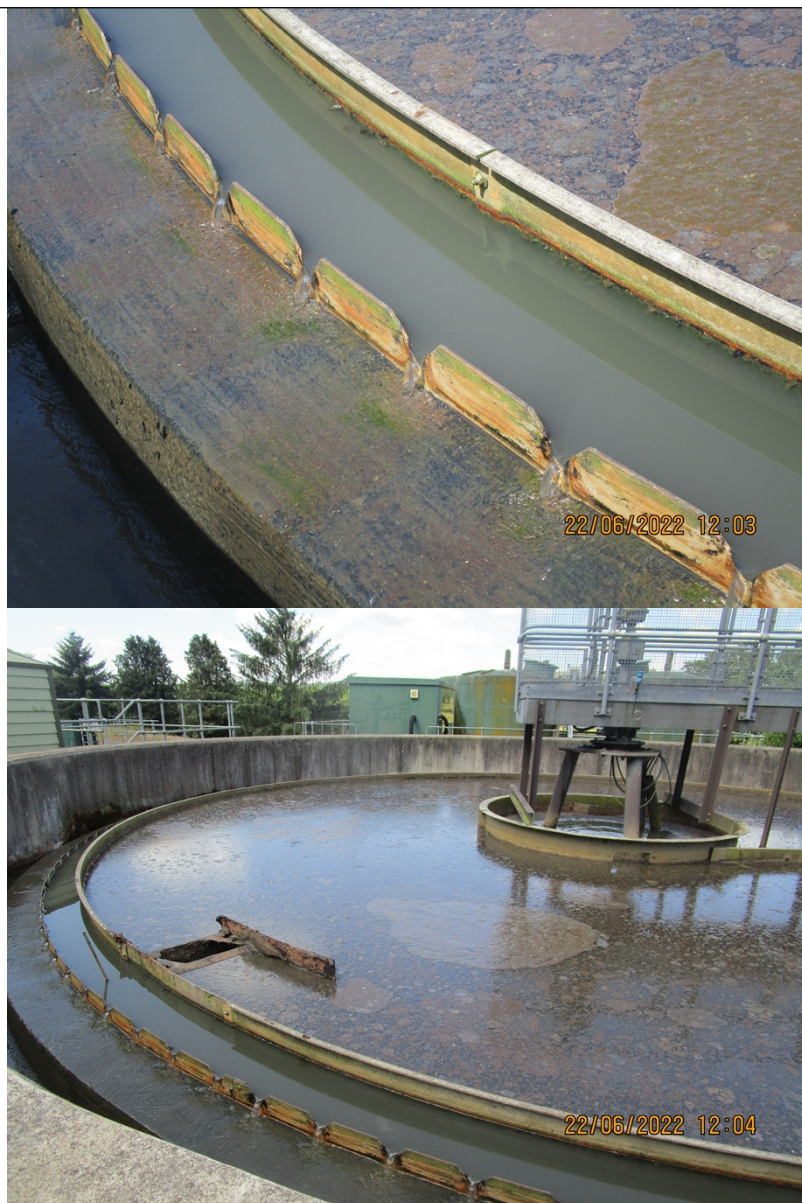
The flow from the inlet of the works is then received ferric dosing, which is added before the flow is distributed to the primary settlement tanks. A motor is in place to mix in the ferric dose, this was clearly operational whilst on site.

The works has two circular primary settlement tanks with rotating bridges and scum scrapers.

The right-hand settlement tank bridge was not rotating when we arrived for the visit. This did not appear to be causing any solids to pass over into the outfall channel. The scum boards within the tank were clearly holding back solids as designed. In the time during the inspection DCWW staff were able to resolve the problem and bring the bridge back into operation.

There were no signs of significant solids carrying over from either of the settlement tanks. Both outfall channels appeared to be running clear.

The flow is then sent to a distribution chamber, which distributes the flow to the 4 filter beds on the site.

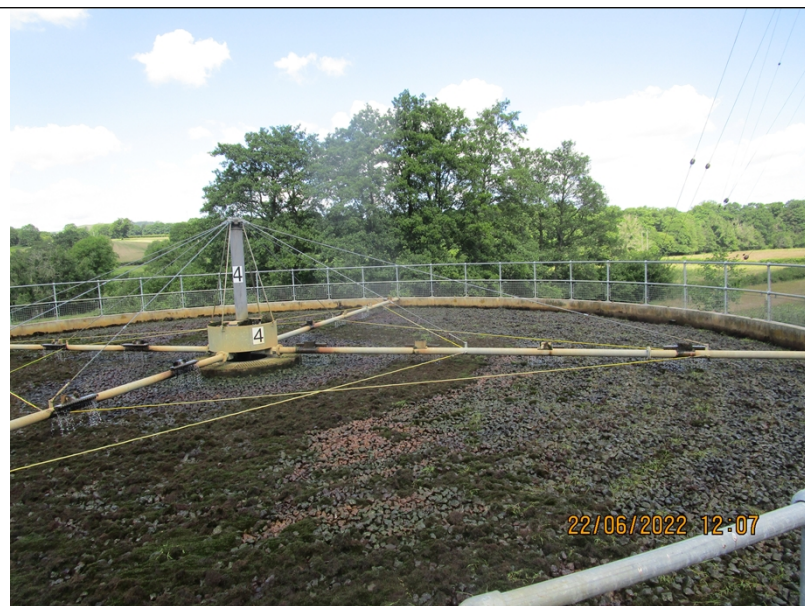
The site has 4 rotating distributor arm filter beds. Filter bed 4 is a newer self-contained stone media filter, which is located uphill from the remaining 3. This filter appeared in good working order and the rotating arm was moving freely, without blockages and was distributing effectively. There is some vegetation grown on the filter media, however this is not hindering the rotation of the arm or spreading of flow into the filter media. There were no signs of ponding observed.

The site is quite overgrown with vegetation. Currently this is not impacting on the treatment process, however this could lead to issues with access etc. This was discussed whilst on site and requests have been made for cutting back the growth and this should be completed soon.

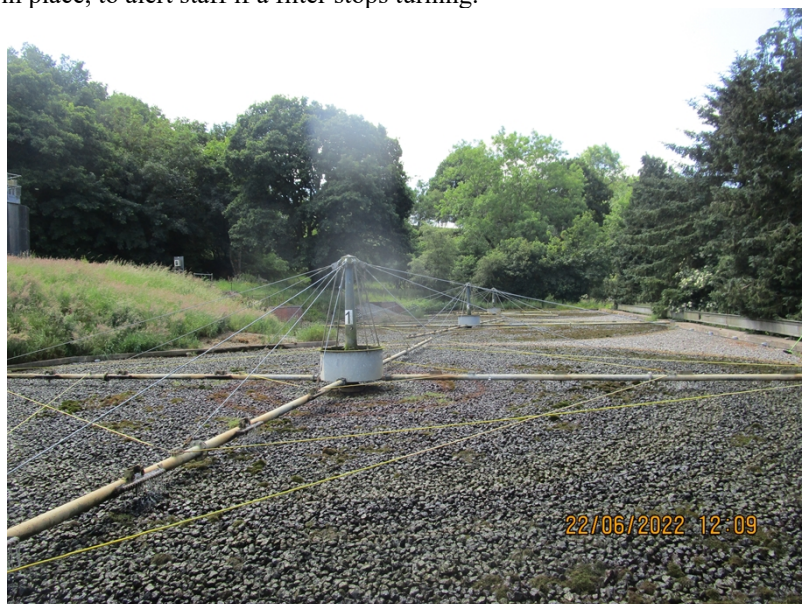
Filter Beds 1-3 are also rotating distribution arms onto stone media, however all three are contained within one large rectangular filter bed housing, which contains stone media of approximately 2m deep. Each filter bed is clearly labelled. All three filters appeared in good working order, there were no signs of blockages within the distribution arms. The filter beds had only minor vegetation present and there were no signs of ponding. There is rotation arm monitoring equipment in place, to alert staff if a filter stops turning.

The filter beds on site appear in good working order. The outfall from the filter beds was running clear. This then passes through a distribution chamber, leading to the humus tanks.

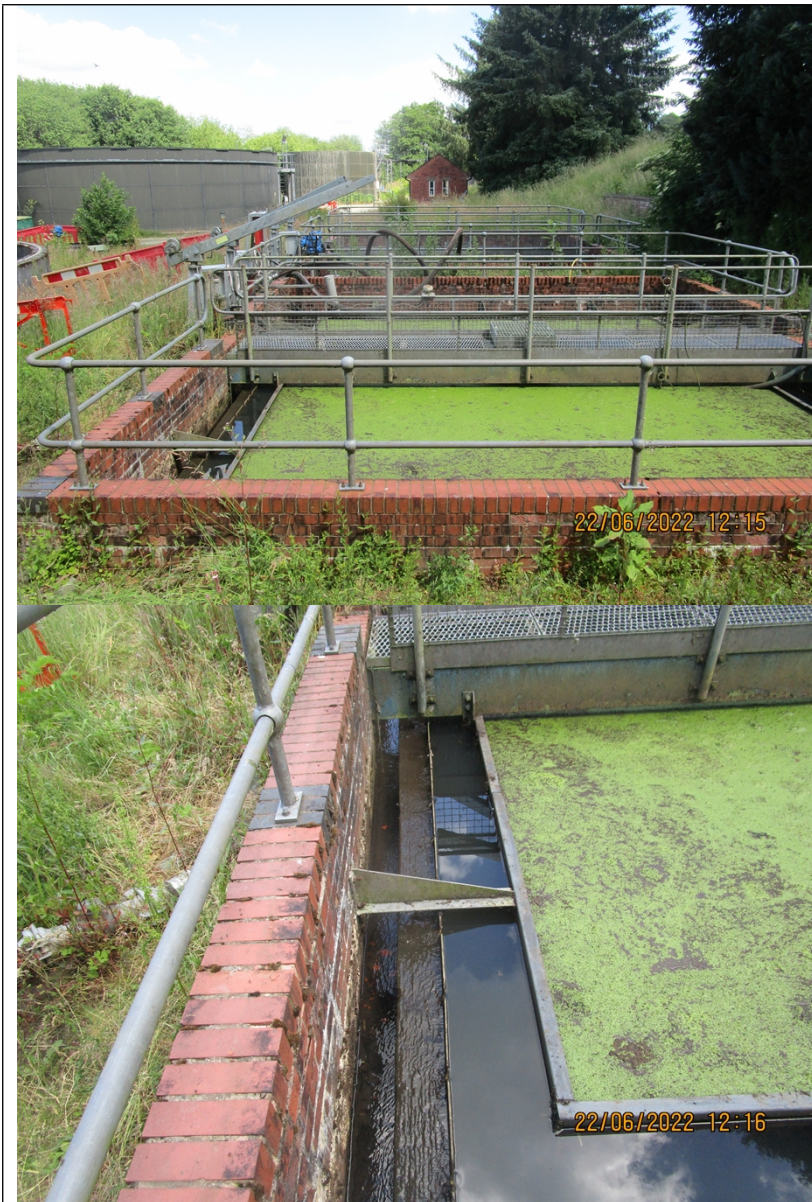
There are two rectangular “Dortmund” type settlement tanks in use, which have a scum retaining board. Solids are retained behind this board and settle down into the tapered edges into the centre of the tank for collection. The humus tanks appeared to be operating effectively and there were no signs of solids in the outfall channels. There was a layer of duckweed present on these tanks tank, however this was largely contained within the scum boards. The eluent from the tank appeared clear and free flowing with no signs of concerns

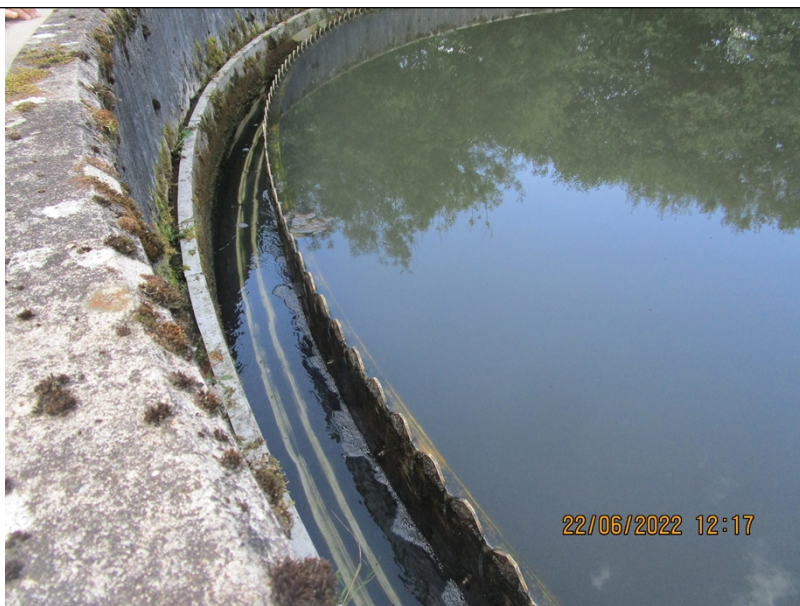
There is a single radial humus tank with a rotating bridge and scum scraper. This appeared in good working order. There were no signs of solids passing over into the outfall of the tank and the effluent appeared clear.

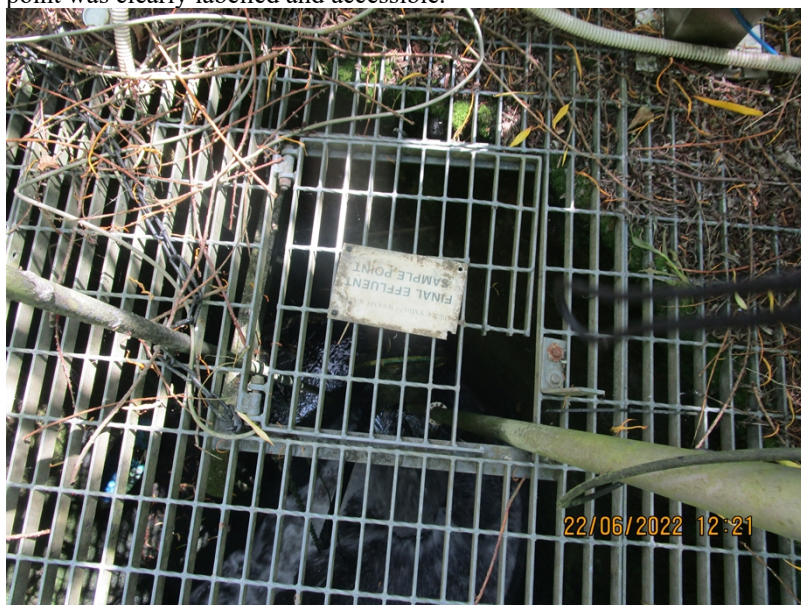
The Final effluent sampling point was clearly marked and easily accessed. The chamber appeared clear, and effluent was flowing freely. There were no signs of solids or contaminants within the effluent. The UWWTV final effluent sampling point was clearly labelled and accessible.

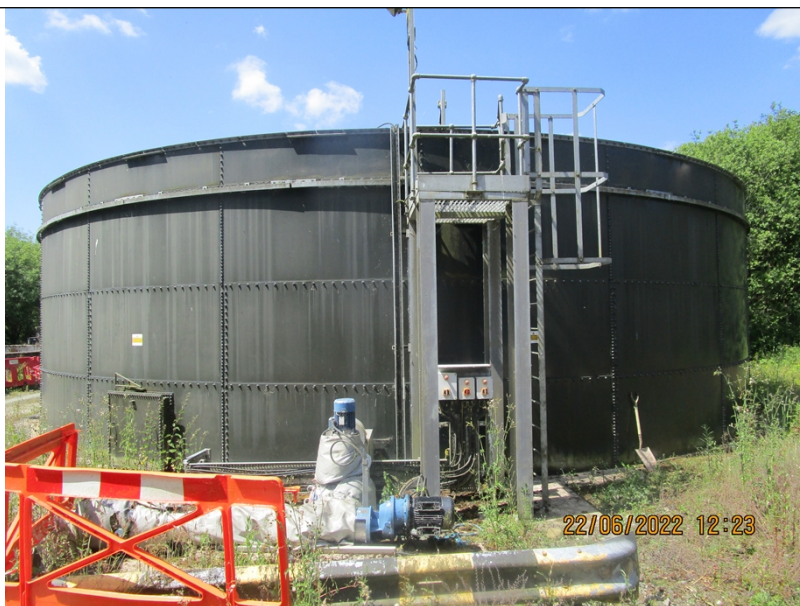
The site has a single large storm tank on site, which can be pumped back to the head of the works. I was not able to visually check if the storm tank was empty. There is EDM in place for the storm channel which can be checked if required.
