## Compliance Assessment Report CAR\_NRW0040092

**Permit being assessed:** AW1001001

For: CILMERY STW, held by DWR CYMRU CYFYNGEDIG

**Type of assessment carried out:** Site Inspection, Reason: Routine.

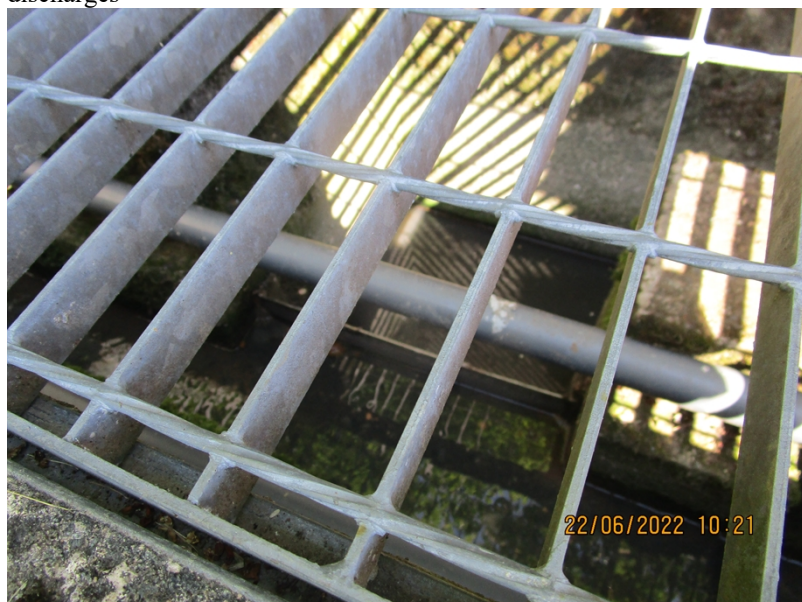
The inlet of the works is at the top of the site. The inlet appeared to be running clear of any contamination or blockages. There were not signs of solids or rag present at the inlet. The storm weir in place is a hard-set weir, as such the storm discharge can only discharge when flows reach the level of the weir. The storm channel has what appears to be a ½ inch hard screen in place, which was clear of debris. At the time of inspection, incoming flows were well below the weir height, and no storm discharge was occurring. There is Event Duration Monitoring Equipment in place to monitor storm discharges

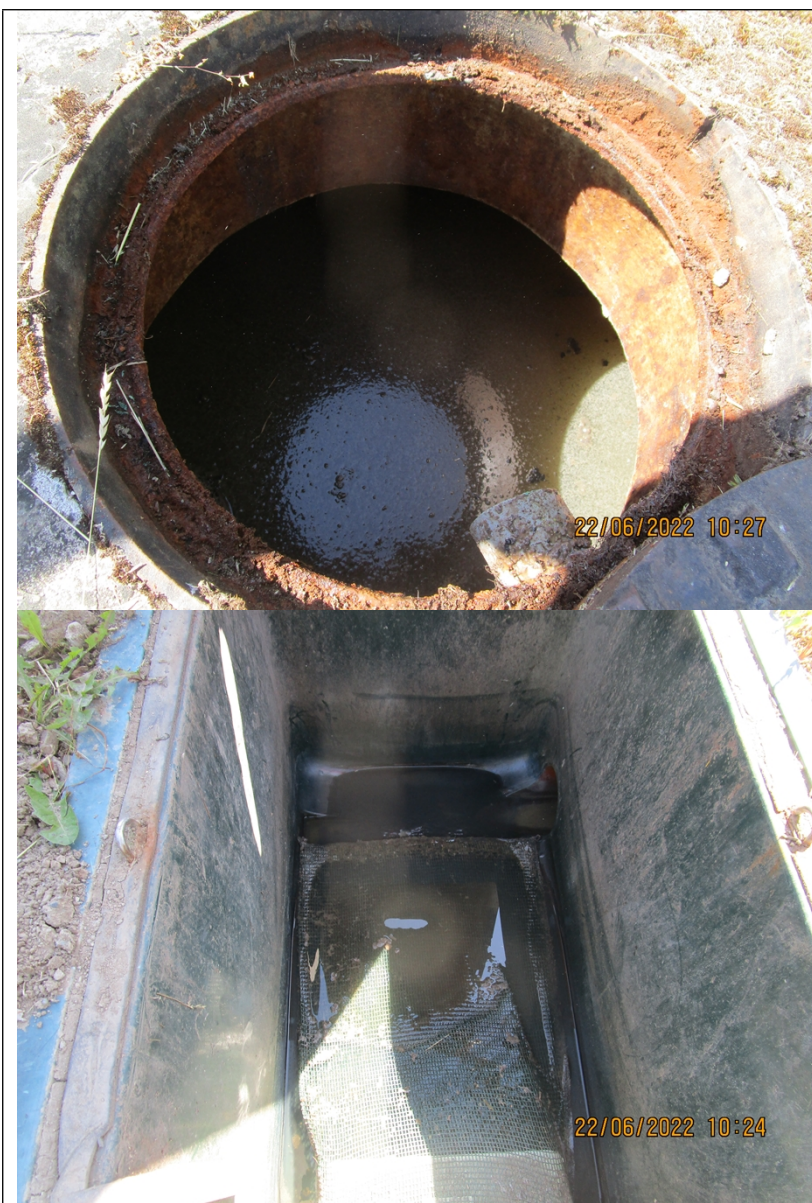
The primary settlement tank at the works is an undercover tank, with a lower outlet height for retaining solids and allowing liquid to discharge. DCWW operatives lifted the manhole covers to allow a visual inspection of the tank.

Overall, the settlement system appeared to be operating effectively. There were no signs of significant solids in the outfall channel from the underground tank. There is a Copa sac in place on the outfall to catch any solids which may pass over. This appeared in good working order at the time, and the outfall flow appeared clear of any solids.

The flow from the primary settlement tank is then pumped and distributed to two contained biofilters.

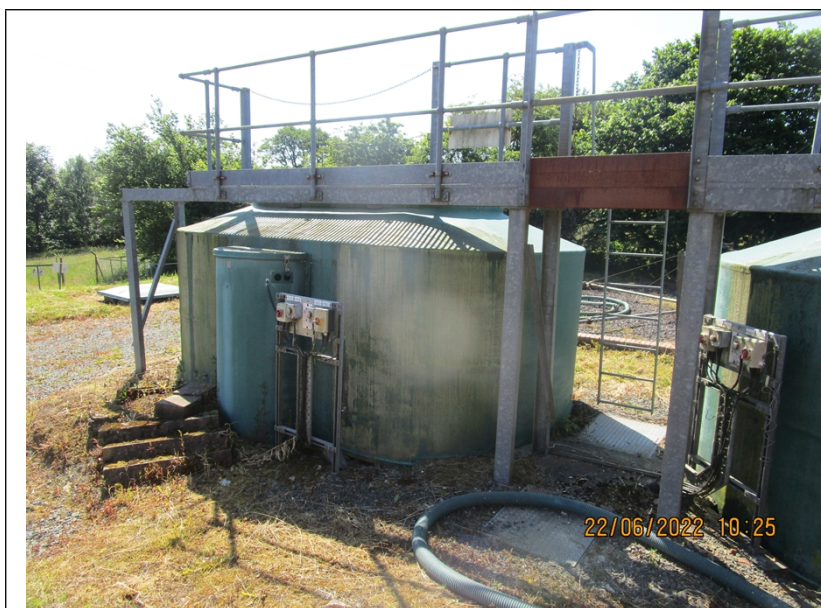
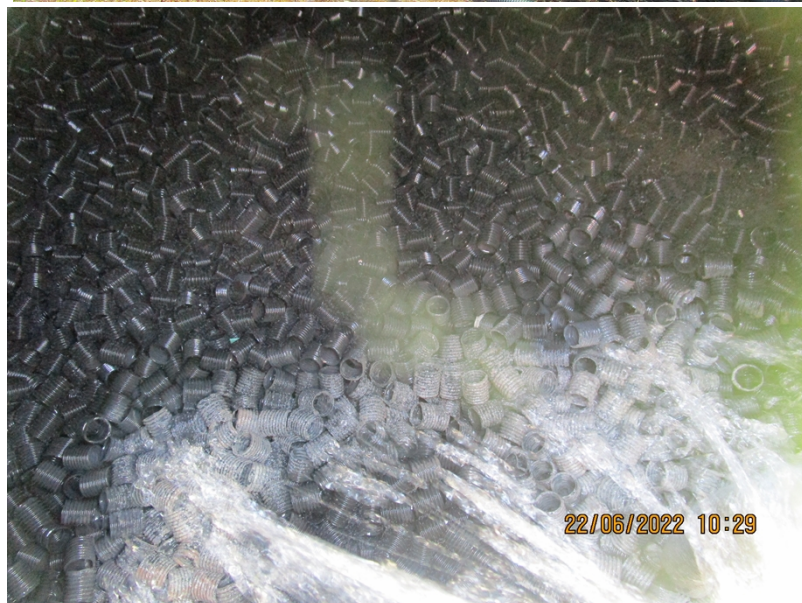
The two biofilters on site operate in a manner like a filter bed. The flow is pumped up to the top and is spread across a plastic filter media. The filter media is contained within the filter housing and is less susceptible to low temperature effects and vegetation growth. The filter media provides contact points for bacteria to break down the sewage material accordingly. The access to the inspection chambers of the filters is at height and therefore were not inspected personally. DCWW operatives used my camera to take photos for visual inspection.

The filters appeared to be in good working order, there were no signs of ponding within the filter media. The two filters then join and pass through to final settlement. On inspection of the outfall channels from the works they appeared clear of any solids or debris. There was what is potentially a small amount of grey fungus present within the right-hand filter outfall channel, however the combined outfall channel appeared clear of any fungus growth.

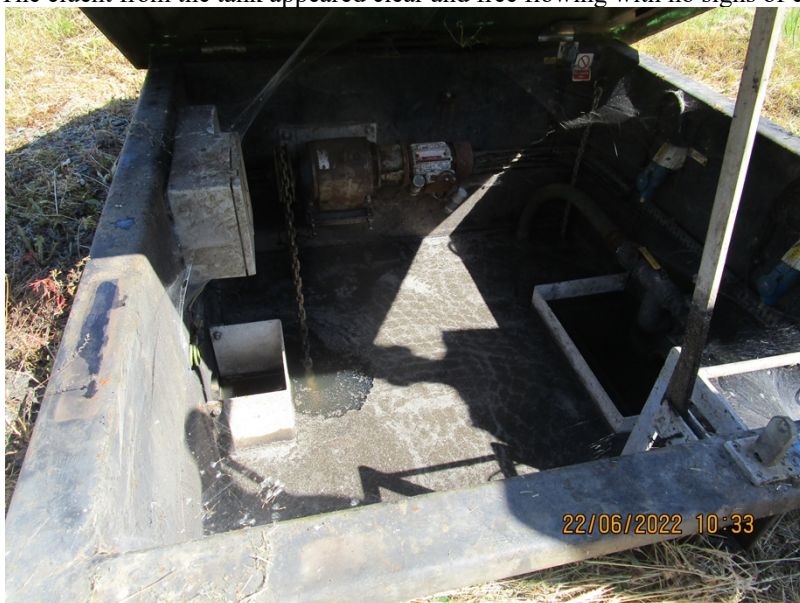
The final settlement tank on the works is situated underground, however the lid can be lifted for inspection. The tank consists of solids retaining boards on both the inlet and outlet of the chamber. The settlement tank also has a pump present for returning flow/ solids to the head of the works.

The final settlement system appeared to be operating effectively and there were no signs of solids in the outfall channels. The eluent from the tank appeared clear and free flowing with no signs of concerns.

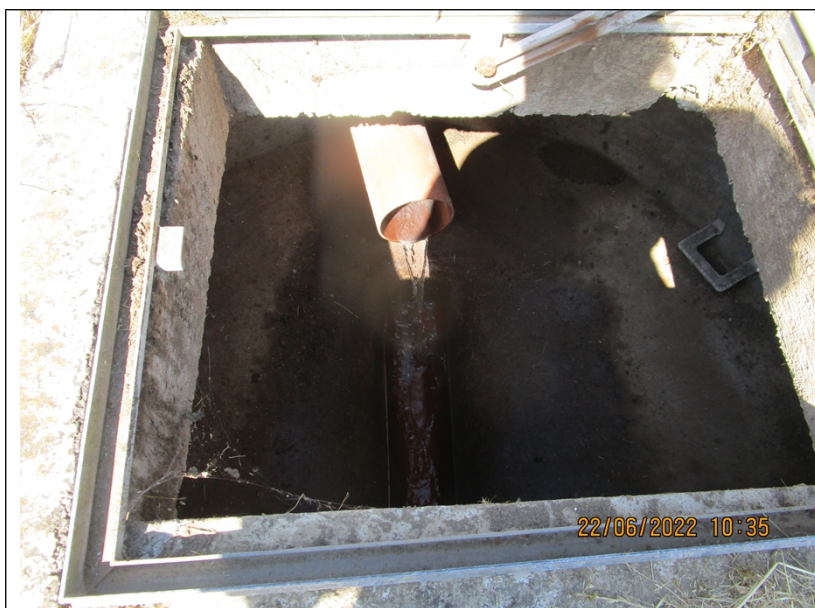
The Final effluent sampling point was clearly marked and easily accessed. The chamber appeared clear, and effluent was flowing freely. There were no signs of solids or contaminants within the effluent. The works has a descriptive permit, so no sampling was required at the time.

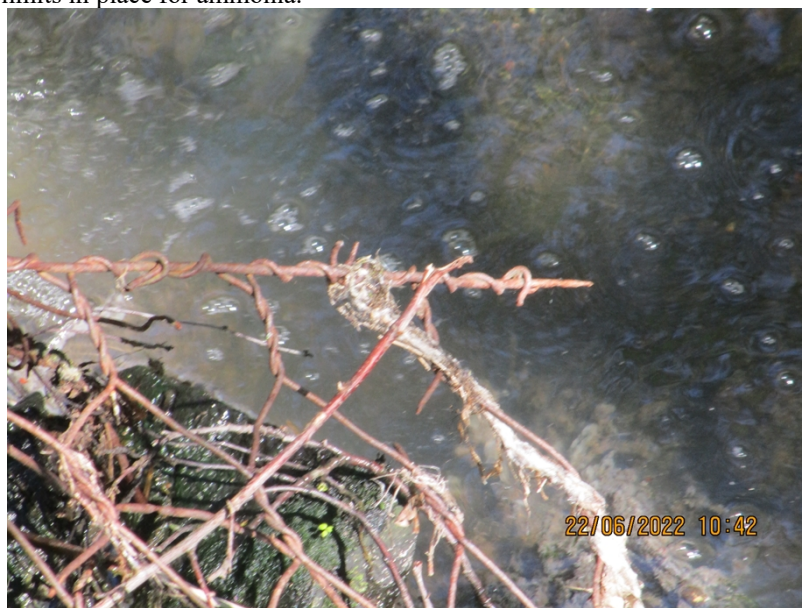
The outfall into the river showed a small build up of sewage fungus which was only present at the outfall and nothing further downstream. I believe this was potential a result a result of limited dilution at the outfall. The river was running very slowly and low and the weather was very warm. The works is a descriptive permit and does not have any numerical limits in place for ammonia.

The river was checked further downstream to see if there has been any negative impact from this. The watercourse appeared clear of any sewage fungus or contamination. The watercourse showed a good range of aquatic life and insect life present. There is evidence of natural algae grown, which was also present upstream of the outfall. From the on-site assessment, I do not believe there was currently any breach of the permit conditions.

The sewage fungus present at the outfall pipe should be monitored, as it may indicate problems within the treatment process. If there are any downstream impacts observed this will need to be investigated as a breach of permit condition.
