## Compliance Assessment Report

Report ID:  
CAR\_NRW0032864

| Site | Dowlais Slaughterhouse<br>EPR/AP3433ES | Permit Ref | AP3433ES | | | |

Site Inspection 6<sup>th</sup> Feb 2018

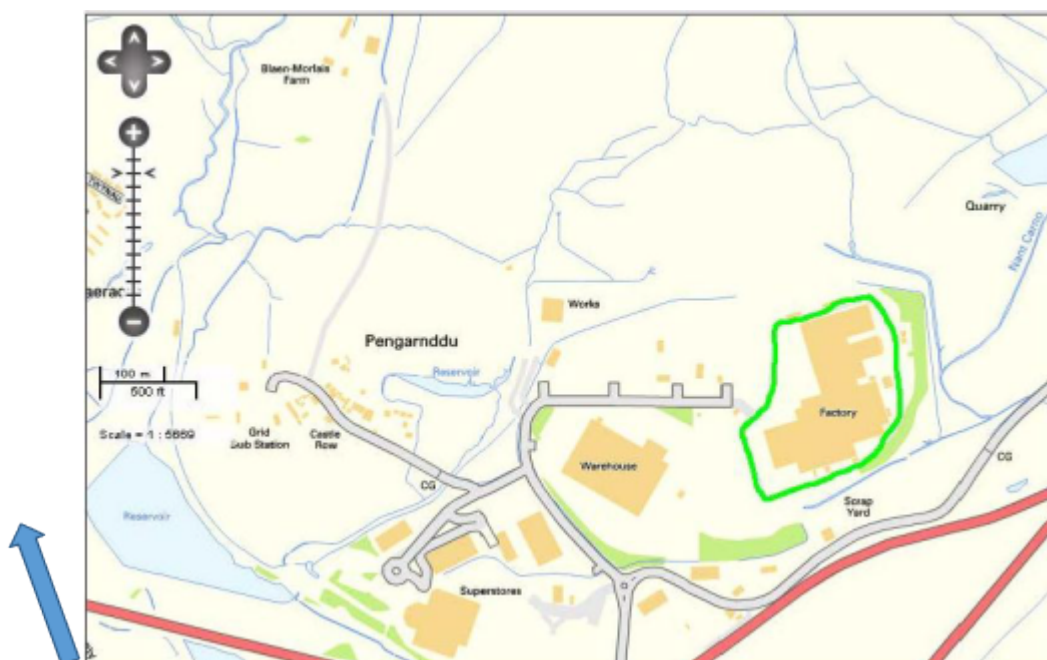
Witnessed at outlet of W2 in drainage ditch for approximately 115m flowing eastwards from the outlet of W2 towards W1. The ditch forms a tributary to the Nant Carno and flows East from the site. The ditch is outside the permitted boundary. The latest permitted boundary is found in permit variation V002 issued 5<sup>th</sup> Aug 2014 and shows the surface water drainage ditch outside the permit boundary. At the time of the inspection, it was thought that this was within the boundary, but subsequently found to be external to it. This has the consequence of being classified as a surface water pollution incident which was observed by a warranted officer for NRW, and seen outside the permit boundary. As a result, **a Category 3 breach of permit conditions has been issued.**

Extract of permit V002 below showing the permit boundary in green and the polluted surface water ditch clearly outside the permit boundary.

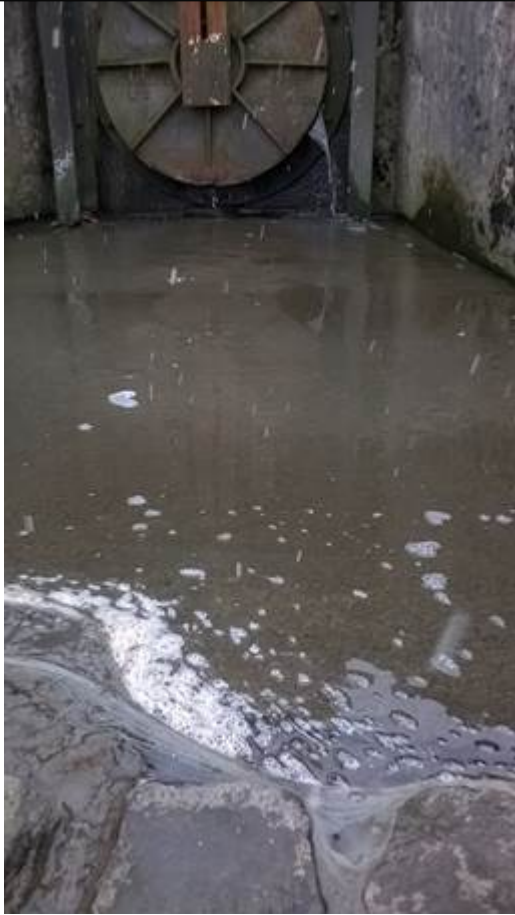
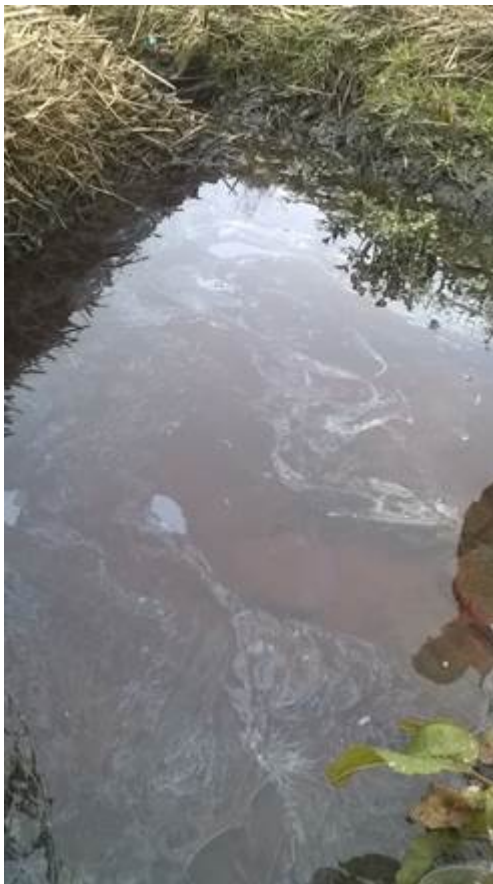
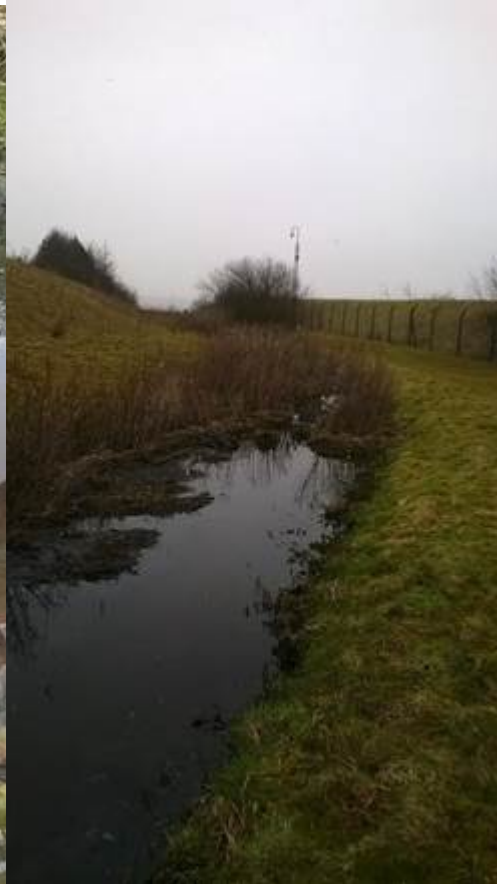
The substance appeared to be a suspended oily fat/grease which was seen to form a skin on the water surface (Pic 1). Site closed the W2 outlet immediately and phoned their pollution control company – Geo Pollution Technology (GPT formerly Natural Solutions Ltd) and requested they attend site immediately. Site representatives were tasked to contain the outflow using available resources. W2 outlet was manually closed to stop the flow. Sandbags and straw bales were used in the length of the ditch and stopped the substance polluting further down. **No booms were available. No emergency spill kit was used by the site** (see recommendations below). If these had been present, the reaction time to the incident would have been quicker. However, in this case, all the polluting material was seen to be prevented from flowing further afield by the low flows present at the time and the vegetation halting the flows. **A sluice gate** approximately 100m downstream (East) of W2 was seen to be constructed in a way which meant it could not be lowered to stop the flow. Consequently, the pollution was allowed to escape a further 15m or so further.

This was inconclusive but the burden of evidence seen pointed to the oil separator seen in Manhole 3 surface water manholes were inspected. Working back upstream from W2, No1 cover was witnessed to have an oily /fatty sheen on the surface. No2, was seen to contain floating solids. No3 was seen to be clear with low flows. It was understood that each one flows into the next, i.e., No3 flows to No2, then to No1. There is an oil separator operating in this location which was apparently serviced a week before. It may be that the capacity of the separator has been breached meaning that it was overtopped. Site needs to evaluate the loading of this separator to ascertain its continued suitability for the job (see list of recommendations below). The car park was also inspected to locate further potential sources, but proved negative. The top part of the car park is currently a construction site. As no other sources were identified, the No2 manhole/ oil separator is suspected as being the source.

The substance was witnessed to be present on the surface from W2 in the direction of W1 for approximately 115 metres eastwards. W1 (See pics)

On leaving the site, the pollution was seen to be clear 115 downstream and only localised to the outlet of W2.

GPT arrived promptly on site within 1-2 hours of notification and tasked to clean out the No2 manhole, and suck up the surface polluting material from No1 as well as the surface grease along the drainage ditch. Booms were employed at W2 to contain further pollution. A sample was taken for analysis. **Please forward the results to NRW for analysis.**

| 1. | No booms or spill kit used by site staff for the immediate response. | Recommendation – booms and emergency spill kits to be available on site. |
| 3. | Current Separator may be under the specification necessary to deal with this discharge | Evaluate the efficiency of this separator and upgrade if required. |

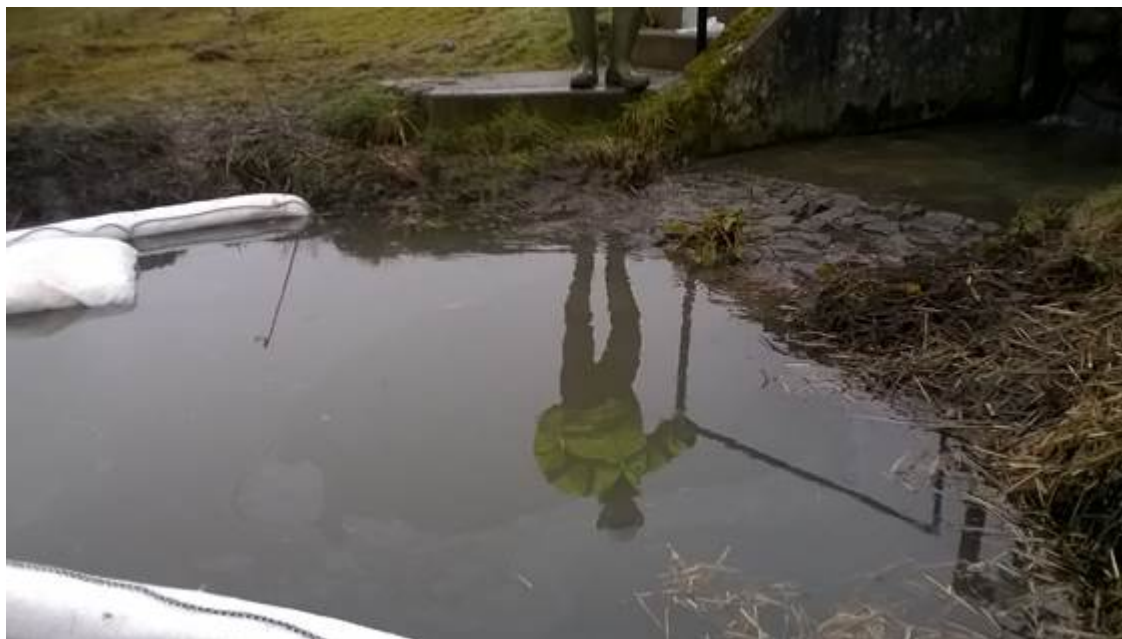
NRW carried out a follow up visit to gain a sample of the suspected pollution. The surface water at W2 was seen to contain booms placed by GPT. There was still surface water fatty/oil deposit seen on the surface although to a lesser level, and this was contained to the local area of W2 and by the booms. 2 samples were taken at this location. One inside the pooled area shown, and one just outside (downstream). These will be analysed for fat/oil content of the water.

W2 outlet – surface sheen still present, but contained by booms.

| 6. | Site to re-evaluate the current provisions for surface water management. This may include an evaluation of the current system and improvements to be made.<br>Note ; A permit variation would be needed to alter the current site boundary to include the W2 tributary to the Nant Carno – as well as alterations to the current W1 and W2 positions. | Please provide a planned solution to the current system in place so that the risk of surface water pollution is reduced.<br><br><b>Report due to NRW on 1<sup>st</sup> May 2018.</b><br><br><b>Site is to continue to use booms at W2 to reduce the risk, ensuring these are inspected regularly and disposed of correctly.</b> |

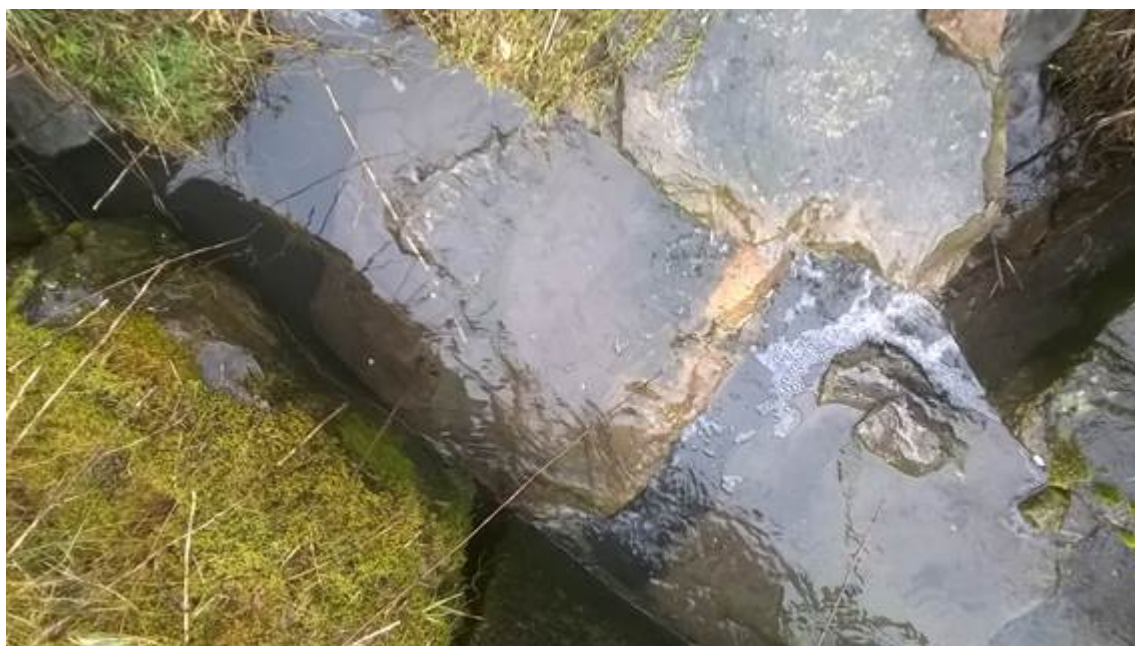
Further downstream at the confluence of W1 and W2 streams the water was seen to be running offsite clear. NRW satisfied no pollution is entering the Nant Carno.
