LIFEDeeRiver

Restoration of Freshwater Features

Erbistock Weir

Final Report

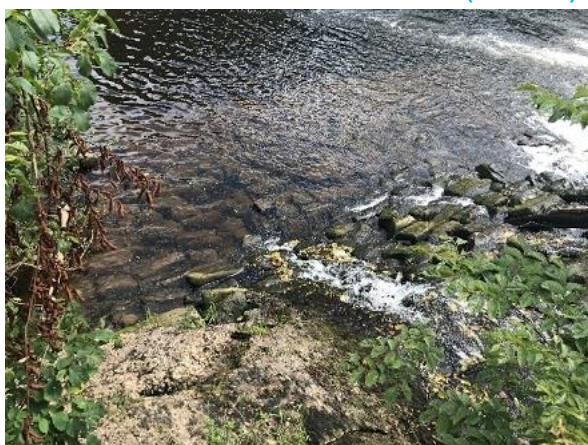
Plate 8-11. LHB side and bottom end of weir, showing dilapidation

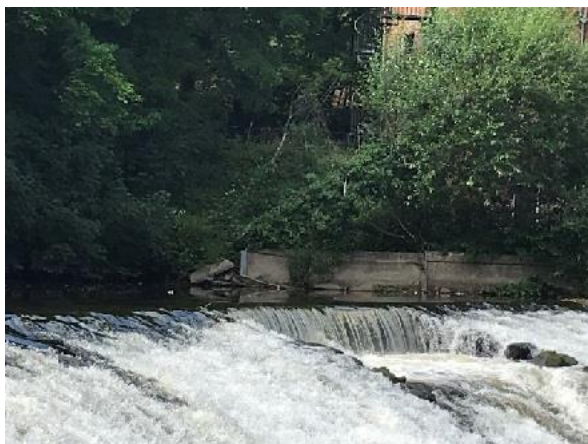
Plate 8-15. Broken up section toward the LHB side of the weir

- The weir is in a poor condition with parts of it notably disintegrated, e.g. as indicated in Plate 8-15.
- An estates rental building (former mill) is located on the left-hand bank and neighbouring the weir. We were advised that this area flooded in February / March 2020 with flows going over the decking and back into the river downstream.
- In the same area there is a leat to the mill with a redundant water wheel (Plates 8-7 and 8-17). The estate have requested that this is sealed up as part of the design. To date, the estate have already undertaken some work to achieve this but some flow still gets through.
- On the right-hand bank there is an existing baulk fish pass which isn't achieving fish passage. There is a sloped concrete apron between the existing fish pass and the right-hand bank.

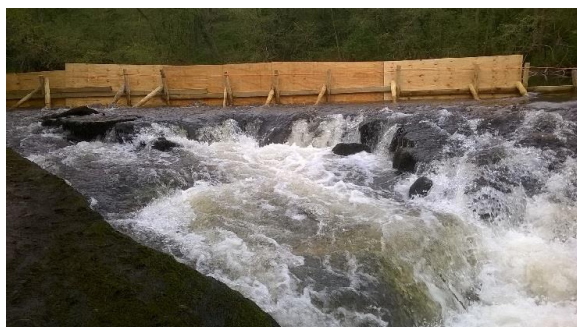
Plate 8-26. Poor condition of the weir, looking from the RHB concrete apron

Following the site visit some photos of the weir were provided to us by NRW, taken when the flow was diverted away from the right-hand bank side of the structure. Some of these are provided in Plates 8-26 to 8-29, and show that much of the weir and existing fish pass are in a poor condition.

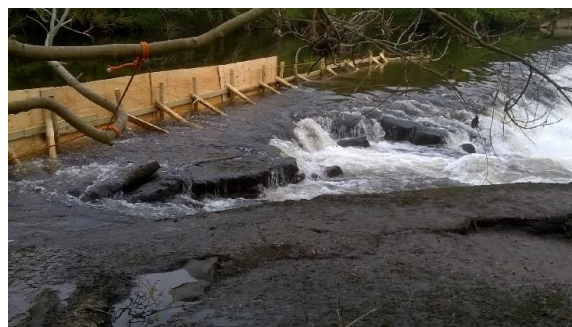
Plate 8-27. Poor condition of the weir including the baulk fish pass, looking from the RHB concrete apron

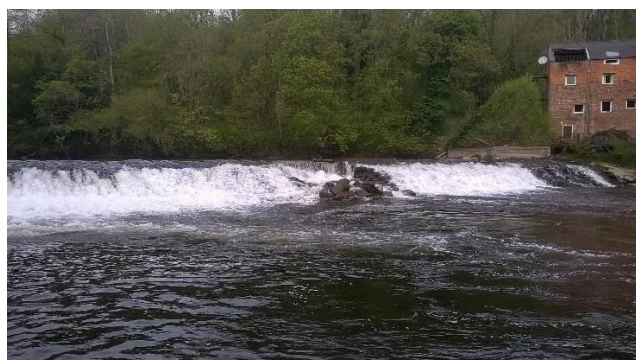
Plate 8-28. Poor condition of the weir including the collapsed section, looking from the RHB downstream of the weir

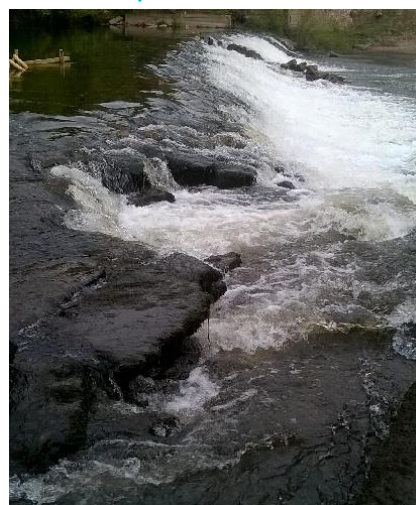
Plate 8-29. Poor condition of the structure, looking across the weir from RHB concrete apron

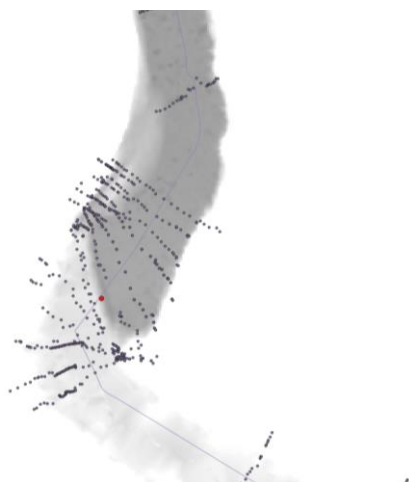
Surveyed points around the weir itself are indicated in Figure 4-1 below, which shows a reasonable coverage with some gaps in the central weir, which could not be surveyed safely. All surveyed river points are shown in Figure 4-2 below along with an indication of the difference between the measured levels and that in LiDAR data. This shows quite stark differences, particularly upstream of the weir showing the survey depths to be 2m or more deeper than represented in the LiDAR (ultimately showing the benefit of undertaking topographic surveys).

Figure 4-1. Topographic data xyz locations for Erbistock weir (true locations)
