Compliance Assessment Report CAR_NRW0040733

Permit being assessed: AB0041501

For: BRECON STW BRECON WWTW BRECON POWYS, held by DWR CYMRU CYFYNGEDIG

Type of assessment carried out: Site Inspection, Reason: Routine.

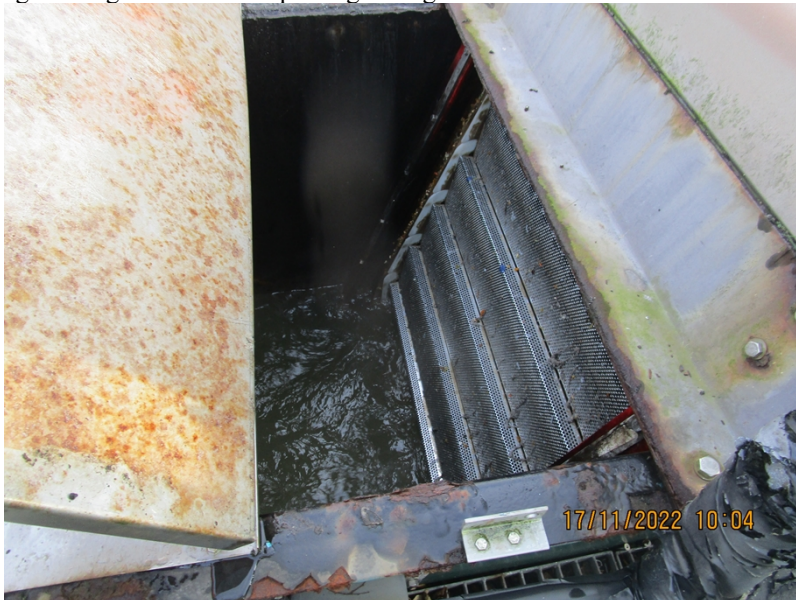
The incoming flow to the site is pumped up to the inlet point. There is a mechanical step screen on the inlet with a 6mm screen size. This was clearly operational at the time of inspection and there were no signs of blockages in the screen, or signs of significant debris passing through.

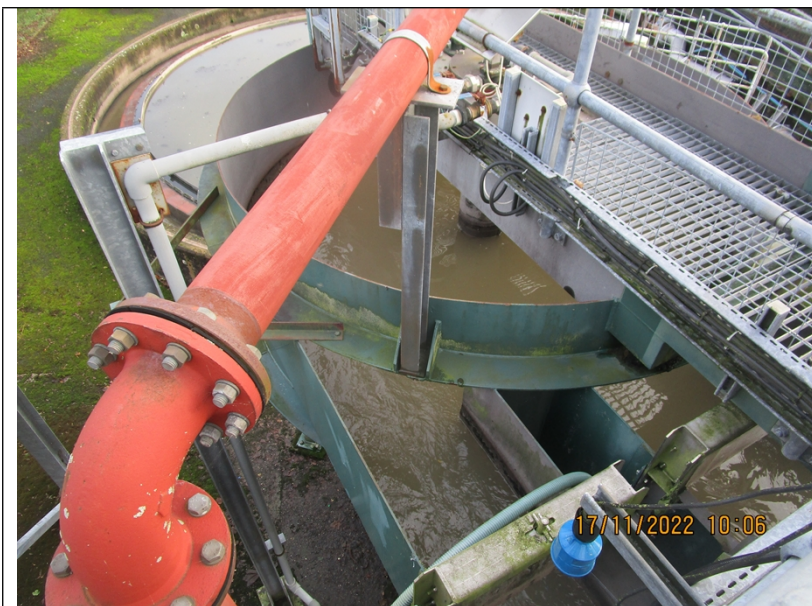
The UWWTD crude influent sampling point was clearly marked and allowed a representative sample of the influent to be taken. The sampling equipment is fixed in place and self-contained. A New Magflow meter (MCERTS) is also planned to be installed during the planned site upgrades.

The incoming flows (post screening) then enter a grit removal trough before reaching the storm weir. This slows down the flow and allows grit to settle out at the bottom of the trough.

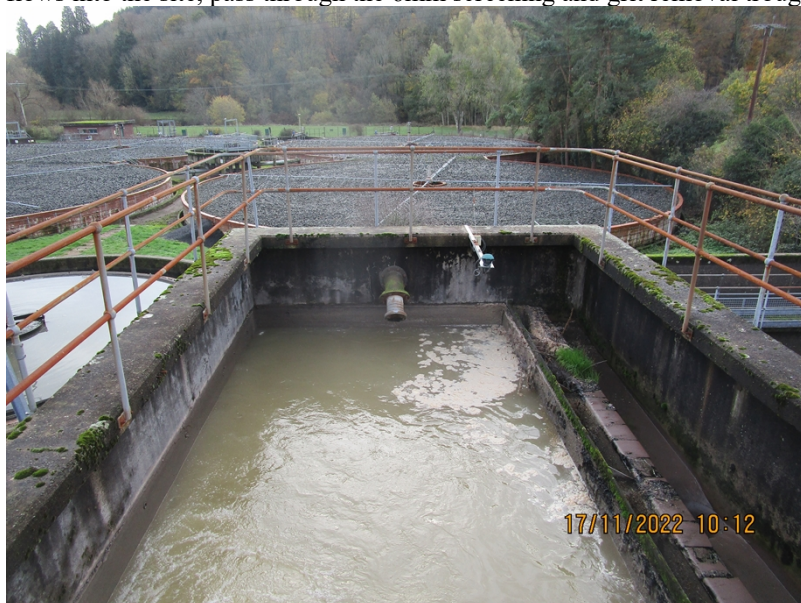
The storm weir on site is a hard-set weir setting, which only discharge once flows reach the set level. The flows were well below the storm weir setting in place and there were no flows entering the storm channel at the time of inspection. The storm channel appeared clear of debris or blockages. The storm channel does not have additional screening as all flows into the site, pass through the 6mm screening and grit removal trough before the storm weir.

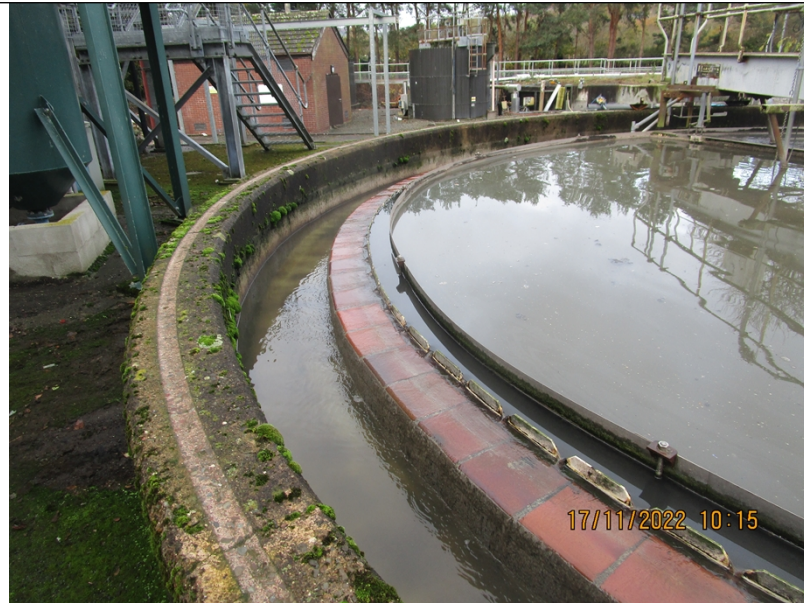
There are 4 circular primary settlement tanks on site, with rotating bridges, scum boards for retaining solids and brushes on the outfall channels. All settlement tanks have monitoring equipment in place. Settlement tanks 1-3 all appeared to be operating effectively. there were no signs of significant solids passing through to the outfall channels.

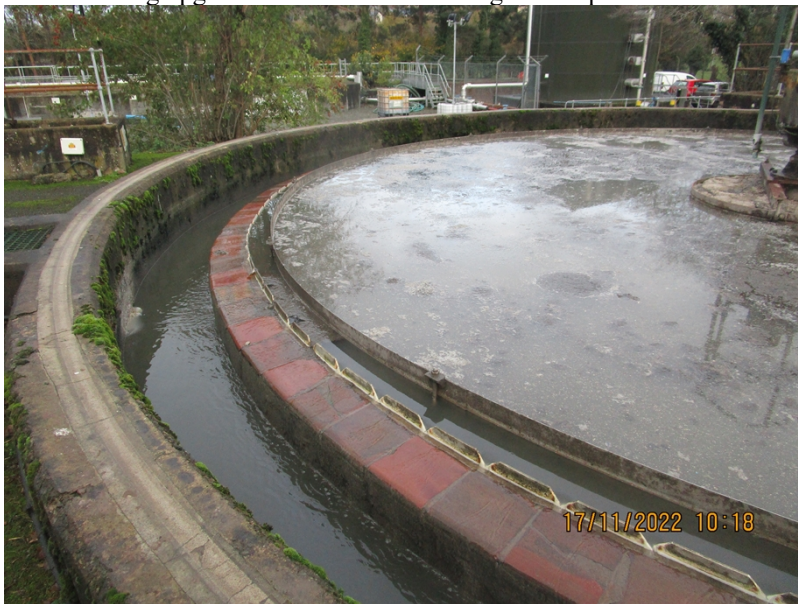
The 4th settlement tank bridge was not rotating and presented with much more solids/scum present within the tank. There was some evidence of solids passing through to the outfall on this tank, however it was not a significant amount and largely the outfall channel appeared clear. Most of the scum and solids was still being retained by the scum retaining boards. I was advised that the bridge system had failed and was being replaced with a new bridge in the planned improvement works (commencing 21st November). A OPNOT is planned to be submitted for this instance. All primary tanks are being upgraded to automatic de-sludge in the planned works.

- Magflow Installation at Inlet
- Replacing Faulty Primary Settlement Tank Bridge

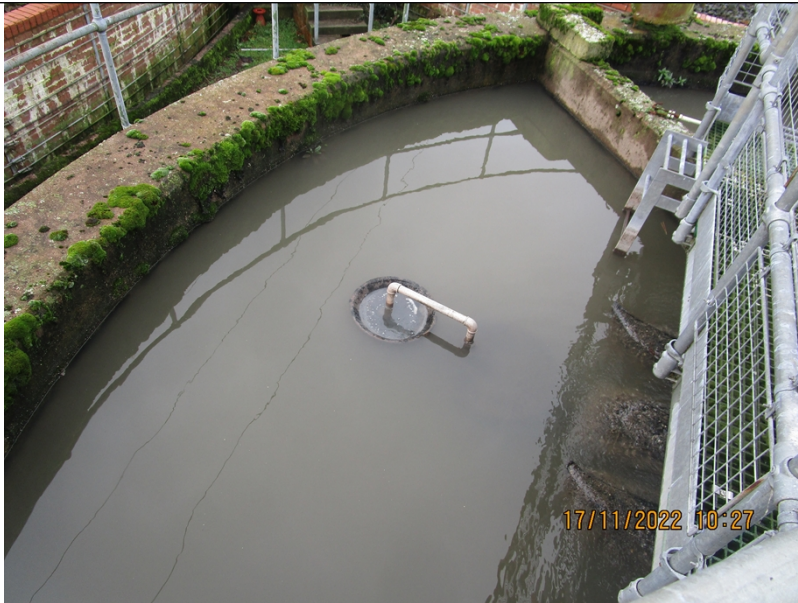
The outfall from the primary settlement tank leads to a 4-way distribution chamber. The purpose of which is to distribute the flows to the 4 filter beds on site. There were COPA sacs installed on all the pipes into the 4 distribution chambers. These appeared to be working effectively and were not blocked at the time of inspection. Once distributed, the flows pass on to treatment in the filter beds.

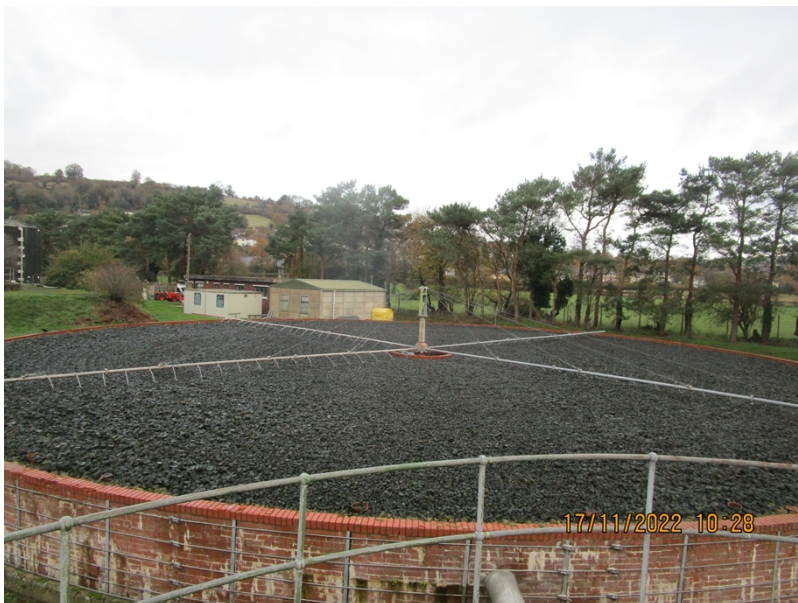
The works contains a 4 circular filter beds containing stone media. The rotation arms on each were moving free and unhindered. There were no signs of ponding or dry patches across the filter beds and no excessive vegetation growth. The filter housings are of brick construction and appeared to have been in place for some time, showing signs of wear. Metal banding has been installed on the filter beds to support the brick walls, and this appears to be in good order. I did not observe any signs of major leakage form any of the filter bed walls on site. The outfalls from the filter beds appeared to be flowing freely and clear of signs of ineffective treatment. The filter bed systems on site appeared to be operating effectively.

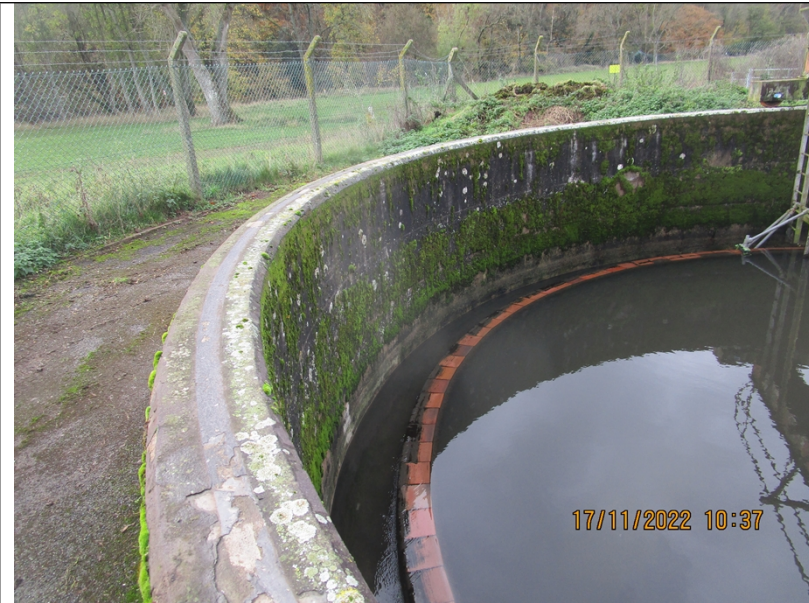
There are three circular final settlement tanks on site, each with rotating bridges and brushes on the outfall channel. Monitoring equipment is in place. These all appeared to be operative effectively, and there were no signs of excessive carry over of solids or signs of sewage fungus present. The final settlement system appeared in good order.

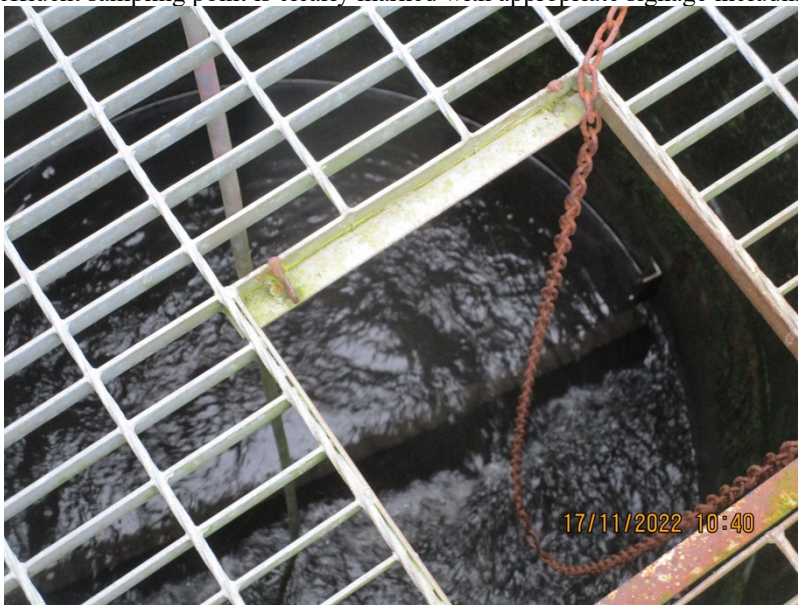
The final effluent then passes through a Magflow flow meter, which appeared to be operating as required and accessible for inspection. The Magflow meter is located in what appears to be a straight section of pipe, which is preferable to provide reliable flow readings. The MCERTS monitor was clearly operational at the time of inspection. The Final effluent sampling point is clearly marked with appropriate signage including the sample point number.

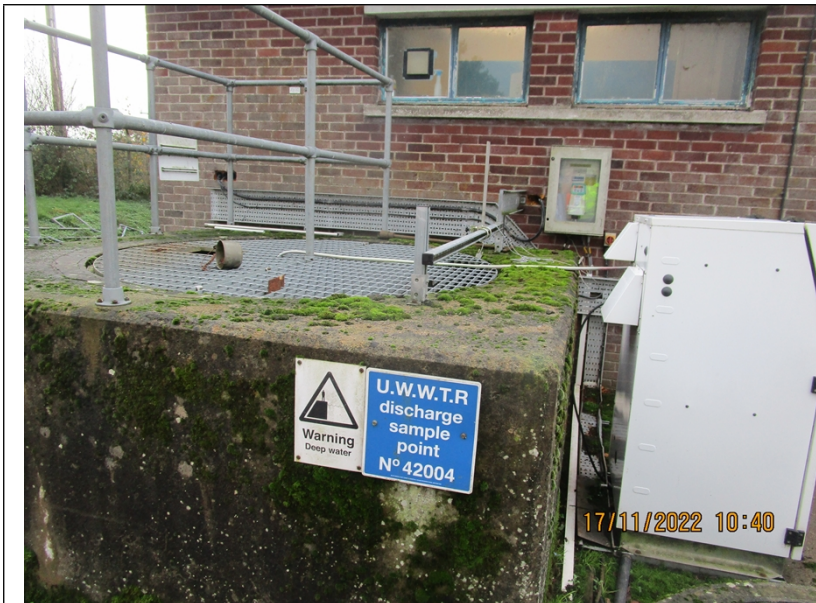
There is a UWWTD sampling point present which was well marked and easy to access. The intake pipe for the sampling equipment is situated within the outfall chamber, and in a suitable location for an indicative sample to be taken. The equipment is fixed and appeared to be suitably operational.

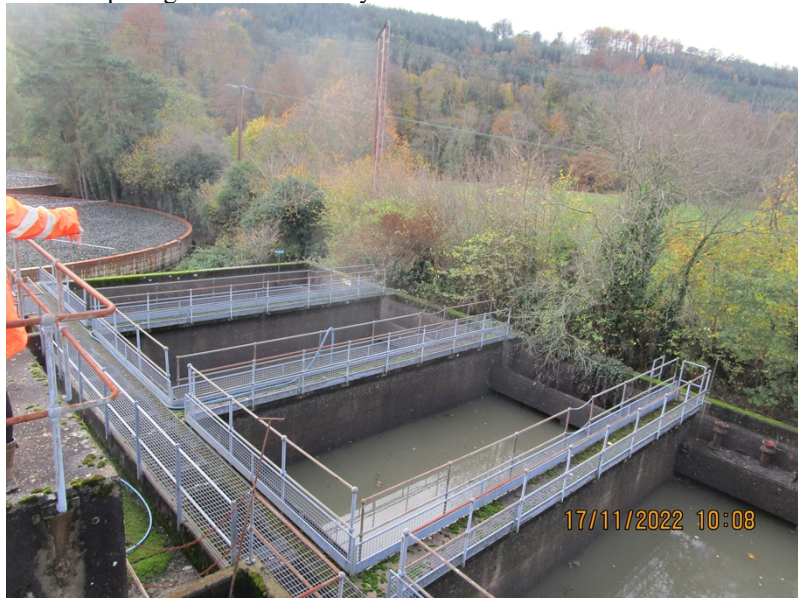
There are 4 connected, open rectangular storm tanks on site, which fill sequentially and have outlets on the final tank. The storm sewage must fill the final tank in the sequence to a set level before any effluent will pass into the storm outfall. The storm tanks are manually returned to the head of the works when required.

The storm tanks all contained water but was well below the level where it would discharge via the storm channel. There had been persistent rainfall in the preceding days, so this was to be expected. There is EDM equipment present to monitor spilling from the storm system on site.
