REPORT
on
GROUND INVESTIGATION
At
NEWHOUSE PARK PLOT 2
CHEPSTOW
OCTOBER 2002
REPORT NO: 20749

Contract: Newhouse Park Plot 2, Chepstow

Document: Factual Report

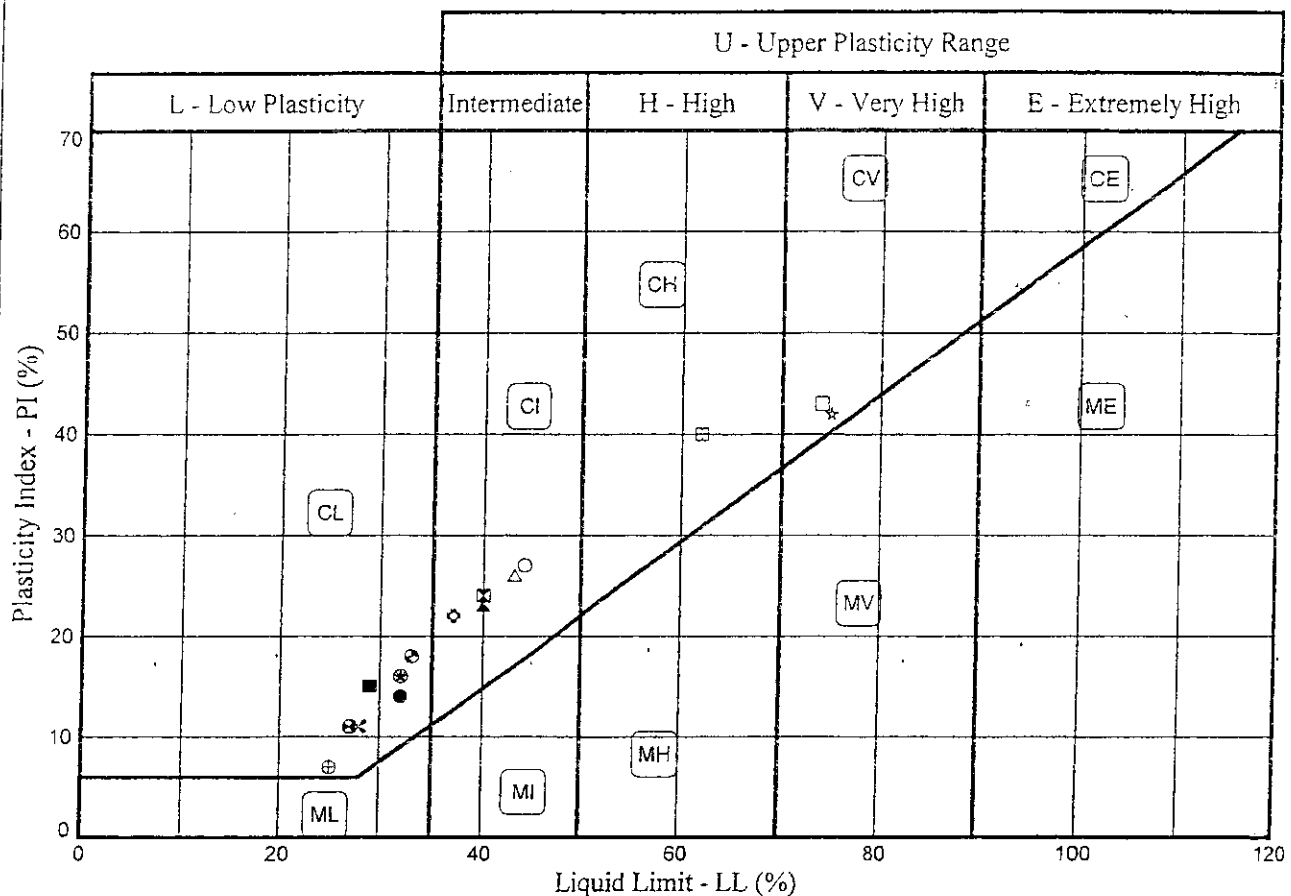
PLASTICITY CHART - PI Vs LL

Sample Identification	MC	LL	PL	PI	<425um	Specimen Description
HoleID Sample Depth	%	%	%	%	%	
● TP01 - B 1.80	12	32	18	14	47	Reddish brown CLAY with mudstone gravel
⊠ TP02 - B 0.50	21	40	16	24	100	Red brown mottled grey CLAY
▲ TP02 - B 1.00	24	40	17	23	100	Red brown mottled grey CLAY
★ TP02 - B 2.00	28	32	16	16	97	Red brown mottled grey CLAY with a little mudstone gravel
⊗ TP03 - B 0.40	14	28	17	11	91	Orangish brown CLAY with a little gravel
⊕ TP03 - B 1.70	18	37	15	22	63	Reddish brown CLAY with some mudstone
○ TP04 - B 1.00	22	44	17	27	100	Red brown mottled grey CLAY
△ TP04 - B 1.50	23	43	17	26	96	Reddish brown mottled green slightly gravelly CLAY
⊗ TP06 - B 1.20	25	32	16	16	100	Red brown CLAY
⊕ TP08 - B 0.40	14	25	18	7	91	Orangish brown CLAY with a little gravel
□ TP13 - B 0.50	26	74	31	43	99	Red brown mottled grey slightly sandy CLAY
⊕ TP14 - B 0.40	14	27	16	11	96	Red brown slightly sandy CLAY with a little gravel

⊕ TP15 - B 1.10	31	33	15	18	76	Reddish brown mottled green CLAY with some mudstone
★ TP17 - B 0.85	27	75	33	42	97	Red brown mottled grey slightly sandy CLAY
⊕ TP21 - B 1.70	27	62	22	40	100	Red brown mottled grey CLAY
■ TP22 - B 0.90	12	29	14	15	80	Reddish brown mottled green CLAY with some mudstone

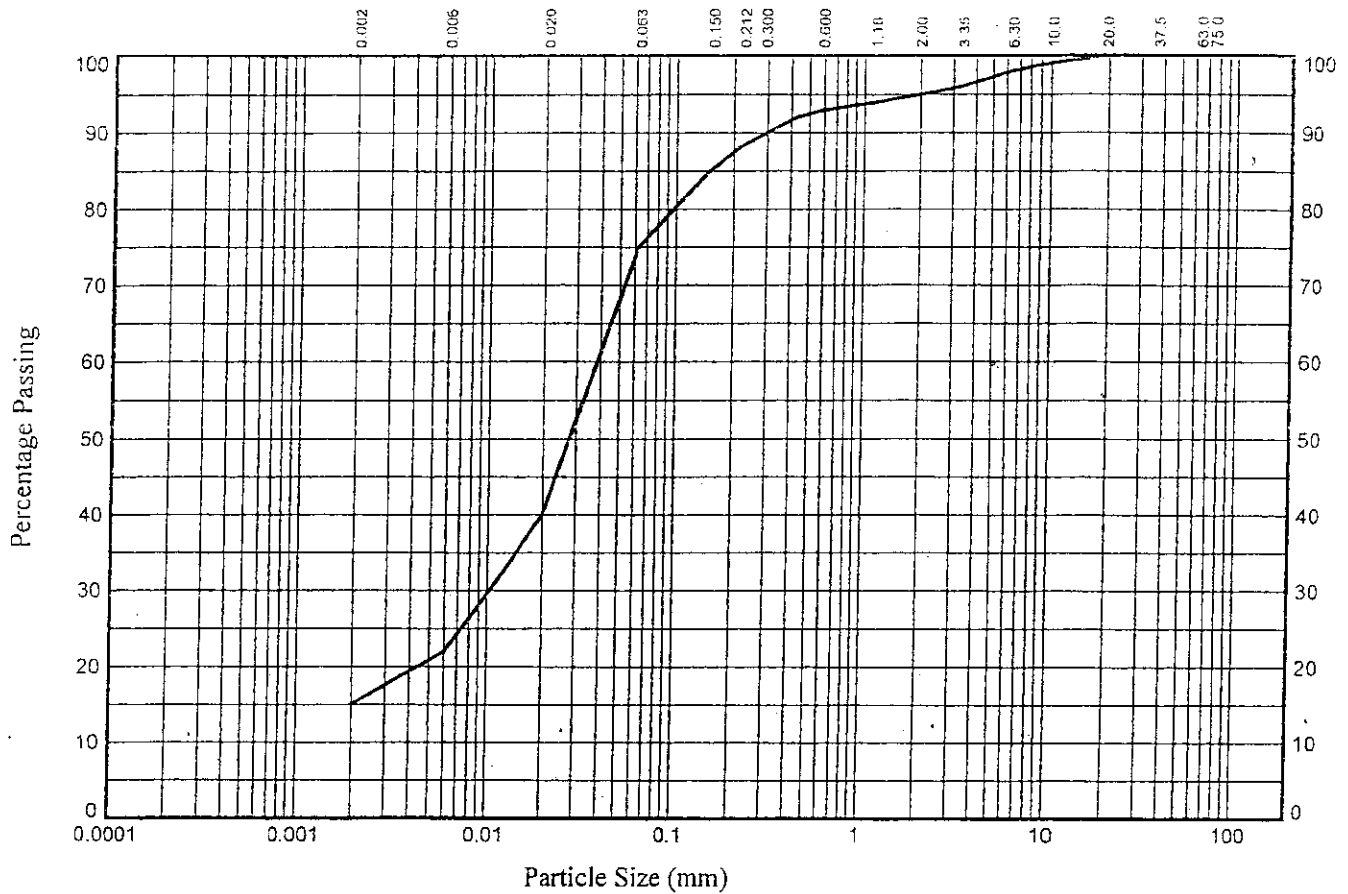
BS Test Sieve (mm)	Percentage Passing
125.0	100
75.0	100
63.0	100
37.5	100
20.0	100
10.0	99
6.30	98
5.00	
3.35	96
2.00	95
1.18	94
0.600	93
0.425	92
0.300	
0.212	88
0.150	85
0.063	75

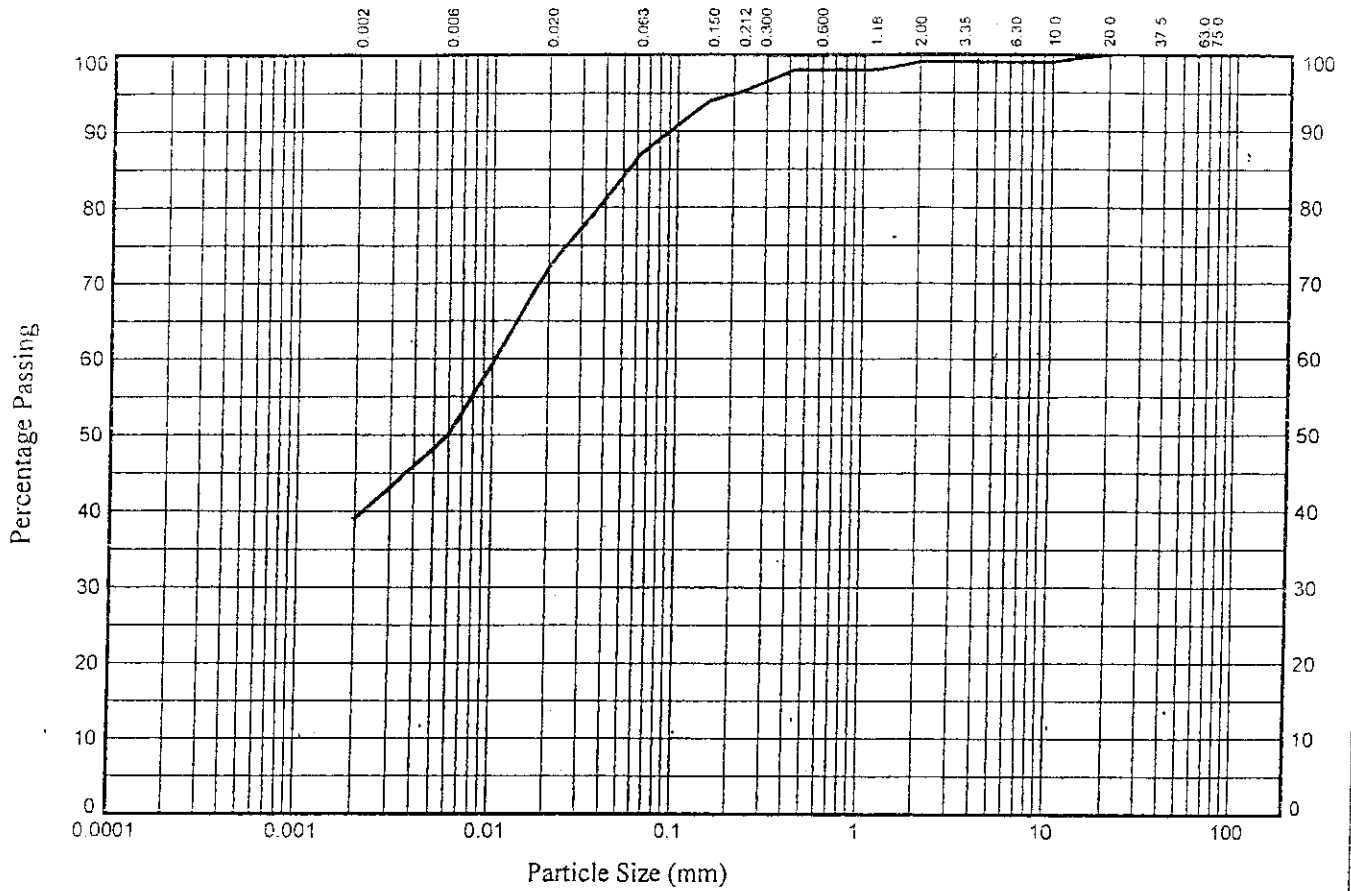
BS Test Sieve (mm)	Percentage Passing
125.0	100
75.0	100
63.0	100
37.5	100
20.0	100
10.0	99
6.30	99
5.00	
3.35	99
2.00	99
1.18	98
0.600	98
0.425	98
0.300	
0.212	95
0.150	94
0.063	87

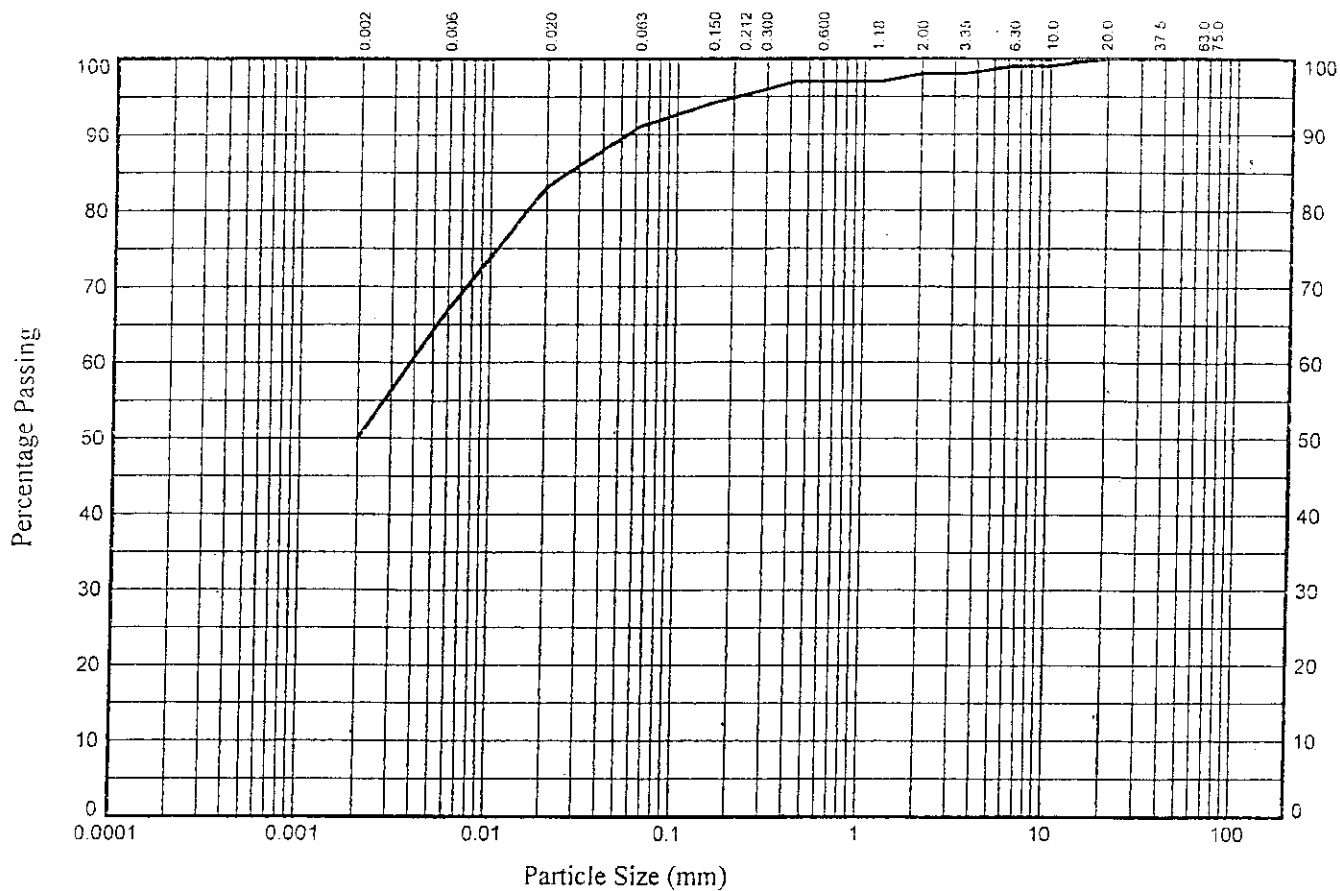
BS Test Sieve (mm)	Percentage Passing
125.0	100
75.0	100
63.0	100
37.5	100
20.0	100
10.0	99
6.30	99
5.00	
3.35	98
2.00	98
1.18	97
0.600	97
0.425	97
0.300	
0.212	95
0.150	94
0.063	91

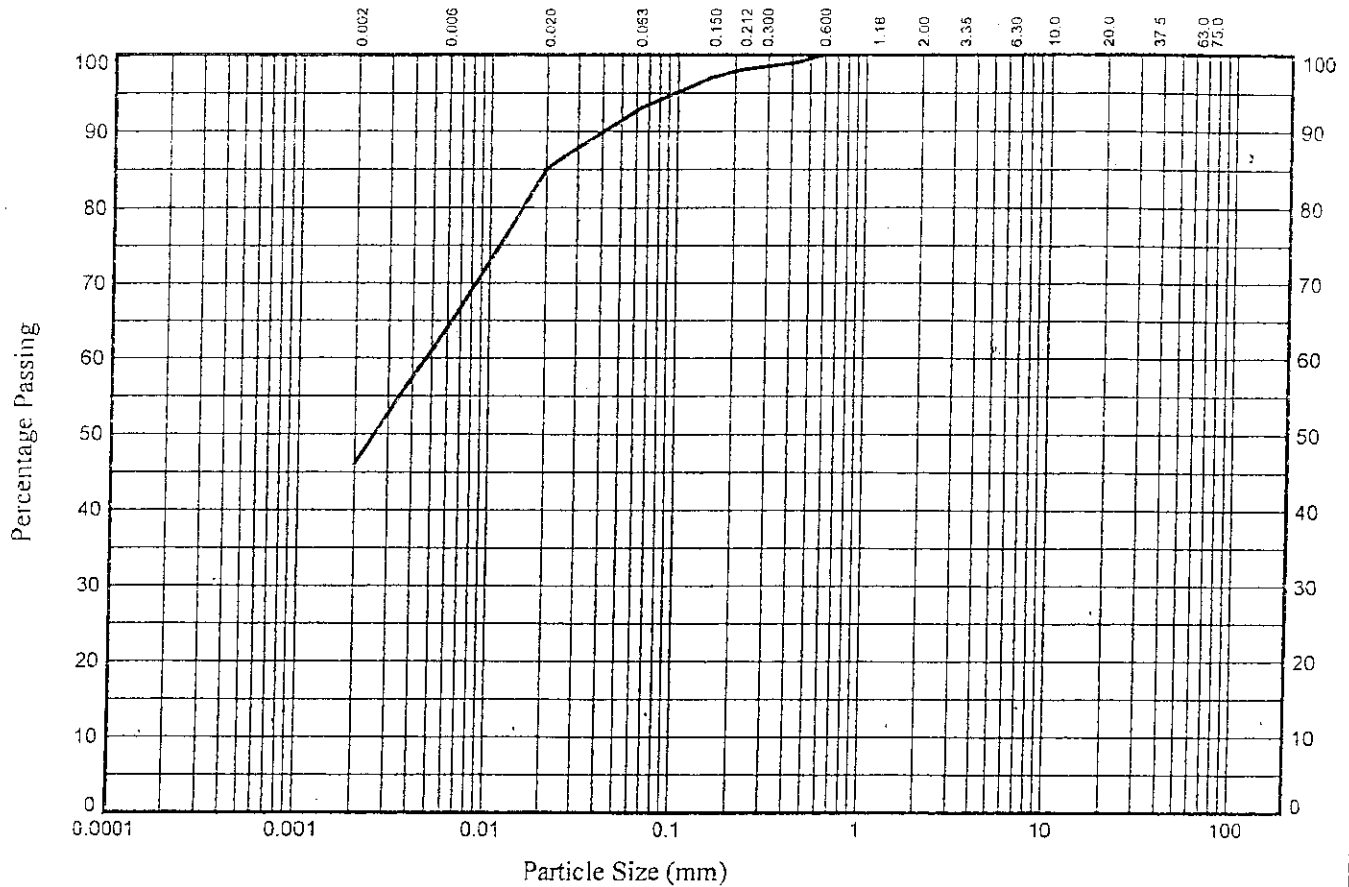
BS Test Sieve (mm)	Percentage Passing
125.0	100
75.0	100
63.0	100
37.5	100
20.0	100
10.0	100
6.30	100
5.00	100
3.35	100
2.00	100
1.18	100
0.600	100
0.425	99
0.300	98
0.212	97
0.150	97
0.063	93

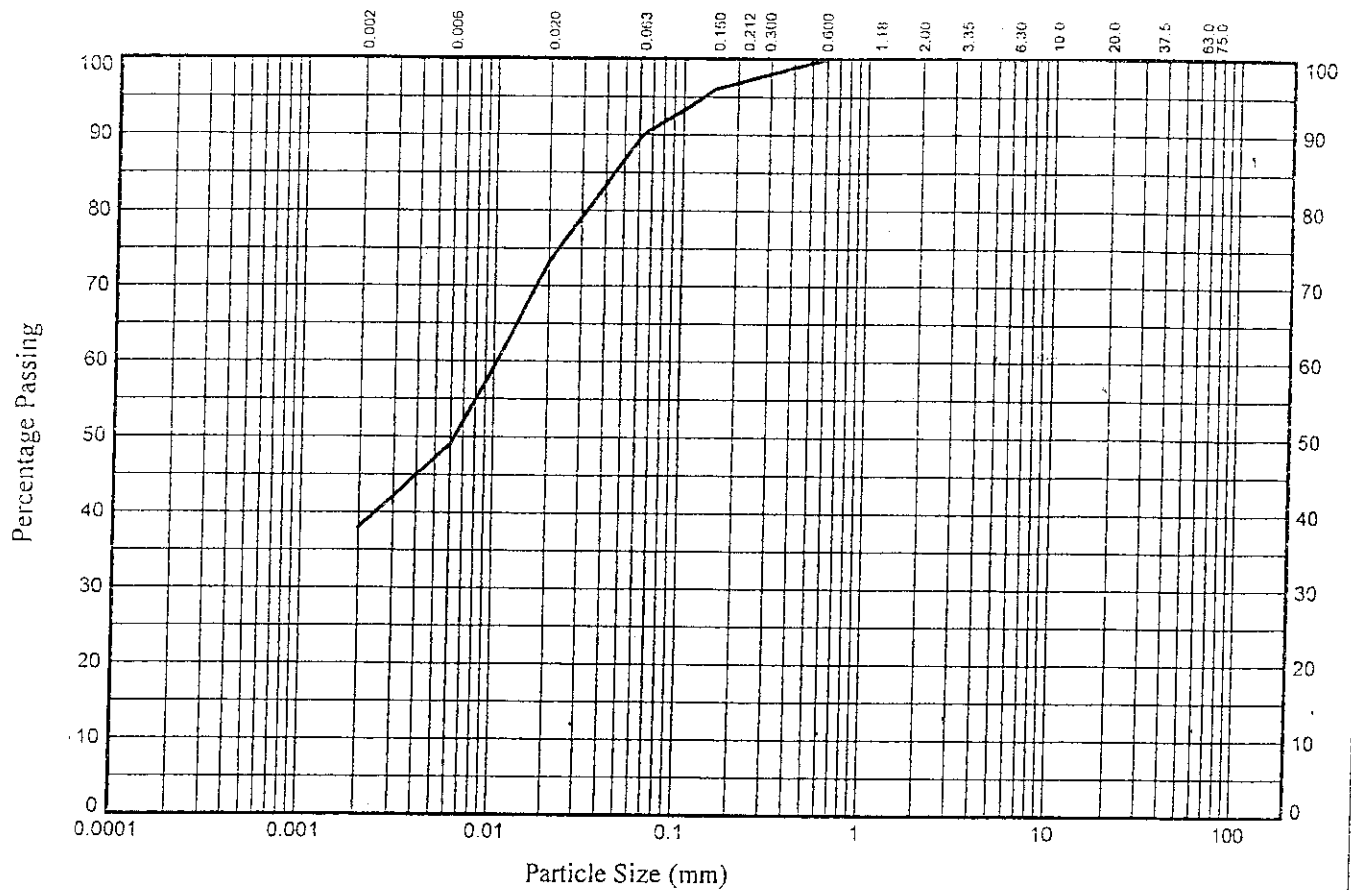
BS Test Sieve (mm)	Percentage Passing
125.0	100
75.0	100
63.0	100
37.5	100
20.0	100
10.0	100
6.30	100
5.00	100
3.35	100
2.00	100
1.18	100
0.600	100
0.425	99
0.300	97
0.212	96
0.150	90
0.063	38

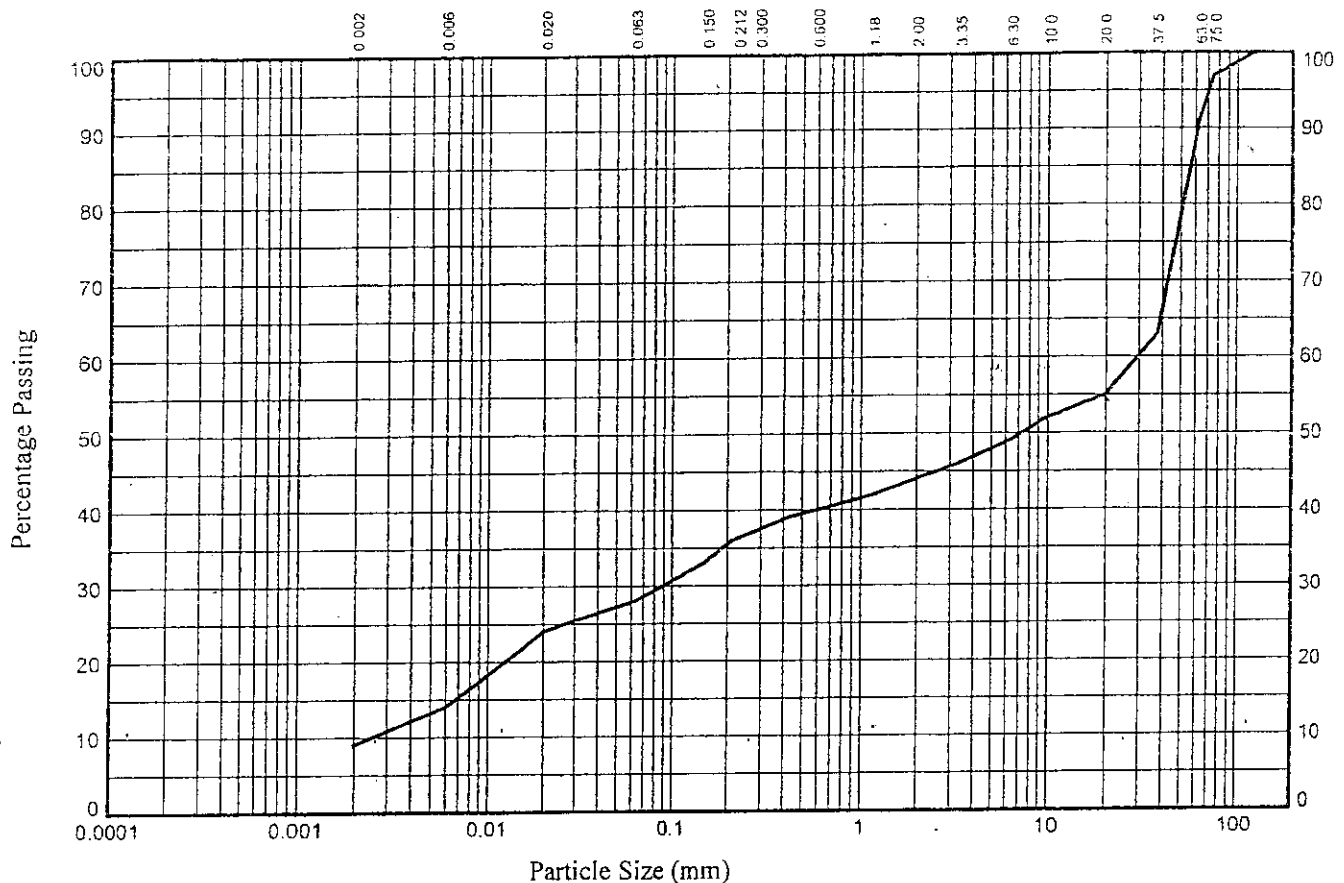
BS Test Sieve (mm)	Percentage Passing
125.0	100
75.0	97
63.0	91
37.5	63
20.0	55
10.0	52
6.30	49
5.00	
3.35	46
2.00	44
1.18	42
0.600	40
0.425	39
0.300	
0.212	36
0.150	33
0.063	28

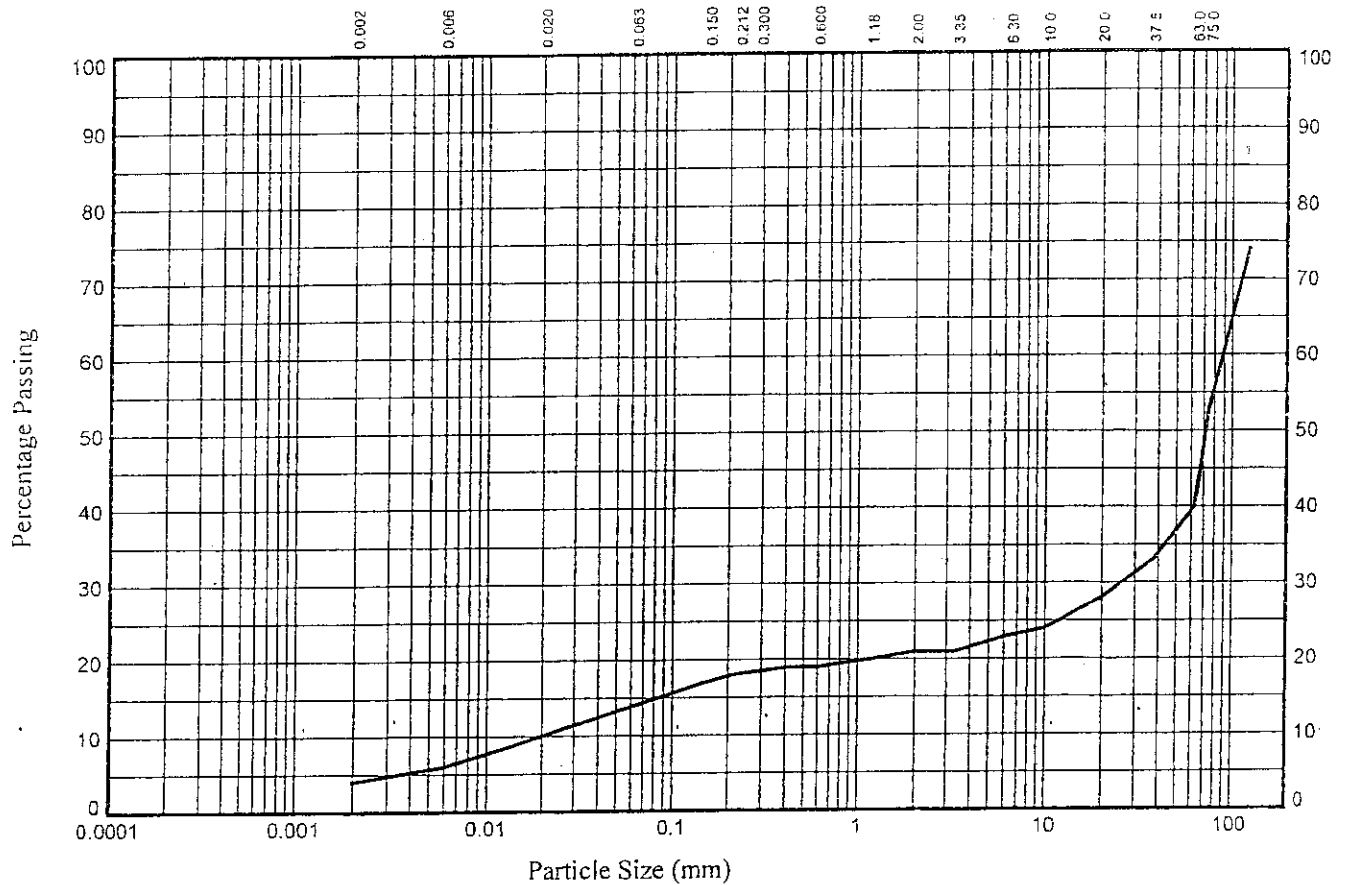
BS Test Sieve (mm)	Percentage Passing
125.0	74
75.0	53
63.0	40
37.5	33
20.0	28
10.0	24
6.30	23
5.00	
3.35	21
2.00	21
1.18	20
0.600	19
0.425	19
0.300	
0.212	18
0.150	17
0.063	14

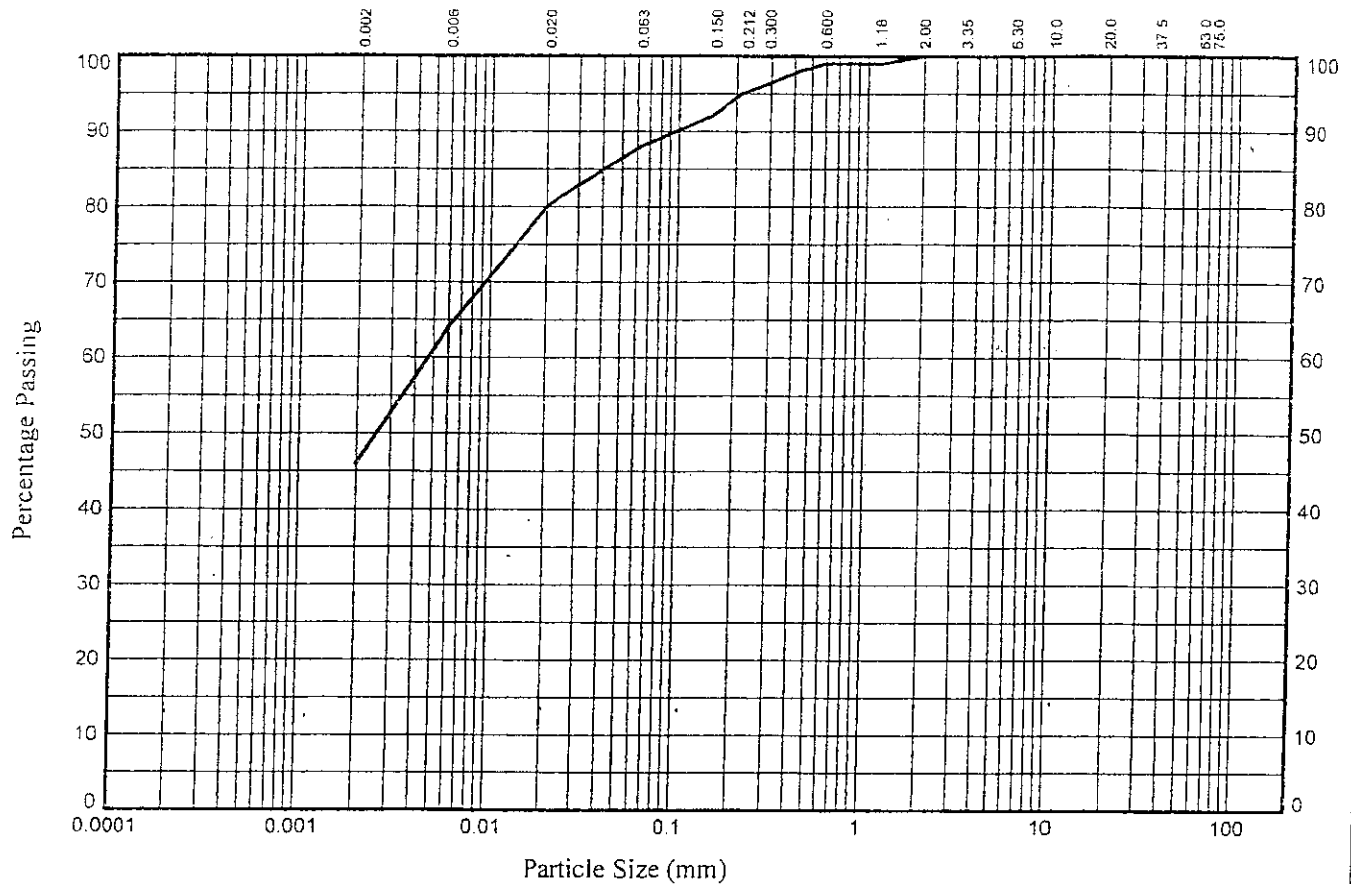
BS Test Sieve (mm)	Percentage Passing
125.0	100
75.0	100
63.0	100
37.5	100
20.0	100
10.0	100
6.30	100
5.00	100
3.35	100
2.00	100
1.18	99
0.600	99
0.425	98
0.300	95
0.212	92
0.150	88
0.063	88

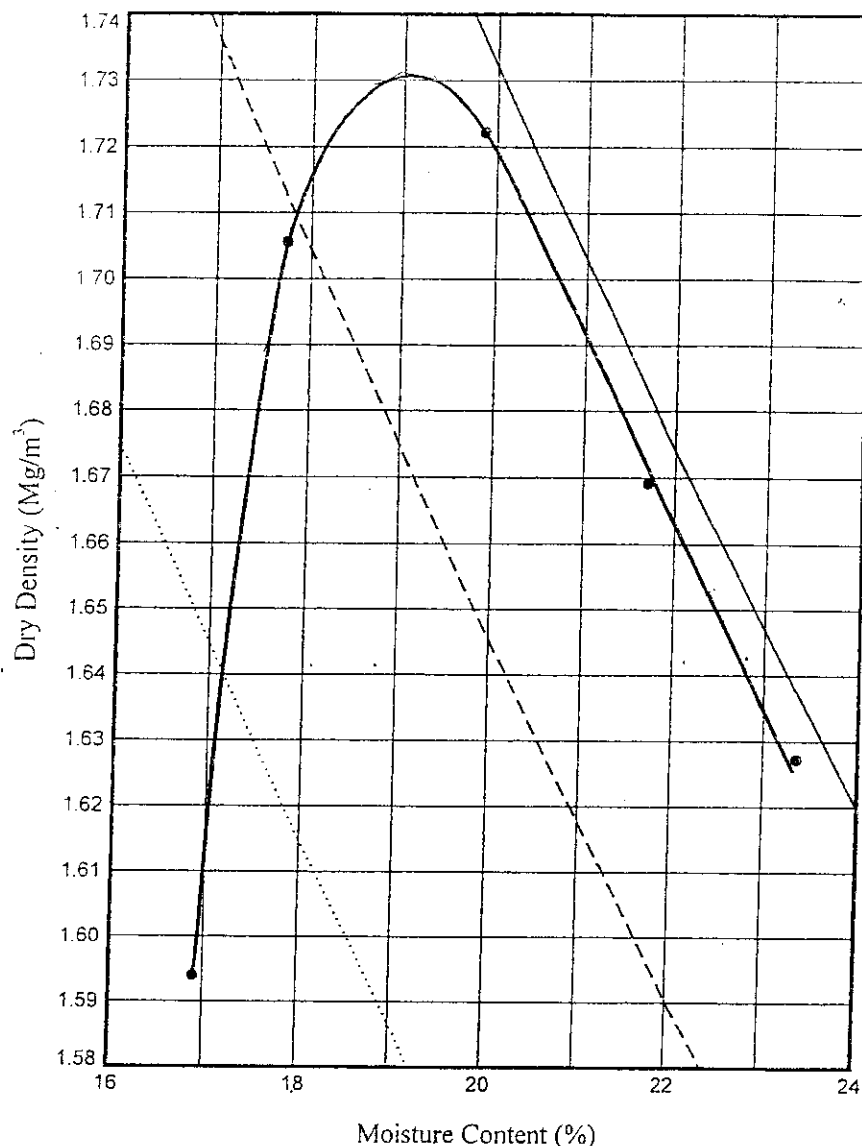
DRY DENSITY / MOISTURE CONTENT RELATIONSHIP TEST

Initial Sample Conditions		Test Details	Test Results
Initial Moisture Content (%)	: 22	Compaction Type : Light	Maximum Dry Density (Mg/m³) : 1.73
% Retained on 37.5mm BS Sieve	: 0	Mass of Rammer (kg): 2.5	Optimum Moisture Content (%) : 19
% Retained on 20.0mm BS Sieve	: 0	Type of Mould : Proctor	Method Used: Clause 3.3
Particle Density - assumed (Mg/m³)	: 2.65		Remarks:
Size of Soil Pieces	: <20mm	Separate samples were used.	
Sample Description			Key to Voids Ratio Lines
Reddish brown slightly sandy CLAY			<div>—— 0%</div> <div>----- 5%</div> <div>..... 10%</div>

content. 2 no. tests were carried out in a standard mould using a 2.5kg rammer and 1 no. test in a CBR mould. The results are presented graphically as dry density/moisture content curves together with values of maximum dry density and optimum moisture content identified from the plot.

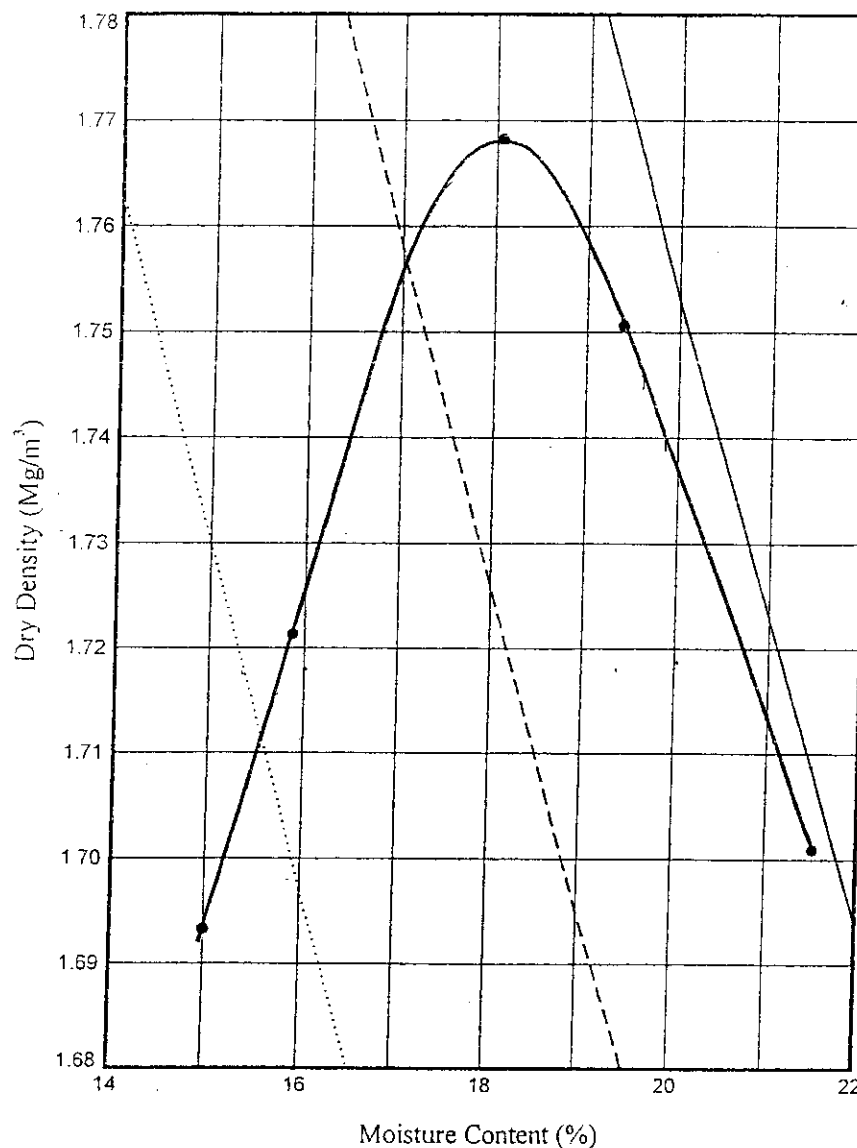
RY DENSITY / MOISTURE CONTENT RELATIONSHIP TEST

Initial Sample Conditions	Test Details	Test Results
Initial Moisture Content (%) : 18	Compaction Type : Light	Maximum Dry Density (Mg/m³) : 1.77
% Retained on 37.5mm BS Sieve : 35	Mass of Rammer (kg): 2.5	Optimum Moisture Content (%) : 18
% Retained on 20.0mm BS Sieve : 18	Type of Mould : CBR	Method Used: Clause 3.4
Particle Density - assumed (Mg/m³) : 2.70		Remarks:
Size of Soil Pieces : <20mm	Separate samples were used.	
Sample Description		Key to Voids Ratio Lines
Reddish brown sandy silty GRAVEL with some cobbles		<div>—— 0%</div> <div>---- 5%</div> <div>... 10%</div>

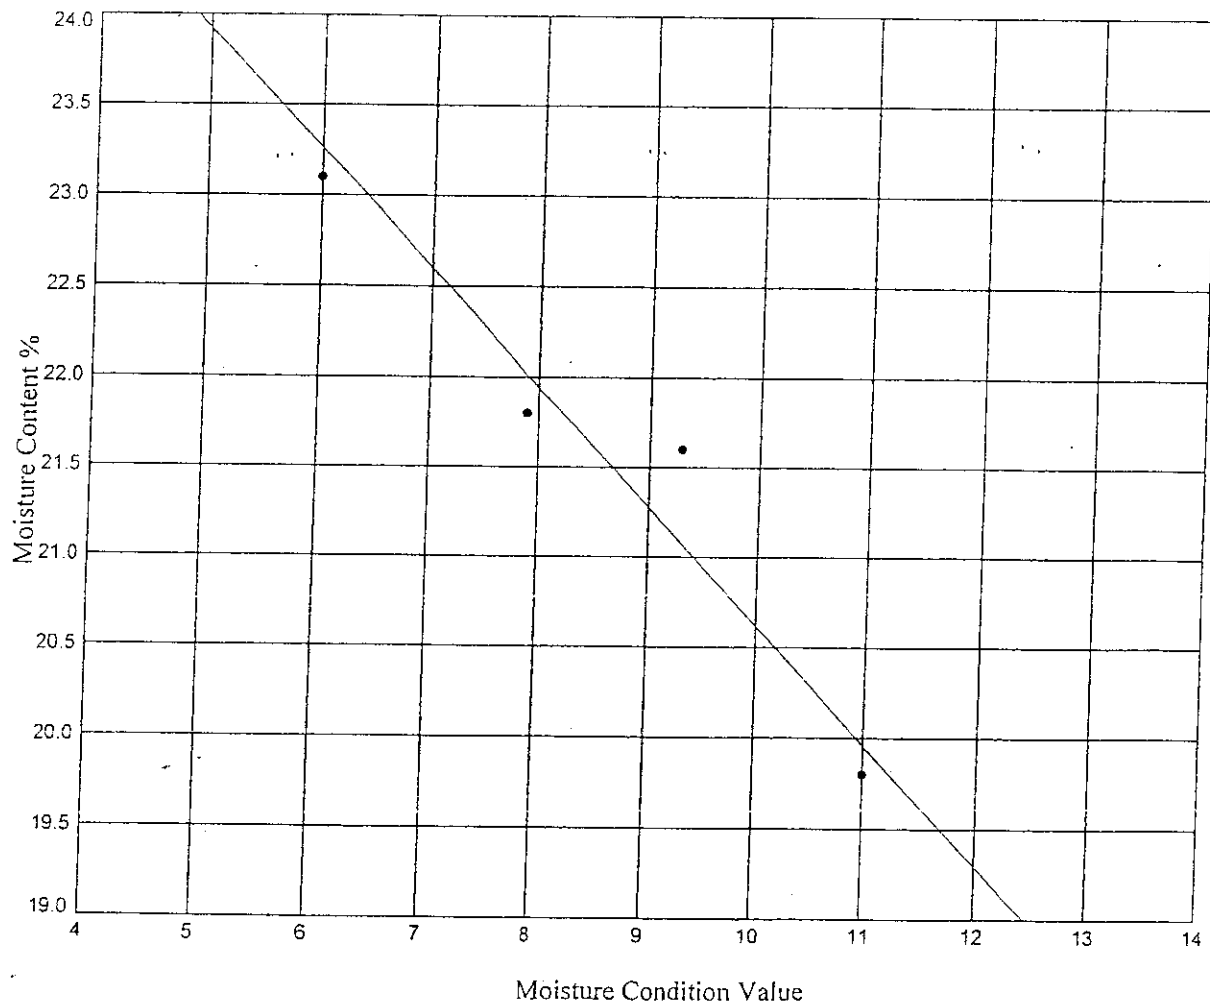
MOISTURE CONDITION VALUE CALIBRATION

Test Number	1	2	3	4	5
Moisture Content	21.8	23.1	21.6	19.8	
MCV	7.9	6.0	9.3	11.0

4 no. moisture condition value/moisture content relationship tests were undertaken in accordance with BS1377: Part 4: 1990. The results are represented graphically showing the relationship between change in moisture content and MCV.

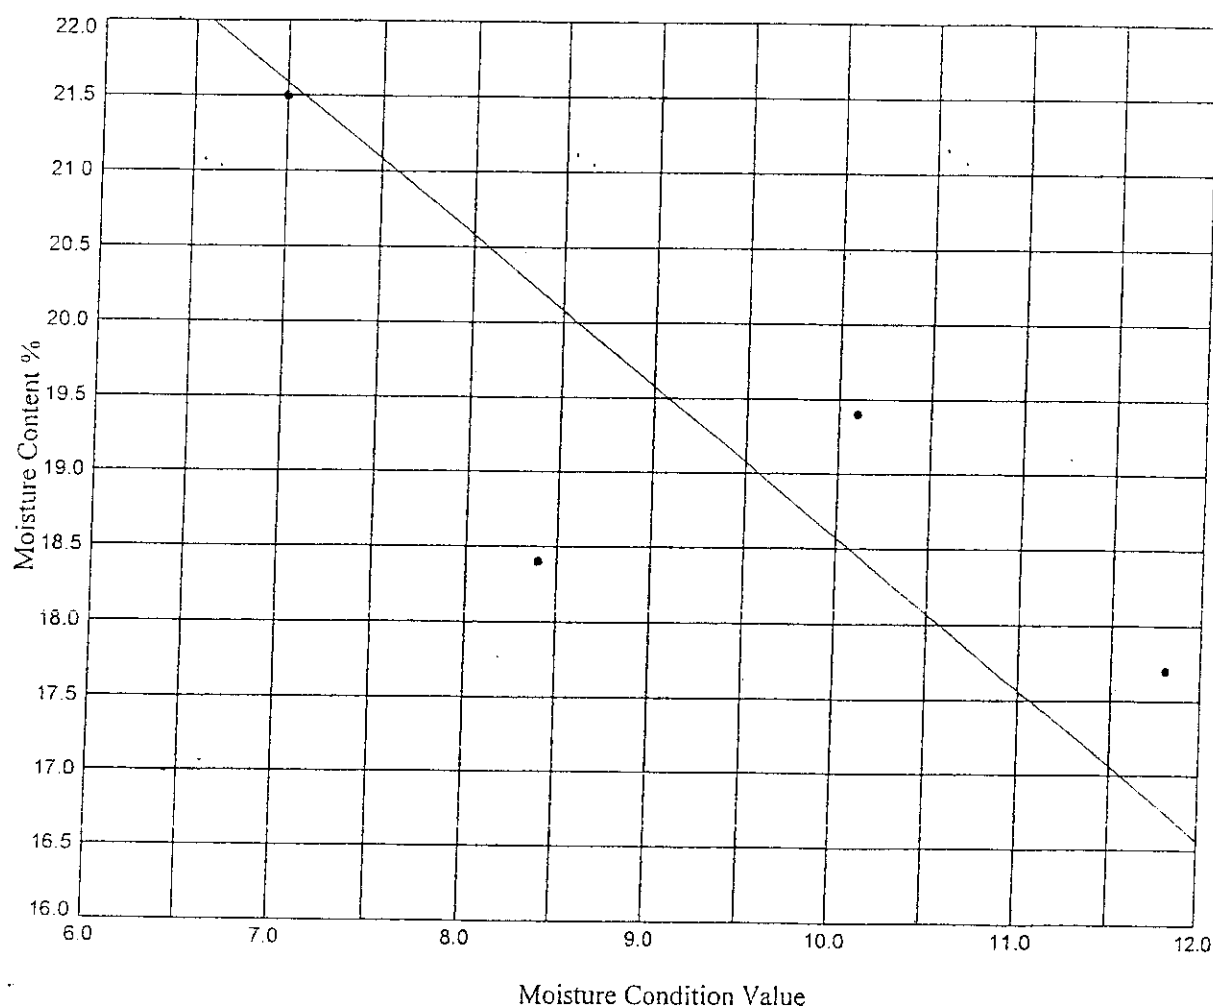
MOISTURE CONDITION VALUE CALIBRATION

Test Number	1	2	3	4	5
Moisture Content	18.4	17.7	19.4	21.5	
MCV	8.4	11.8	10.1	7.0

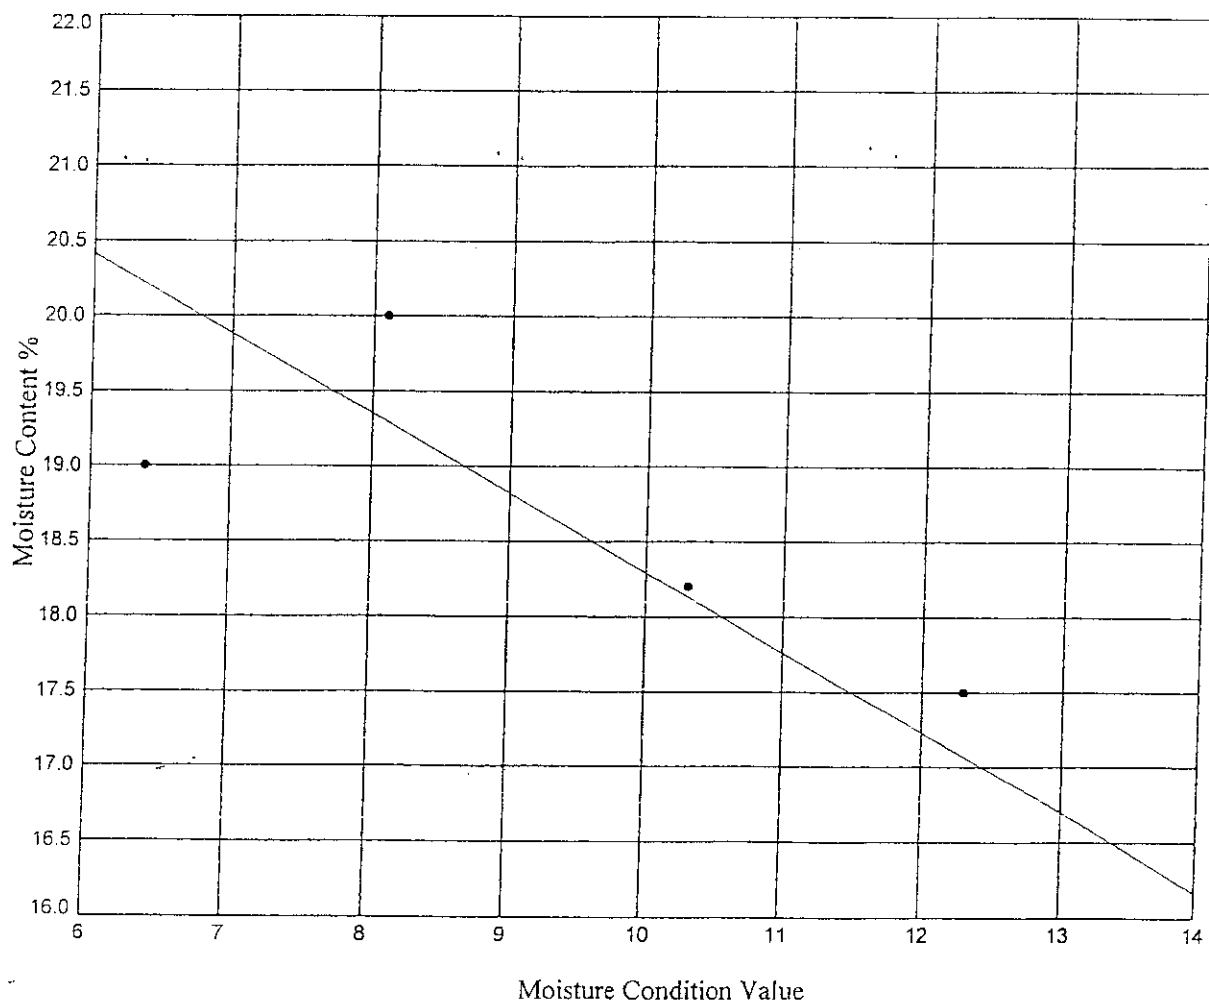
MOISTURE CONDITION VALUE CALIBRATION

Test Number	1	2	3	4	5
Moisture Content	17.5	19.0	20.0	18.2	
MCV	12.3	6.4	8.1	10.3

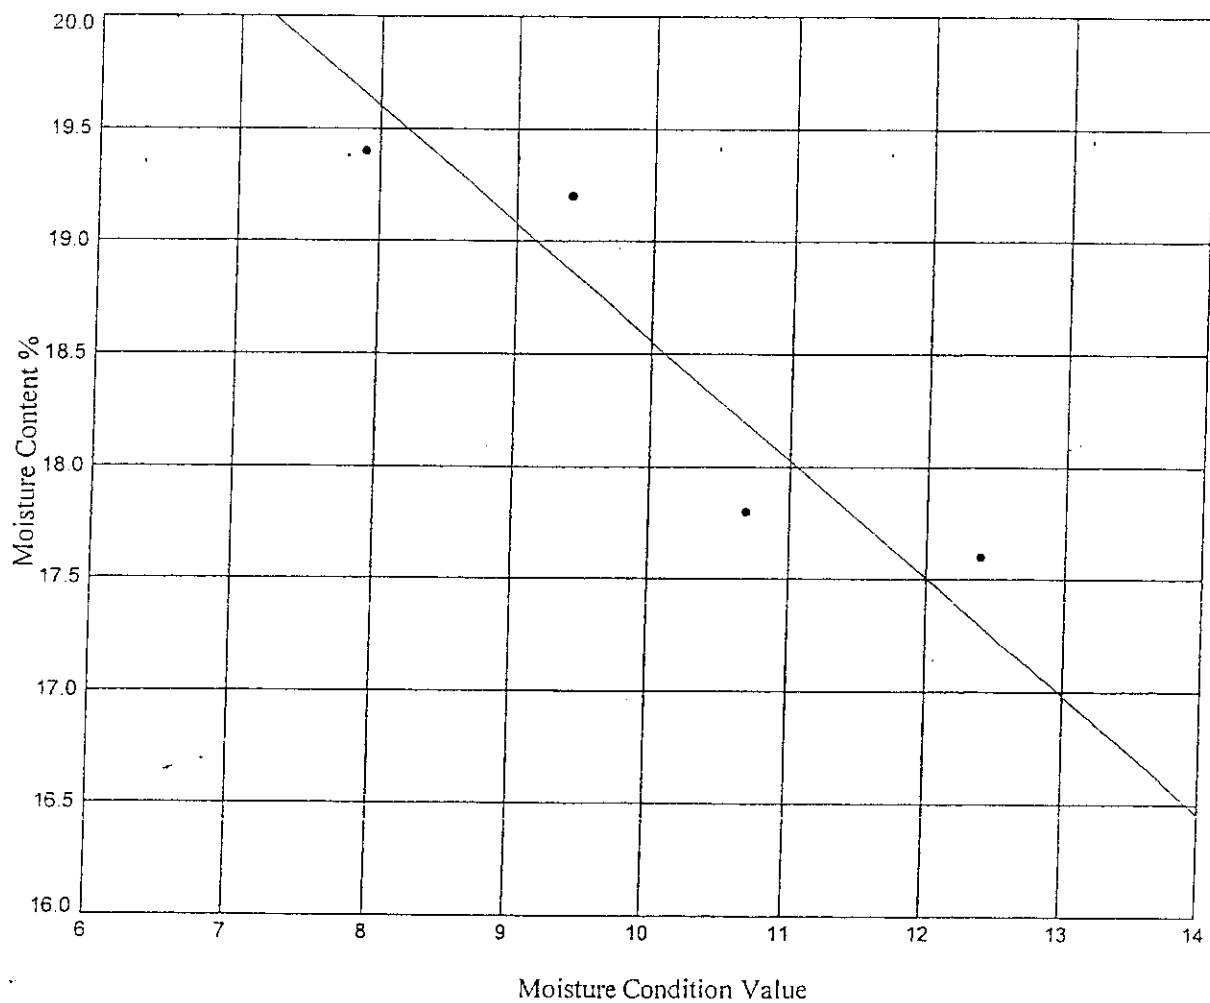
MOISTURE CONDITION VALUE CALIBRATION

Test Number	1	2	3	4	5
Moisture Content	17.6	17.8	19.2	19.4	
MCV	12.4	10.7	9.4	7.9
