MABEY HOUSE,
NEW HOUSE PARK, CHEPSTOW

ALUK (UK)

PHASE 1 DESK STUDY REPORT

Document Ref. 6283b/2258
Date: May 2016
Status: Draft Report
Revision: 0

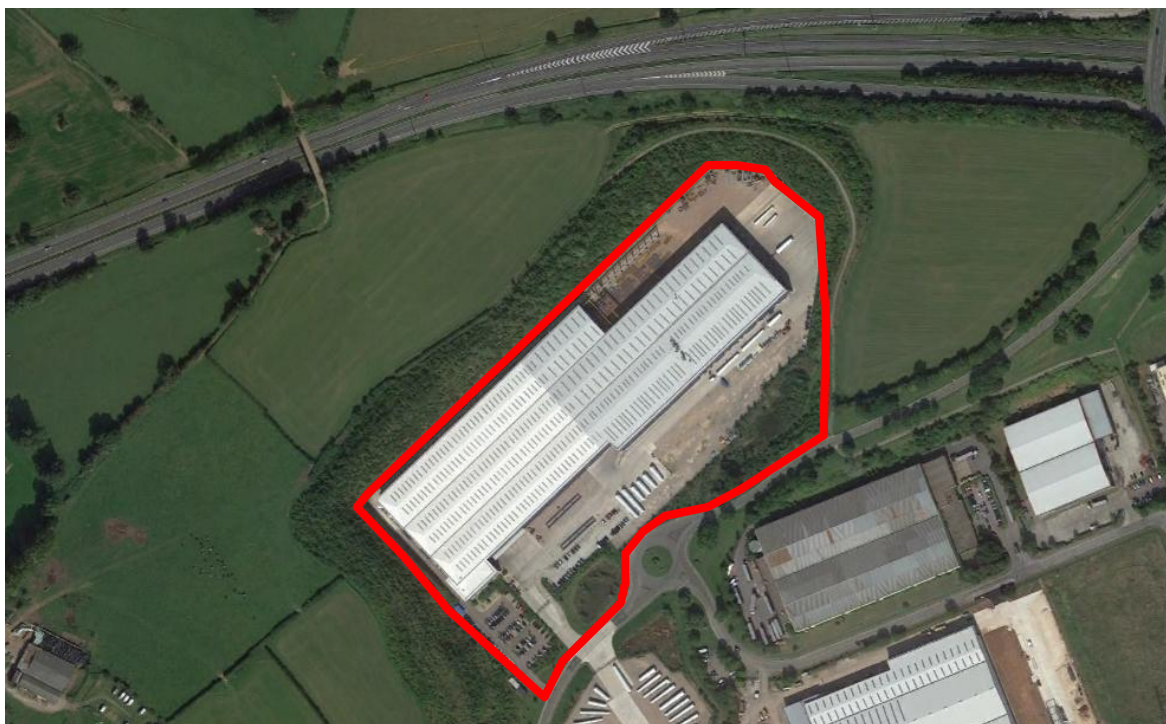
Inset 1: Current Site Layout

The west and north boundaries are indicated to be surrounded by an embankment and heavily vegetated. Two ponds are noted in the south portion of the site. A general layout of the site is presented on Inset 1 below.

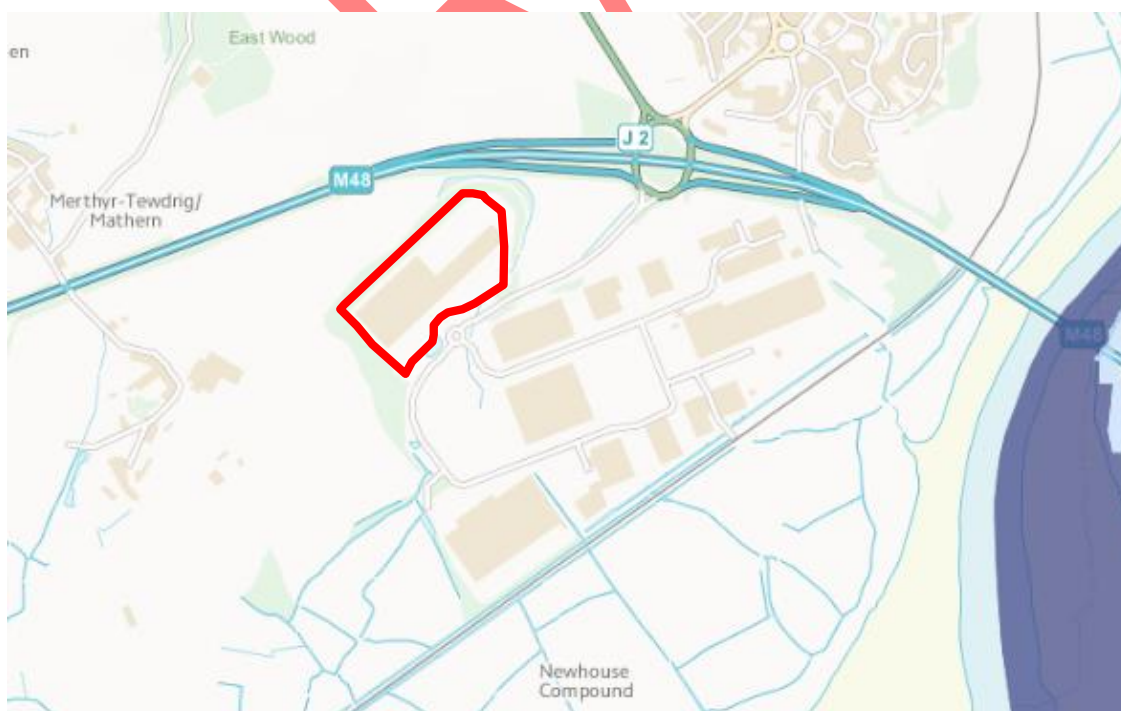
Inset 2: Flood Risk Mapping (EA - May 2016)

From a review of topographical plans and flooding maps presented on the Environment Agency (EA) website (EA, 2015), the site is not indicated to be at risk from flooding.
