# Bynea Tidal Flap

## Otter Survey Report

| DOCUMENT INFORMATION | | | |
|---|---|---|---|
| Document Ref | EV000876/OSR | Issue / Revision | 1.0 |

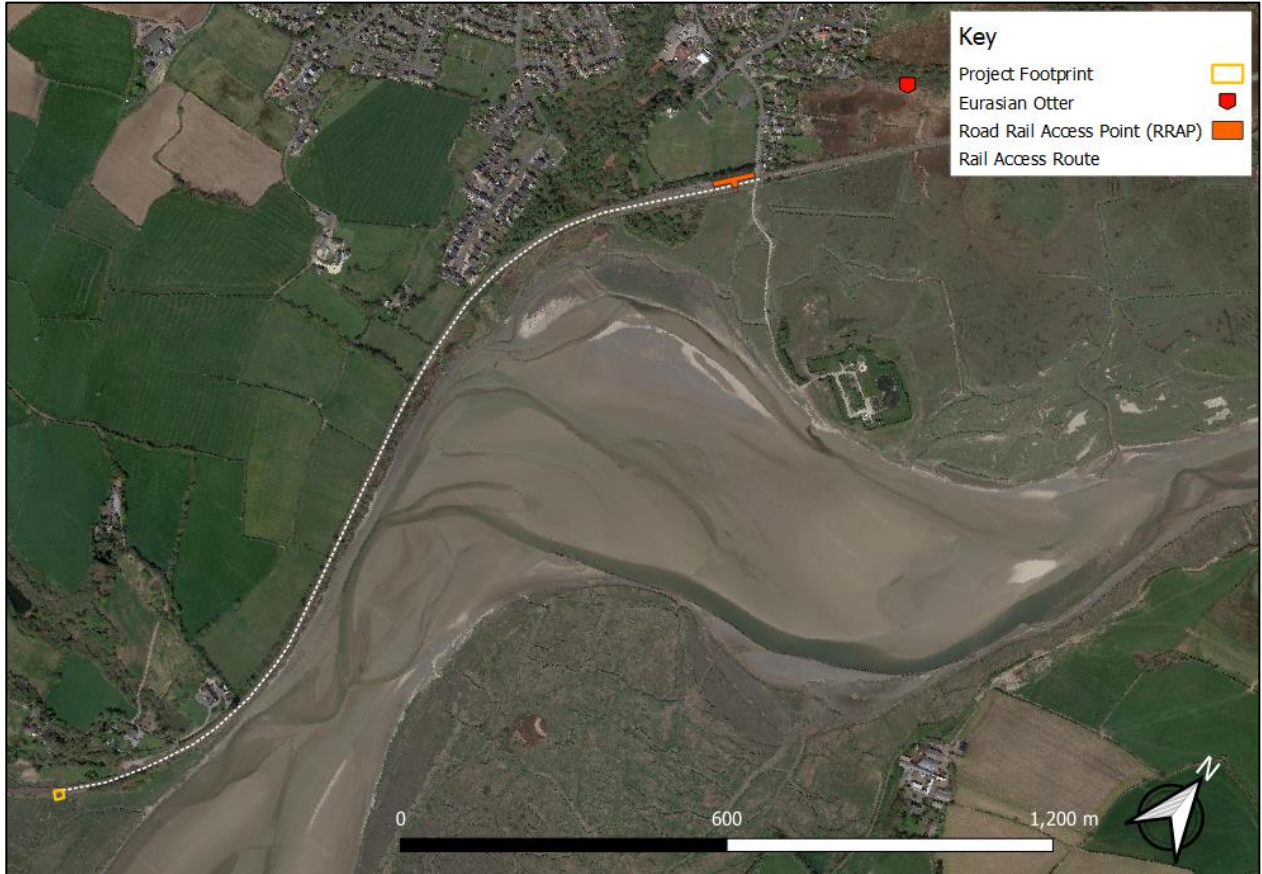
Figure 1: WWBIC Records.

2.1.1 The figure below illustrates known Otter records from the WWBIC dataset within proximity to the project area.

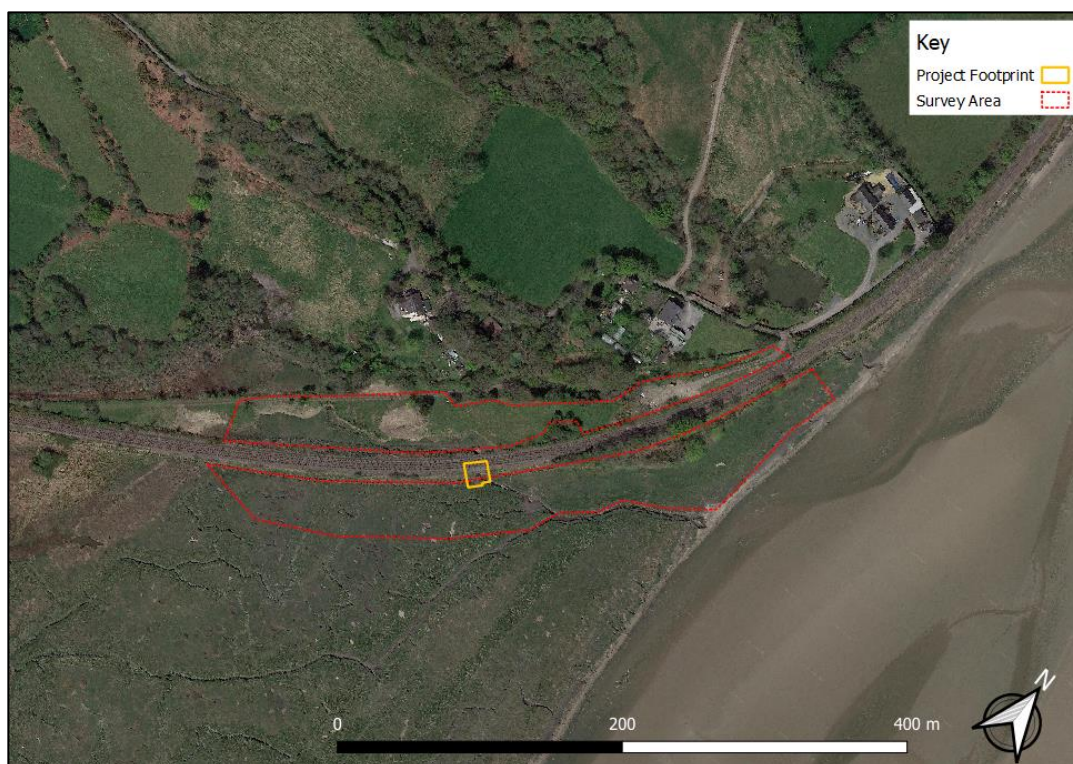
**Figure 2: Survey Area**

2.2.1 The survey was focused on areas of habitat directly connected to the proposed working area.

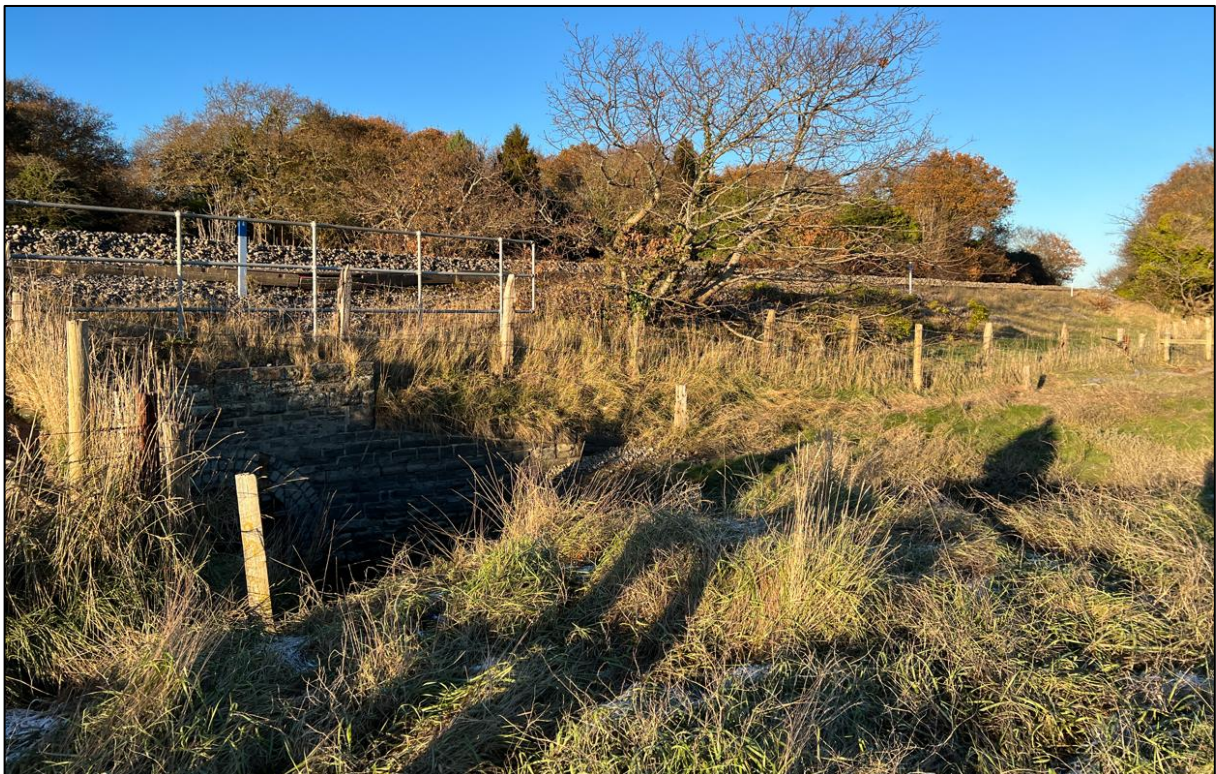
3.1.2 The images below were taken during low tide conditions.

**Figure 3: Habitat around mouth of tidal flap**

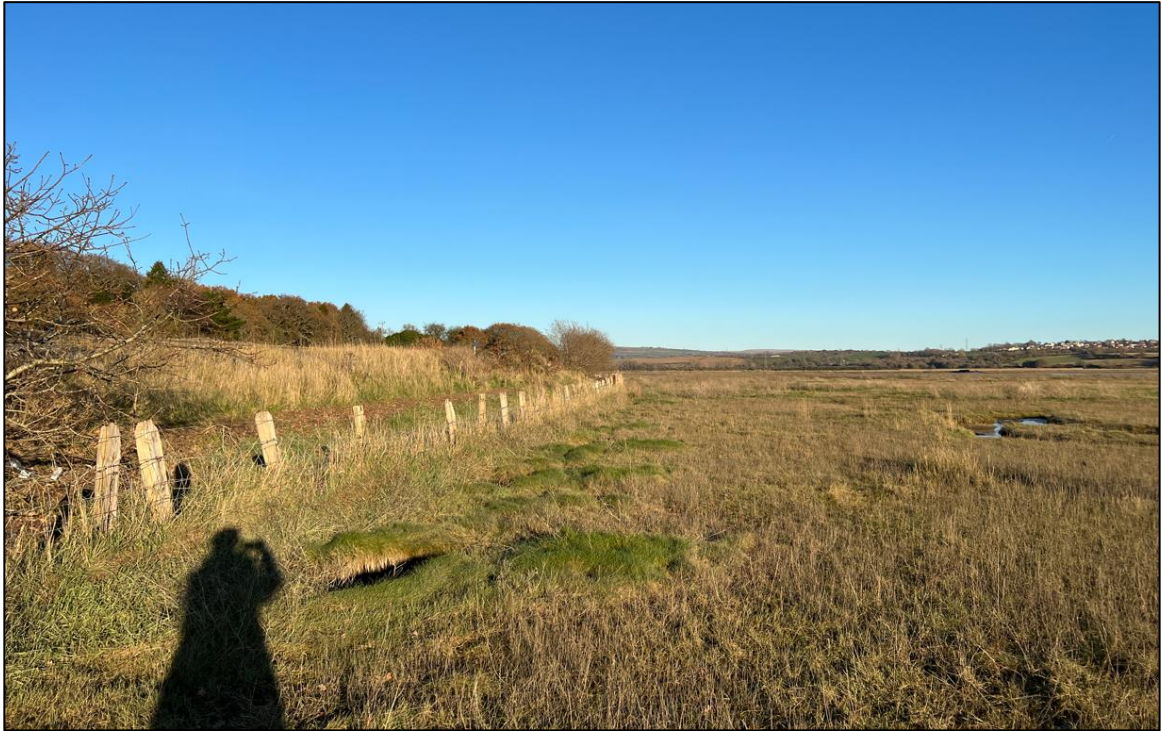
**Figure 4: Approx. 100m+ further south of the tidal flap.**

- 3.1.3 The estuarine facing habitat is generally very exposed, with salt marsh along the base of the rail being within the strand line.

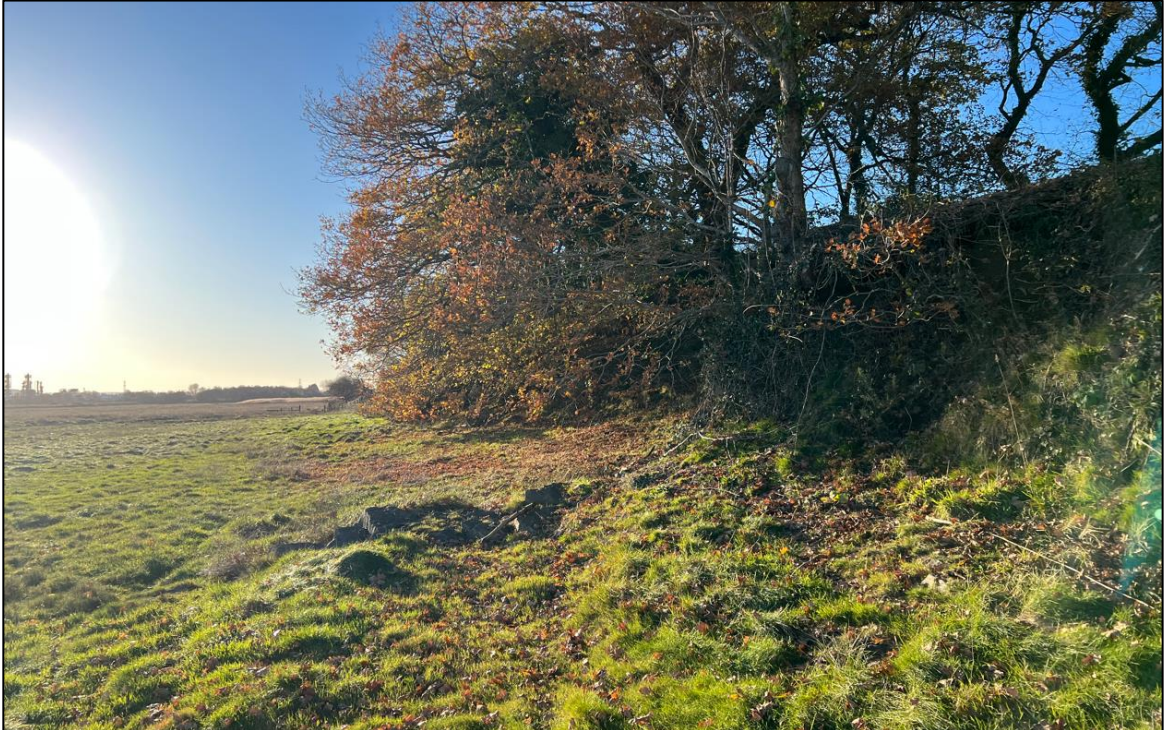
**Figure 5: Raised ground in front of small rail cutting, north (upstream) of Tidal Flap.**

- 3.1.4 Small mammal holes (likely rabbit) were noted along the exposed, south facing side of the outcrop.

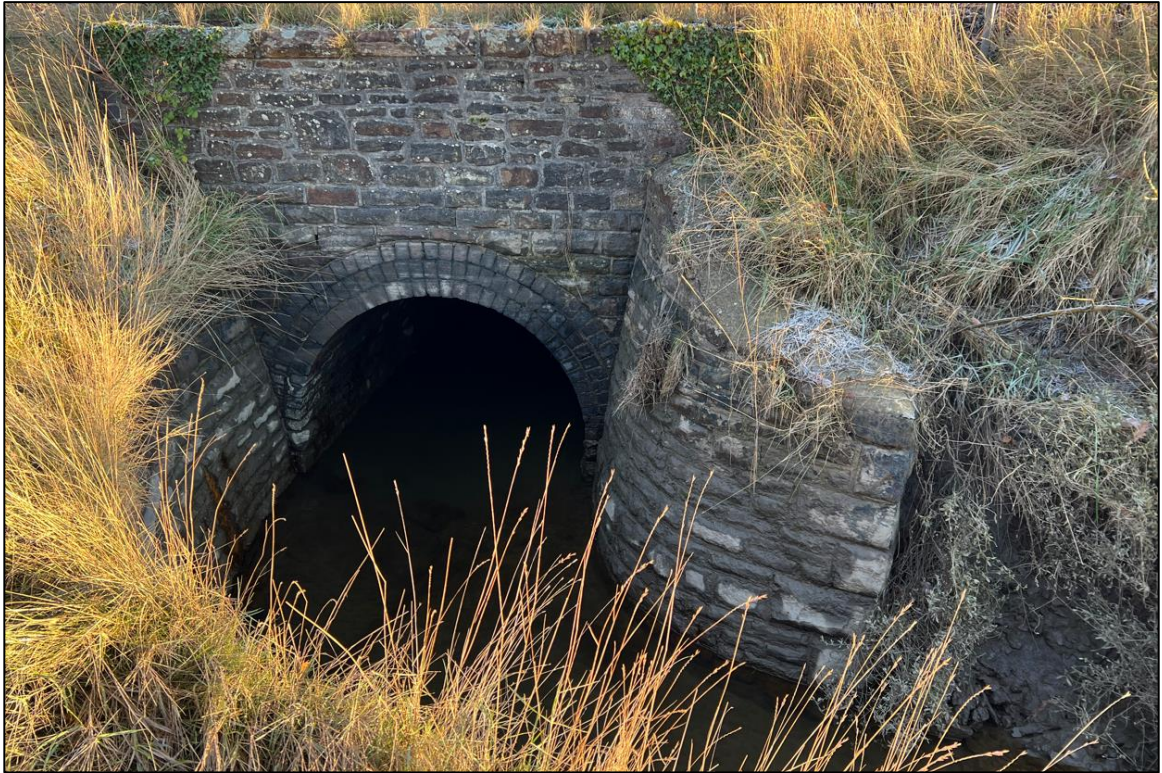
***Figure 6: Inlet of culvert below rail corridor (north side).***

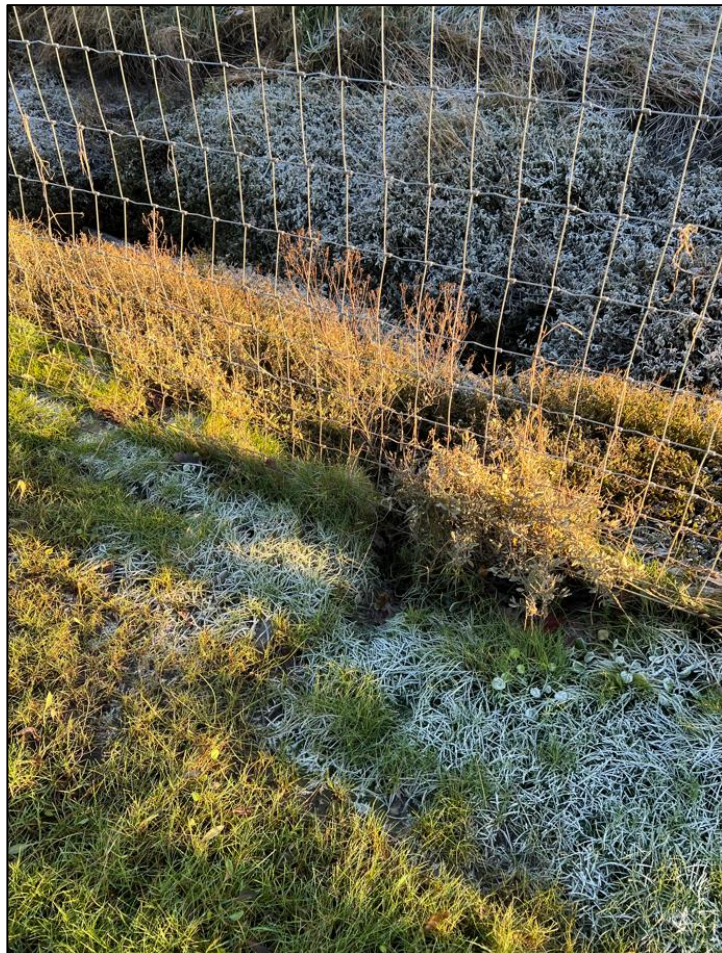
***Figure 7: Mammal path below NR boundary fence.***

| Target Note: | Field Sign | Descriptions |
|---|---|---|
| 01 | Mammal paths | (Figure 7) A distinct mammal was observed below the network rail boundary fence approx. 30m upstream of the culvert. |

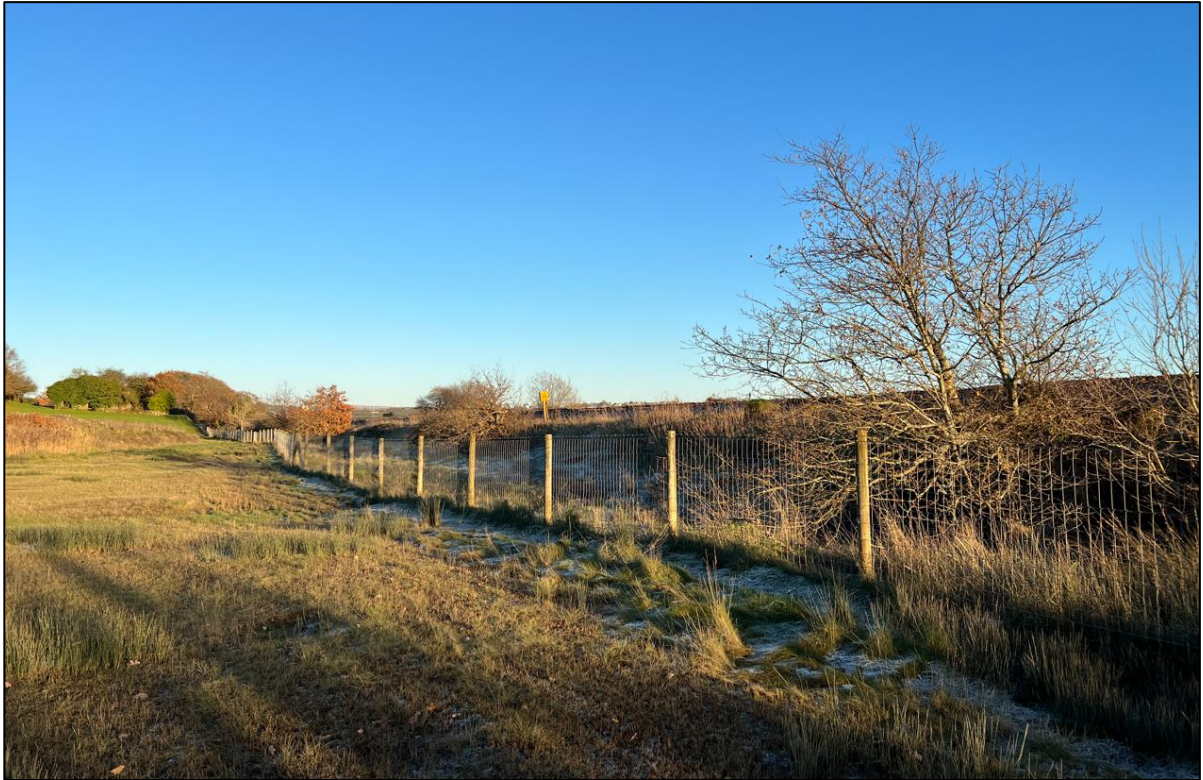
**Figure 8: North Side, 100m south of Culvert.**
