# NANTYCAWS LANDFILL

**Landfill Surface Emissions Survey 2022**  
**Prepared for: CWM Environmental Limited**

SLR Ref: 402.064394.00001  
Version No: v1.0  
January 2023

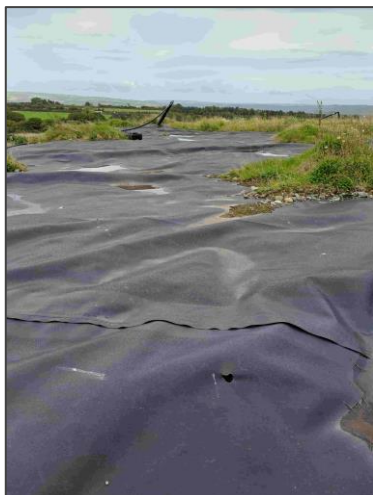
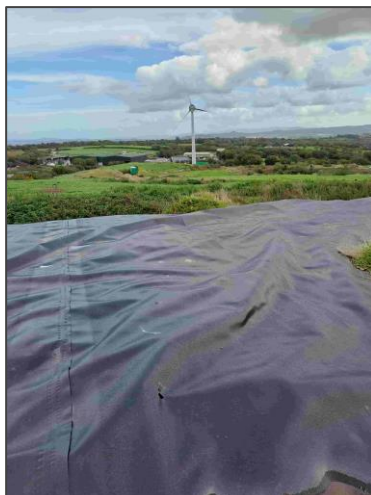
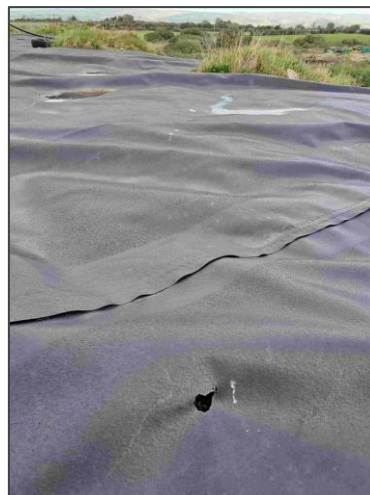
| Ref. | Grid Reference (NGR) (m) | Maximum Methane Concentration (ppm) | Exceedance Information |
|---|---|---|---|
| C1 | x246897, y217420 | 250 | Hole in membrane, ~10m west of NYCW1201 |

| Reference | Remediation undertaken | Maximum Methane Concentration (ppm) |
|---|---|---|
| C1 | Extrusion wield | 0 |

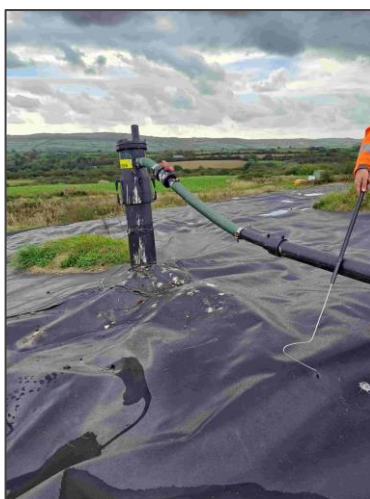
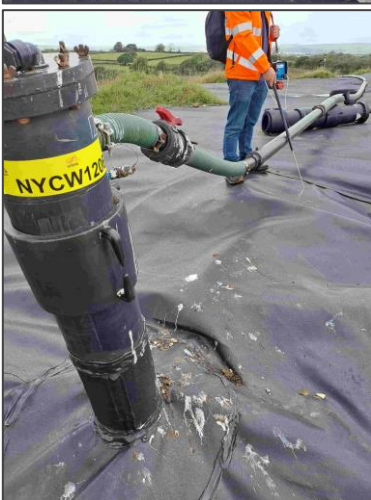
| Ref. | Grid Reference (NGR) (m) | Maximum Methane Concentration (ppm) | Exceedance Information |
|---|---|---|---|
| C2 | x246895, y217394 | 1,000 | Small hole in membrane, ~2m north of NYCW1206 |

| Reference | Remediation undertaken | Maximum Methane Concentration (ppm) |
|---|---|---|
| C2 | Extrusion wield | 0 |

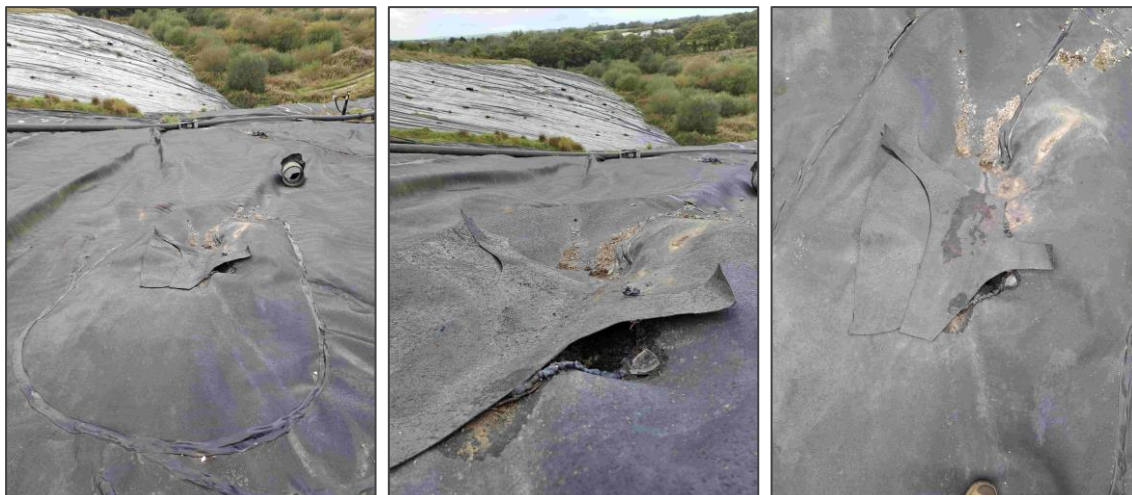
| Ref. | Grid Reference (NGR) (m) | Maximum Methane Concentration (ppm) | Exceedance Information |
|---|---|---|---|
| C3 | x246850, y217386 | 10,000 | South-east of NYCW1407 |

| Reference | Remediation undertaken | Maximum Methane Concentration (ppm) |
|---|---|---|
| C3 | Extrusion wield | 0 |

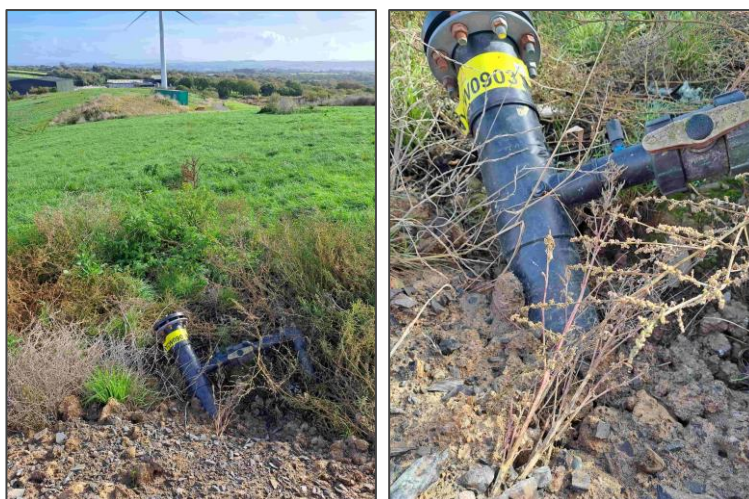
| Ref. | Grid Reference (NGR) (m) | Maximum Methane Concentration (ppm) | Exceedance Information |
|---|---|---|---|
| F1 | x246987, y217497 | >5,000 | NYCW0903 – base of well |

| Reference | Remediation undertaken | Maximum Methane Concentration (ppm) |
|---|---|---|
| F1 | Removal of soil to uncover gas infrastructure beneath to allow repair works | 10 |

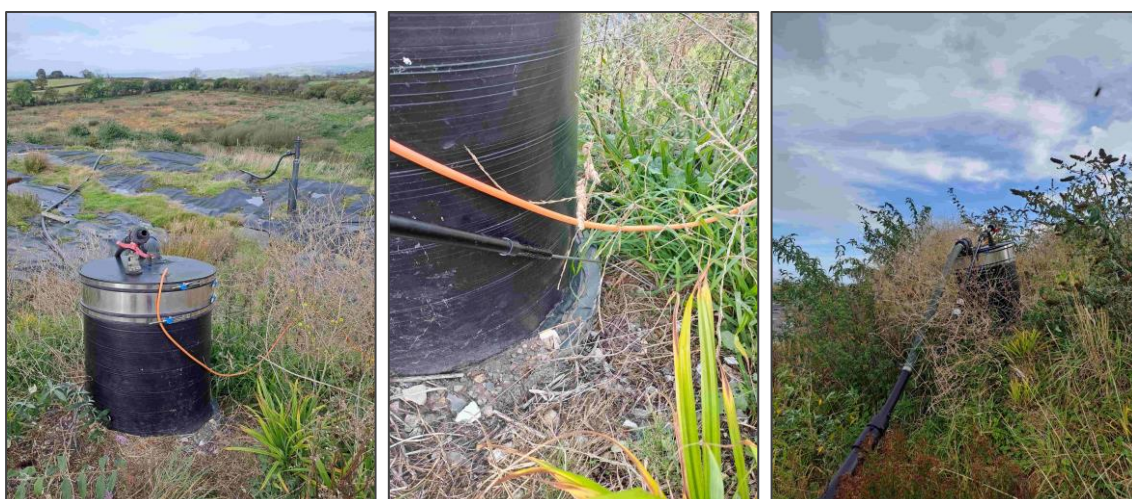
| Ref. | Grid Reference (NGR) (m) | Maximum Methane Concentration (ppm) | Exceedance Information |
|---|---|---|---|
| F2 | x246874, y217457 | >5,000 | NYCLW016 – base of well |

| Reference | Remediation undertaken | Maximum Methane Concentration (ppm) |
|---|---|---|
| F2 | New collar and extrusion wield at base of well | 100 |

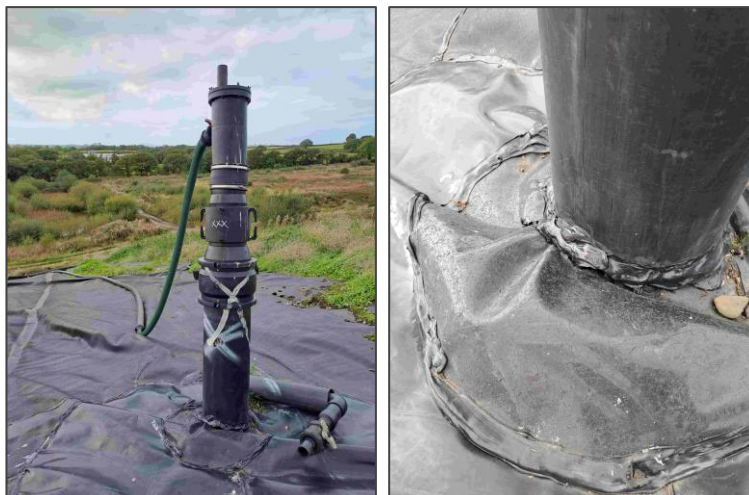
| Ref. | Grid Reference (NGR) (m) | Maximum Methane Concentration (ppm) | Exceedance Information |
|---|---|---|---|
| F3 | x246830, y217420 | 5,000 | NYCLW017 – cracks around old sealant |

| Reference | Remediation undertaken | Maximum Methane Concentration (ppm) |
|---|---|---|
| F3 | Extrusion wield at base of well | 0 |

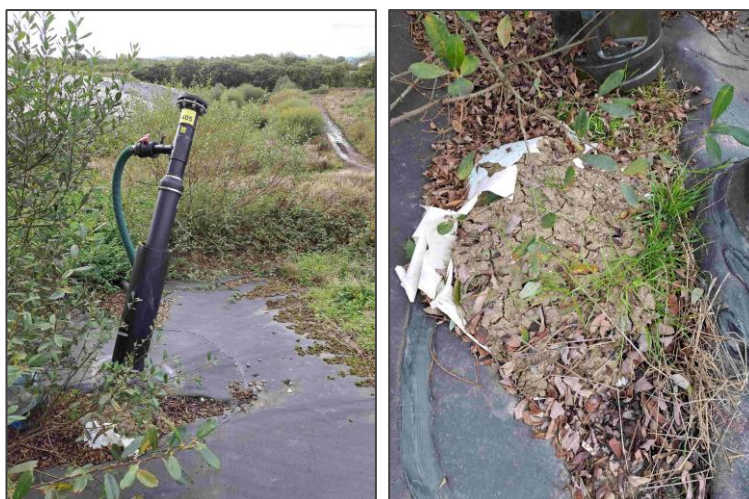
| Ref. | Grid Reference (NGR) (m) | Maximum Methane Concentration (ppm) | Exceedance Information |
|---|---|---|---|
| F4 | x246804, y217424 | 2,000 | NYCW1405 – base of well |

| Reference | Remediation undertaken | Maximum Methane Concentration (ppm) |
|---|---|---|
| F4 | Extrusion wield at base of well | 0 |

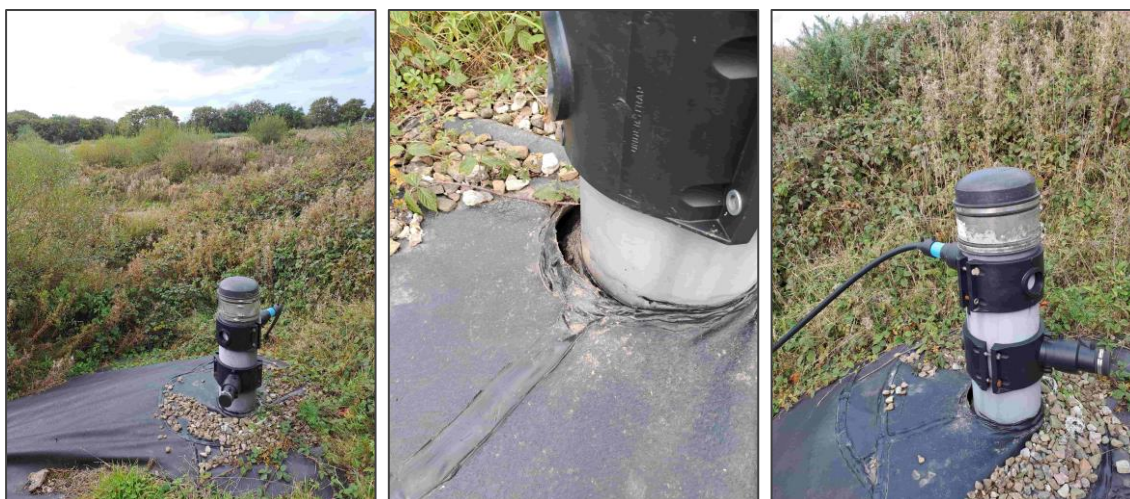
| Ref. | Grid Reference (NGR) (m) | Maximum Methane Concentration (ppm) | Exceedance Information |
|---|---|---|---|
| F5 | x246775, y217424 | >5,000 | SUMP2 - gap between membrane and base of well |

| Reference | Remediation undertaken | Maximum Methane Concentration (ppm) |
|---|---|---|
| F5 | Extrusion wield at base of well | 0 |

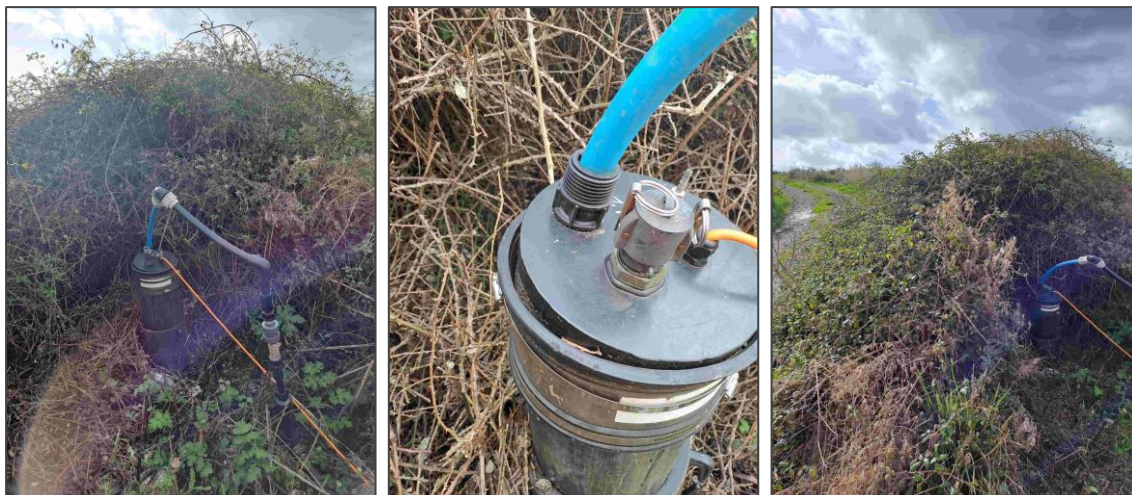
| Ref. | Grid Reference (NGR) (m) | Maximum Methane Concentration (ppm) | Exceedance Information |
|---|---|---|---|
| F6 | x246987, y217456 | 1,000 | NYCL0005 – cap of well dislodged |

| Reference | Remediation undertaken | Maximum Methane Concentration (ppm) |
|---|---|---|
| F6 | New collar | 50 |
