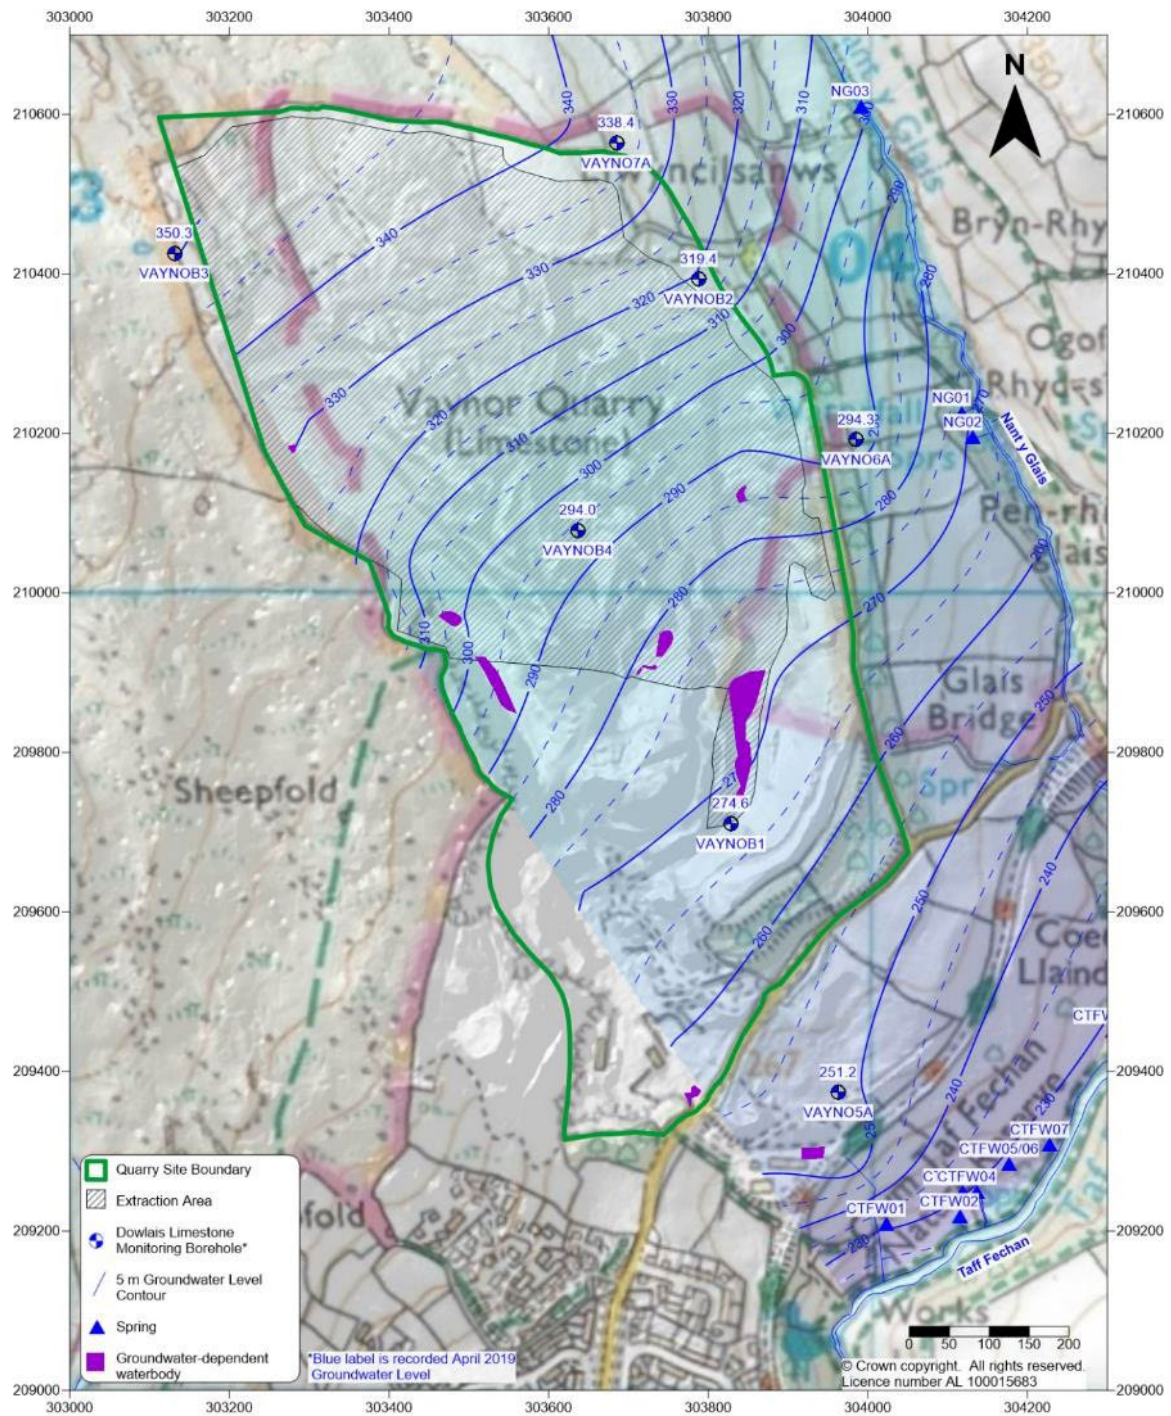
Figure 9.13 Dowlais Limestone groundwater contours: April 2019

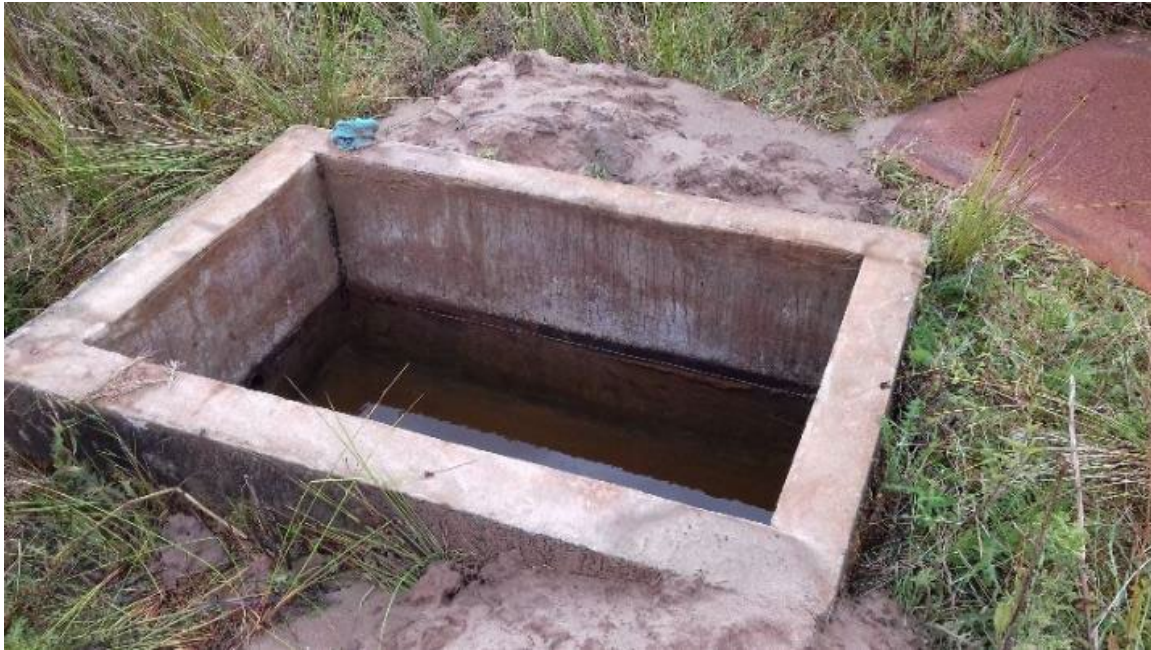
Figure 9.18 Llwynsilanws Farm springs (from July 2018 visit)
