Ecological Baseline Report

Snowdonia Visual Impact Provision Project

Hochtief UK Ltd

January 2023

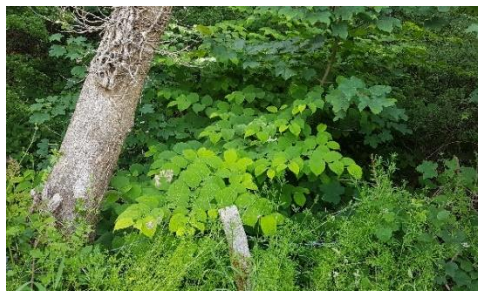
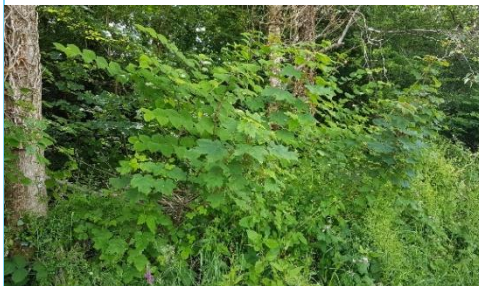
Invasive Species Report Reference	Grid Reference (GPS)	Type Of Invasive Species	Approximate No of stems	Other Info
1A	52.926275, -4.094052	Japanese Knot Weed	30 with additional 10 stems slightly to east

<p>Additional Block</p>

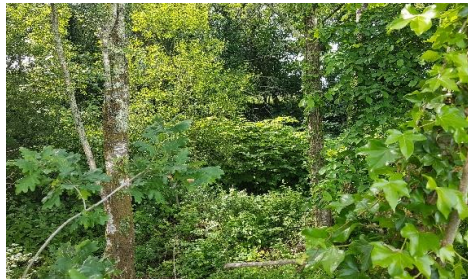
1B	52.926356, -4.093426	JKW	100+ Block approx. 10m x 15m	<p>Block may be considerably larger once able to gain access to site</p>

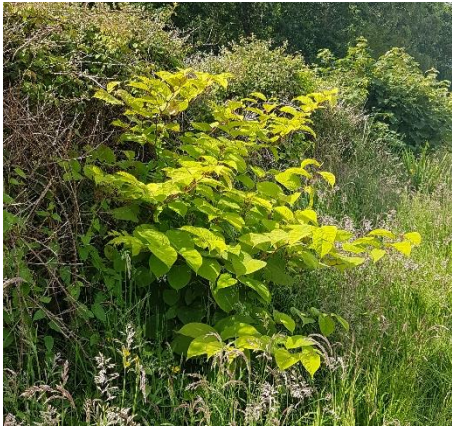
2A	52.926679, -4.092799	JKW	10	Measures need to be taken to prevent plant being cut during hedge management operations e.g.,

Invasive Species Report Reference	Grid Reference (GPS)	Type Of Invasive Species	Approximate No of stems	Other Info
				fencing/signage

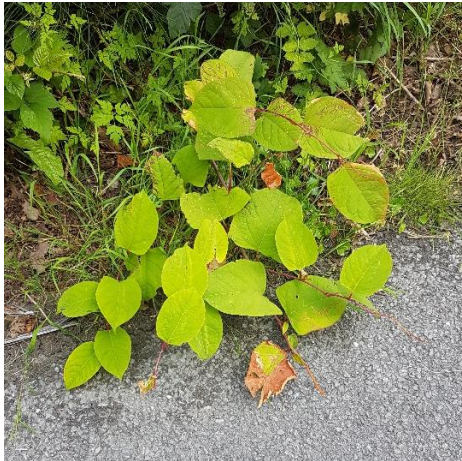
2B	52.926598, -4.092888	JKW	3	One stem snapped and fallen into road

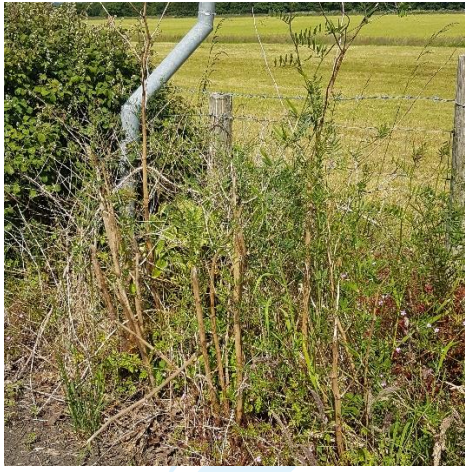
2C	52.926733, -4.092486	JKW	no stems – all stems dead, no evidence of regrowth	Been foliar sprayed by highways management contractor

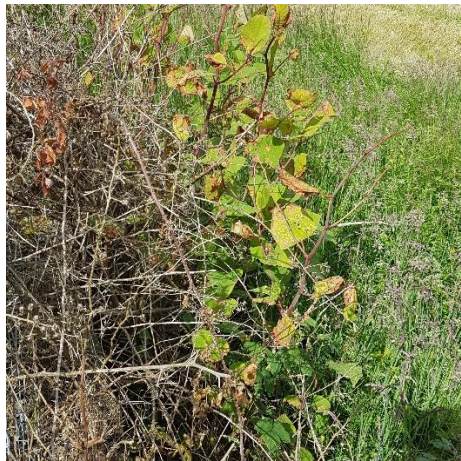
2D	52.92676, -	JKW	20	Although not growing on highway verge,

Invasive Species Report Reference	Grid Reference (GPS)	Type Of Invasive Species	Approximate No of stems	Other Info
	4.092351			has been partially treated by highways contractor

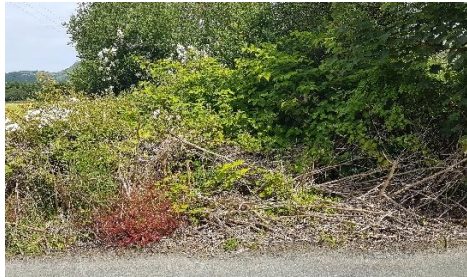
2E	52.926787, -4.092217	JKW	100+ Approx 10 x 3m in area	Roadside face been treated by highways contractor, but large stand remains in garden combined with dense bramble thicket. Ditch present behind roadside wall. Area will need treating and then cutting to ground over winter

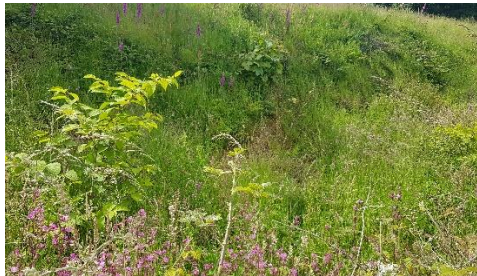
2F	52.926679, -4.092217	JKW	15	Total of 3 small stands in close proximity to each other, one of which been foliar sprayed

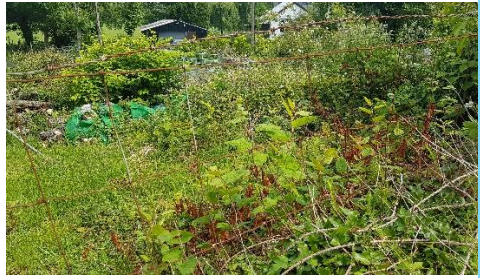
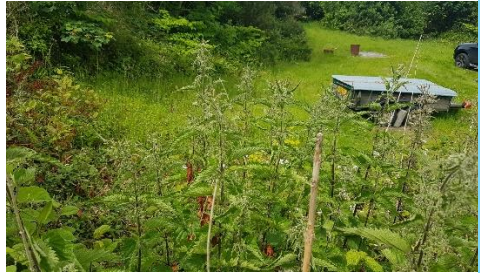
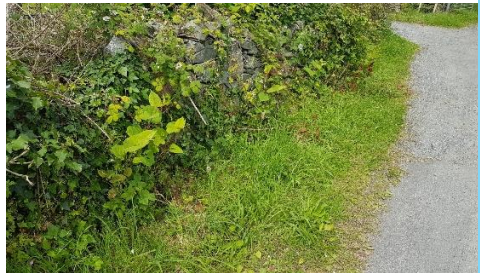
2G	52.926895, -4.091814	JKW	100+	Multiple blocks along boundary, in garden/parking area, growing out of walls etc. Appears to have been mown/cut in places

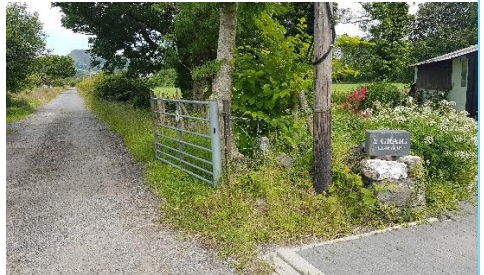
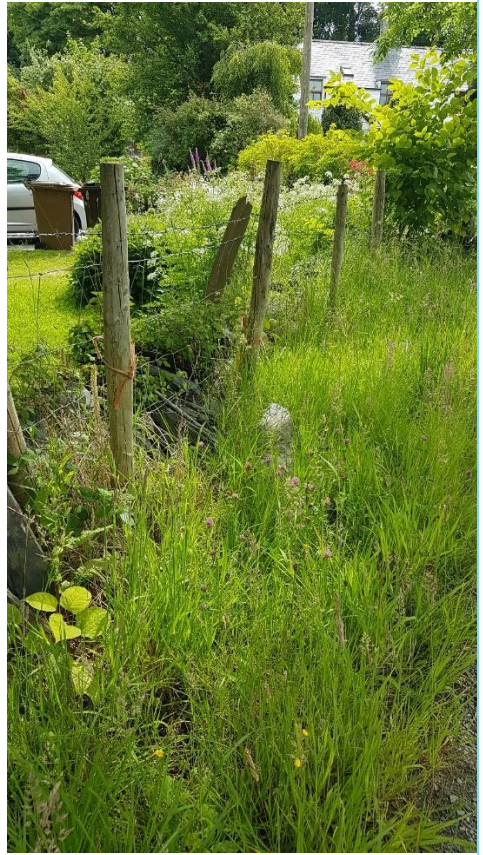
3	52.92711, -4.091814	JKW	30	<p>Location in the Invasive Species Survey report is incorrect. Use Grid Reference. Plants around power pole, entrance to house and along stock fence.</p>

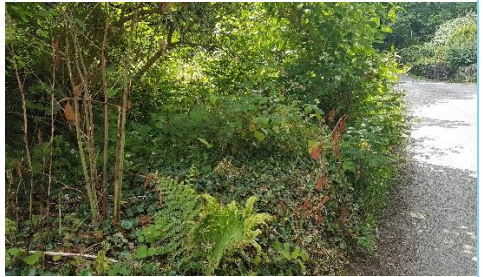
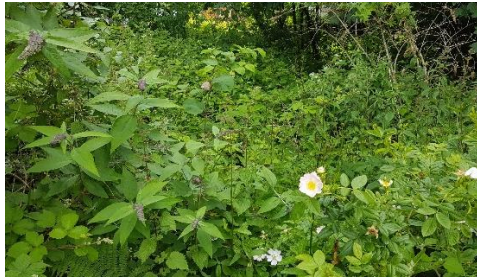
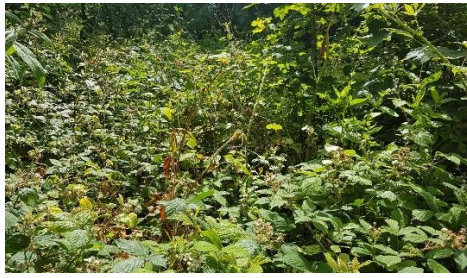
4	52.927245, -4.090472	JKW	30	<p>Multiple small stands throughout the area, some of which been foliar sprayed, others not. Area needs treating, plants marking and then vegetation cut over winter.</p>

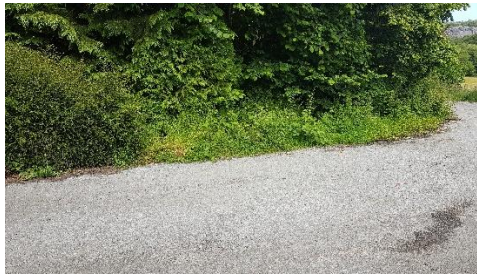
5	52.927488, -4.090382	Montbretia	4 plants in tipped pile of garden waste, just behind garden wall, where wall collapsed.	<p>No sign of JKW, but a lot of other vegetation for small stems to hide in. Picture below shows location to access collapsed wall.</p>

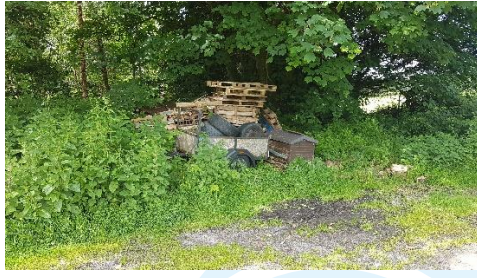
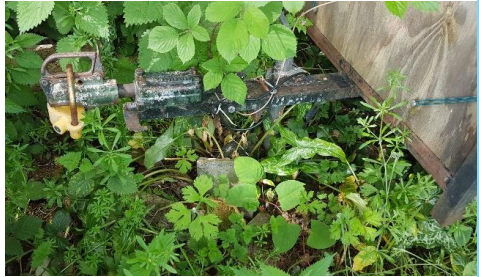
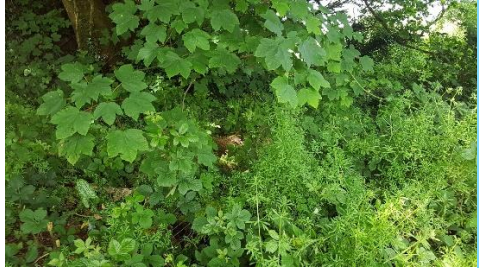
6	52.927784, -4.090561	JKW & Montbretia	1 stem JKW and small Montbretia	<p>Single stem beside trailer and small Montbretia under large sycamore.</p>

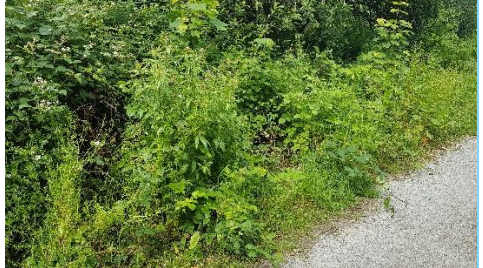
7	52.927865, -4.090606	JKW	3	<p>2 of the 3 stems have been foliar sprayed. Invasive Species Survey has incorrect location marked, use Grid Reference.</p>

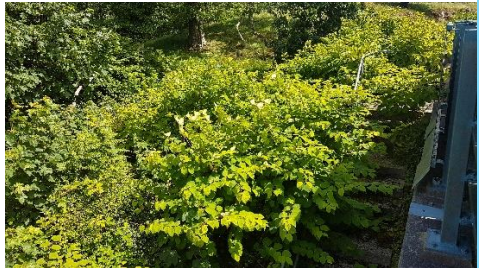
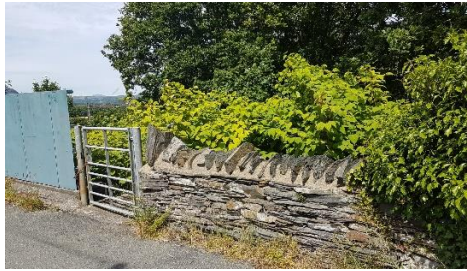
8	52.927595, -4.087831	JKW	100+	<p>Large block on NWR land.</p>

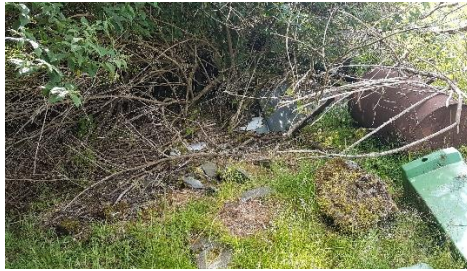
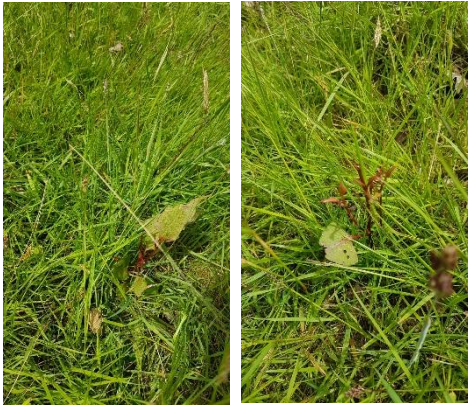
9	52.927622, -4.087473	None	0	No evidence of any INNS in this area
10	52.927892, -4.086131	JKW	50

<p>Multiple tiny stems, as per pictures below, throughout grassland area under power lines. Some treatment done by landowner, but created stunted growth as done at wrong time of year.</p>

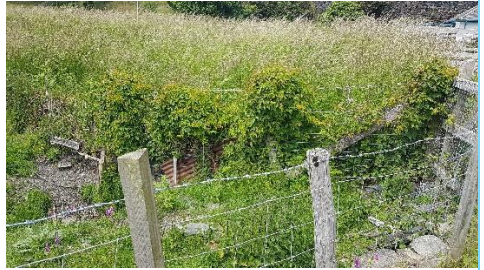
11A	52.928215, -4.066886	Virginia Creeper	On railway boundary Fence	Growing on posts above ditch, will need spray licence to treat.

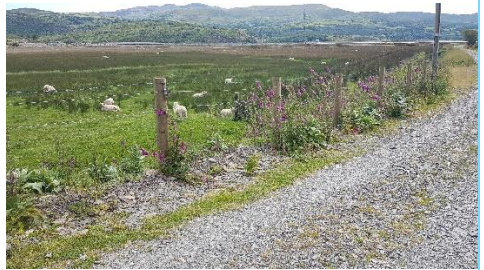
11B	52.928081, -4.066752	None	0	<p>No evidence of any INNS.</p>

<p>No evidence of any INNS, however evidence of recent works undertaken to access track, as per picture above.</p>
12	52.928647, -4.060307	JKW	50+	<p>Multiple stands along railway embankment furthest from road, with signs of historic treatment.</p>
